Serious incident

to the Bombardier CRJ700 registered **F-GRZL**
and to the Airbus A319-111 registered **G-EZAZ**
on 17 March 2017
at Lyon Saint-Exupéry (Rhône)

Near incursion of an aeroplane cleared to cross the runway during the take-off of another aeroplane

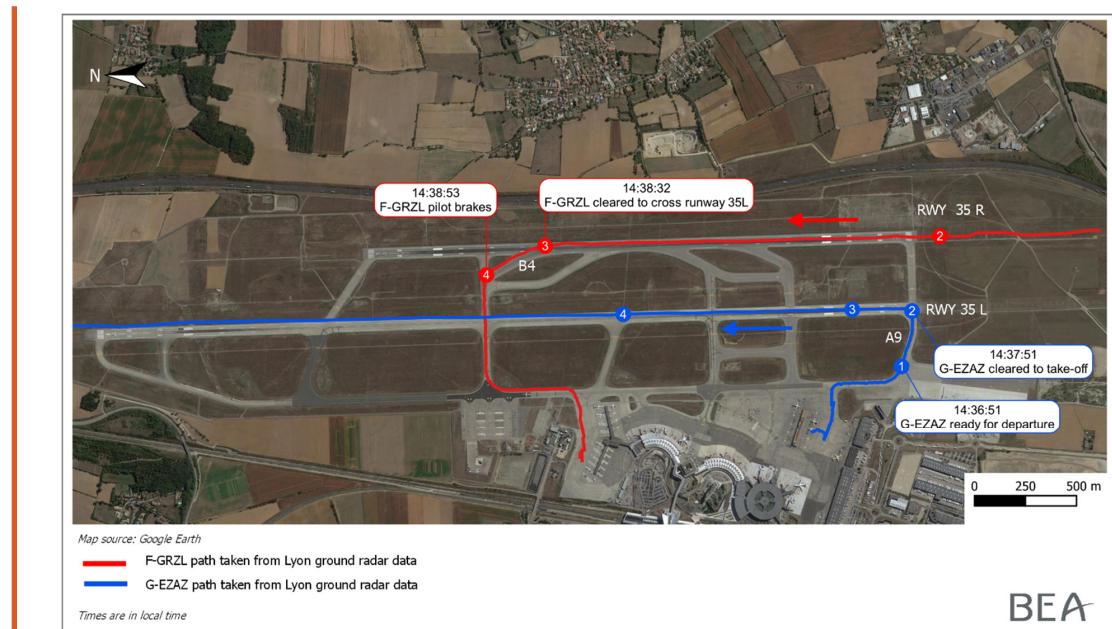
Figure 1: paths of F-GRZL and G-EAZZ

Forty-one seconds later, the LOC controller cleared HOP83AJ to cross runway 35L via B4, *"Hop83 Alpha Juliet, traversez la piste 35 Gauche"*³, and then cleared the following flight to land on runway 35R. EZY748Z had started its take-off run and was at this point around 1,000 m from taxiway B4³.

Twenty seconds later, the crew of HOP83AJ started braking⁴ as they had seen flight EZY748Z taking off from runway 35L⁴. Almost simultaneously, the LOC controller ordered HOP83AJ to hold its position, *"Alpha Juliet, maintenez position."* The latter came to a halt before crossing the CAT III⁽⁶⁾ runway-holding position marking. EZY748Z was at this point around 300 m from taxiway B4.

At 14:38:58, EZY748Z, still in the take-off run phase passed in front of HOP83AJ. Following this incident, the LOC controller was relieved by his assistant.

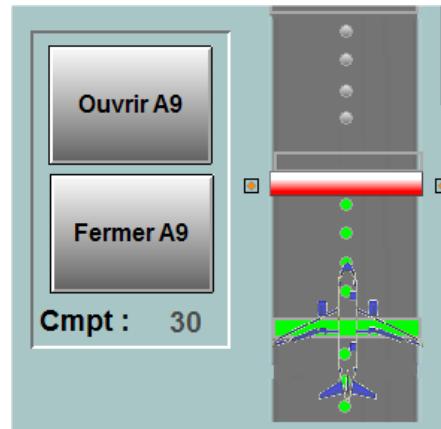
Figure 3: detail of stop bar control at control position

The controllers interviewed specified that having to carry out a manual action for each aeroplane movement and not being able to use all the taxiways means that this stop bar system is poorly adapted to the denser traffic existing outside LVP.

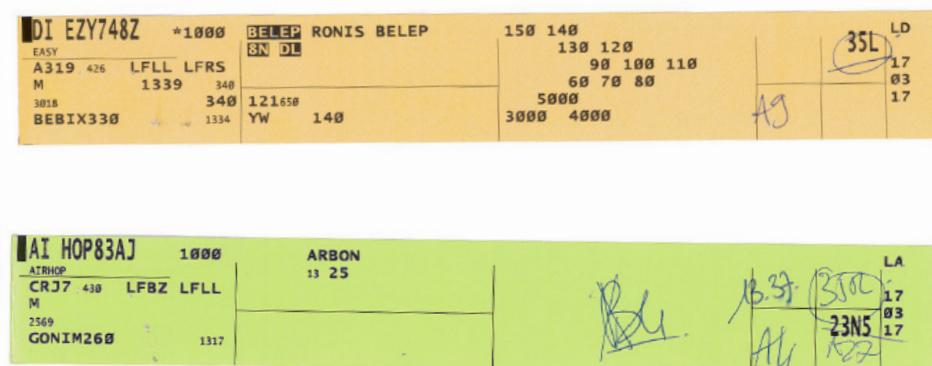
Figure 5: HOP83AJ and EZY748Z strips

During the occurrence, the meteorological conditions were good and the controller said that he did not use the ground radar display. When he gave the crossing clearance to HOP83AJ, he positioned the latter's strip on the EZY748Z strip which was positioned in the runway 35L bay. This positioning was carried out "mechanically" and the placing of one strip over the other did not allow the controller to detect the conflicting clearance.

The rhythm imposed by the density of the traffic, and the repetition of the same clearances, in particular during the inbound hub, inevitably led to the controller carrying out the various tasks somewhat automatically (management of strips, clearances, out-of-window scan). The detection of a conflicting clearance can then fail, particularly as the strip board, used in the conditions laid down at Lyon Saint-Exupéry, does not constitute a robust barrier. The distinction between an aeroplane lined up and an aeroplane cleared to take-off is solely based on the runway number being ringed or simply underlined. This difference is barely noticeable when quickly handling the strips. Overlaying the strips in these situations leads to the masking of an aircraft which might be conflictual.

- **The DSNA implement suitable work tools and methods to, in particular, reinforce the physical indication of the runway's occupancy so as to prevent conflicting clearances being given while the runway is being crossed.**
[Recommendation FRAN-2020-003]
- **The DSNA, in collaboration with the Lyon Saint-Exupéry airport managing body suitably implement alert systems and runway protection tools so as to increase the possibilities of detecting conflicts while the runway is being crossed, even when outside LVP conditions.**
[Recommendation FRAN-2020-004]
