Report

IN-015/2019

Incident involving a BOEING B-737-524, registration LY-KLJ, at the Getafe Air Base (Madrid) on 5 April 2019

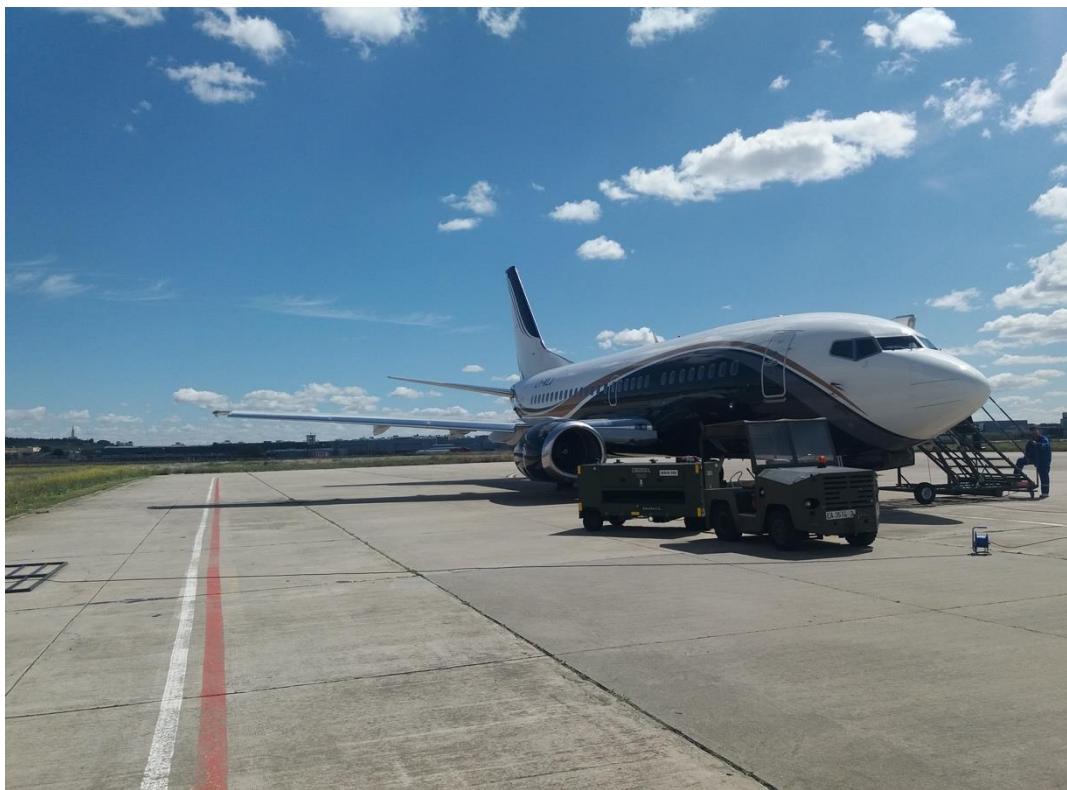
Figure 1. Photo of the aircraft at the air base

There were no injuries and the aircraft was not damaged.

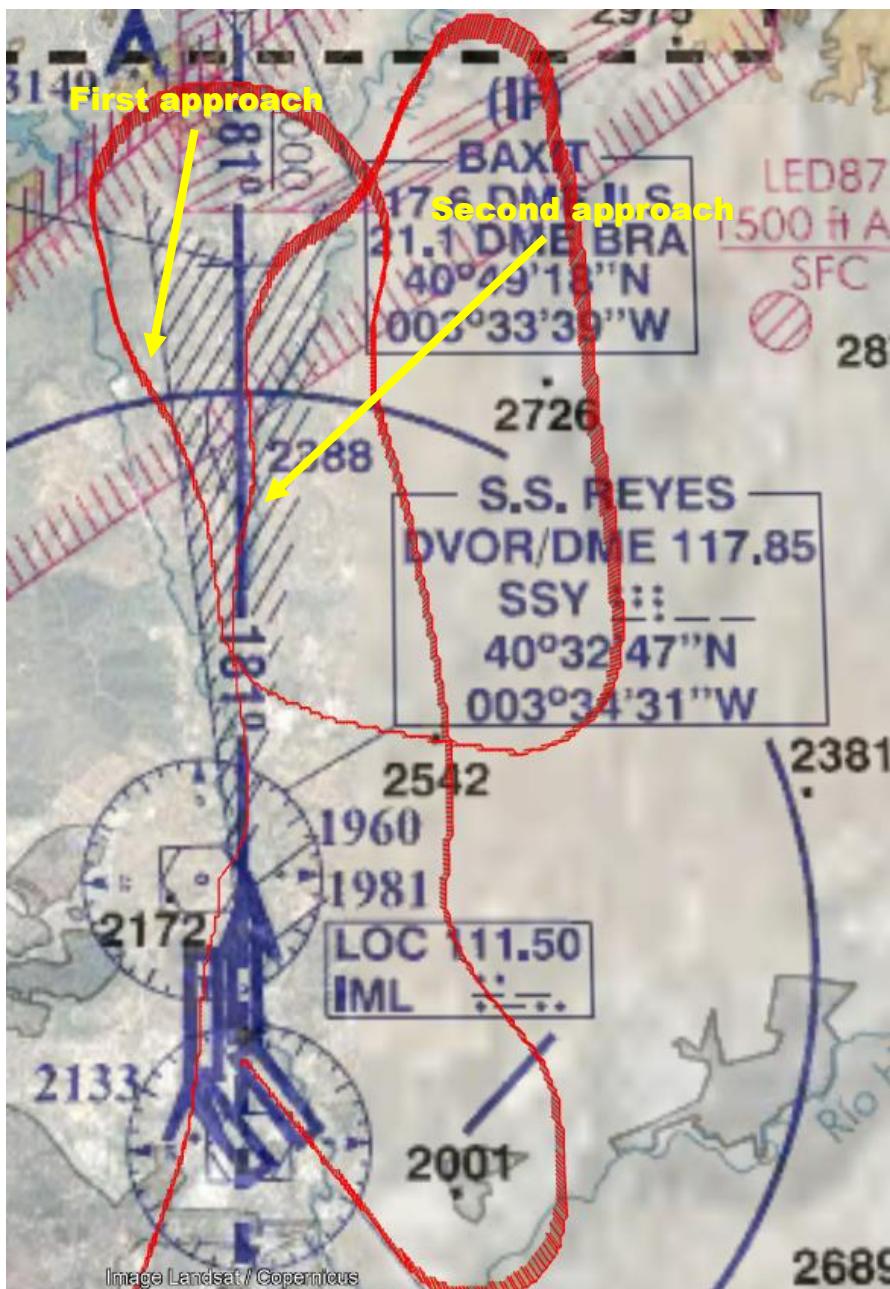
Figure 13. Missed approaches to runway 18 L

At 14:36:51, it reached its minimum altitude of 2,604 ft and aborted the landing a second time. Its heading was 203° and its GS was 176 kt. The crew was still having problems maintaining the ILS localizer and glide slope. During the descent, the flaps were lowered to 15° at first and then fully extended, equivalent to a deflection of 30°.

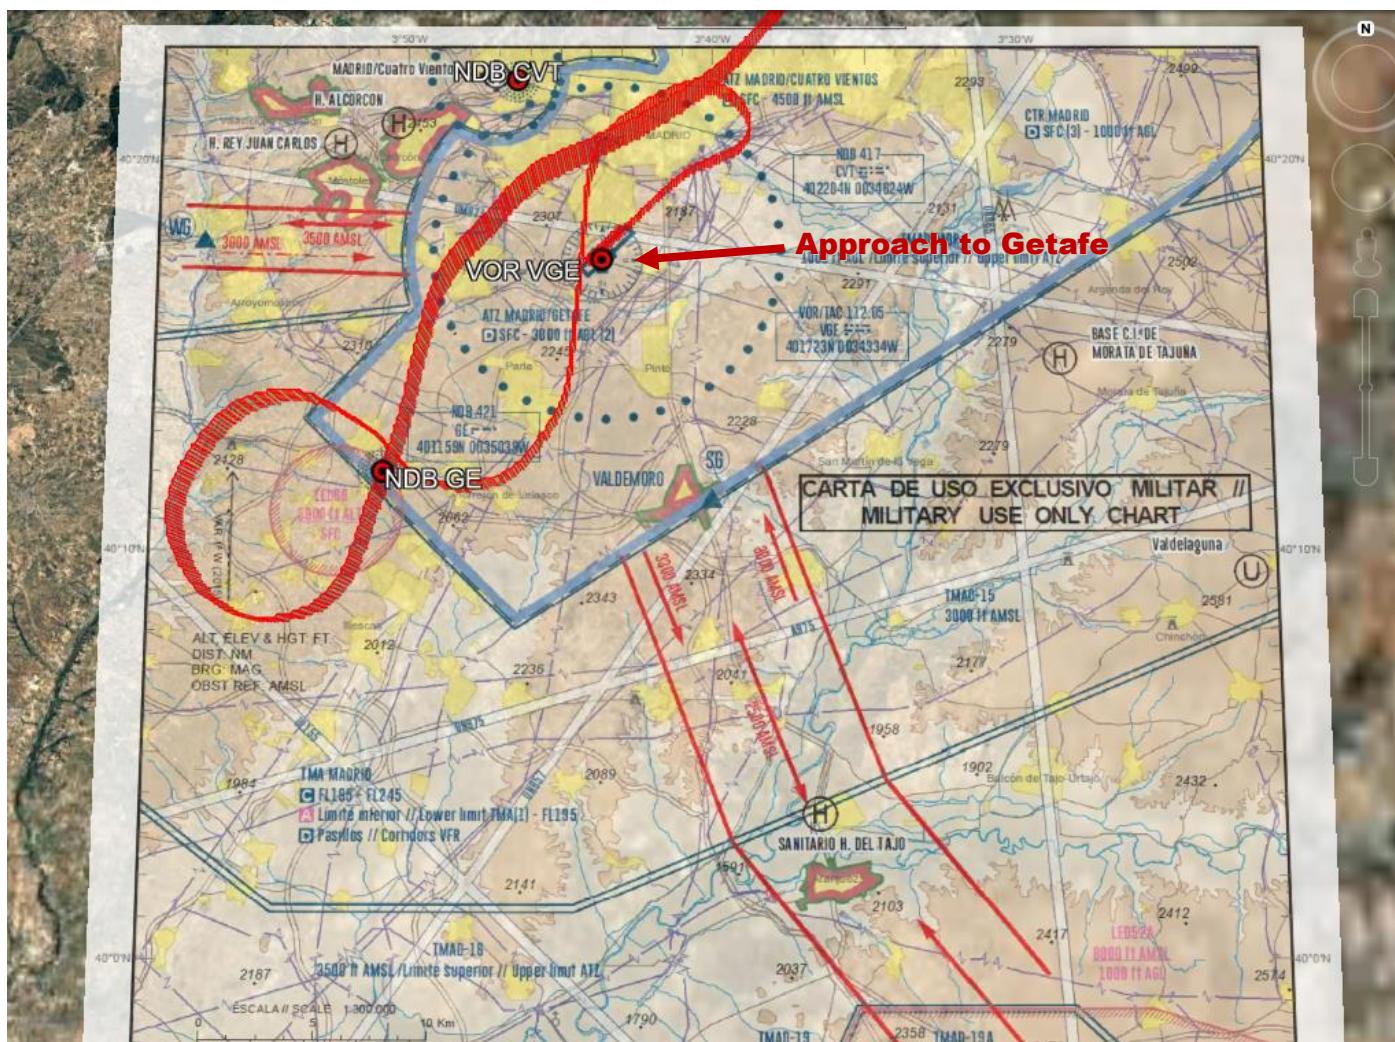
Figure 14. Approach to runway 23 at Getafe

At 14:50:43, it was on the runway heading (229°) with a GS of 170 kt at an altitude of 3,520 ft. It eventually landed at 14:52:28 with a GS of 160 kt (CAS of 145 kt).
