Air Accident Investigation Sector

Incident - Final Report -

AAIS Case N°: AIFN/0008/2019

Aircraft Struck Runway Edge Lights on Landing

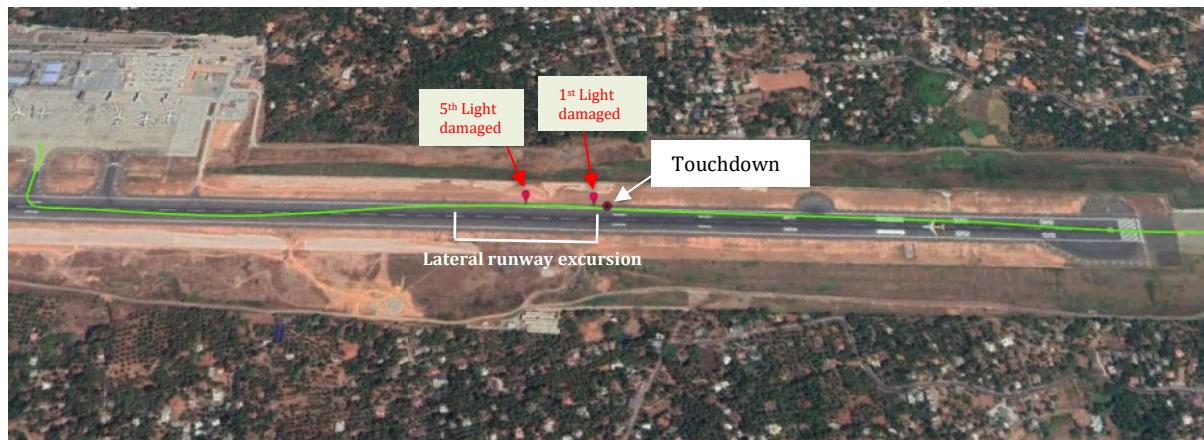
Figure 1. Flight path on landing at runway 28 of Calicut International Airport (VOCL)

On landing at 2339:00, the Aircraft touched down to the right of the runway centerline, and the right main landing gear then struck five runway edge lights. The Commander was able to steer the Aircraft to the centerline and continue the landing roll (figure 1). A message indicating tire low pressure appeared on the electronic centralized aircraft monitoring (ECAM).

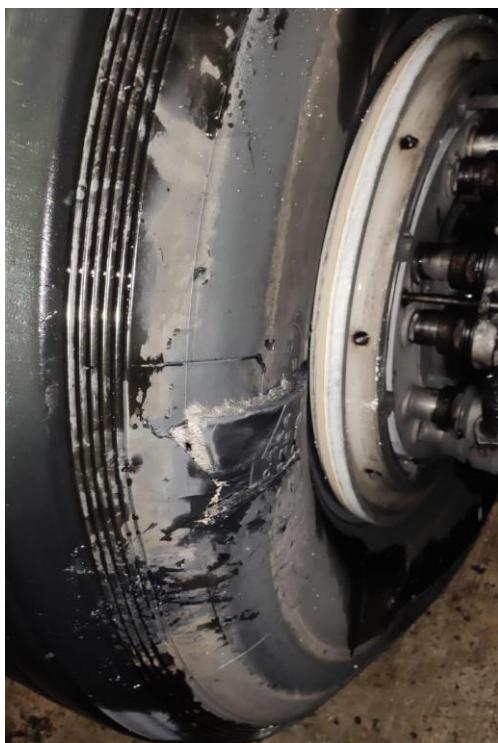
After landing in Calicut and shutting down the engines, the flight crew requested the Aircraft maintenance engineers to carry out an assessment of the landing gear. After the assessment, the engineers advised that the right main landing gear inboard wheel tire was damaged (figure 2) and the outboard tire was worn beyond limits with some tread separation (figure 3).

Figure 2. Right main landing gear - inboard wheel tire

The brake pressure of the right main landing gear inboard wheel remained at 200 psi, whereas the brake pressure of the other wheels increased progressively up to 2,300 psi. Therefore, the right main landing gear inboard wheel tire was, most probably, damaged due to contact with the edge lights. The right main landing gear outboard wheel tire was found to have significant wear and partial ply separation, most likely, due to the higher load carried as a consequence of the Aircraft lateral movement on the ground over at least five seconds.

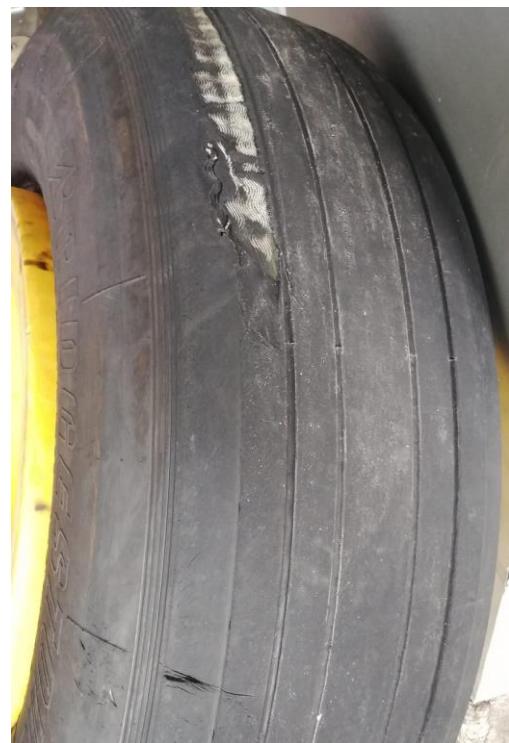
Figure 3. Right main landing gear - outboard wheel tire

The ground engineer was requested by the Commander to check the right wheel tires since the pressure of No.3 tire showed zero pressure on the ECAM, and the flight crew was then informed about the deflation of the No.3 tire, and the No.4 tire was worn beyond limits with some tread separation.

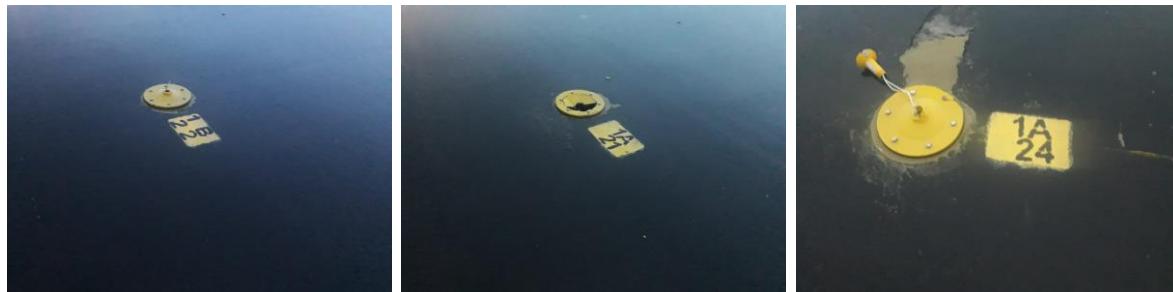
Five runway 28 edge lights were damaged (figure 4).

Figure 4. Three of the five damaged runway edge lights

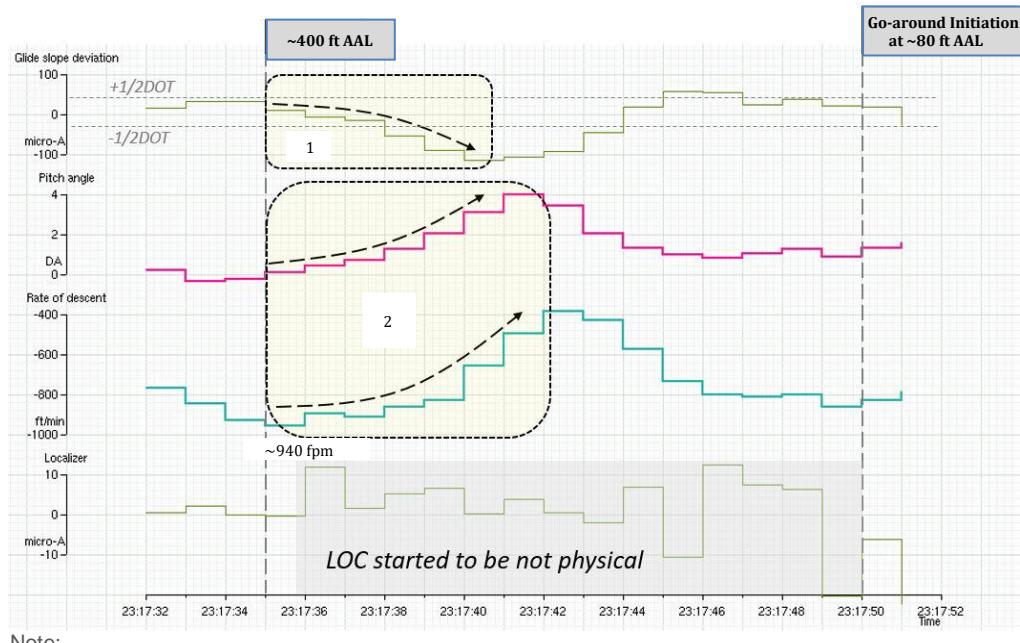
As the Aircraft descended between 400 feet and 305 feet AAL, the glideslope deviation was on the glide path and started to move to 1.5 dot below the glide path (profile) within 5-6 seconds, as shown in figure 7. The 1.5 dot deviation should have represented an increment of an absolute value of the vertical speed of approximately 1,000 feet per minute, which did not occur. The rate of descent was approximately 940 feet per minute and decreased to 380 feet per minute during this period.

1. Glide slope deviation started to decrease to 1.5 dot within 5-6 seconds below profile
2. APs ordered a pitch-up dynamic leading an increment of pitch angle and a decrement of ROD

In order to counteract the glide deviation below the profile, the autopilots ordered a pitch-up dynamic that led in an increase in pitch angle and a decrease in the rate of descent. During this period, no significant atmospheric perturbations were observed.

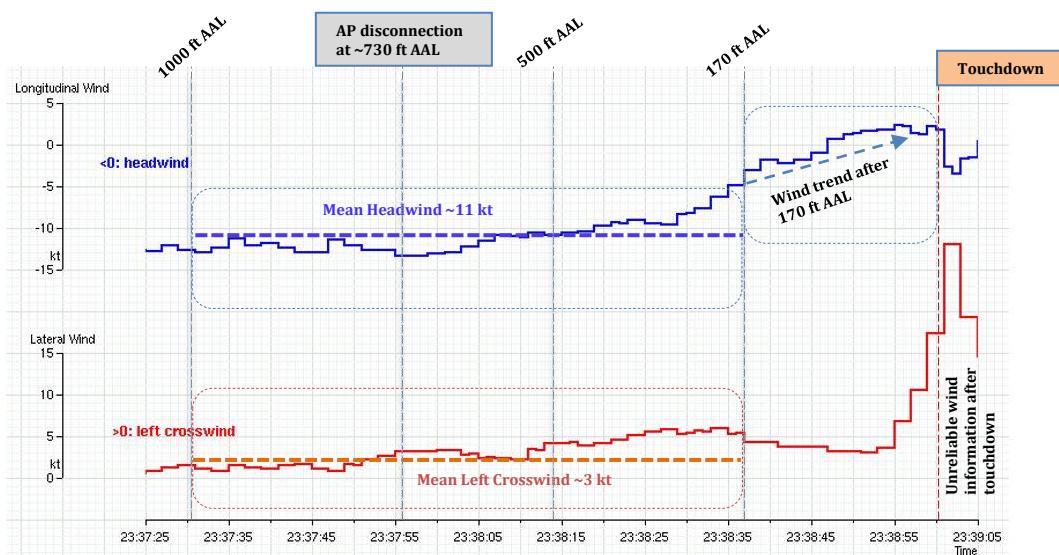
As the Aircraft descended below 170 feet AAL, the recorded wind information could be used to determine a trend. The wind trend information gave an indication that the headwind had changed to a slight tailwind. The Commander did not notice this change. He had last reviewed the wind information when the Aircraft was at approximately 1,500 feet pressure altitude, and the wind was the same as reported by the Tower Controller. After touchdown, the wind information was unreliable.

Figure 9. Wind information on short final approach

At 15 feet AAL, the Commander applied left rudder leading to a dynamic motion on the yaw axis. This dynamic motion had a significant effect on the recorded crosswind trend, which from that point could not be considered as trend information.

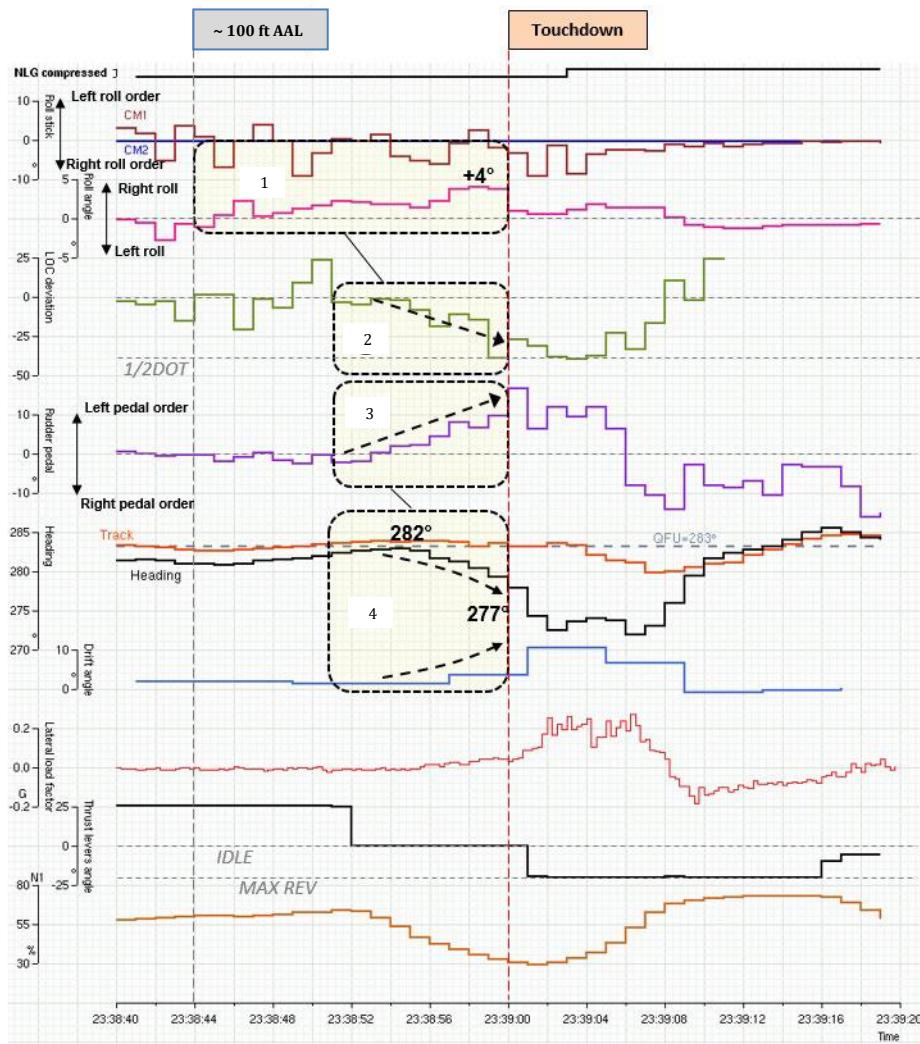
At about 15 feet AAL, the Commander realized that the Aircraft was on the right side of the runway as he observed that the left hand edge lights became more blurred than the lights on the right hand side. This was one second after he retarded the thrust levers to idle. The Commander progressively applied a left rudder pedal input of up to 2/3 full deflection. The Commander tried to recover the Aircraft to the centerline of the runway. The left rudder pedal input led an increase in the drift angle from 1 to 8 degrees (Aircraft nose to the left of track) and a heading change from 282 to 277 degrees. The Commander's control inputs resulted in no significant change to the aircraft trajectory to cancel the lateral deviation.

The Investigation believes that when the Commander realized that the Aircraft had drifted away to the right of the runway centerline, he should have also used left roll control inputs within the recommended limitation to recover the Aircraft to the centerline.

In this case, the use of left rudder only without left lateral input, as the Aircraft lateral flight path had already drifted away from the runway centerline, did not allow for an easy realignment back to the centerline before touchdown. The optimum technique is explained in the *Flight Crew Techniques Manual (FCTM)*.

1. Several right roll inputs over around 8 seconds of up to 4 degrees
2. Aircraft deviated to the right of the runway centerline
3. At approximately 15 feet above the runway, left rudder pedal input was progressively applied up to 2/3 full deflection
4. Drift angle increase from 1 to 8 degrees and heading change from 282 to 277 degrees
