Final Report No. 2370 by the Swiss Transportation Safety Investigation Board STSB

on the accident involving
the Junkers Ju 52/3m g4e
commercial aircraft, HB-HOT,

operated by Ju-Air,

on 4 August 2018

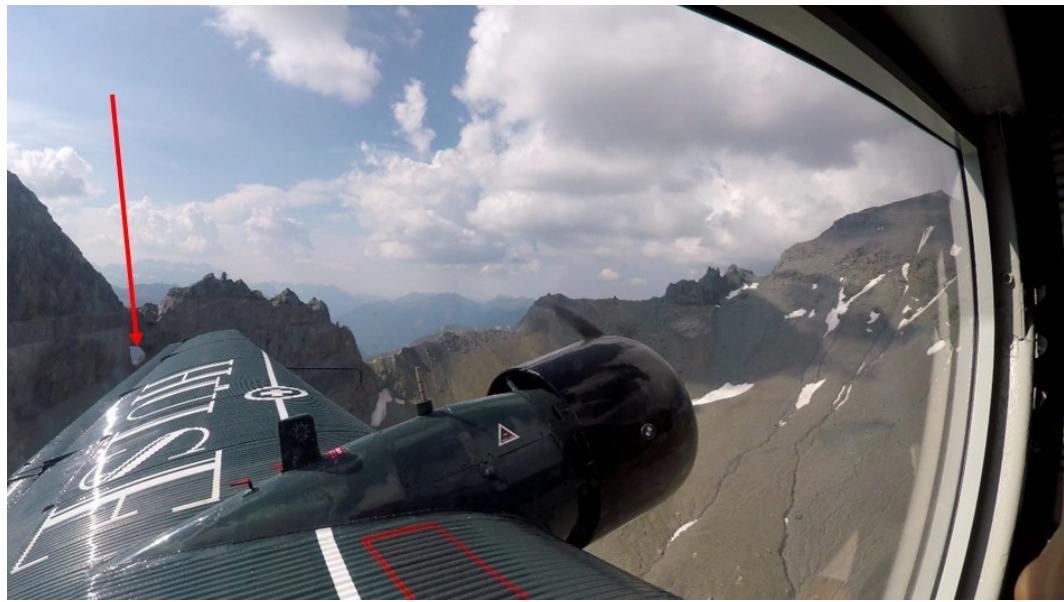
Figure 3: Still image from a video at point F10, recorded from the cabin of HB-HOT looking towards the Martinsloch (red arrow). The pitch attitude was 11.0 degrees, the left bank attitude 4.8 degrees and the altitude 2,749 m AMSL. The difference between the flight path angle and the pitch angle was 20.6 degrees.

During roughly the next 4 seconds, the aircraft descended by 25 m and the already negative flight path angle became even more negative, which is clearly apparent when comparing figures 3 and 4 as well as in figure 5.

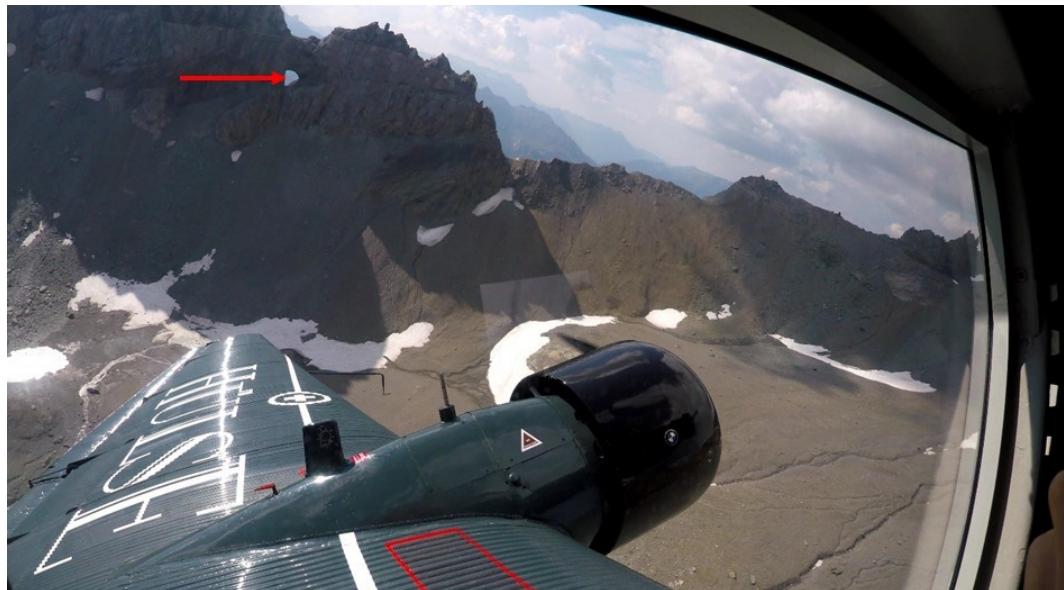
Figure 4: Still image from a video at point F13, recorded from the cabin of HB-HOT looking towards the Martinsloch (red arrow), 4.3 seconds after the image shown in figure 3 was taken. The pitch attitude was 12.1 degrees, the left bank attitude 32.7 degrees and the altitude 2,724 m AMSL.

After point F13, the roll to the left increased steadily and did not decrease even when a significant aileron deflection to the right was made. The ailerons were then brought into a neutral position and temporarily deflected into a position for a left turn.

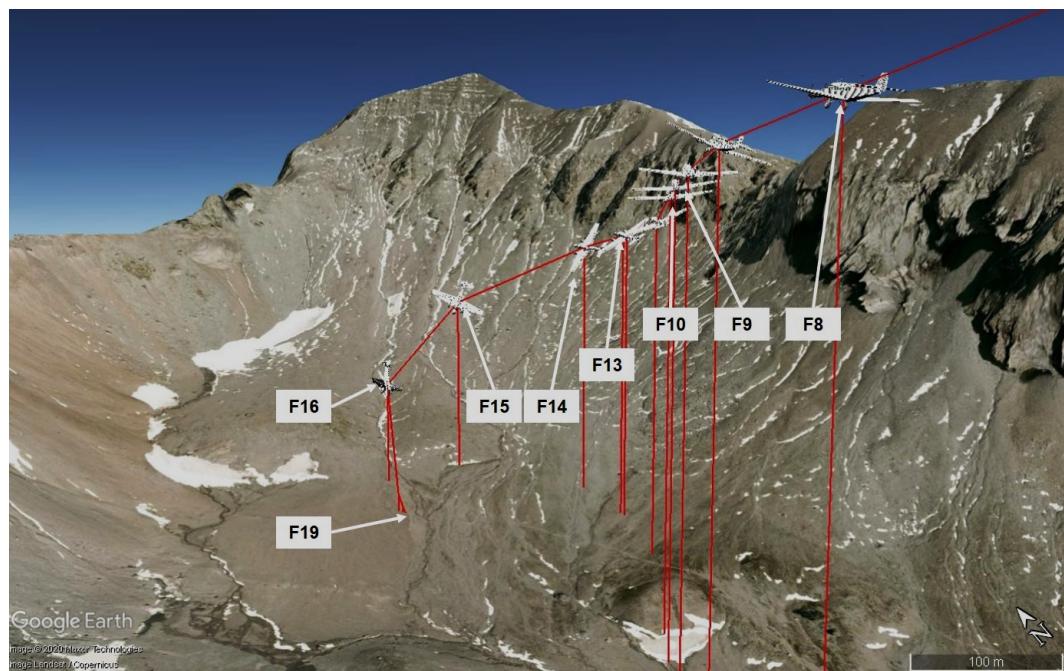
At the same time, the pitch attitude began to decrease and the flight path ran increasingly steeper downwards whilst the left bank attitude constantly increased (see figure 6).

Figure 6: Photogrammetrically reconstructed flight path of HB-HOT on 4 August 2018 (red) between point F8 and the site of the accident (F19), with Piz Segnas in the background; shown on Google Earth. The aircraft has been enlarged by a factor of 2.5 to make it easier to see.

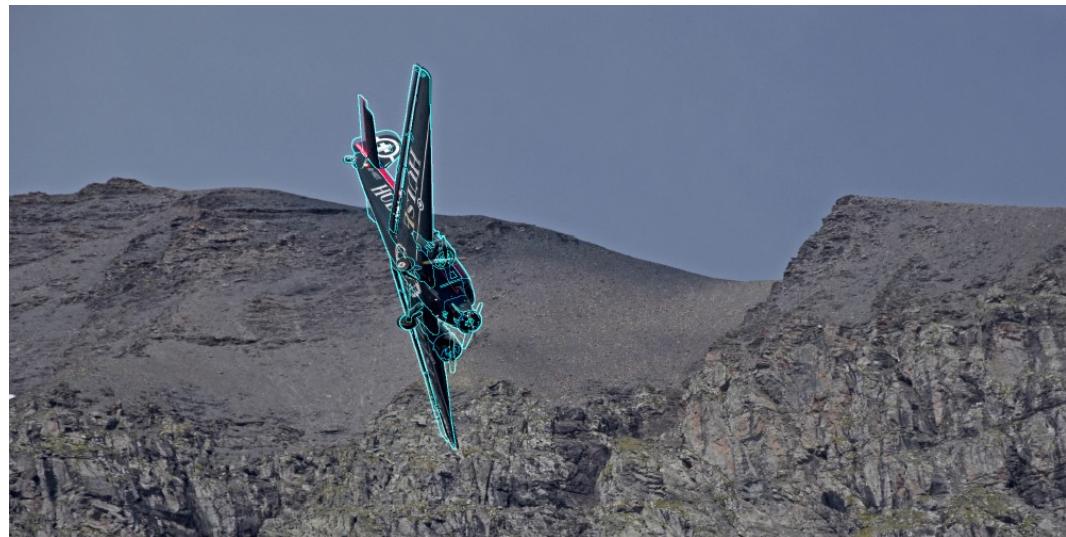
During this last flight phase, the aircraft experienced low-frequency vibrations. Ultimately, when the aircraft was 108 m above ground (point F16, see figures 6

and 7), its longitudinal axis was pointing downwards by 68 degrees from horizontal. By this time, the elevator had deflected upwards by approximately 13 degrees and the rudder was pointing 2 degrees to the right.

Figure 7: Image showing HB-HOT at point F16, including a superimposed three-dimensional model of an identical Ju 53/3m g4e (light blue) for the purpose of determining attitudes, wing deflection and deflections of the control surfaces. The direction of view is north-eastwards, the southern spur of Piz Segnas is visible in the background.

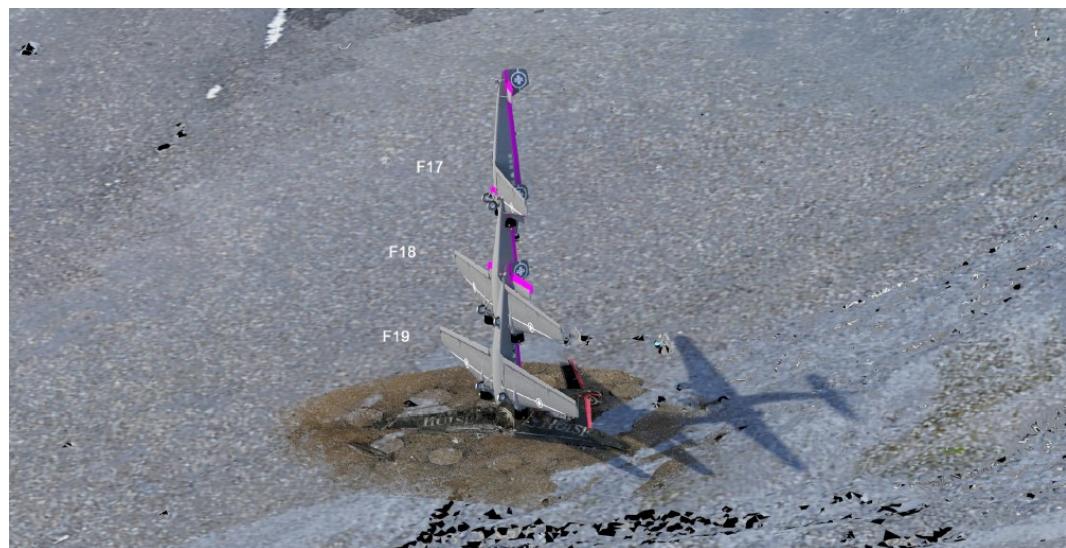
The roll to the left accelerated significantly during this phase. Shortly after 16:57, the aircraft hit the ground in a vertical flight attitude with an almost vertical flight path and at a speed of approximately 200 km/h (see figure 8).

Figure 8: Reconstructed spatial positions and flight attitudes of HB-HOT before impact at points F17, F18 and F19. The three-dimensional model of an identical Ju 52/3m g4e is shown in the reconstructed 3D terrain model with a direction of view to the north. The final position of the wreckage and debris were left vague for a better overview.
All 20 people on board the aircraft lost their lives in the accident. The aircraft was destroyed. Fire did not break out.

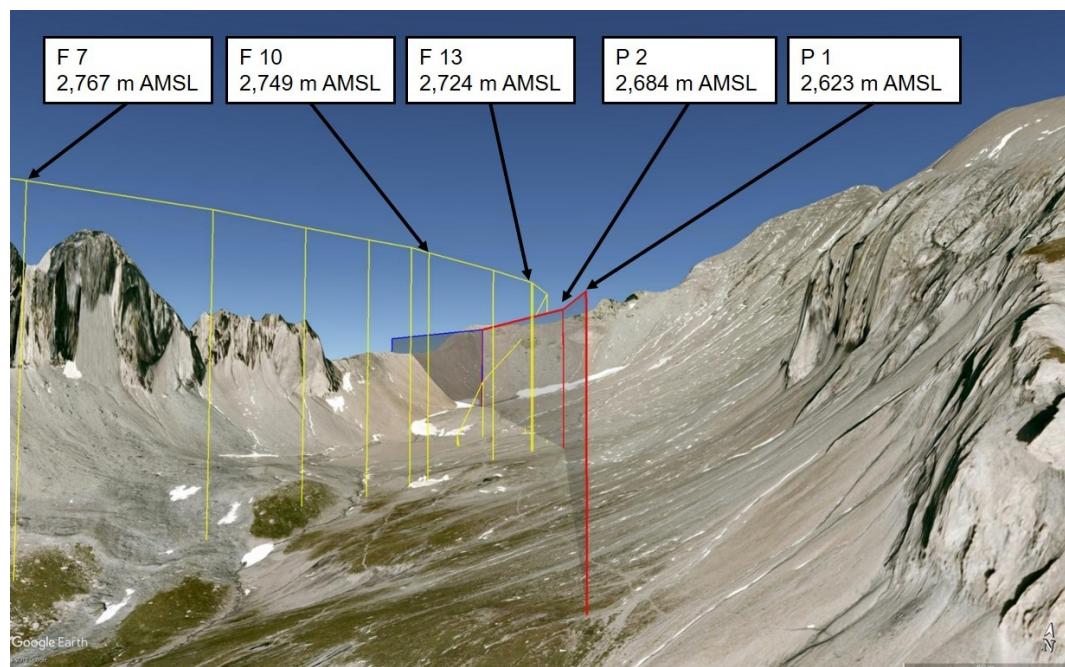
During a climb in sister aircraft HB-HOP on 6 July 2013, pilot B as commander, together with pilot A in the role of co-pilot at the time, entered the basin south-west of Piz Segnas in a similar manner to during the accident flight and flew over the ridge of the Segnes pass at approximately 30 m above ground (see figure 9).

Figure 9: Comparison between the reconstructed flight paths of 6 July 2013 (red, points labelled 'P'), including extension of the flight path (blue), and the accident flight on 4 August 2018 (yellow, points labelled 'F'); shown on Google Earth.

During this flight, a 180-degree turn or an alternative flight path in the northern section of the basin south-west of Piz Segnas would not have been possible.

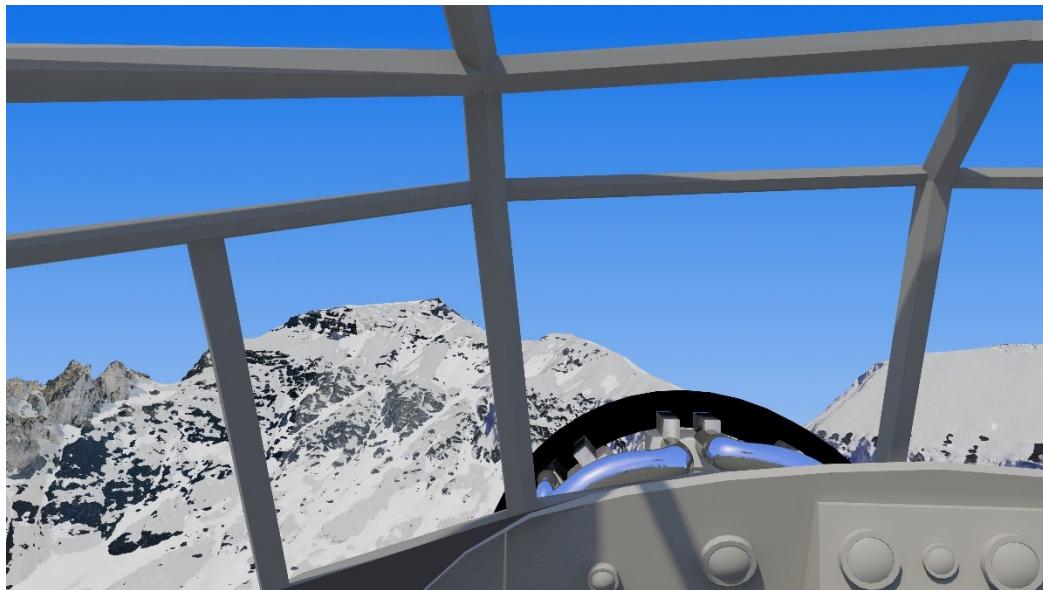
It is conceivable that due to their preoccupation with the engines and the view from the cockpit, which made it difficult to easily recognise the descent, the flight crew's increase in pitch attitude was made subconsciously in order to compensate for this (see figure 21). Furthermore, the fact that the centre of gravity was beyond the rear limit facilitated the process and made the aircraft more unstable around its pitch axis, which represents a factor that directly contributed to the accident.

Figure 21: Reconstructed view from the position of the commander of HB-HOT at point F9. Piz Segnas can be seen in the line of sight. Shown using a simplified model of the aircraft and the three-dimensional terrain model. The absence of visible reference points made it difficult to detect the descent caused by the downdraught.

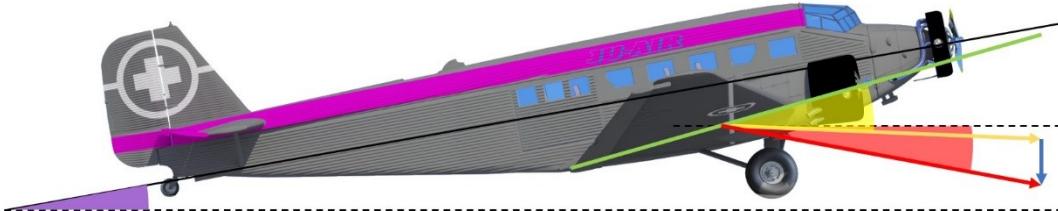
From an aerodynamic point of view, the stall can be explained as follows: HB-HOT had been caused to enter a descent by an area of downdraught. The descent in the downdraught, which was partially compensated by increasing the pitch attitude, led to a flight attitude close to the maximum angle of attack. Given this flight attitude, the additional increase in the angle of attack caused when flying into an updraught was sufficient to lead the airflow to at least partially stall. This development would not have been expected had the downdraught continued or eased slowly. The air currents observed in the basin indicate that the aircraft was moving from an area of downdraught into an area of updraught. A change in the vertical component of the wind's vector from a downdraught with a speed of 2 to 5 m/s to an updraught with a speed of 0 to 3 m/s was sufficient to exceed the critical angle of attack (see figures 22 and 23). As both the measurements and the airflow calculation have shown, even larger shear values were easily possible. Correspondingly turbulent conditions in the mountains are not unusual and become a risk when flying close to the terrain.

Figure 22: Stationary flight in an area of downdraught. Black line: longitudinal axis of the aircraft; Black dashed line: horizontal plane; Green line: chord line; Yellow vector: movement for the aircraft in relation to the area of downdraught; Blue vector: downdraught vector; Red vector: flight path (i.e. the resulting vector of movement for the aircraft in space); Purple angle: pitch angle (angle between the horizontal plane and the aircraft's longitudinal axis); Red angle: flight path angle (angle between the horizontal plane and the flight path); Yellow angle: angle of attack (angle between the direction of airflow, which is the inverse of the vector of movement for the aircraft in relation to the area of downdraught, and the chord line).

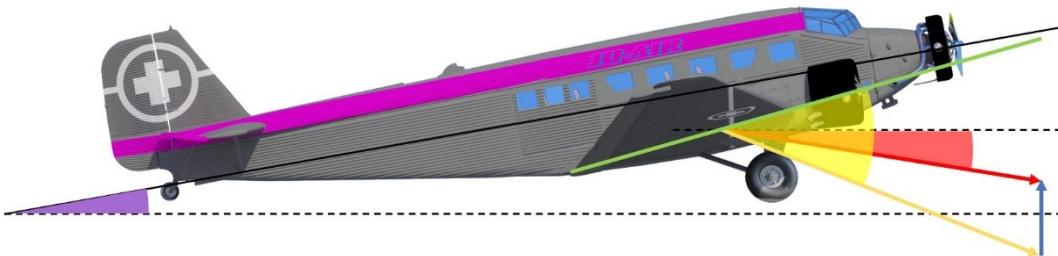
Figure 23: Entry into an area of updraught from an area of downdraught. The flight path vector (red) momentarily remains the same because of the inertia of the aircraft; Blue vector: updraught; Yellow vector: vector of movement for the aircraft in relation to the area of updraught. The angle of attack (yellow) increases considerably. Black line: longitudinal axis of the aircraft; Black dashed line: horizontal plane; Green line: chord line; Purple angle: pitch angle (angle between the horizontal plane and the aircraft's longitudinal axis); Red angle: flight path angle (angle between the horizontal plane and the flight path); Yellow angle: angle of attack (angle between the direction of airflow, which is the inverse of the vector of movement for the aircraft in relation to the area of updraught, and the chord line).

It is therefore also one of the fundamental principles of flying in mountainous areas that the airspeed, and thus the energy of the aircraft, must be increased during turbulent conditions and when in closer proximity to the terrain, so that wind shear does not cause a stall, even if it would usually only do so for a short time. It must be ensured that the aircraft is not overloaded by gusts or deflection of the control surfaces, so that the calculated manoeuvring speed lends itself to be the optimum speed. HB-HOT had a true airspeed of approximately 180 km/h during this phase (when it encountered wind shear) which was roughly 55 km/h or 44 % above the stall speed in the prevailing conditions. This level of speed reserve is too small for the turbulence that is common in the mountains.
