SERIOUS INCIDENT

Aircraft Type and Registration:	Airbus A320-214, G-EZWE	
No & Type of Engines:	2 CFM56-5B4/3 turbofan engines	
Year of Manufacture:	2012 (Serial no: 5289)	
Date & Time (UTC):	16 September 2019 at 1959 hrs	
Location:	Lisbon Airport, Portugal	
Type of Flight:	Commercial Air Transport (Passenger)	
Persons on Board:	Crew - 6	Passengers - 167
Injuries	Crew - None	Passengers - None
Nature of Damage:	None	
Commander's Licence:	Airline Transport Pilot's Licence	
Commander's Age:	57 years	
Commander's Flying Experience:	16,000 hours approximately (of which approximately 8,000 were on type) Last 90 days - approximately 130 hours Last 28 days - approximately 20 hours	
Information Source:	AAIB Field Investigation

Synopsis

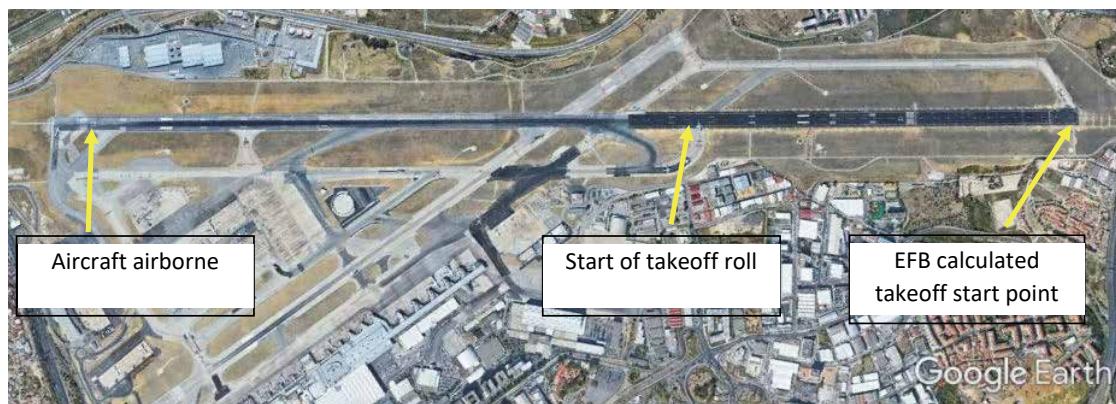
Figure 1

The takeoff distance available from U5 was 1,395 m less than that used for the performance calculation, and the aircraft became airborne with only 110 m of the runway remaining (Figure 1). During the flight the crew realised what had happened, and they reported it to the operator after landing.

Image of Lisbon Airport showing the calculated and actual takeoff points
©Google Earth

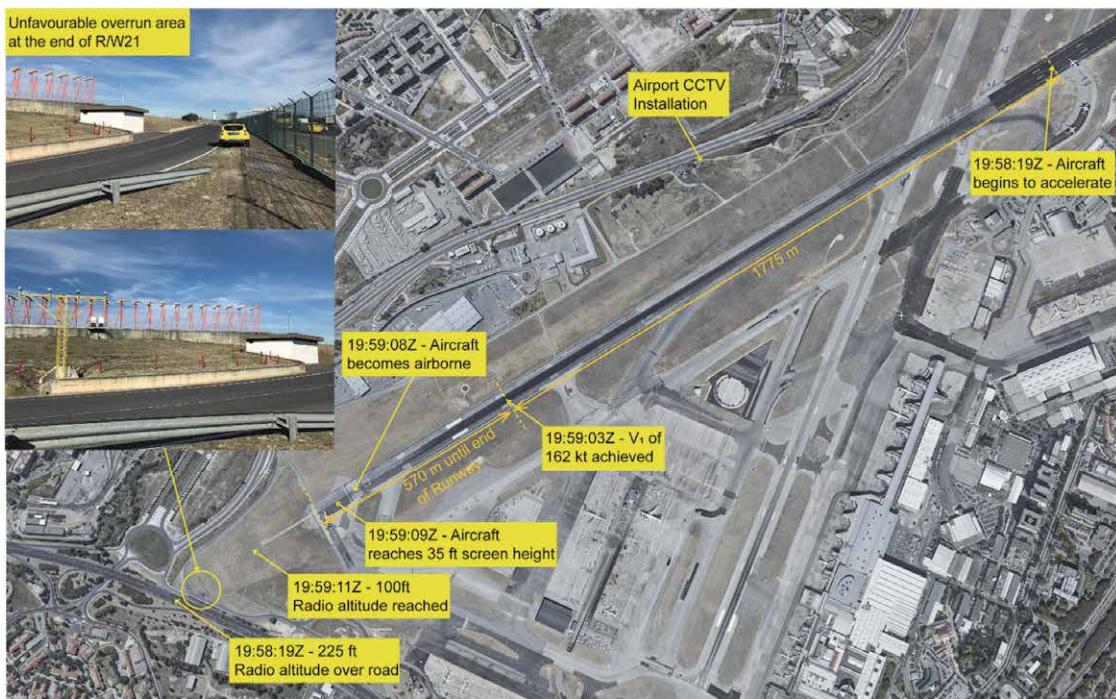
The QAR data (Figure 2) showed that the aircraft commenced its takeoff roll at 1958:19 hrs having entered Runway 21 from Taxiway U5. 44 seconds later, at 1959:03 hrs, after a ground roll of 1,775 m and with approximately 570 m of runway remaining ahead of the aircraft, a V_1 of 162 kt was achieved. Five seconds later, at 1959:08 hrs, the aircraft became airborne approximately 110 m from the end of Runway 21. At the speed the aircraft was travelling over the ground this distance would have taken approximately 1.3 seconds to cover. One second later, whilst still over the paved surface of Runway 21, the aircraft achieved the regulatory screen height of 35 ft, for a dry runway, and crossed the airport boundary at 225 ft radio altitude. TOGA thrust was not selected at any point.

Figure 2
QAR Data showing G-EZWE's takeoff roll

As shown in Figure 2, there are several obstructions beyond the runway that could have caused significant damage to the aircraft and its occupants should an overrun have occurred.

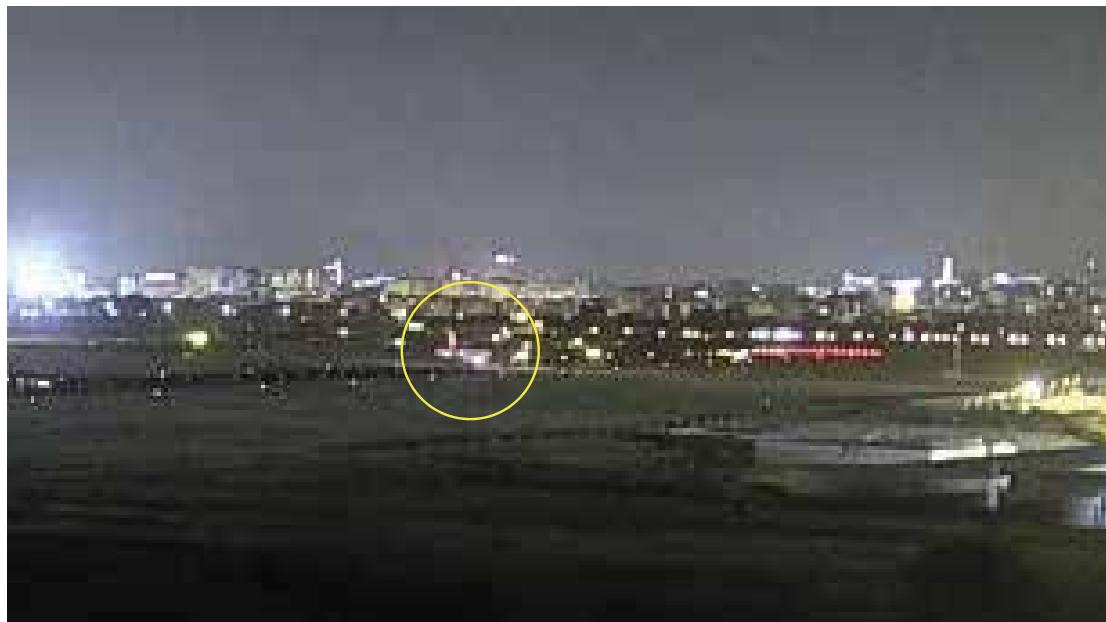
Figure 3

G-EZWE's takeoff roll was captured on several CCTV cameras around the airport. One of these cameras (situated as shown in Figure 2) covered the latter part of the aircraft's takeoff roll. The frame shown below (Figure 3), where the aircraft is highlighted by the yellow circle, was recorded just after the aircraft reached V_1 , and the end of the runway is indicated by the row of red lights towards the right of the image.

CCTV screenshot showing G-EZWE just after reaching V_1

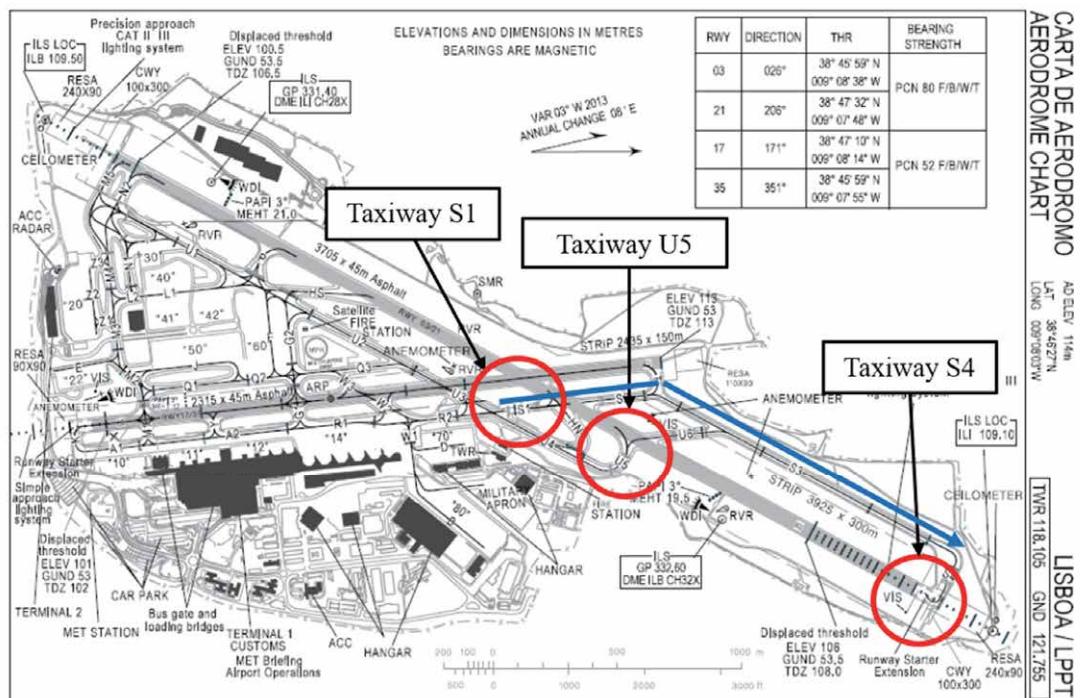
When Runway 21 is in use, the preferred departure point for all aircraft, except heavy jets, is 'Position U', which is the intersection of the runway with Taxiway U5. Pilots must advise air traffic control on start-up if they require the full length of the runway for departure. Full length departures are from holding point S4 which is known as 'Position S'. At the time of the incident, Taxiway S began abeam Runway 17, before crossing Runway 21 at Taxiway S1, and then turning north-east to run parallel to Runway 21. This is marked on Figure 4 in blue. The taxiway ends at the threshold of Runway 21. There were therefore two points on Runway 21 where Taxiway S intersected the runway.

Figure 4
Plan of Lisbon Airport showing Taxiways S1, U5 and S4
Note: north is to the right of the image

In all three cases the pilots were confused by the EFB intersection selections as they did not use the actual taxiway names. Also, there were two points on the runway which intersect Taxiway S (1 and 4) both of which might have been thought by the crew to be in the EFB as PSNSTMP as the taxiway numbers are not used in the nomenclature.

As a result of the two previously reported incidents, but after this occurrence, the airport operator re-designated the taxiways on 5 December 2019 to eliminate this issue. The new taxiway designations are shown in Table 1.

Following the previous incidents, the AAIB reported that the Lisbon Airport operator intended to rename taxiways to remove the risk of confusion between the two points where Taxiway S crossed Runway 21. The taxiways would be renamed so that Taxiway S intersected the runway at only one point; S4 (full length). This safety action was completed, albeit after the incident to G-EZWE, and is reported here.

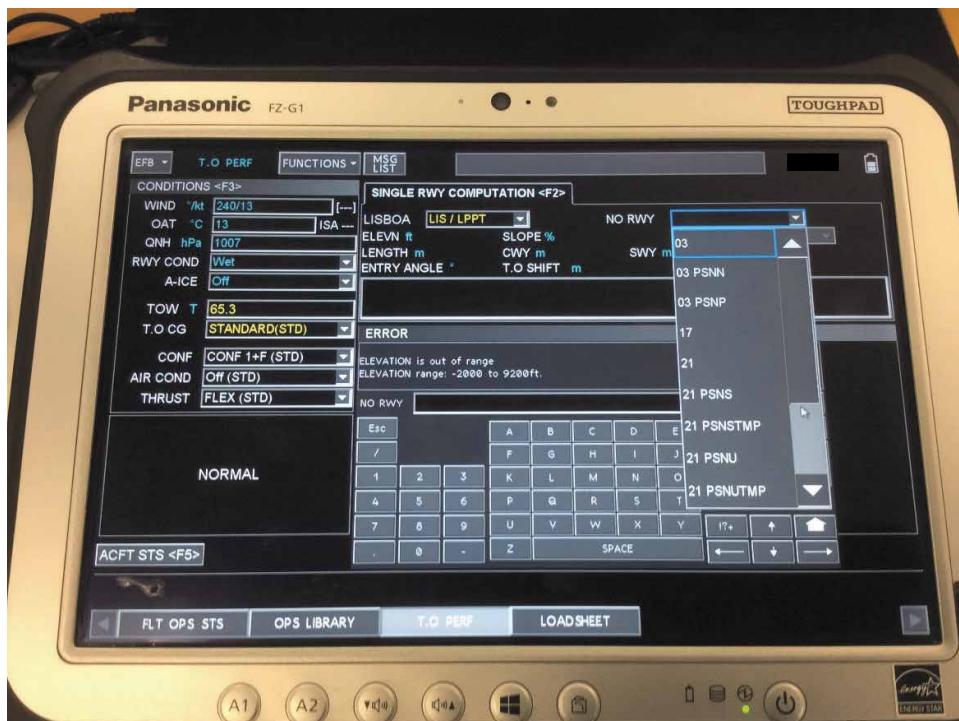
Figure 5

available for departure and, in the case of Lisbon Runway 21, two positions are available, Position U and Position S. These are named in the software as PSNU and PSNS. At the time of the incident, there was a NOTAM affecting the takeoff performance calculation (referring to an obstacle in the climb-out zone). This meant that the data supplier had inserted two further temporary selections for the two takeoff positions for Runway 21, which were labelled PSNUTMP and PSNSTMP as shown in Figure 5.

EFB drop-down menu showing the all the intersections available
(not the actual incident data)

The crew discussed the likely takeoff point and decided that they could use the S1 intersection if necessary, from which there was a lower TORA than from U5. They then performed the calculation in the EFB, using PSNSTMP as the selection for the S1 intersection. S1 is not an approved intersection for departure on Runway 21.

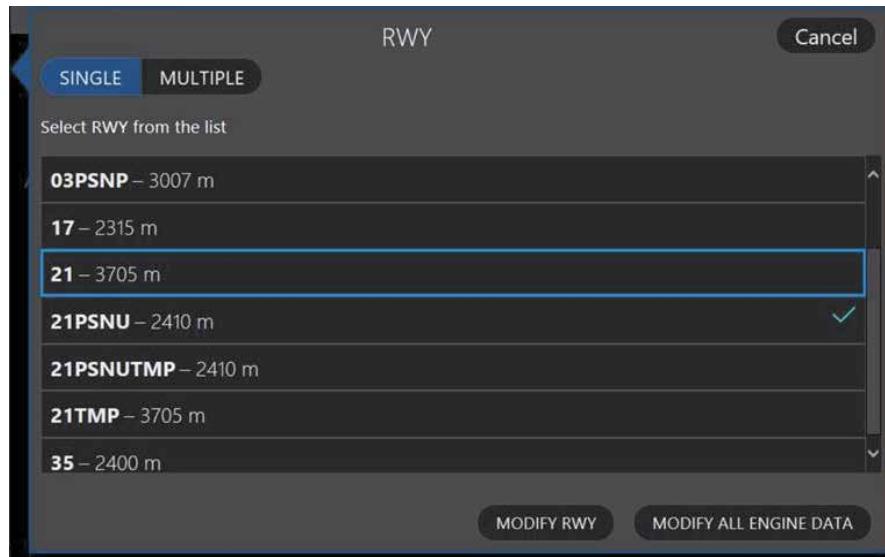
**Figure 6**

New nomenclature in EFB drop-down menu

As a result of this incident and the two previous cases, the operator changed the nomenclature in the EFB for Runway 21. This change eliminated the use of Position S, instead using merely '21' to indicate that this point is the full length of the runway. The new drop-down selection is shown at Figure 6.

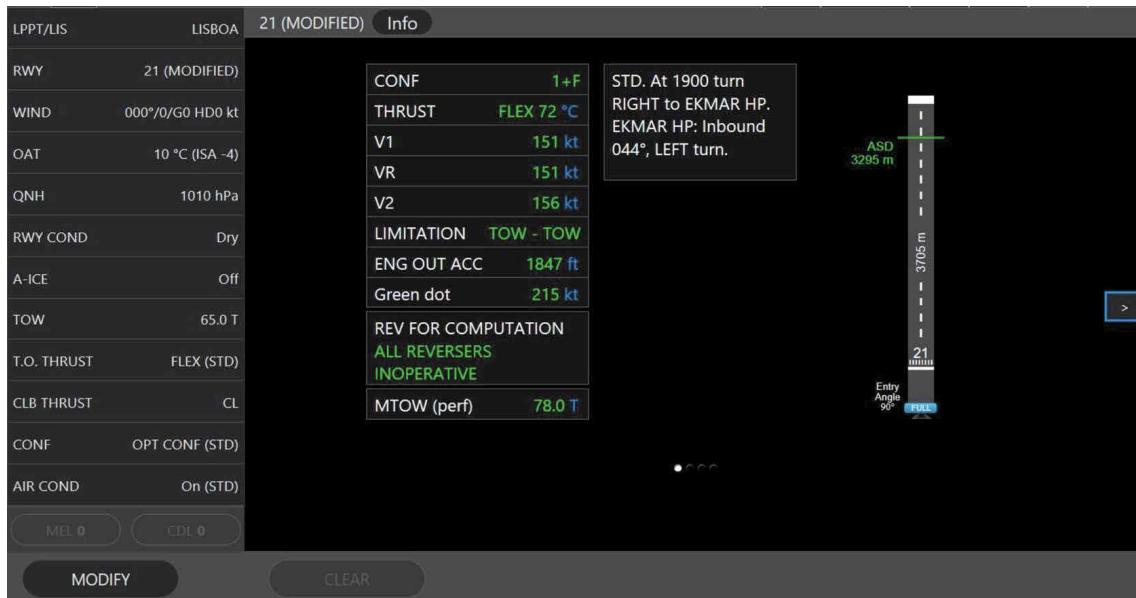
**Figure 7**

New software calculation display for Runway 21 Position S

In December 2019, the operator also moved onto a newer version of the performance software, Flysmart L6, which offers a pictorial representation of where the performance calculation was referenced to. Figures 7 and 8 show how the new software would have shown a calculation from Position S and Position U on Runway 21 (not using incident data).

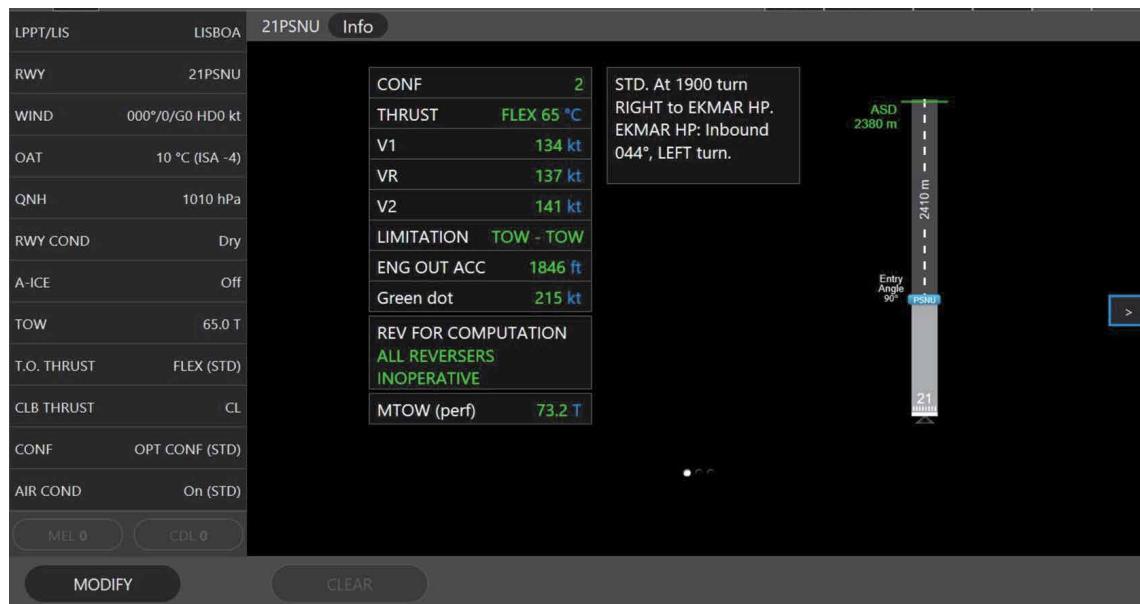
Figure 8
New software calculation display for Runway 21 Position U
