**AIRCRAFT ACCIDENT INVESTIGATION BUREAU
GOVERNMENT OF INDIA**

**FINAL REPORT ON SERIOUS INCIDENT INVOLVING
AIRPROX THAT OCCURRED IN DELHI AREA
BETWEEN NCR840, KLM875 AND EVA061
ON 22.12.2018**

**Final Report on Serious Incident involving Airprox that occurred in Delhi Area
between NCR840, KLM875 and EVA061 on 22.12.2018**

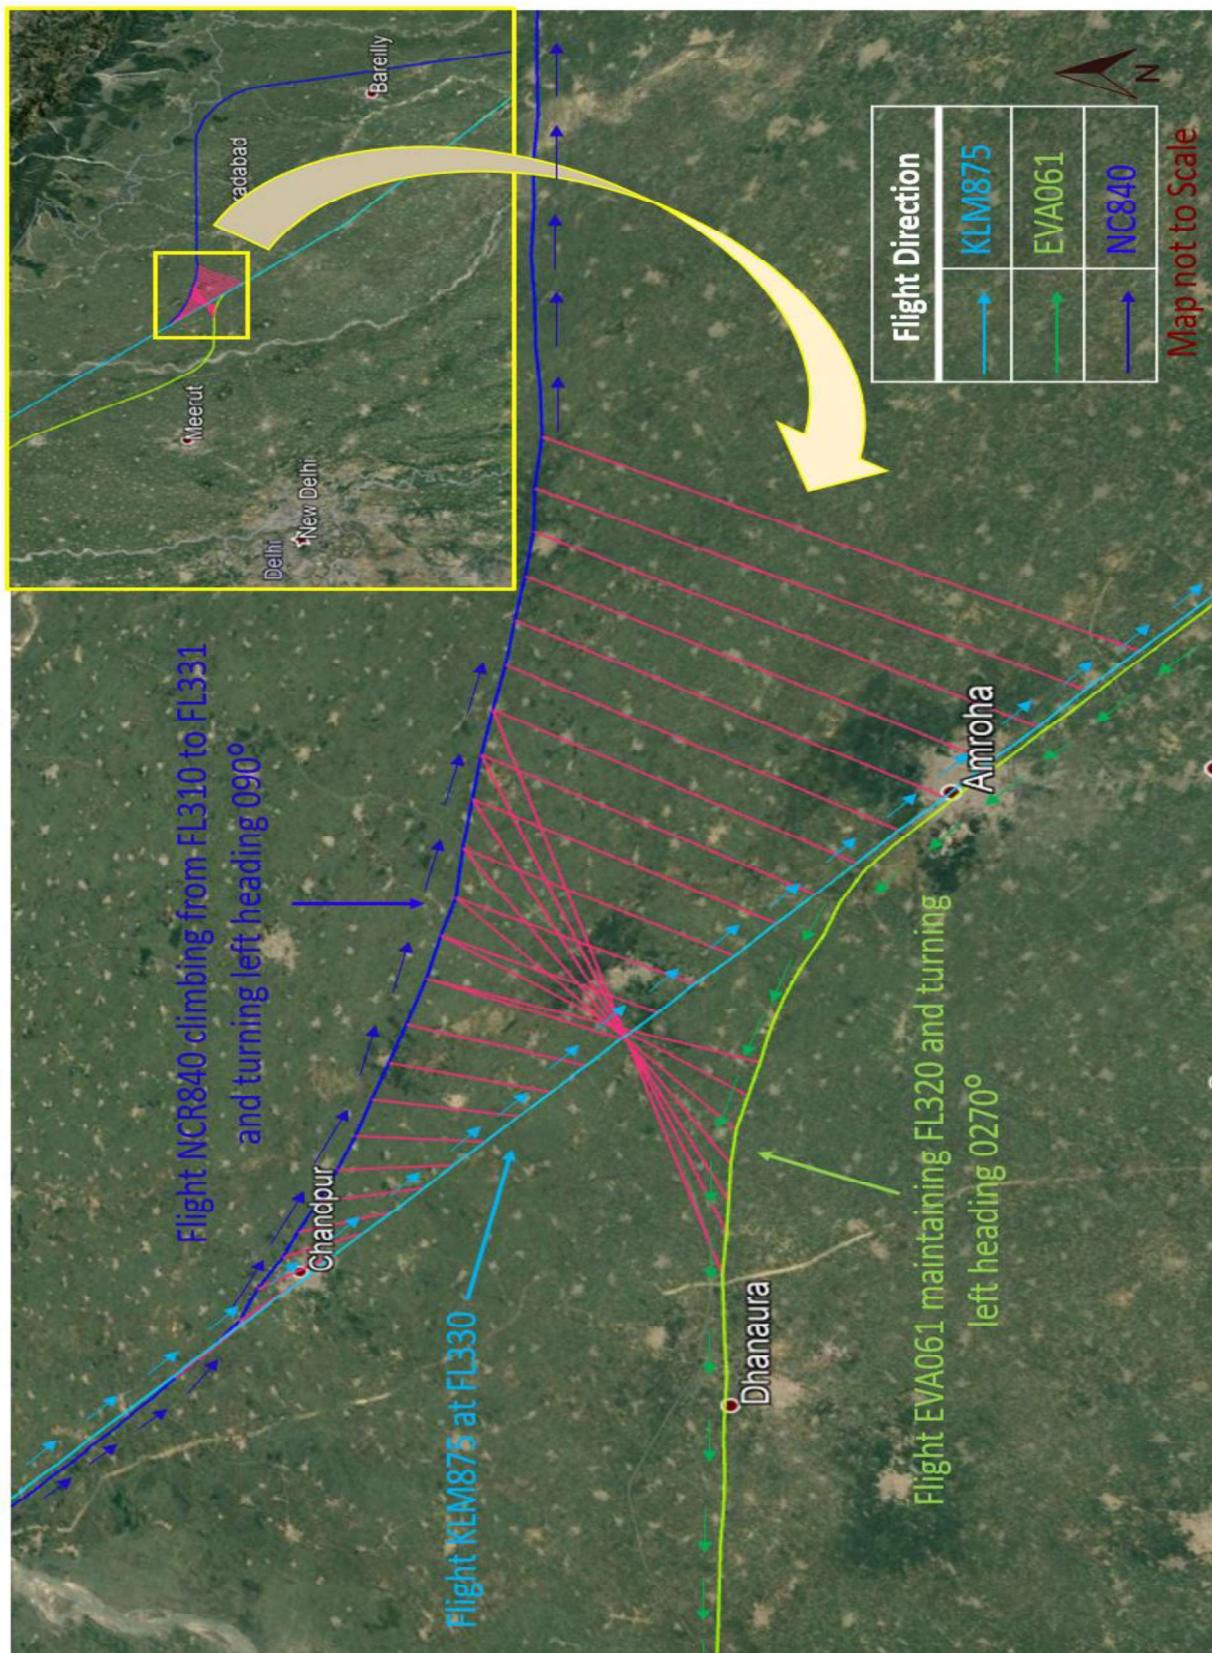
Figure 1: Flight Track superimposed on map.

Flight Tracks were plotted using data from the Delhi Radar. The tracks can be seen in the figure below: -

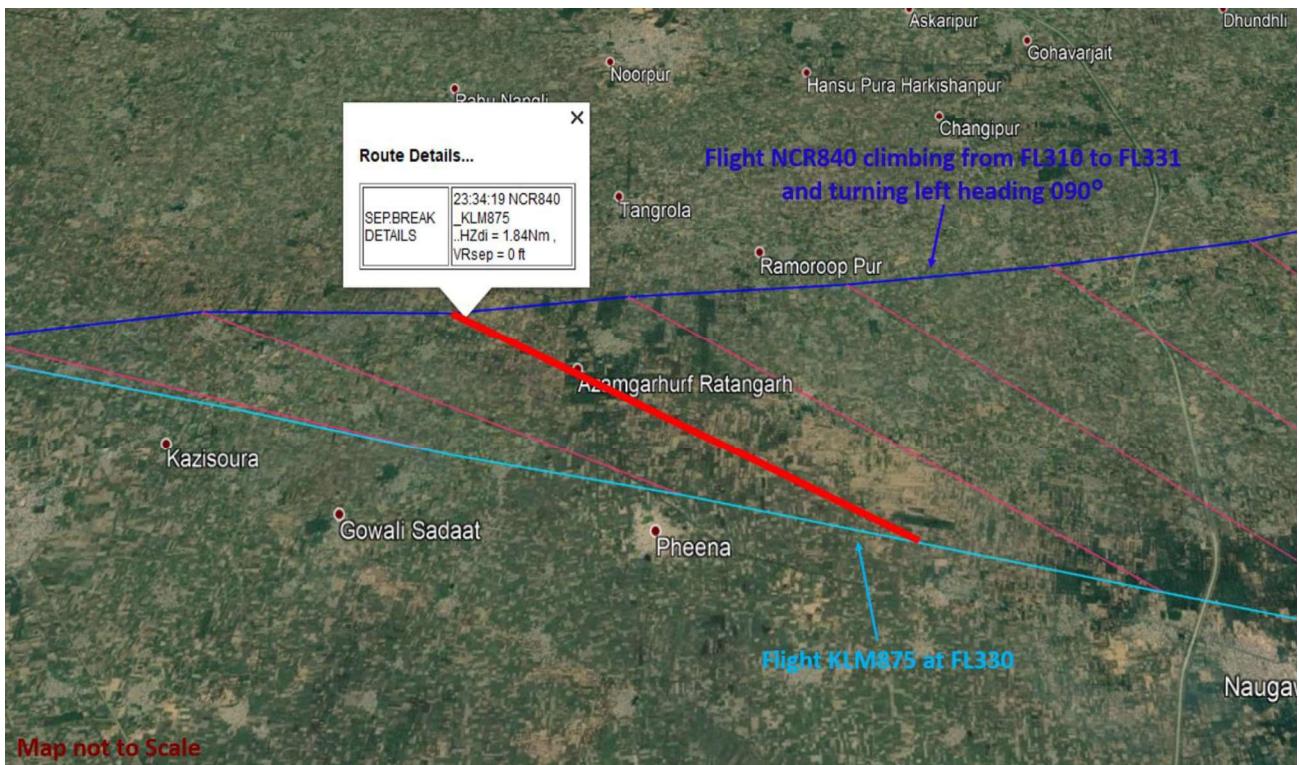
Figure 2: Separation between NCR840 and KLM875

The Lateral Separation between NCR840 and KLM875 at 23:34:19 UTC can be seen as 1.84 Nm while Vertical Separation was 0 Feet, in the Figure 2 below: -

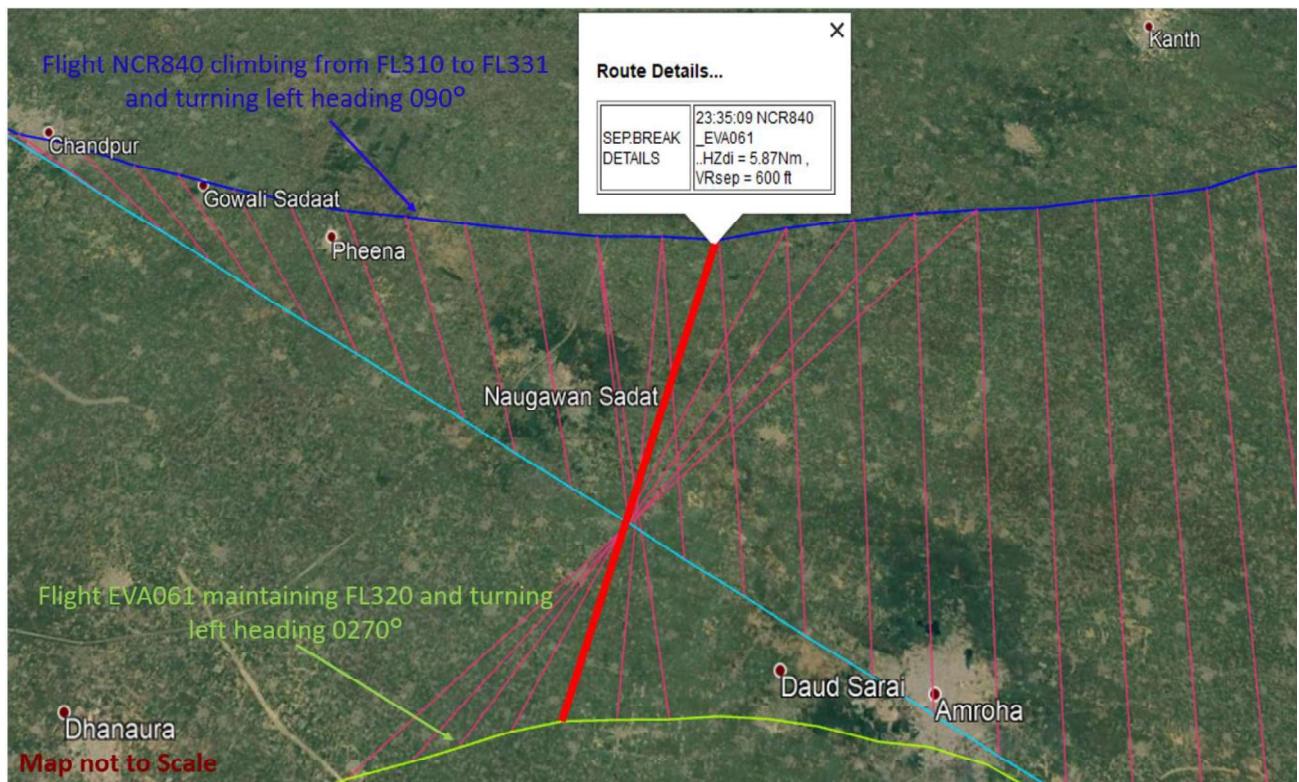
Figure 3: Separation between NCR840 and KLM875

The Lateral Separation between NCR840 and EVA061 at 23:35:09 UTC can be seen as 5.87 Nm while Vertical Separation was 600 Feet, in the Figure 3 below: -

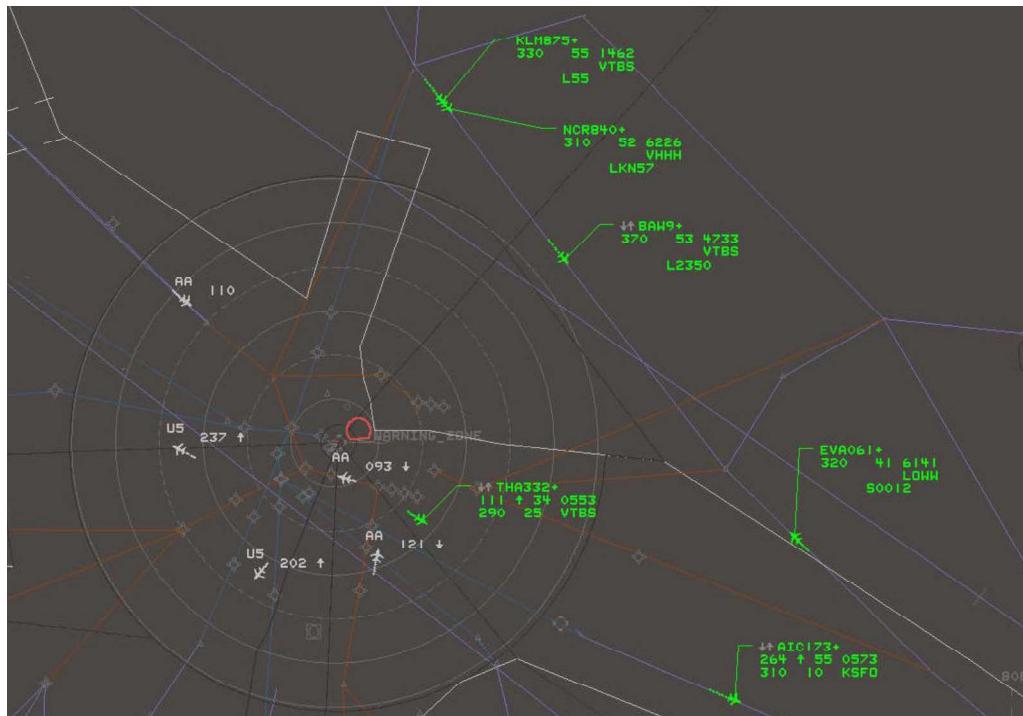
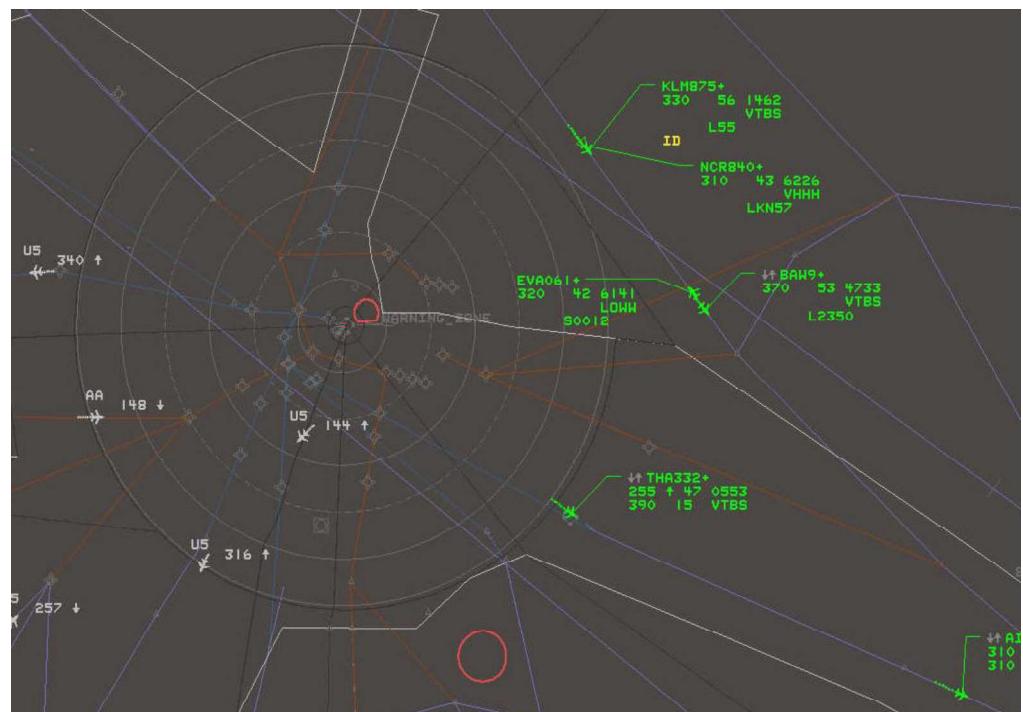
The radar snapshot of time 23:27:11 UTC and 23:32:41 UTC shown in Figure 4 and 5, shows NCR840 maintaining FL310 and KLM875 maintaining FL330. EVA061 is maintaining FL320 flying in reciprocal direction to NCR840 and KLM875.

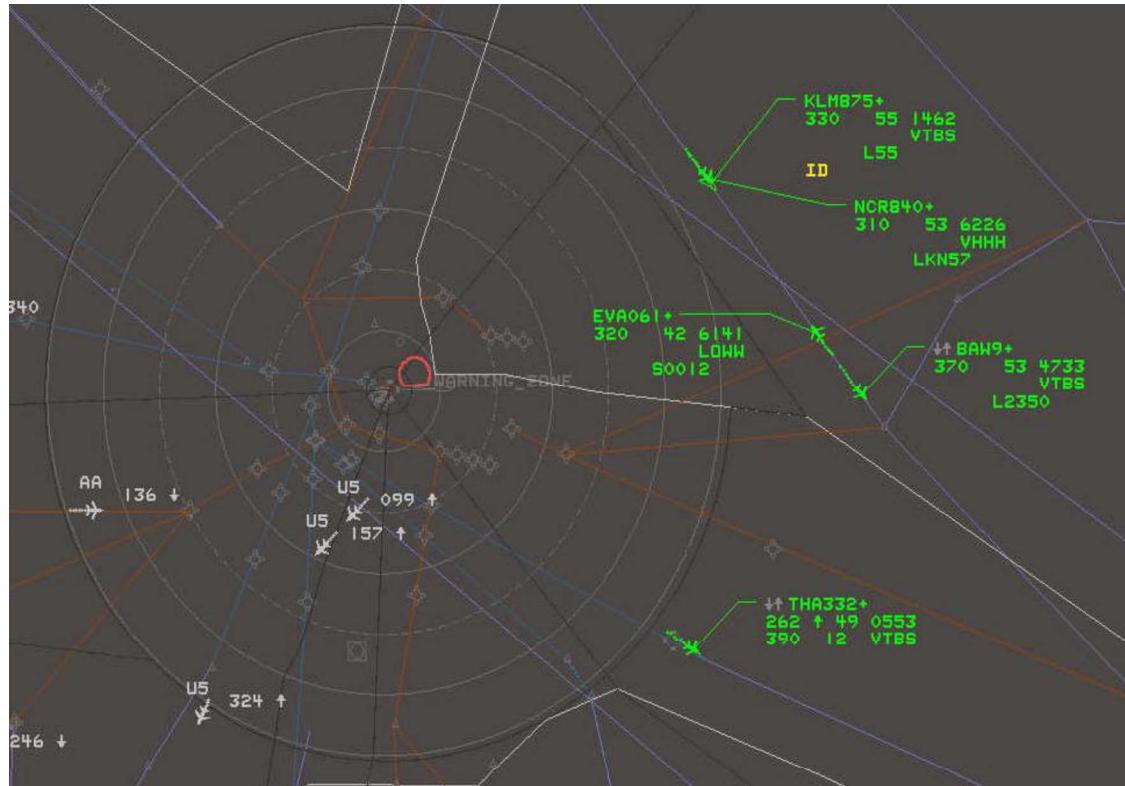
Figure 6: 23:33:12 UTC

At 23:33:12 UTC, KLM875 was just above NCR840 at FL 330 and FL310 respectively, as per the radar snapshot shown in Figure 6.

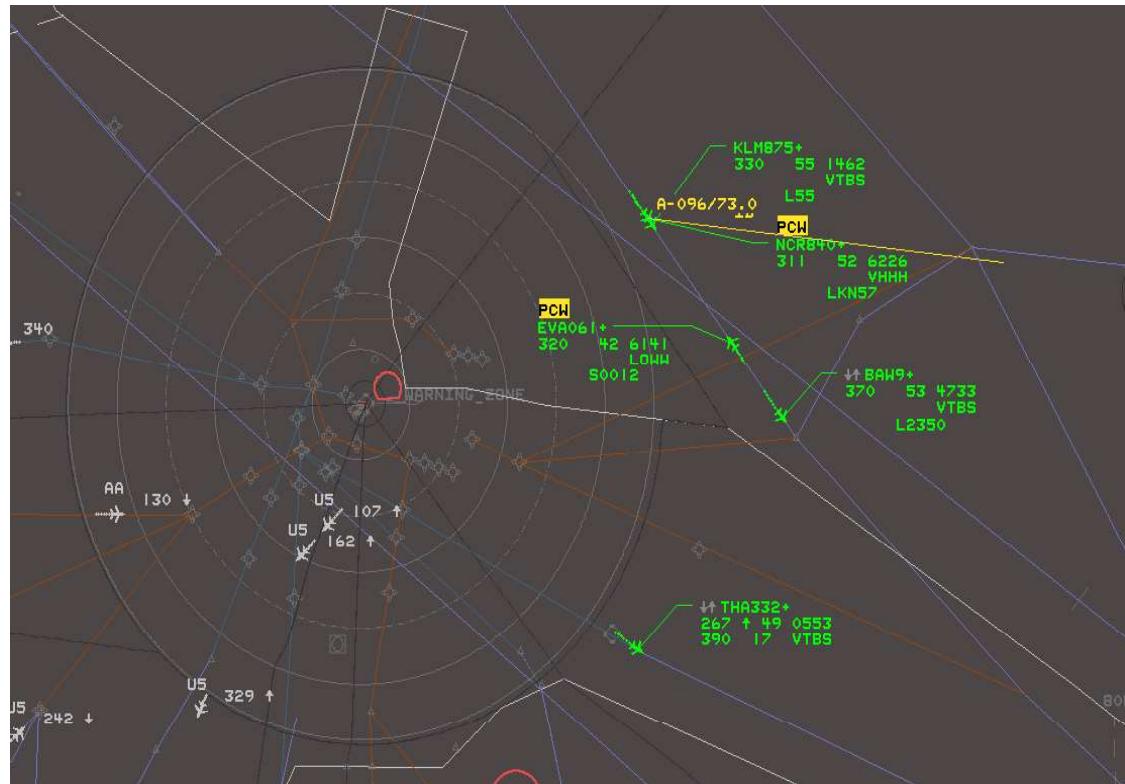
Figure 7: 23:33:28 UTC

In radar snapshot of time 23:33:28 UTC shown in Figure 7, NCR840 can be seen commencing climb. PCW is generated between NCR840 and EVA061.

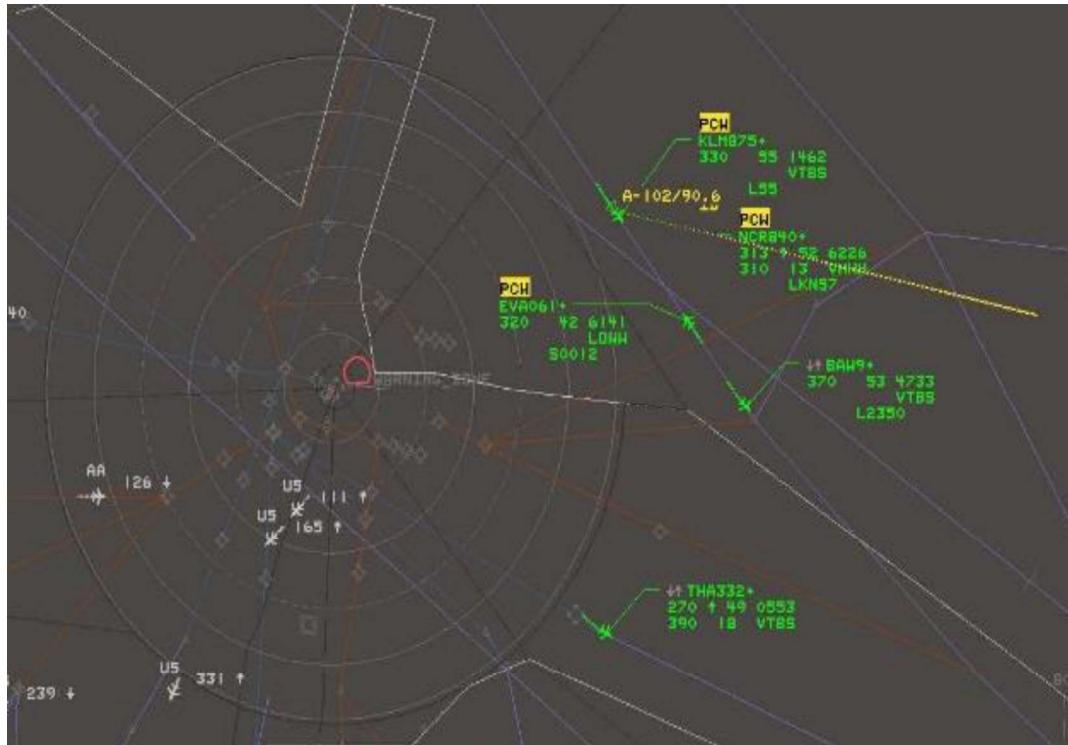
Figure 8: 23:33:38 UTC

In radar snapshot of time 23:33:38 UTC shown in Figure 8, NCR840 can be seen as climbing and having reached FL313. PCW is also seen generated between NCR840 and KLM875.

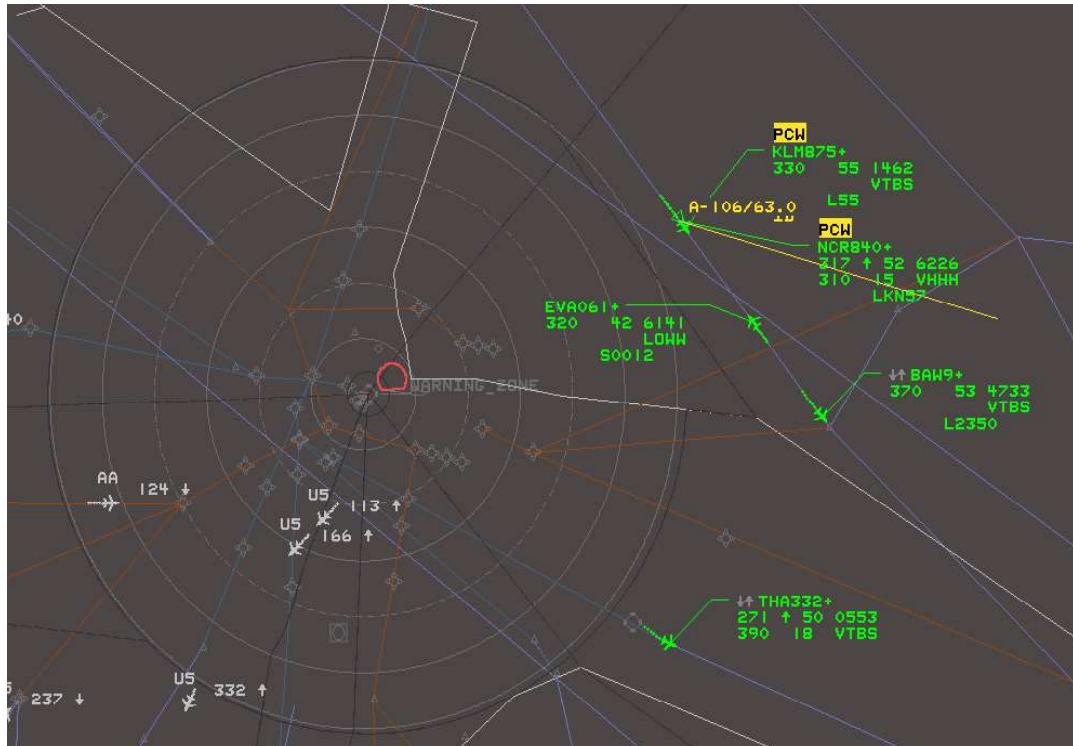
Figure 9: 23:33:44 UTC

In radar snapshot of time 23:33:44 UTC shown in Figure 9, NCR840 can be seen as climbing and having reached FL317. PCW between NCR840 and EVA061 is not seen any more.

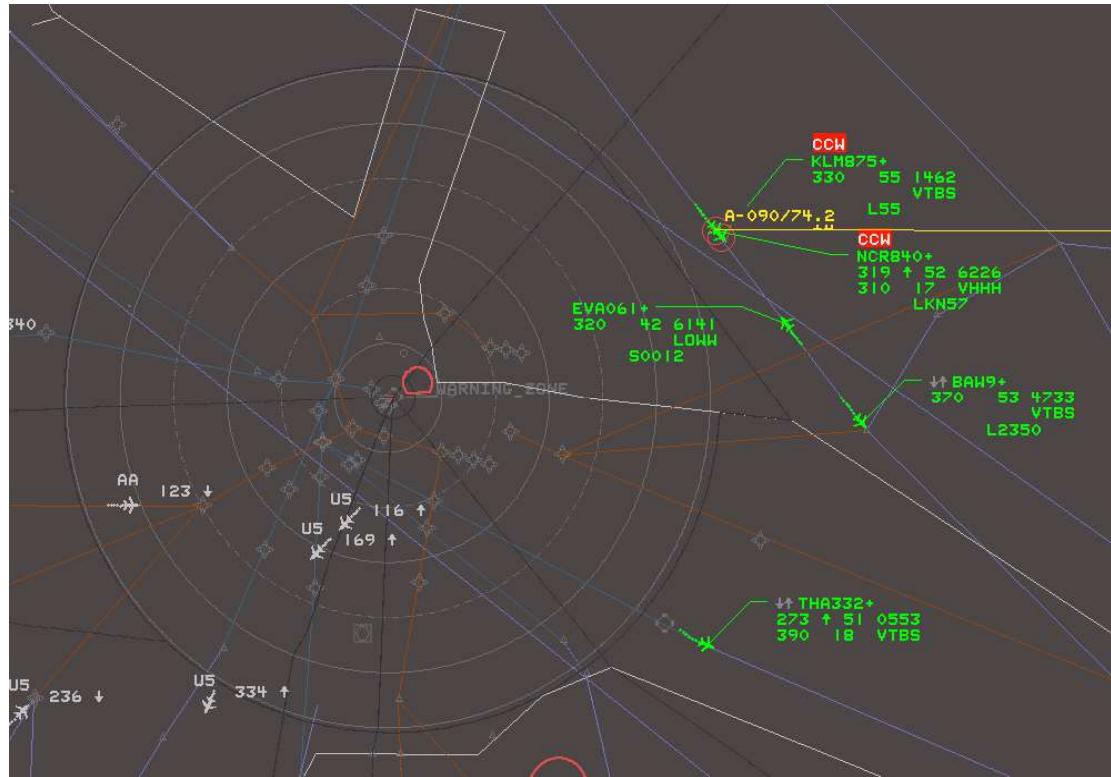
Figure 10: 23:33:50 UTC

In radar snapshot of time 23:33:50 UTC shown in Figure 10, NCR840 can be seen as climbing and having reached FL319. CCW is seen generated between NCR840 and KLM875.

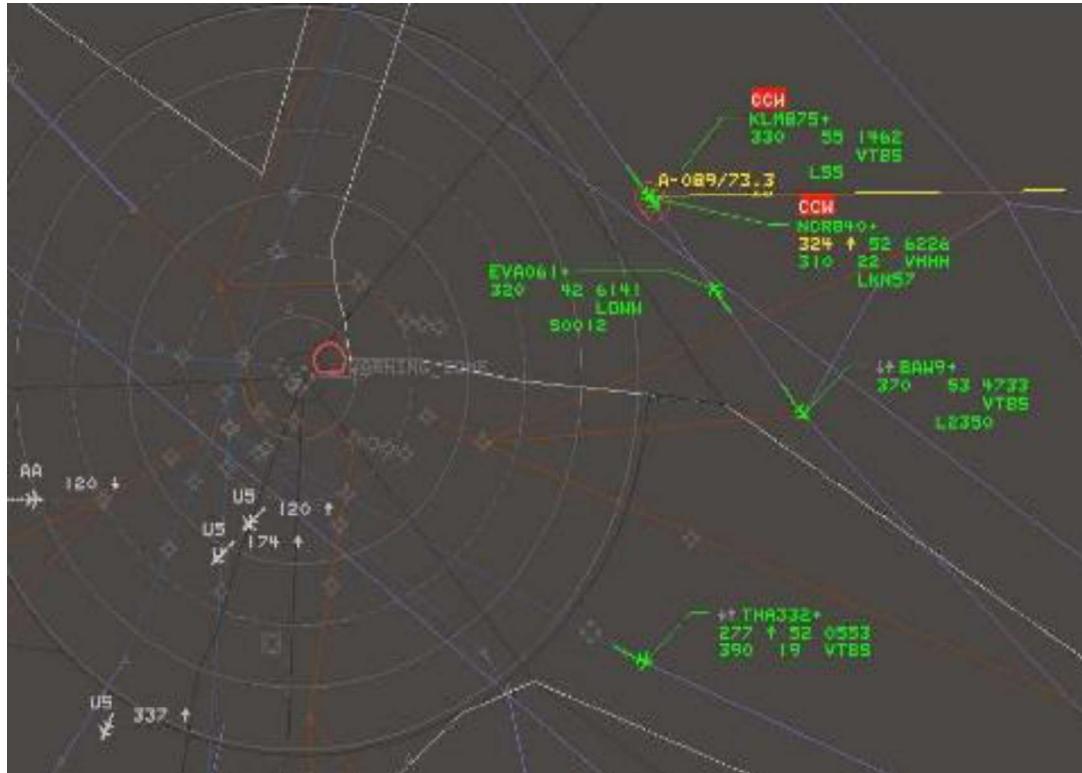
Figure 11: 23:34:01 UTC

In radar snapshot of time 23:34:01 UTC shown in Figure 11, NCR840 can be seen as climbing and having reached FL324. CCW continues between NCR840 and KLM875.

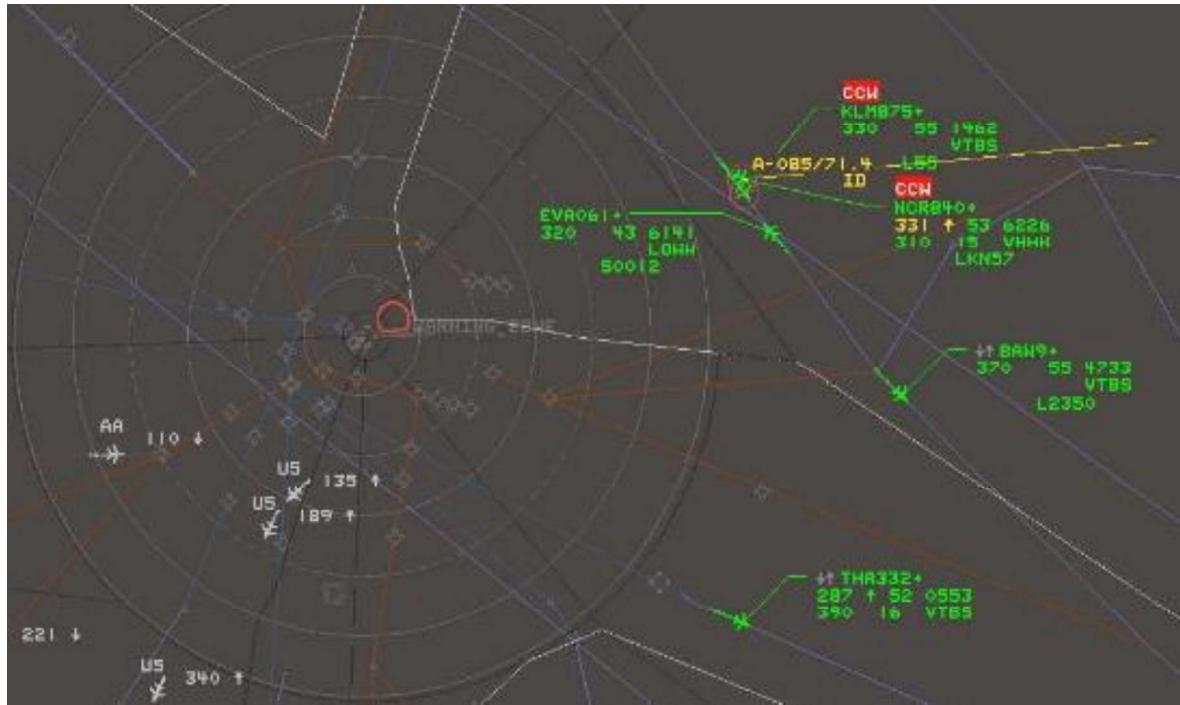
Figure 12: 23:34:38 UTC

In radar snapshot of time 23:34:38 UTC shown in Figure 12, NCR840 can be seen as climbing and having reached FL331, but visibly turning left. CCW continues between NCR840 and KLM875.

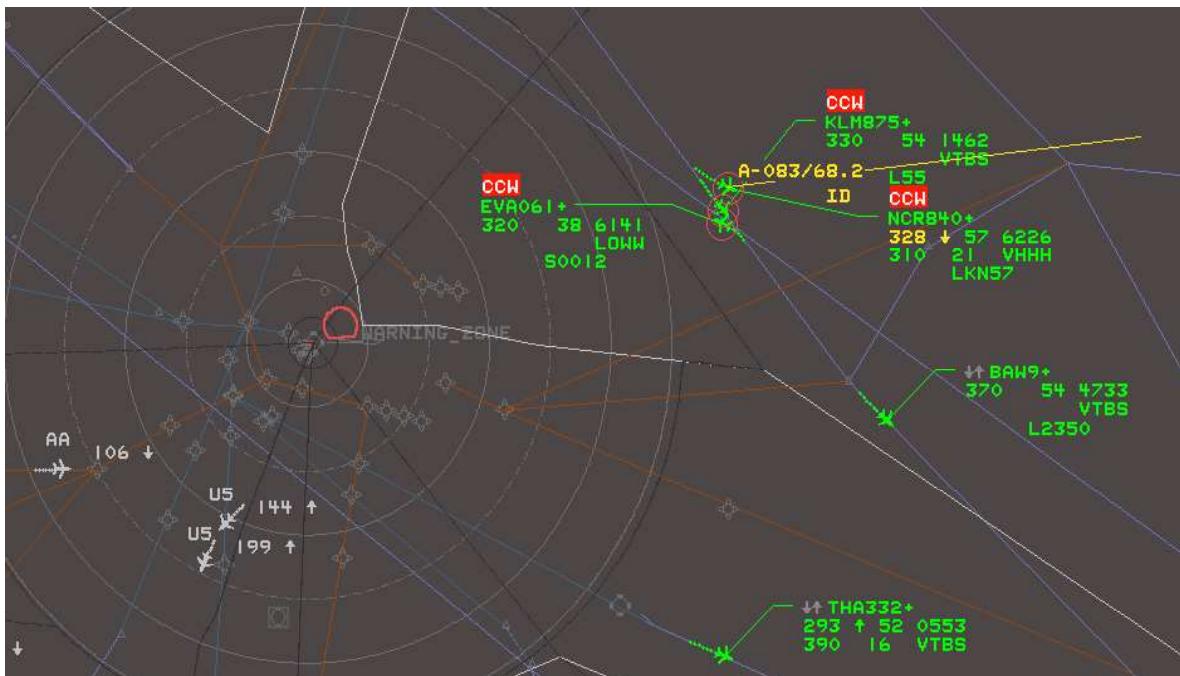
Figure 13: 23:35:00 UTC

In radar snapshot of time 23:35:00 UTC shown in Figure 13, NCR840 can be seen having descended to FL328 and maintaining heading 090°. EVA061 is also seen turning left to maintain heading 0270°. CCW continues between NCR840 and KLM875 and is also generated for NCR840 and EVA061.

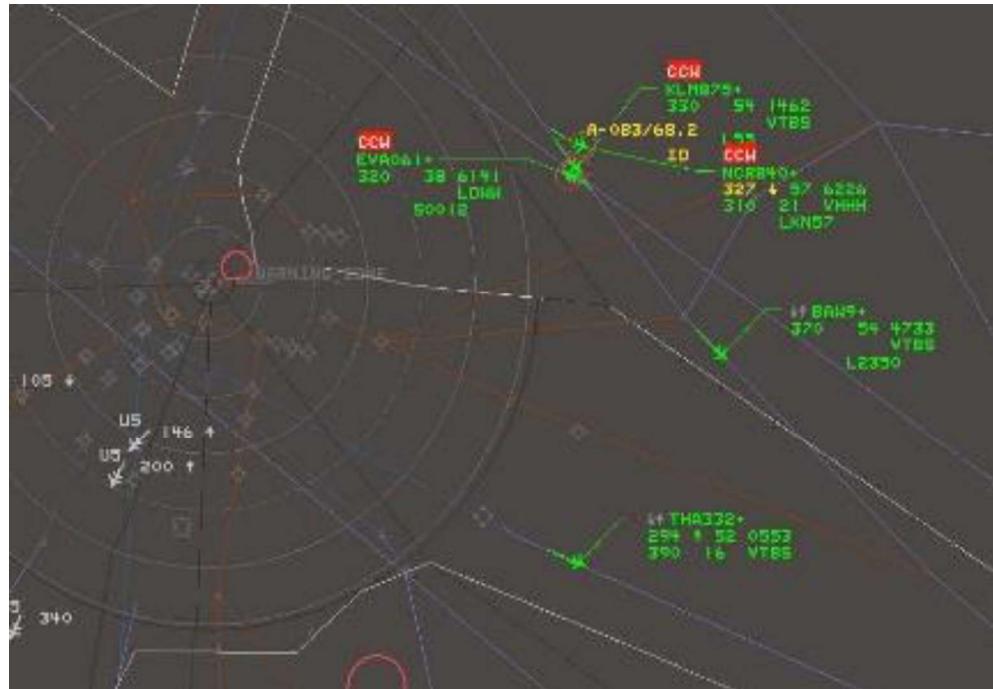
Figure 14: 23:35:03 UTC

In radar snapshot of time 23:35:03 UTC shown in Figure 14, CCW between NCR840 and KLM875 as well as CCW between NCR840 and EVA061 persists. NCR840 can be seen having descended to FL327 and both NCR840 and EVA061 continue left heading.

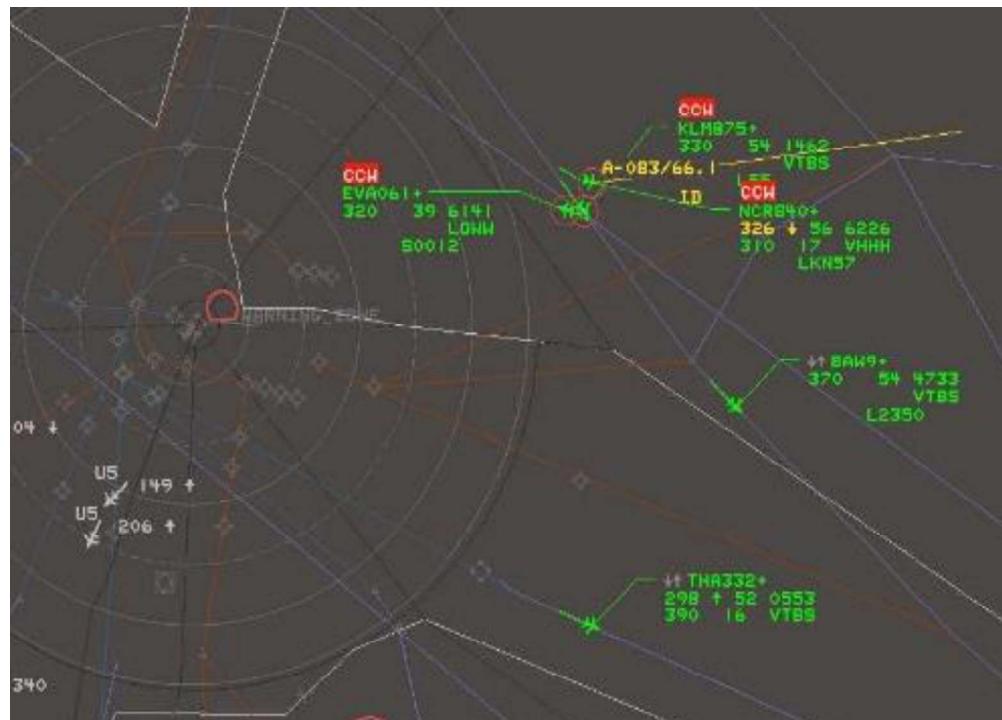
Figure 15: 23:35:16 UTC

In radar snapshot of time 23:35:16 UTC shown in Figure 15, CCW between NCR840 and KLM875 as well as CCW between NCR840 and EVA061 persists. NCR840 can be seen having descended to FL326 and both NCR840 and EVA061 continue left heading.

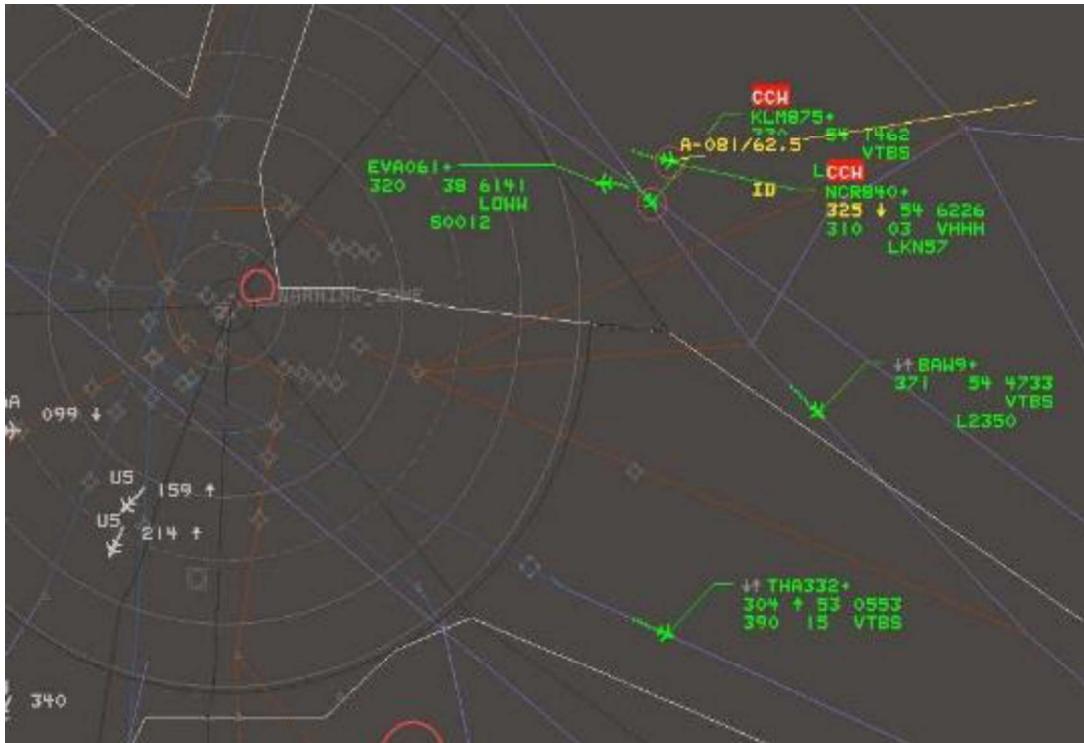
Figure 16: 23:35:43 UTC

In radar snapshot of time 23:35:43 UTC shown in Figure 16, CCW between NCR840 and KLM875 persists but CCW between NCR840 and EVA061 is resolved. NCR840 can be seen having descended to FL325 and both NCR840 and EVA061 continue with left heading. CCW had ceased when standard separation of 10 NM was re-established between EVA061 and NCR845.
