Report IN-051/2019

Incident involving an AIRBUS A320, registration EC-MKO, operated by VUELING, and an EMBRAER 145, registration F-HRAM, operated by AERO4M, 17.4 NM northeast of Barcelona-El Prat airport (Spain) on 27 September 2019

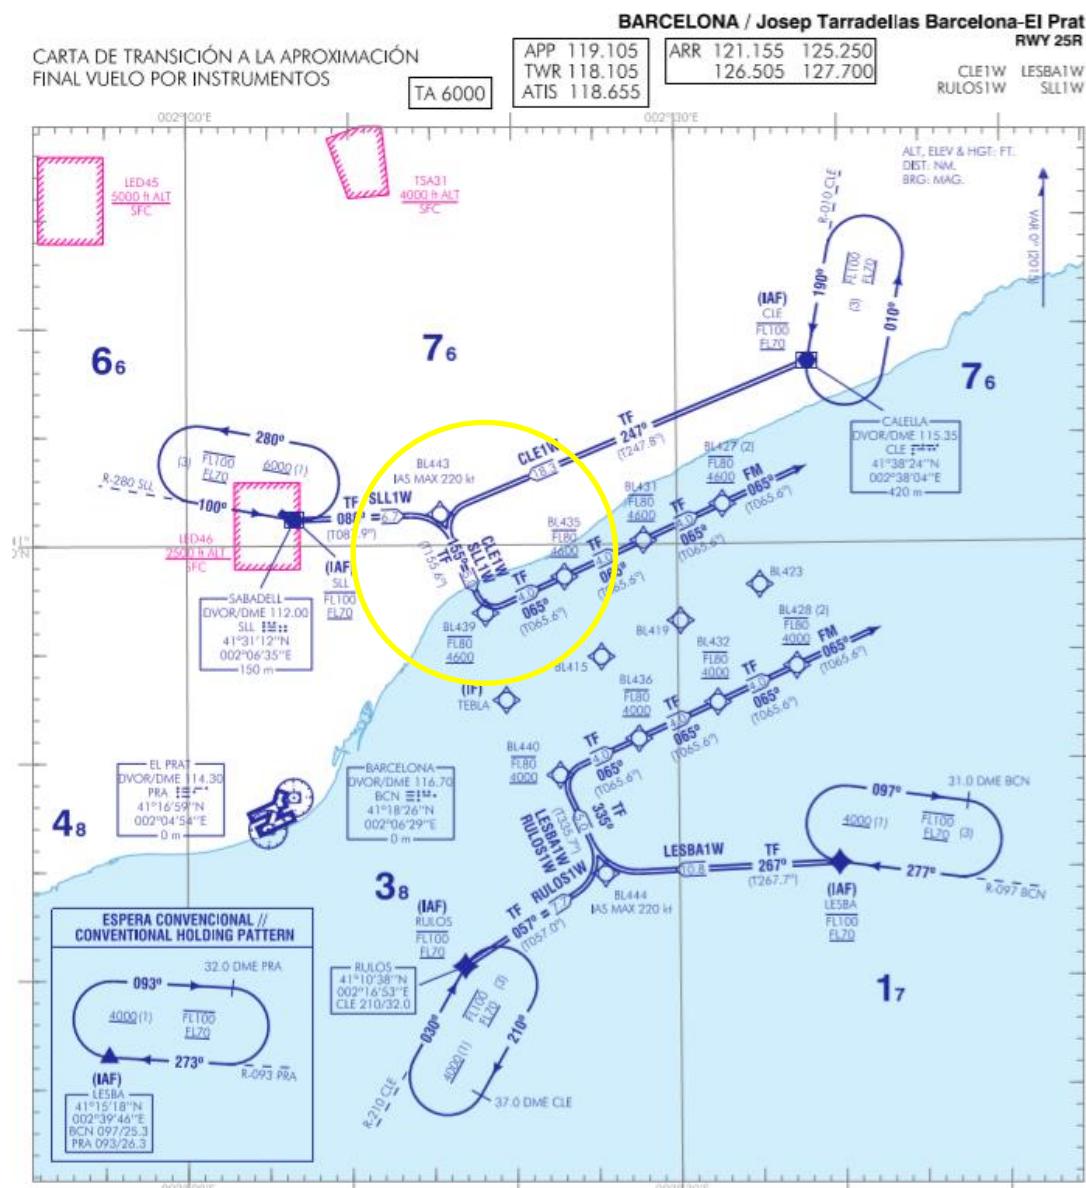
Fig. 1 Detail of chart AD 2 – LEBL TRAN 5.1 (CLE1W).
Points BL443, BL439 and BL435 are inside the yellow circle.

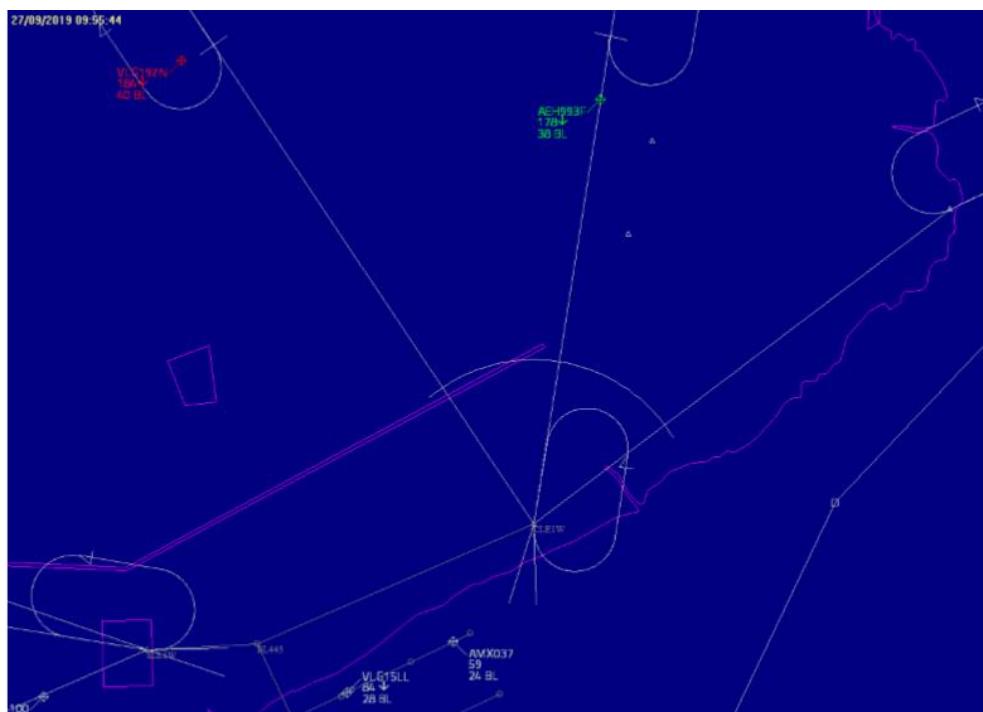
Fig. 2 Palestra image for 09:55:44

At 09:54:24, the controller in sector T1W instructed VLG19ZN to fly direct to point BL443. The crew correctly acknowledged the instruction. The controller then instructed AEH993F to “*fly direct to the BL443 to continue with the transition*”, but the crew only acknowledged “*fly direct BL443*”, which ATC did not correct.

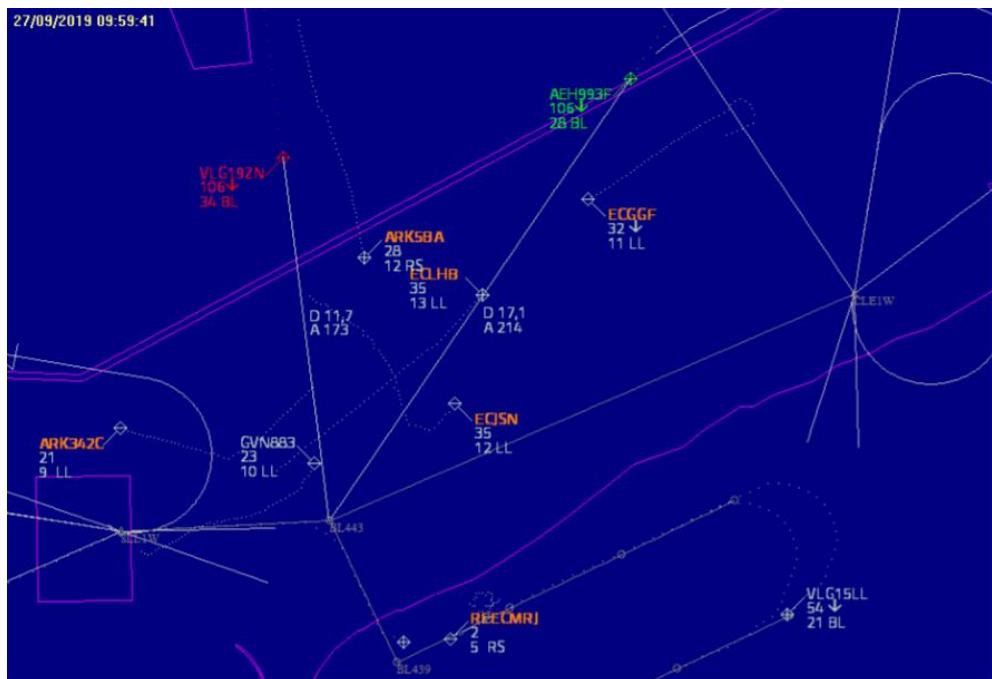
Fig. 3 Palestra image for 09:59:41

Then, the controller in sector T1W instructed VLG19ZN to descend to 5000 ft, which the crew acknowledged correctly. Afterwards, he instructed AEH993F to descend to FL080, which its crew acknowledged correctly.

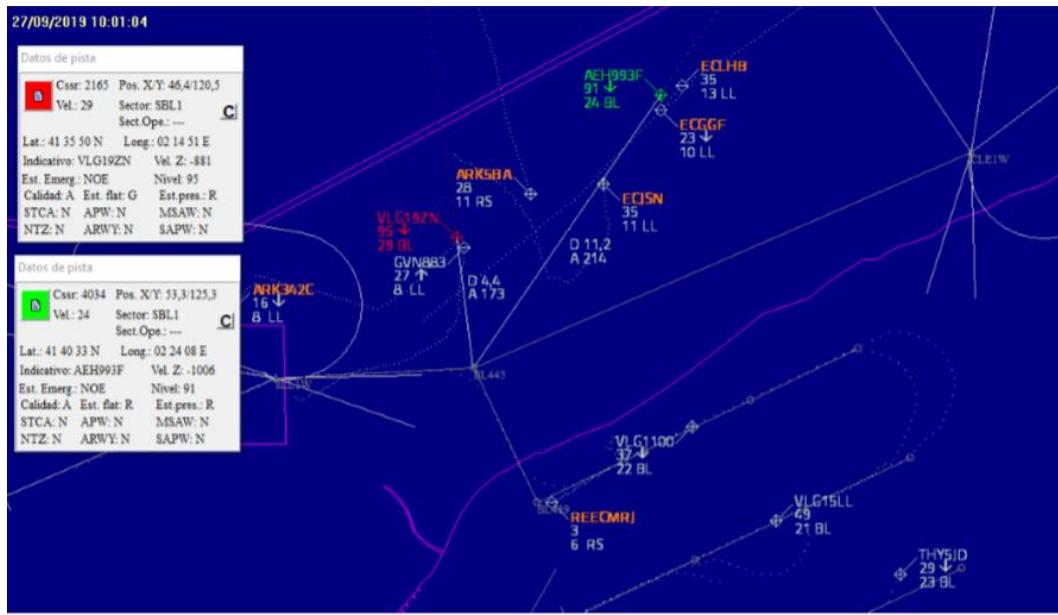
Fig. 4 Palestra image for 10:01:04

At 10:01:04, the controller in sector T1W instructed AEH993F to descend to 6000 ft. The crew acknowledged correctly.

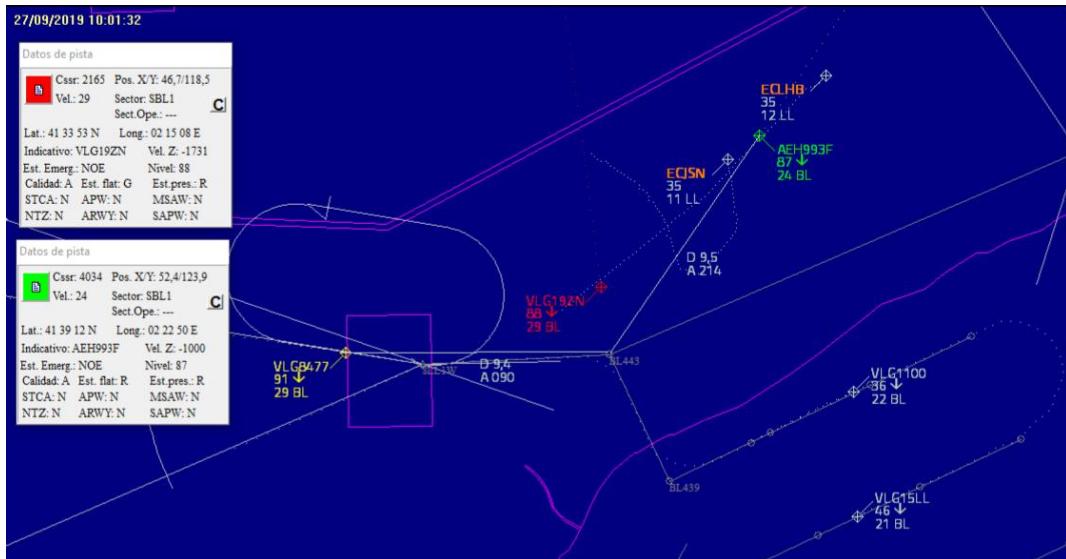
Fig. 5 Palestra image for 10:01:32

At 10:01:32, the controller in sector T1W instructed AEH993F to “fly direct to the BL435”, which the crew acknowledged correctly (see location of point BL435 in Figure 1).

In addition, the lack of coordination with sector F25W notwithstanding, this instruction is considered inappropriate since it made AEH993F and VLG19ZN converge at point BL435 at very similar altitudes. It has been deemed that the controller in sector T1W correctly detected the conflict but he implemented a faulty plan and executed it improperly, resulting in the loss of prescribed separation between the two aircraft.

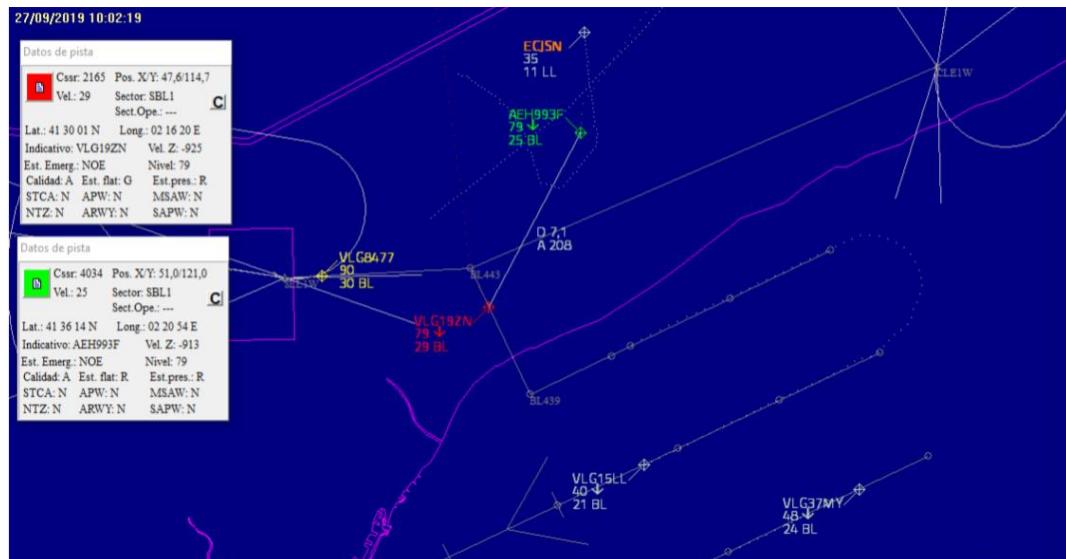
Fig. 6 Palestra image for 10:02:19

At 10:02:04, the controller in sector T1W instructed VLG19ZN to reduce to its minimum clean approach speed and transferred it to 119.105 MHz, which is the frequency for sector F25W. The crew of the aircraft acknowledged correctly.

The controller in sector F25W then instructed VLG19ZN to descend to 2300 ft and reduce to its minimum clean speed, which the crew acknowledged correctly.

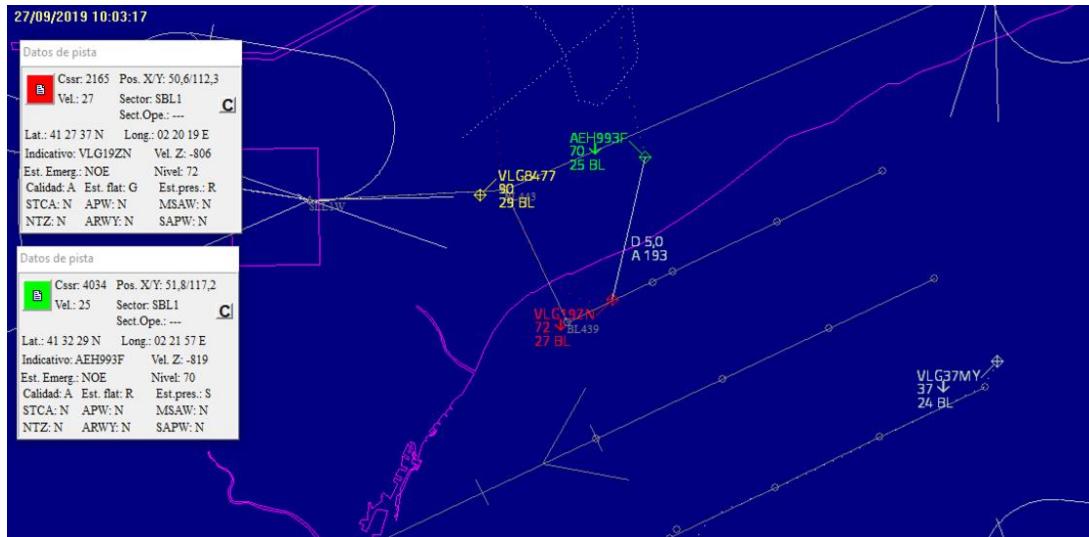
Fig. 7 Palestra image for 10:03:17

At 10:03:11, the controller in sector T1W coordinated with the controller in sector F25W and asked him to instruct VLG19ZN to increase its rate of descent. The controller in sector T1W then instructed AEH993F to turn right immediately to heading 070°. The crew asked for the instruction to be repeated, so the controller in sector T1W instructed AEH993F to turn left

immediately to heading 070°. The crew requested confirmation that the turn was to the left, which the controller in sector T1W did. In response, the crew reported that they had VLG19ZN on TCAS and again requested confirmation of the left turn, since the other aircraft was proceeding toward its left. The controller in sector T1W instructed the crew to maintain its current heading.

The controller in sector F25W then instructed VLG19ZN to increase its rate of descent until it passed 5000 ft, which the crew acknowledged correctly.

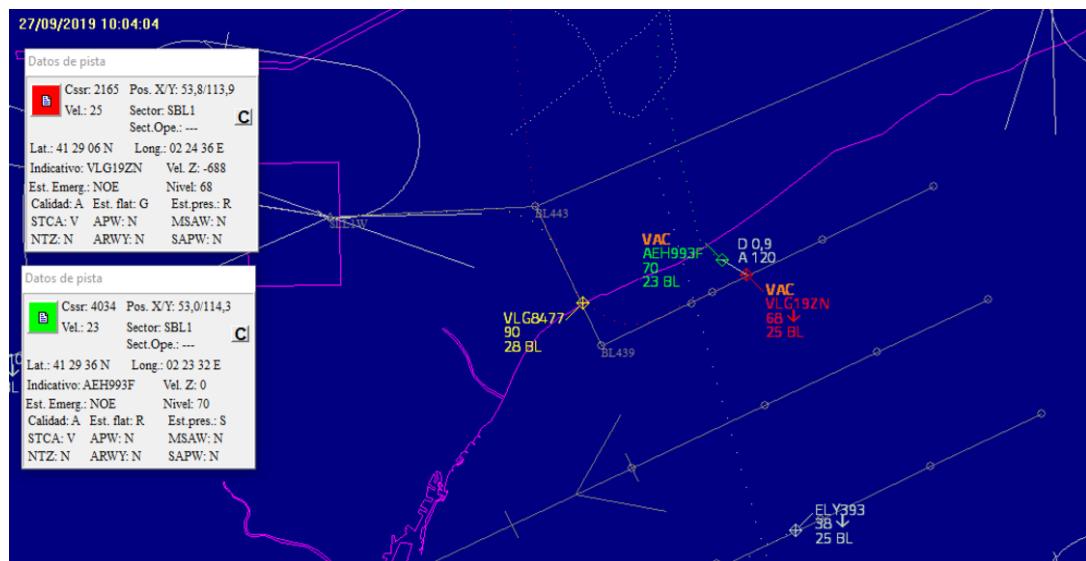
Fig. 8 Palestra image for 10:04:04

At 10:04:04, VLG19ZN reported a TCAS RA, which the controller in sector F25W acknowledged. The figure below, which is for that time, shows the activation of the STCA-VAC feature. At the time, the aircraft were separated by 0.9 NM and 200 ft.

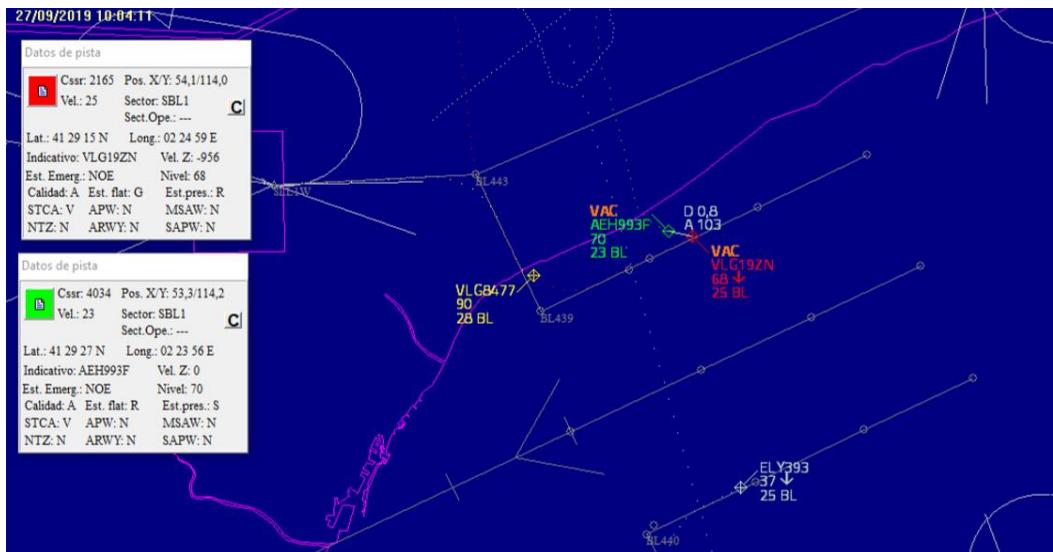
Fig. 9 Palestra image for 10:04:11

At 10:04:12, the controller in sector T1W instructed AEH993F to turn to heading 060°. The crew of the aircraft acknowledged correctly and reported they had received a TCAS RA,

and that they had the traffic in question in sight. It was then that the aircraft were at their closest point of approach: 0.8 NM and 200 ft.
