Investigation Report

Type of Occurrence:	Serious Incident
Date:	30 September 2017
Location:	Sylt Airport
Aircraft:	Airplane
Manufacturer / Model:	Airbus Industry / A320-214
Injuries to Persons:	None
Damage:	None
Other Damage:	Runway edge lighting
State File Number:	BFU17-1339-5X

An Airbus A320 landed at Sylt Airport on runway 32. It overshot the runway and came to a stop in the grass about 80 m after the end of the runway.

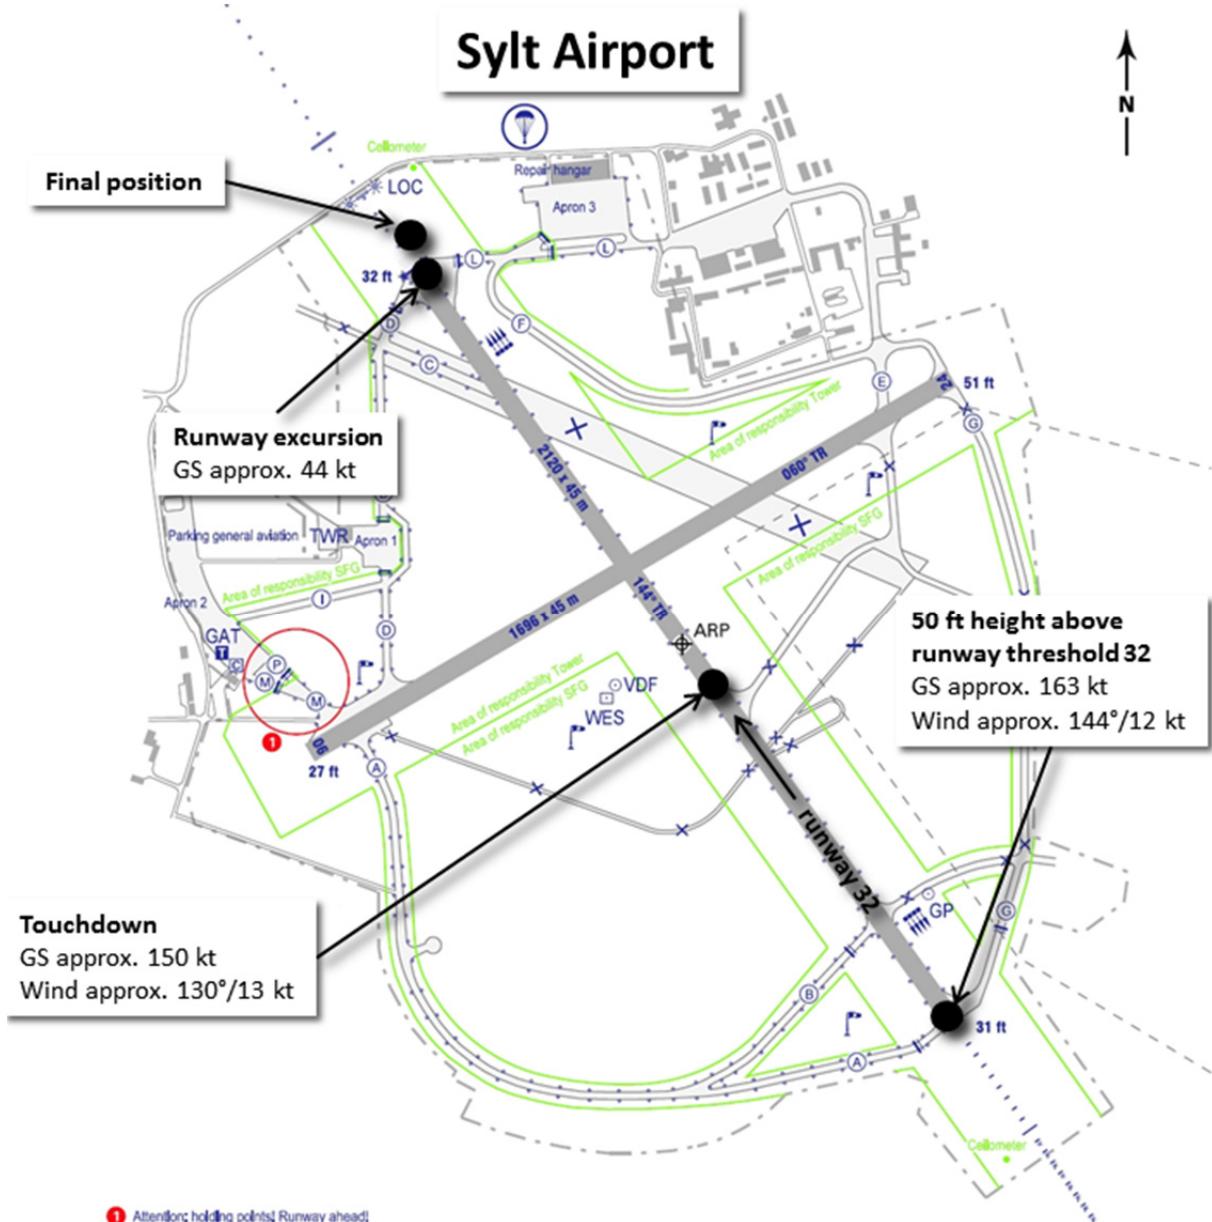
Fig 2: Aerodrome chart of Sylt Airport with FDR data

Figure 2 shows the aerodrome chart of Sylt Airport with red markings for the crossing of the threshold, the touchdown point, for the runway excursion and the final position of the airplane.

The markings were determined with the FDR data and incorporated into the AIP chart (of 18.09.2014).

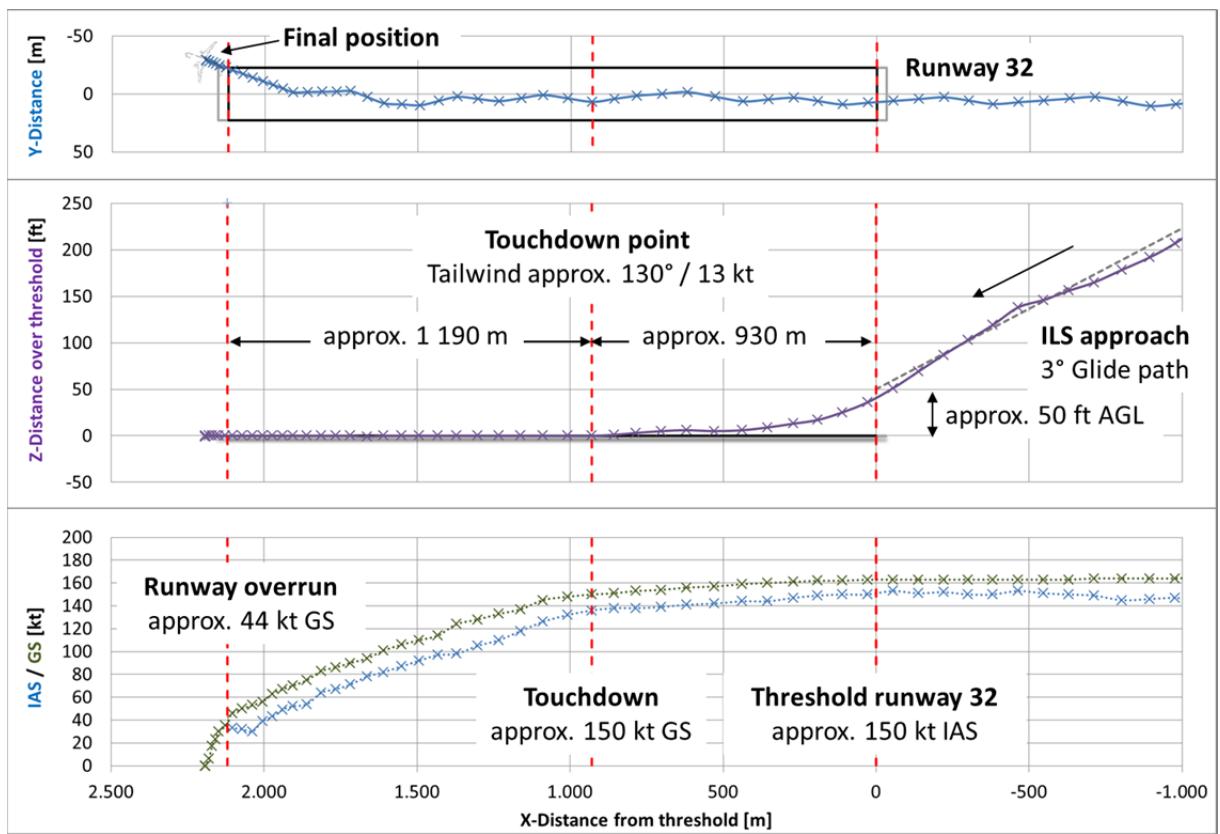
Fig. 3: Vertical view from 50 ft AGL (radio altitude)

Figure 3 shows the vertical view from about 200 ft AGL (radio height) and the rolling distance until the final position. The FDR data was converted in relation to the middle of the threshold from the AIP and the distance given in meters (x-distance and y-distance from threshold). The crosses are the converted FDR values which were connected with plane lines.

The value of the radio altimeter indicates the height of the landing gear in feet above threshold 32 until touch-down and is depicted with a purple line in Figure 3 (Z-distance over threshold).

Touch-down occurred about 930 m after crossing threshold 32. After about 1,190 m from the touchdown point the airplane veered right off the runway. After the runway excursion the ground speed shows the strong deceleration on the grass until the stop after about 80 m.

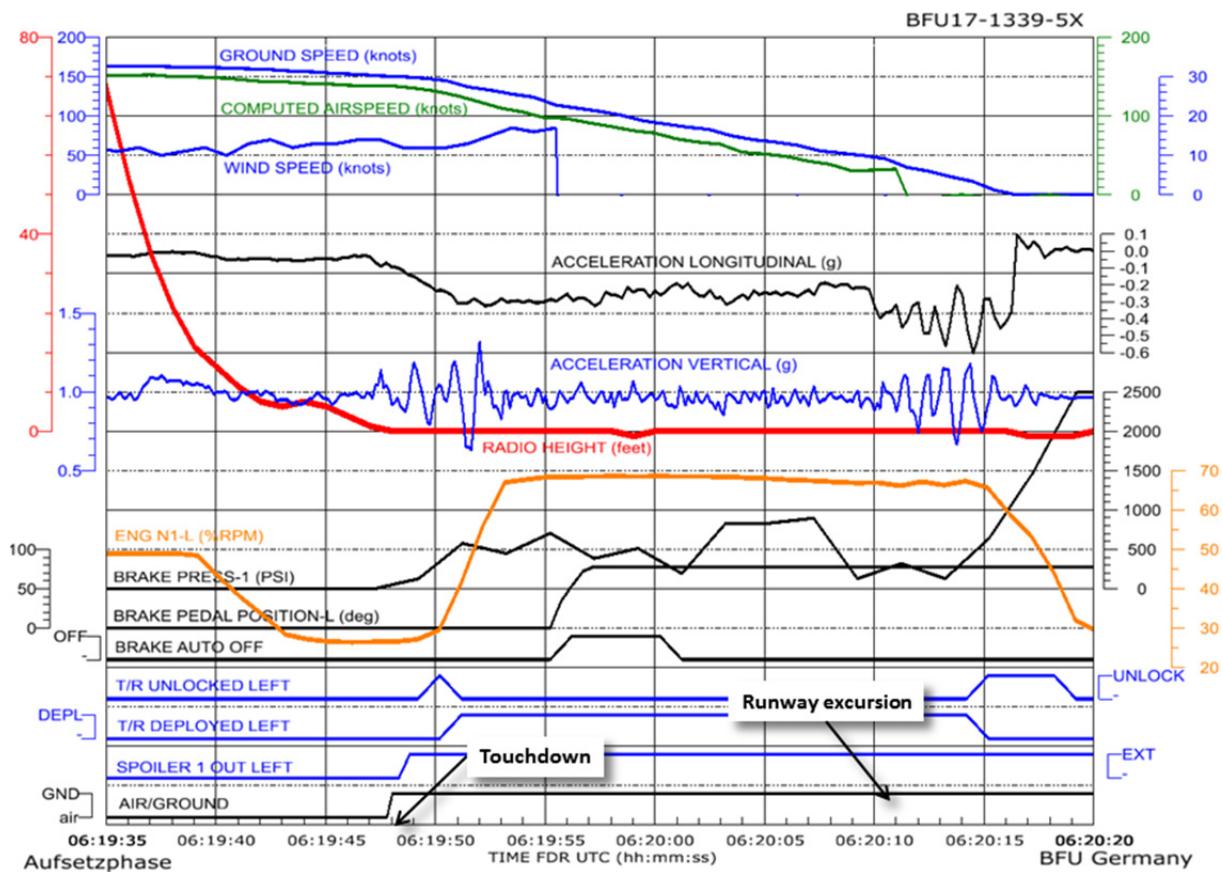
Fig. 4: FDR data, which was recorded during touch-down and the runway excursion

Figure 4 shows the touch-down point on the runway and the subsequent runway excursion.

The FDR parameter Acceleration Vertical (g) was chosen as indicator for the runway excursion. The FDR parameters Spoiler, T/R Unlocked and Deployed (Thrust Reverser), Brake Auto, Brake Pedal Position, Brake Press and Eng. N1 were selected for the depiction of the deceleration on the runway.

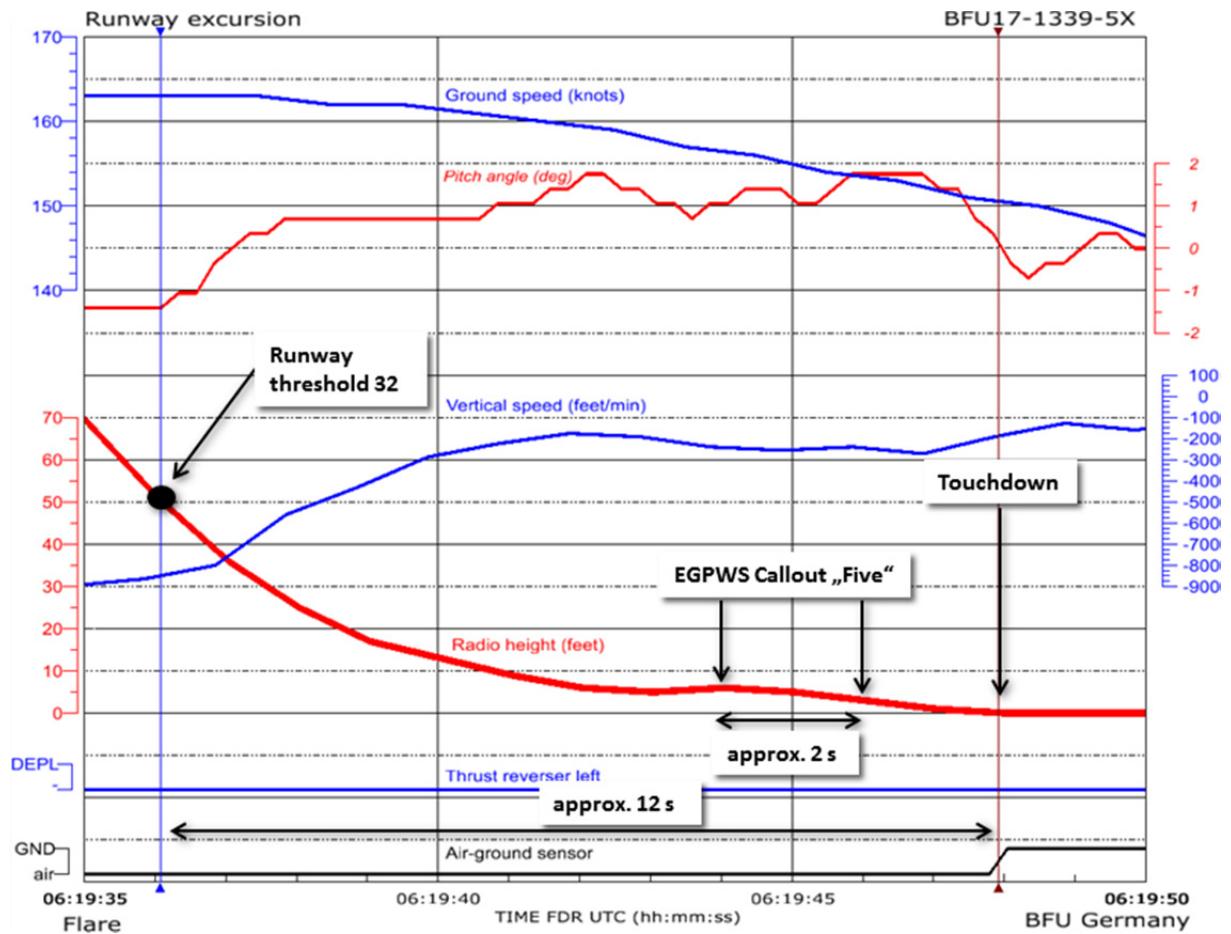
Fig. 5: FDR and CVR data of the flare phase until the touch-down point on runway 32

The following FDR parameters were selected for the examination of the touch-down phase from the 50 ft AGL point, which is the crossing of the threshold, to the touch-down point: Radio Altitude, Pitch Angle, Ground Speed and Vertical Speed (Fig. 5).

During the occurrence flight the airplane needed approximately 12 s from the 50 ft radio height point to the touch-down point.

As comparison, the above-mentioned parameters of the last 20 flights, which were also recorded on the FDR, were examined as well. The airplane needed on average approximately 8 s for the same distance. During the occurrence flight the flare phase lasted about 4 s longer than on average.

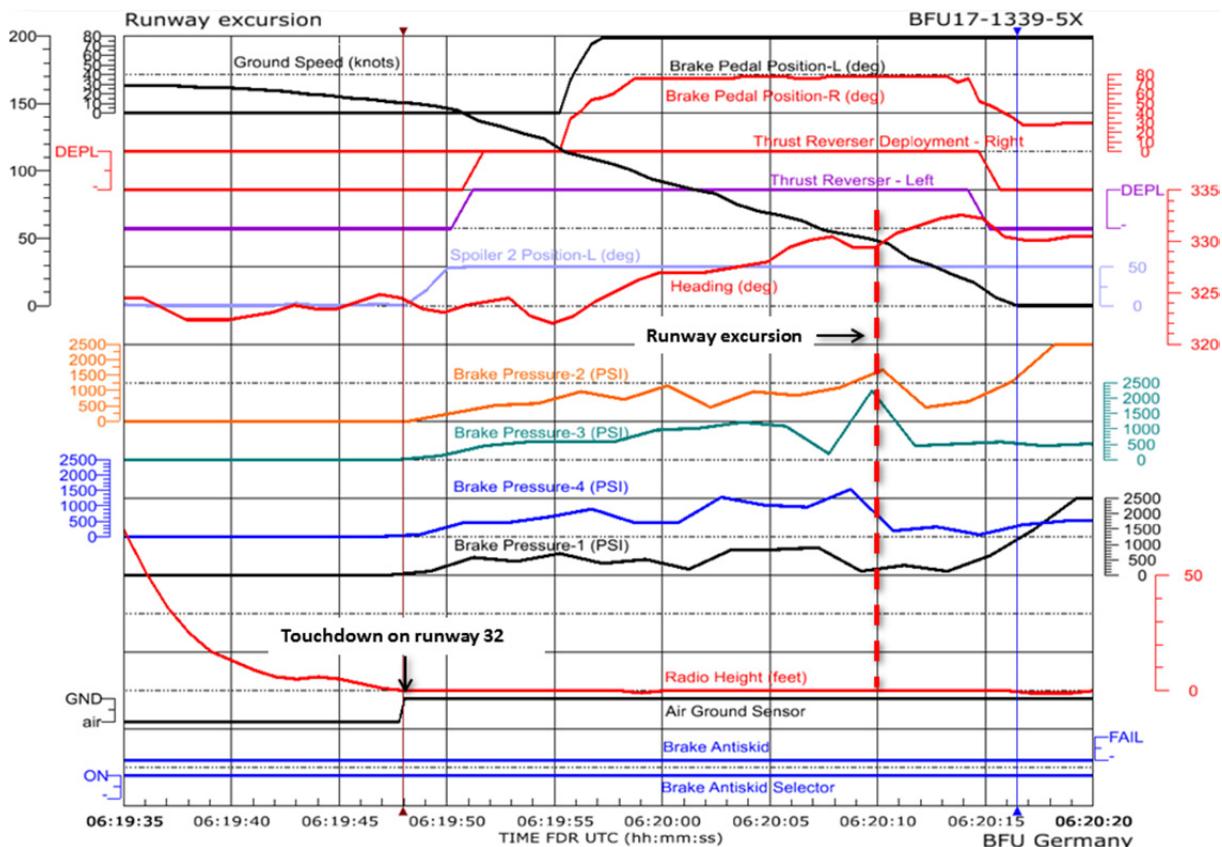
Fig. 6: FDR data illustrating the deceleration of the airplane on runway 32

The following FDR parameters were selected for the examination of the deceleration of the airplane on the runway, between the touchdown point until the runway excursion: Brake Pedal Position, Brake Pressure No. 1-4, Thrust Reverser Activation, Spoiler Activation (Fig. 6).

The analysis of the FDR data showed that the deceleration began after the air ground sensor was activated to ground. The mean rate of deceleration was approximately 0.3 g.

By pushing the pedals in the cockpit the auto brake system was deactivated. Afterwards the mean rate of deceleration fluctuated between 0.19 g and 0.32 g. According to the FDR, brake pedal position was about 80°. This was the maximum possible angle. The brake pressure, which was generated through the auto brake system, was between about 550 psi and about 2,200 psi.

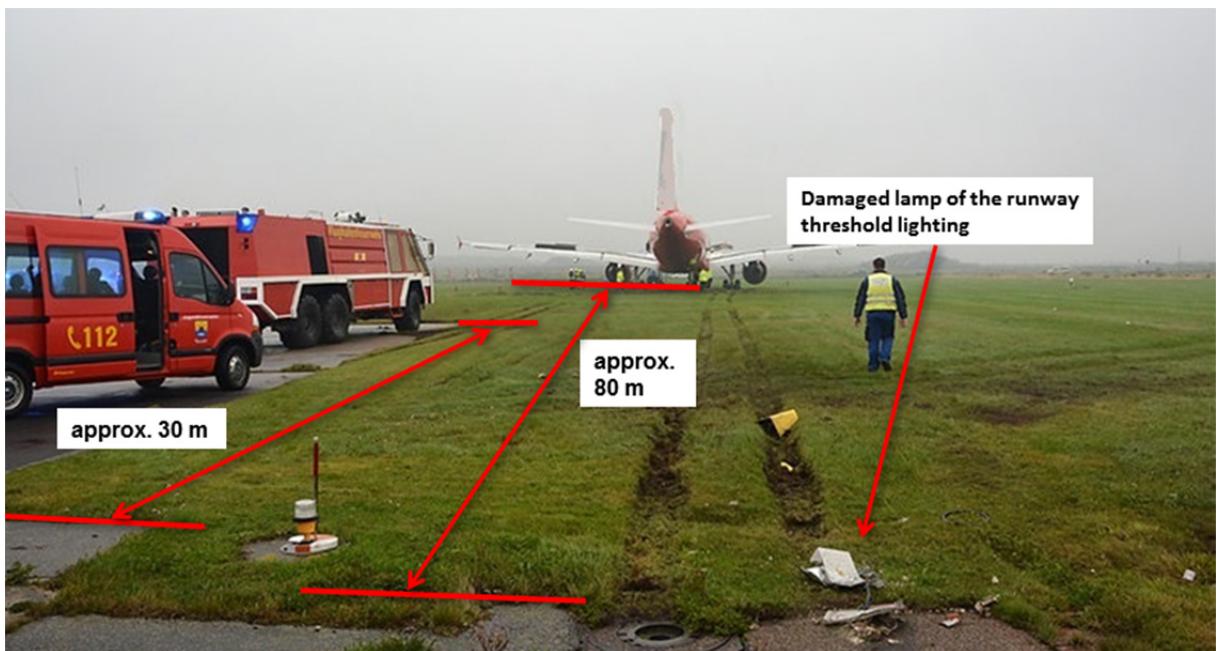
Fig. 7: Airplane position and damaged lighting

The airplane had come to a stop in the grass about 80 m north of the end of the runway. One lamp of the runway threshold lighting of runway 14 had been damaged.

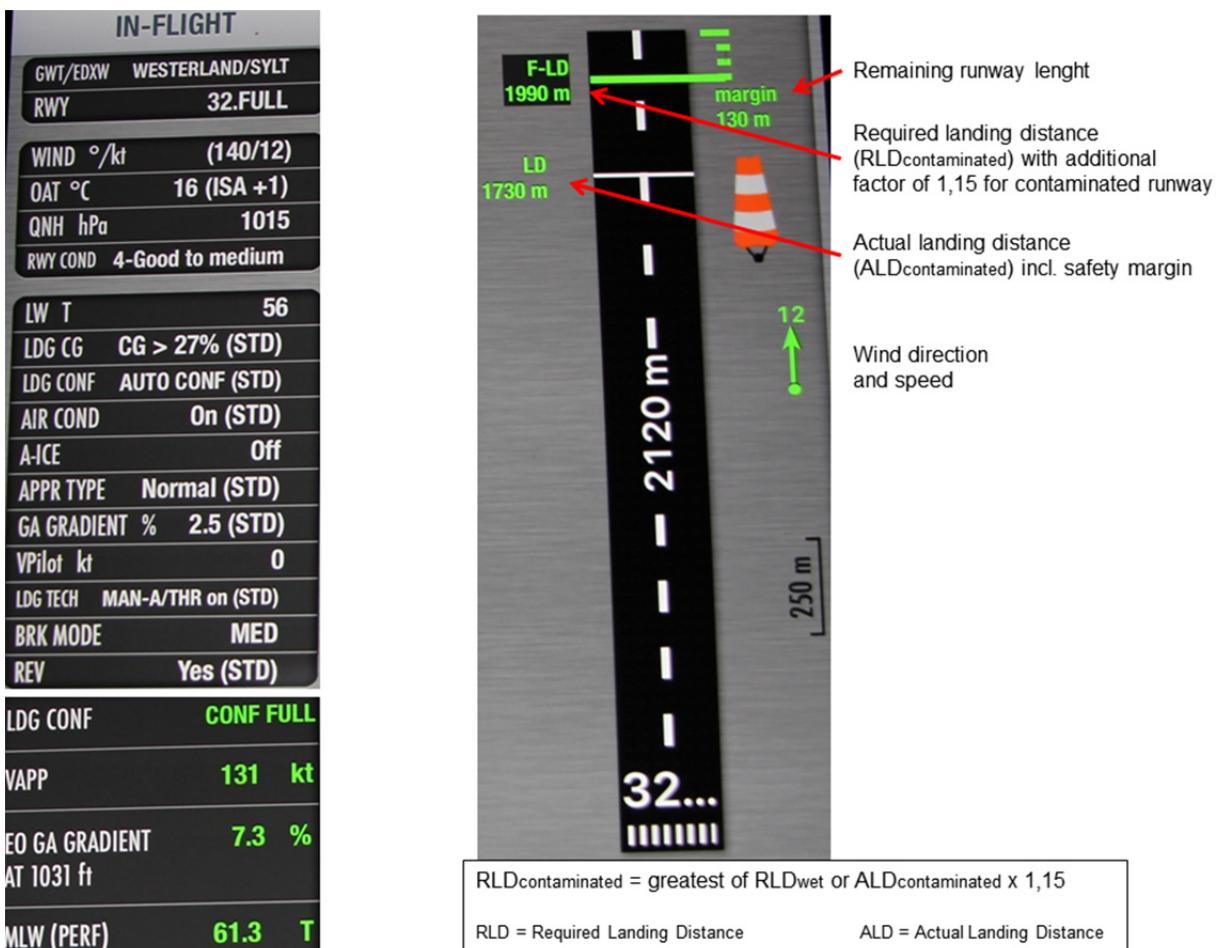
Fig. 8: Screen shots of the input mask for calculation of the landing distance

Figure 8 shows which data the pilots had entered into the EFB software to calculate the landing distance and the result. These are screen shots of the input mask on the EFB which were taken on site. The BFU has added more inscriptions.

Both pilots used the Runway Condition Assessment Matrix for Landing. Based on the degree of the runway surface contamination the respective brake performance classification was determined. The pilots classified the runway contamination as 4 - Good to Medium. The landing distance calculation based on this classification. Comparison of landing distance required and landing distance available showed a safety margin of 130 m.

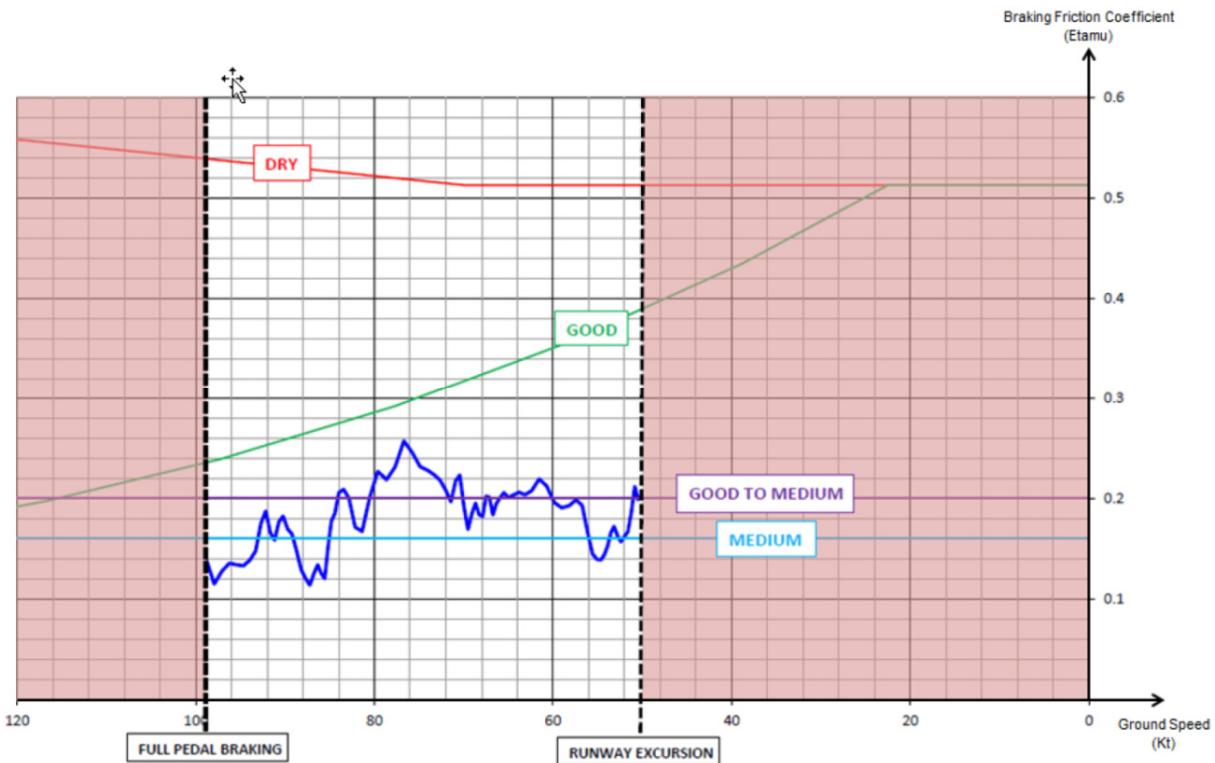
Fig. 9: Calculation of the friction coefficient for the classification of the code for the landing distance calculation

Based on the FDR data the aircraft manufacturer calculated the runway condition. Examined was the part of the runway where the airplane had a speed of 100 kt GS until the end of the runway. According to the Runway Condition Assessment Matrix for Landing, this runway area had a value of 4 (medium to good) to 3 (Medium). The following Fig. 9 illustrates this.
