# AIRCRAFT ACCIDENT REPORT

SAL/2018/09/12/F

**Accident Investigation Bureau**

**Report on the serious incident involving Gulfstream G-IV Aircraft operated by Skybird Air Limited with nationality and registration marks 5N-BOD which occurred during landing at Nnamdi Azikiwe International Airport Abuja On 12th September, 2018.**

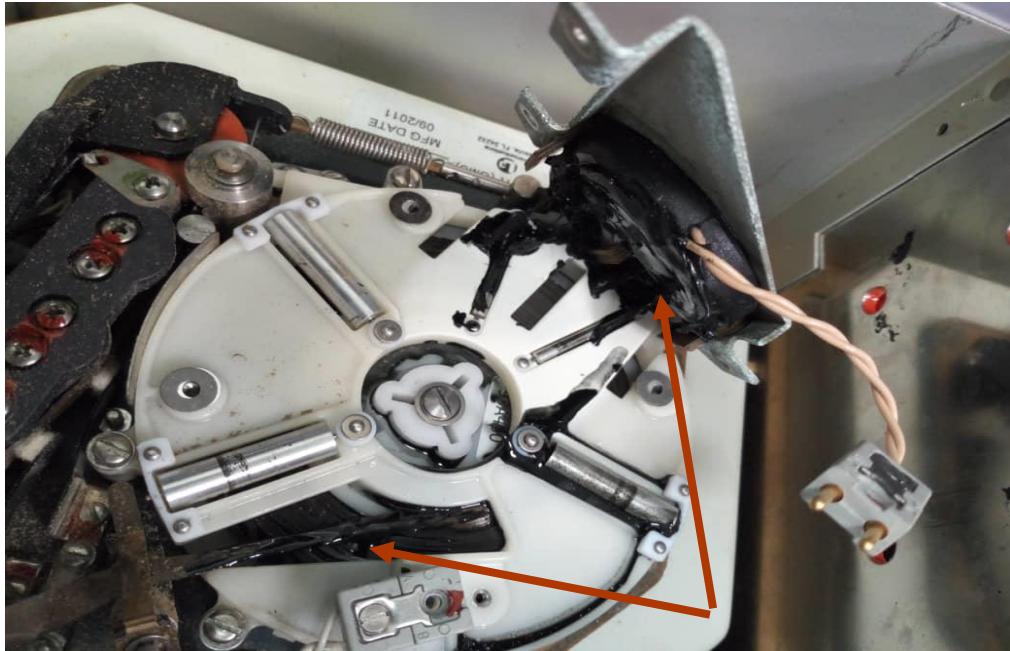
- I. The CVR might not be serviceable as at the time of the incident.
- II. At some time in the past, a bulk erase was used on the CVR which caused the bulk erase coil to melt. See Figure below

III. It might also likely be that the bulk erase function was faulty.

**Figure 8:** Melted bulk erase coil of the CVR

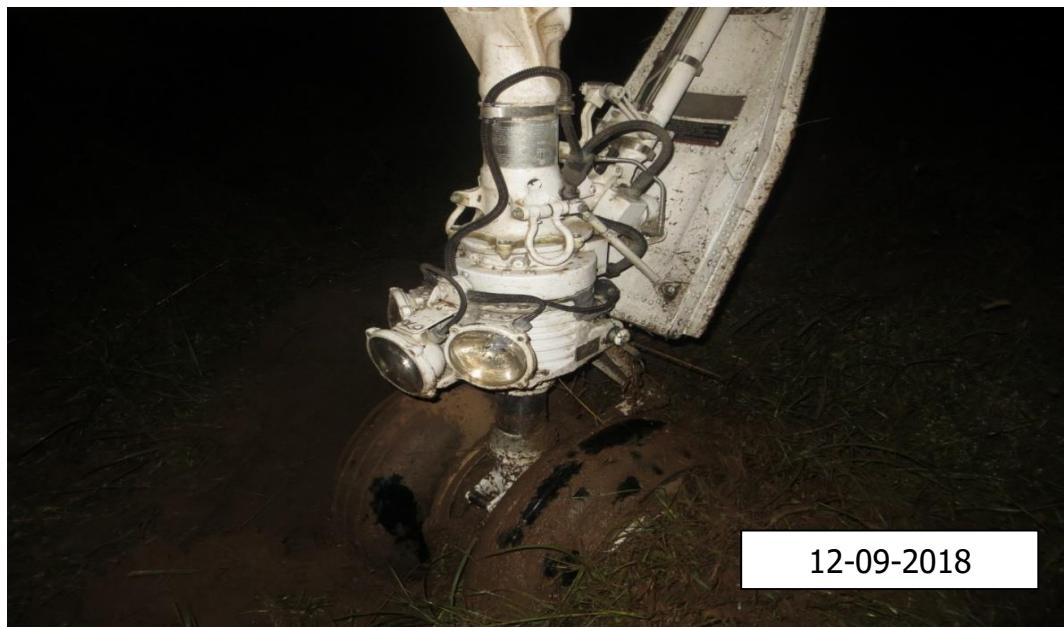
**Figure 10:** The Nose Wheel bogged in mud.

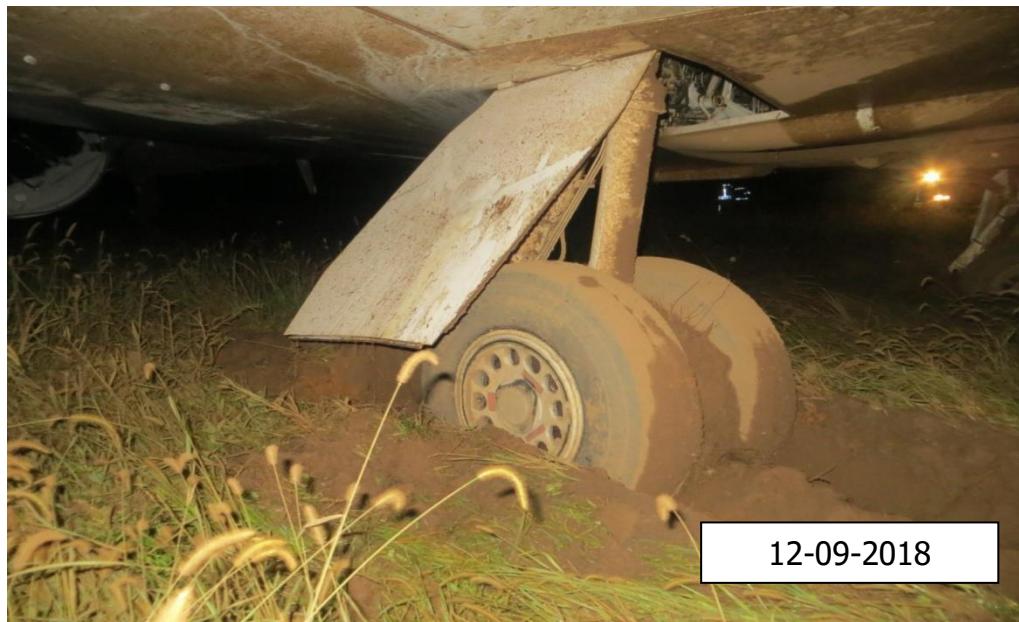
**Figure 11:** One of the Main Wheel showing the aircraft bogged in mud.

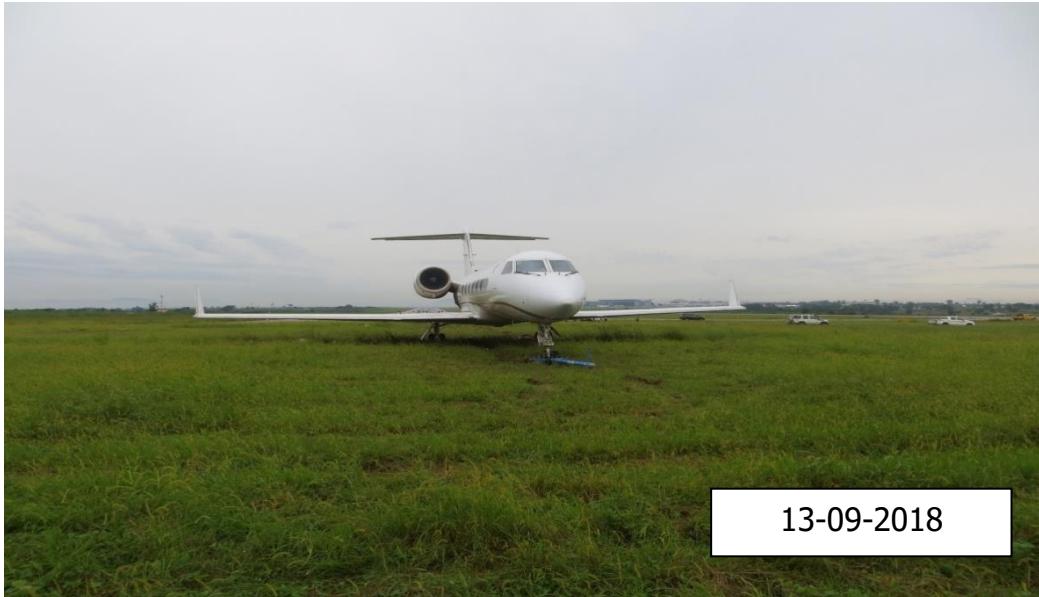
**Figure 12:** The aircraft after the incident
