Investigation Report on
Incident of Communication Failure
'Enroute Air India Flight AI-171'
on 10/03/17

O/o Director Air Safety(WR)
Mumbai

1	Aircraft	Type	B787-8
		Nationality	Indian
		Registration	VT-ANT
2	Owner & Operator		M/s Air India Ltd.
3	Pilot in Command (PIC) Extent of Injuries		Licence: ATPL Nil
4	First Officer (F/O) Extent of Injuries		Licence: ATPL Nil
5	Date & Time of incident		07:45 to 08:54 UTC
6	Place of Incident		Romanian-Hungarian Airspace
7	Last point of departure		Ahmedabad Airport (VAAH)
8	Intended landing place		London Heathrow Airport (EGLL)
9	No. of Passengers on board		152
10	Type of Operation		Scheduled
11	Phase of Flight		Cruise
12	Type of incident		LOSS OF COMMUNICAION

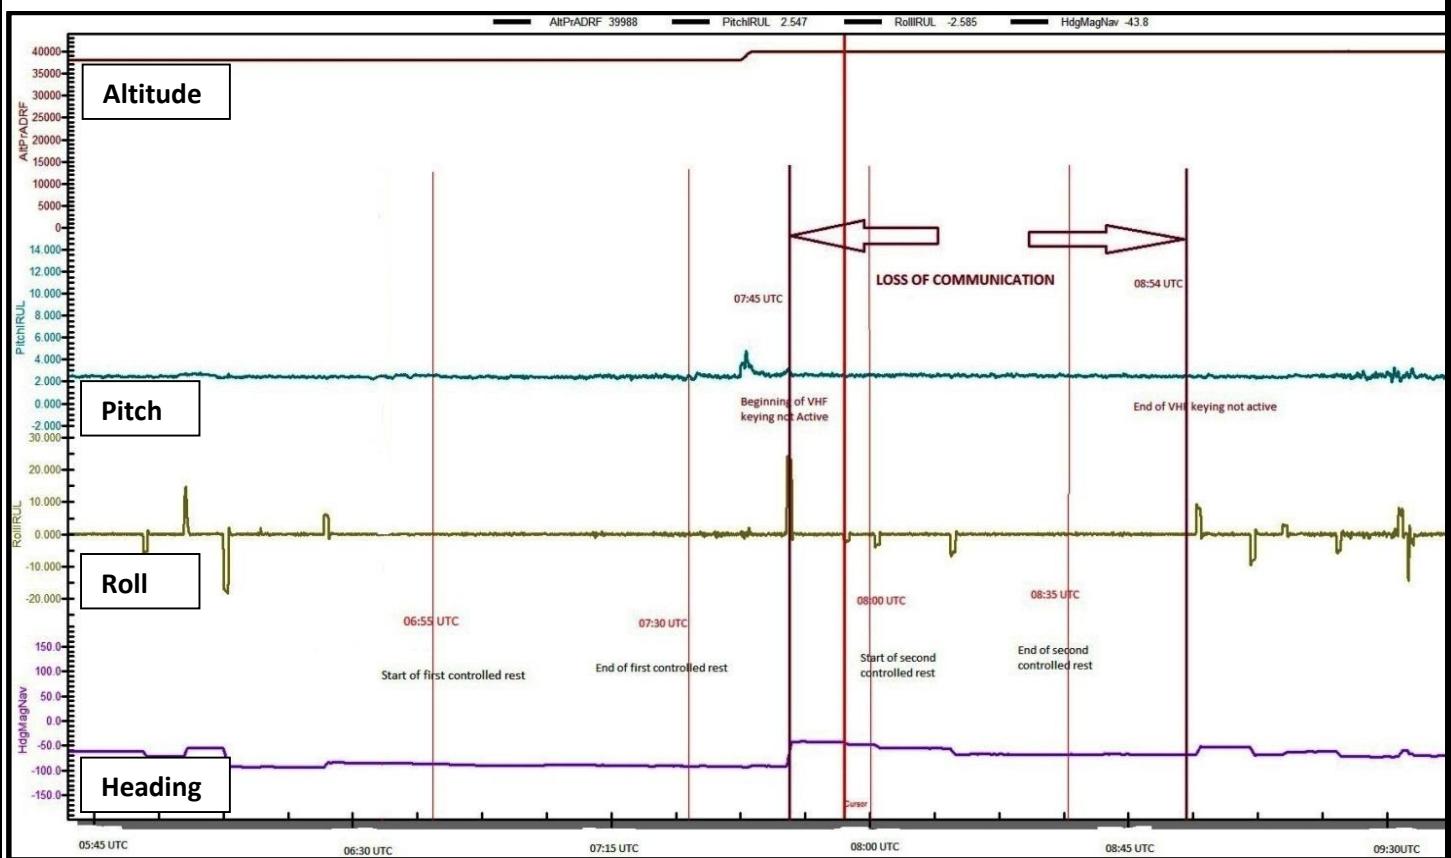
1.11.1 **DFDR Data**

Flight progress during the both the controlled rests in cruise

- DFDR data confirms that there was no keying on VHF communication systems from 07:45:25UTC to 08:54:09UTC, it is indicated in the plot above.
- The examination of data confirms that the aircraft was on autopilot during period of incident. During cruise there is no abnormality observed w.r.t. Heading, Roll, Pitch, Alt.

DFDR confirms that there were no keying on VHF communication systems from 07:45:25UTC to 08:54:09UTC indicates that during this period there was no communication between 'non resting pilot' that is F/O & ATC.

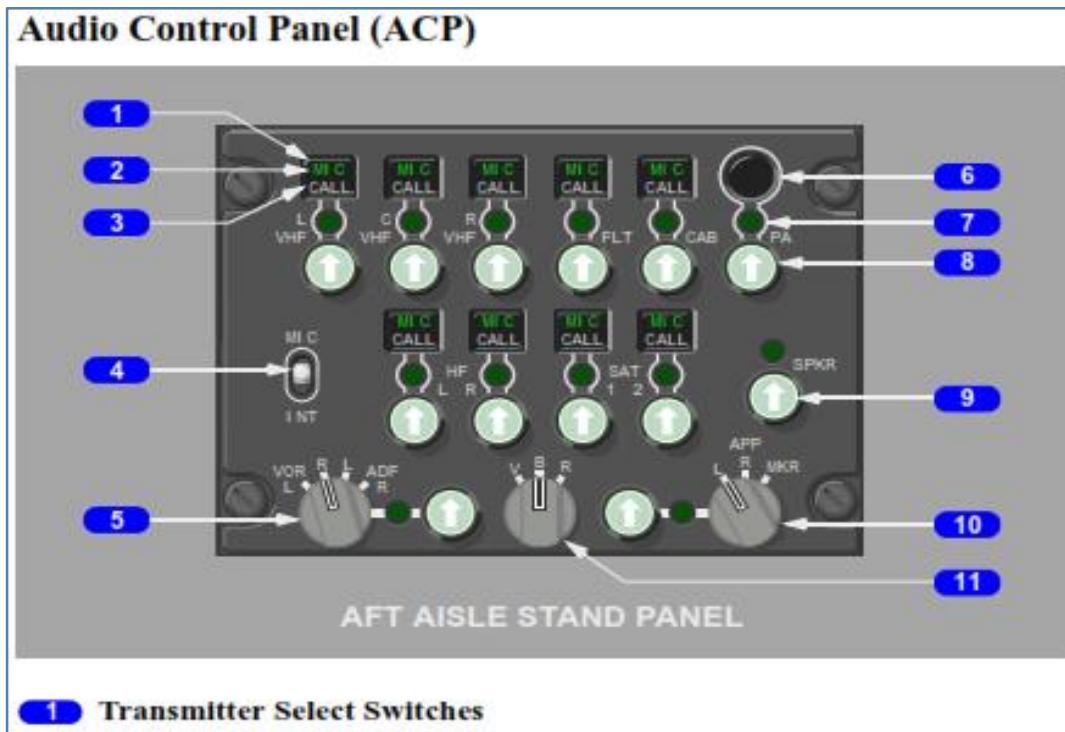
1.18.1 **Excerpts from FCOM:**

The speaker volume control switches are shown above Button 9 is for the flight deck speaker. It's pushed to turn speaker On/Off (toggle switch) and rotated for Volume control.

Speaker have toggle switches that is push to turn On-Off. Thus highly probable that F/O may have turned the speakers OFF, inadvertently & couldn't notice till PIC noted when he intended to contact the fighter aircraft. On communicating with fighter pilot, the fighter pilot advised PIC to contact ATC.

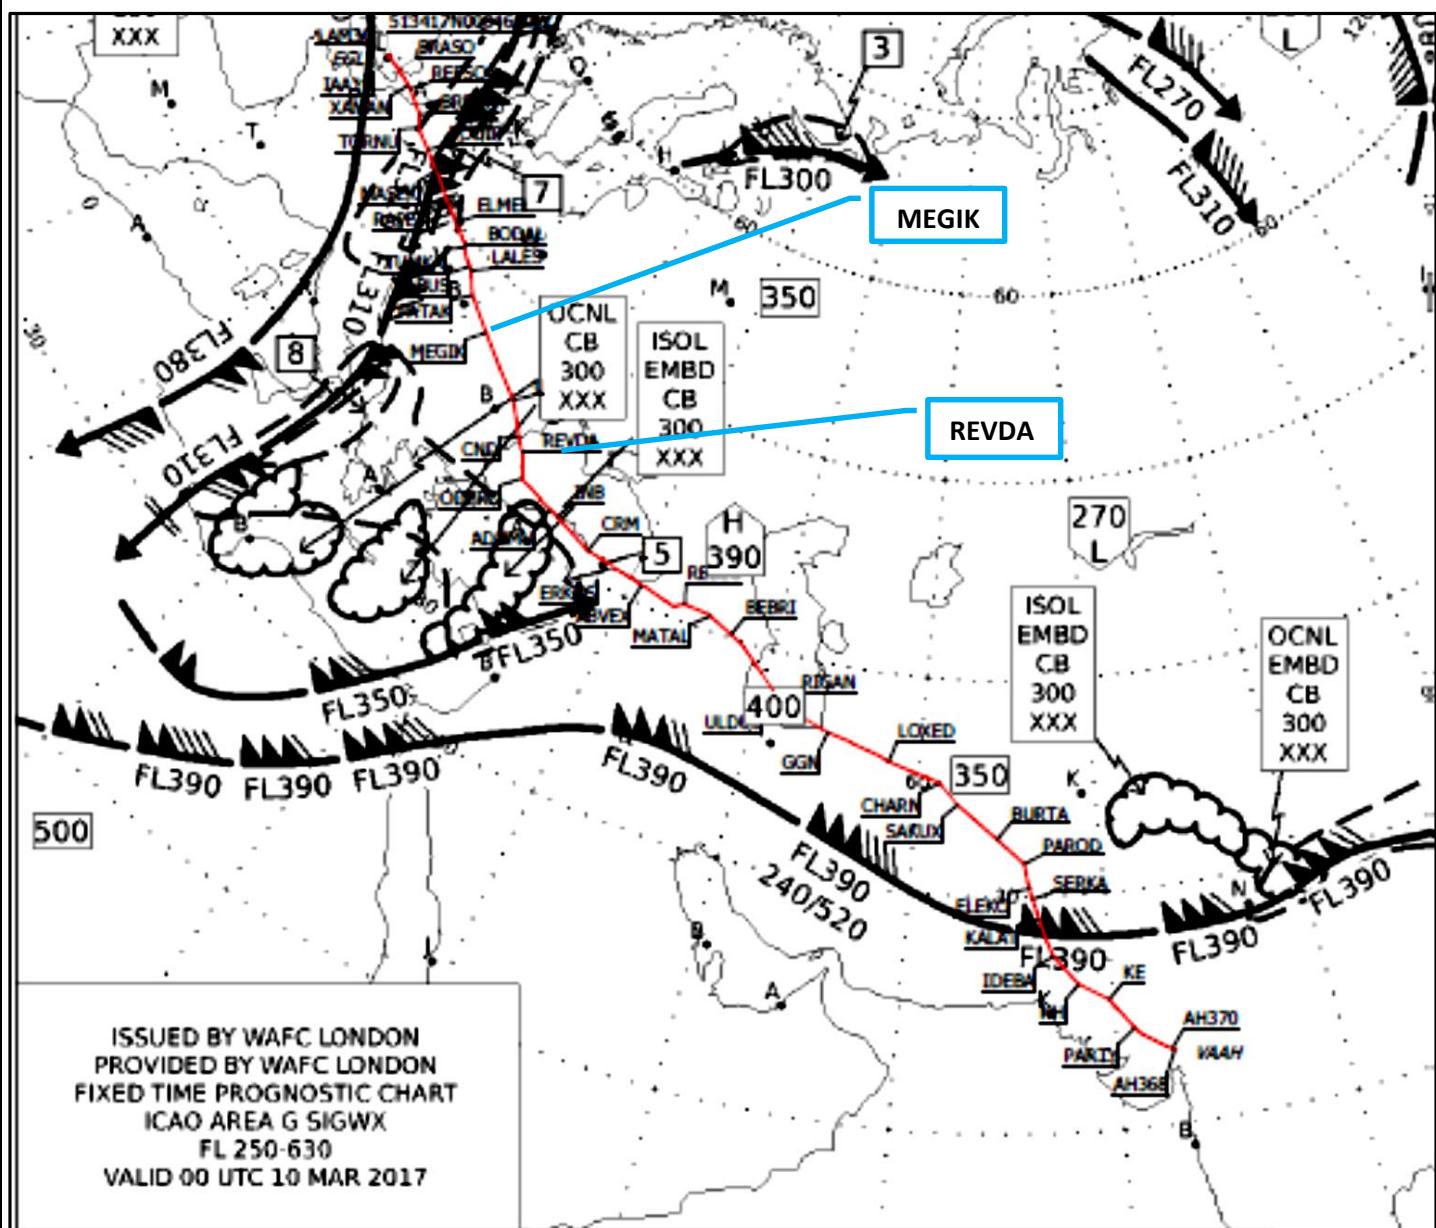
1.18.4 Flight Progress:

Correlating the time of loss of communication with the flight progress timings, it's understood that loss of communication may have been between waypoint REVDA (Romania) & MEGIK (Hungary). Flight from LRRB FIR (BUCURESTI in ROMANIA) to LHCC FIR (BUDAPEST-HUNGARY) required a formal ATC changeover and that was not done. Further, the crew did not respond to the call by ATC and a relayed message by another traffic as per ATC tape transcript. This led to the deployment of the fighter jet.
