SERIOUS INCIDENT

Aircraft Type and Registration:	Boeing 737-86N, G-DRTN	
No & Type of Engines:	2 CFM CFM56-7B26 turbofan engines	
Year of Manufacture:	2002 (Serial no: 32735)	
Date & Time (UTC):	9 February 2020 at 1122 hrs	
Location:	East Midlands Airport	
Type of Flight:	Commercial Air Transport (Passenger)	
Persons on Board:	Crew - 6	Passengers - 193
Injuries:	Crew - None	Passengers - None
Nature of Damage:	No 4 brake unit and wheel deformed due to brake heating	
Commander's Licence:	Airline Transport Pilot's Licence	
Commander's Age:	45 years	
Commander's Flying Experience:	12,300 hours (of which 893 were on type) Last 90 days – 75 hours Last 28 days – 13 hours	
Information Source:	Aircraft Accident Report Form submitted by the pilot and further enquiries by the AAIB

Synopsis

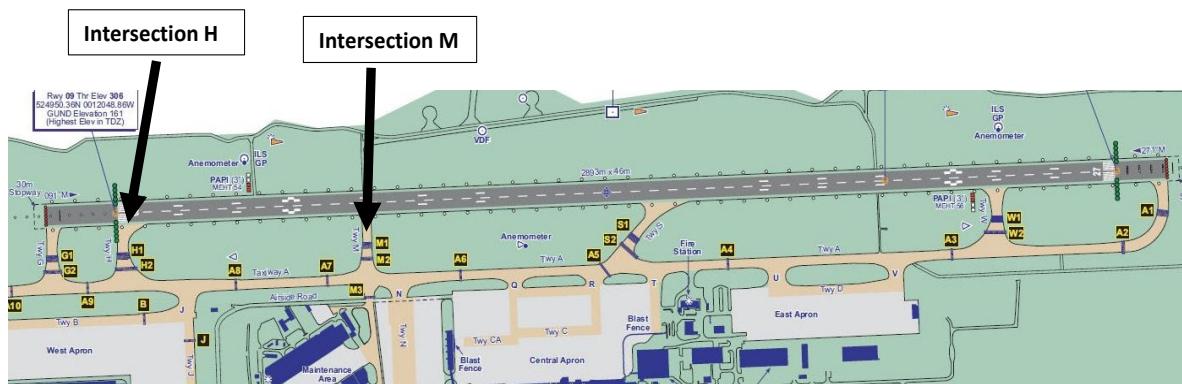
Figure 1
East Midlands Airport Diagram

At approximately 120 kt, the commander recalled a transitory reduction in airspeed of between 10 and 15 kt. He called this to the co-pilot but, as the acceleration resumed, decided to continue. The commander stated that approaching V_1 (134 kt) the aircraft deviated dramatically from the centreline to the right. He estimated the deviation was between 20° and 30° of heading. The commander saw a large downtrend on his airspeed indication and felt that the co-pilot's attempts to control the heading were ineffective. He stated to the investigation, "as PM, my instant snapshot was that indicated airspeed was reducing and we were below V_1 , so I called Stop." During this sequence of events both pilots recalled hearing the automated V_1 callout. The commander took control in accordance with Standard Operating Procedures (SOP), the RTO actions were carried out and the aircraft stopped on the runway centreline between M and H taxiways (Figure 1), with approximately 600 m remaining.

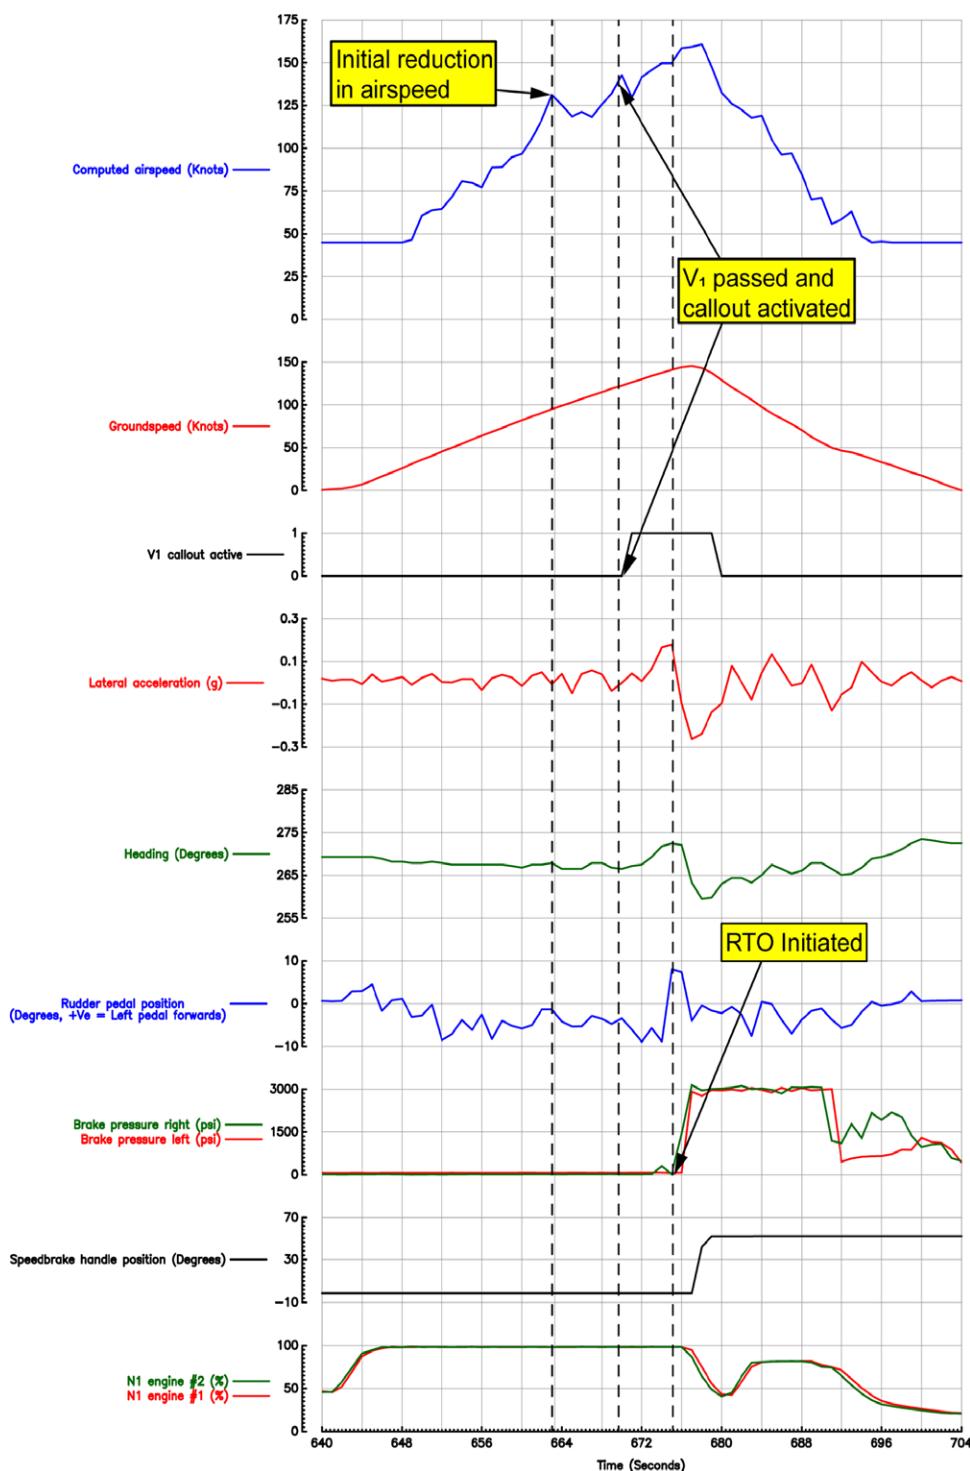
Figure 2
Flight Data Monitoring Extract

No FDR or CVR information was recovered for the event, but the Quick Access Recorder (QAR) recorded information which was available to the investigation through the operator's Flight Data Monitoring (FDM) system. An extract of the data is at Figure 2.

A brief reduction in airspeed before V_1 , as described by the commander, is shown in the trace. The indicated airspeed reduced briefly from 131 kt to 118 kt before recovering. V_1 and the initiation of the V_1 auto callout are highlighted by the second dashed line on the chart. Almost immediately after this point there was a reduction in airspeed from 142 kt to 129 kt over approximately 1.5 seconds and the aircraft heading changed to the right. There was a significant left pedal input and, between five and six seconds after V_1 , both brake pressures increased to 3,000 psi indicating autobrake RTO action. This is indicated by the third dashed line in Figure 2. The autobrake RTO mode is triggered by retardation of the thrust levers to idle. The RTO was initiated at an airspeed of approximately 149 kt but, because no CVR information was recovered, it was not possible to ascertain when the commander called "Stop" in this sequence of events.

Between V_1 and the start of the RTO the aircraft turned right by approximately 8° . Once the RTO was initiated, the aircraft responded to the left pedal input and turned rapidly left through approximately 14° before recovering to the centreline of the runway. Around the start of the RTO there were substantial changes in lateral g commensurate with the rapid changes in heading.
