**FINAL REPORT**  
**IG - 065/CENIPA/2018**

OCCURRENCE:	SERIOUS INCIDENT
AIRCRAFT:	PR-GTN and FAB 2345
MODEL:	737-8EH and C-95M
DATE:	10APR2018

This is the Final Report of the 10APR2018 serious incident with the 737-8EH aircraft, registration PR-GTN and FAB 2345, model C-95M. The serious incident was classified as “[RI] Runway Incursion”.

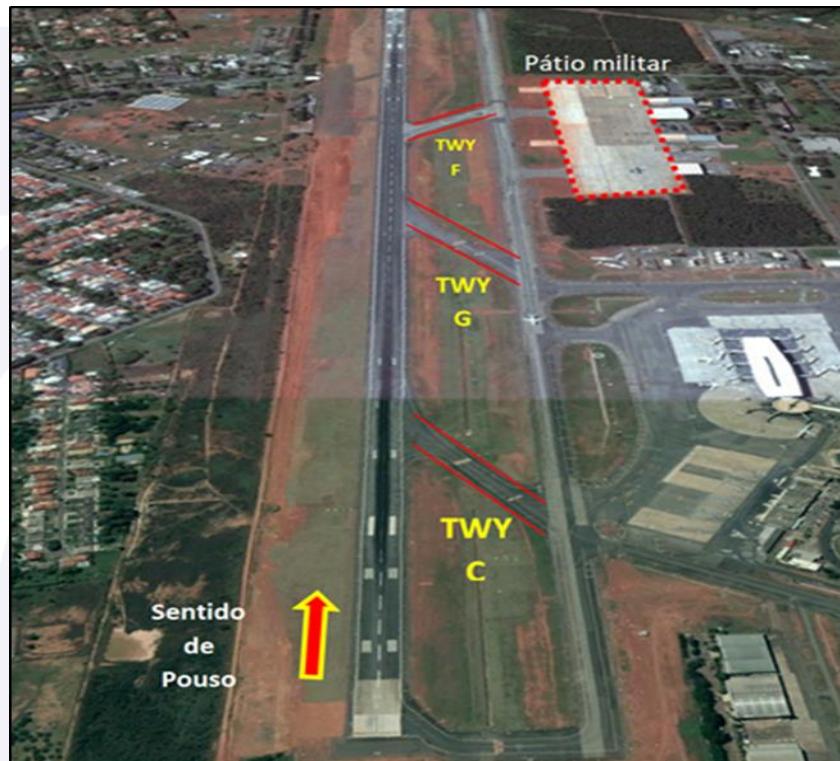
Figure 2 - Satellite image (Google Earth) of SBBR 11L runway and indications of TWY C (Charlie), G (Golf) and F (Foxtrot).

Figure 2 shows an air image of the used runway with the indication of the mentioned exit intersections.

As the aircraft began to position itself toward TWY "F" (Foxtrot) to clear the runway, the occupants of that military aircraft suddenly perceived a very intense light coming from outside, accompanied by an extremely loud noise and a strong vibration.

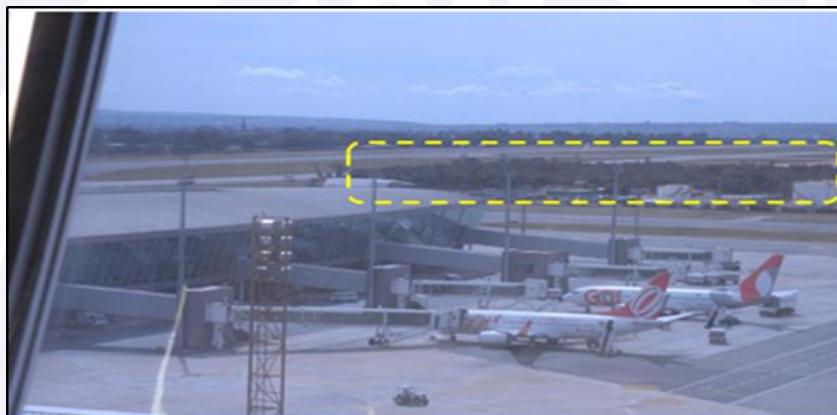
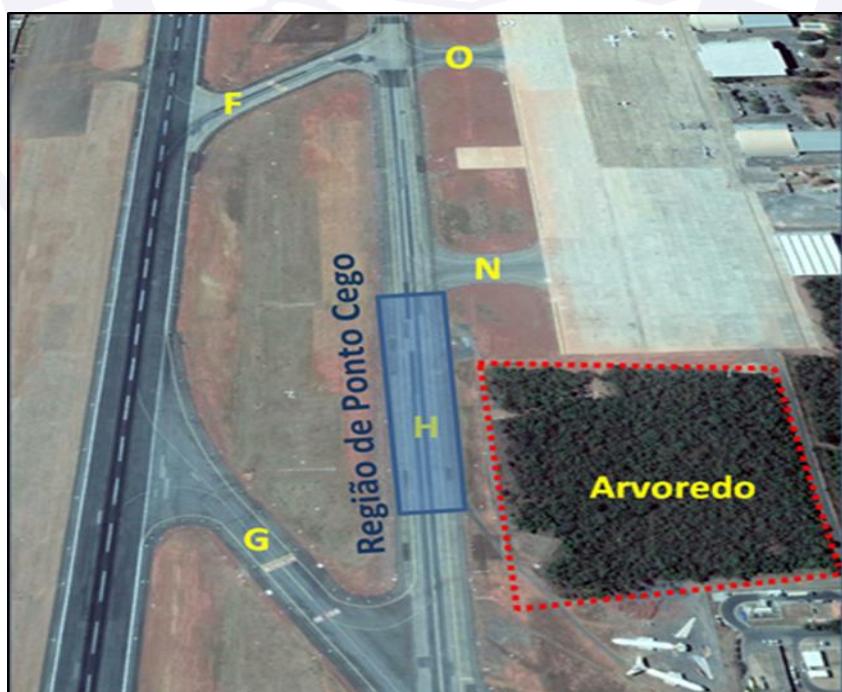
**1<sup>st</sup> Latent Condition:** the Brasilia Aerodrome had several "blind spots", in which the view of the controllers, from the Control Tower, was impeded by obstacles. One of these blind spots was the stretch of TWY "H" (Hotel), between TWY "G" (Golf) and TWY "N" (November), where a grove made it impossible to see smaller aircraft from the angle of the Tower. (Figures 3 and 4).

Figure 3 - Detail of the trees blocking the view of part of TWY "H". Aimed at TWR position.

Figure 4 - Blind spot region in TWY "H" due to trees in the TWR line of sight.

In addition, the failure to view the aircraft due to the TWY "H" (Hotel) blind spot led him to conclude that the runway was clear for another operation.

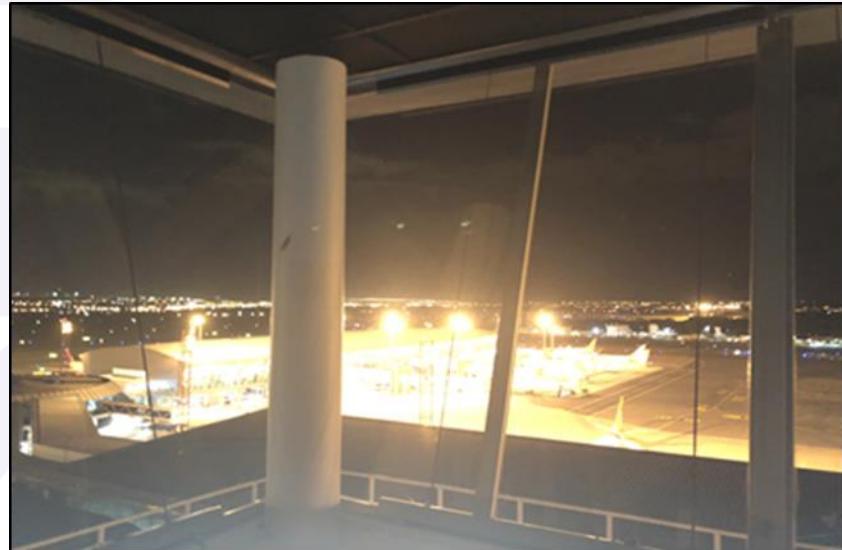
Figure 5 - Influence of the lighting of the North Pier apron in the view of the TWR.

**2<sup>nd</sup> Latent Condition:** the reflectors used for the illumination of aprons in the positions known as North Pier and South Pier were in the TWR controllers line of sight and there was no device that would allow the reduction of glare, due to the light beam produced by the lamps in the night period.

Figure 5 shows the view of a section of the runway, from an angle similar to that of Figure 3, but in a photograph taken at night, demonstrating the influence of the North Pier illumination on the North Tower controller's view.

The Investigation Team identified that the working conditions of the Brasilia Tower controllers, at night, occurred under heavy negative interference caused by the glare from the lighting of the aprons.

Thus, under these conditions, the identification of some aircraft, especially small aircraft, was greatly impaired, due to the glare produced by the spotlight bulbs, as shown in Figure 5.

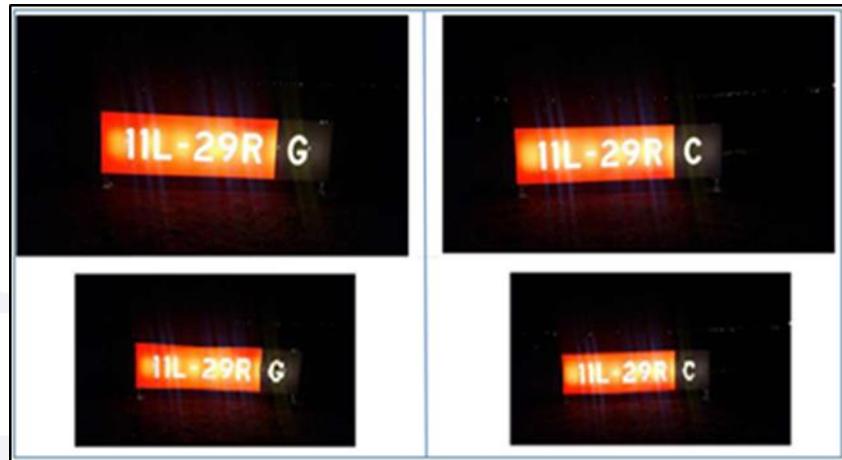
Figure 6 - Vertical signaling of the "G" and "C" taxiways represented in different sizes, simulating a variation of the viewing distance.

**7<sup>th</sup> Latent Condition:** The first two intersections from threshold 11L had very similar spelling designations, which could be confused visually, depending on the viewing conditions, namely "C" and "G".

Figure 6 represents the visualization of respective vertical signs in two aspect ratios to illustrate the visual perception of two different distances and how much these designations could be confused.

It should be noted that this type of distorted perception is plausible, considering the similarity of the letters and the conditions of visualization, which, in this case, were aggravated by the fact that it was a night period.

The similarity between the letters "C" and "G" associated with the conditions for their visualization at the night period contributed to the pilot's misperception.

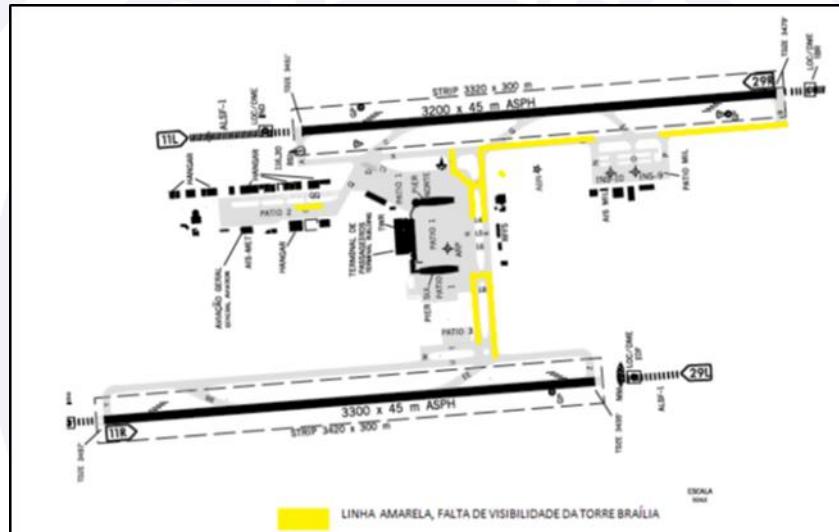
Figure 7 - Identification of blind spots of SBBR from the TWR-BR sight.

The Investigation Team observed that the Brasilia Aerodrome had other blind spots from the Control Tower sight. These blind spots can be identified in the yellow markings of Figure 7.

For some of these blind spots, the aerodrome operator had provided video cameras that would allow viewing of these "shadow areas" by video monitoring.

Still on the blind spots of SBBR, there was no indication in the respective Aerodrome Chart (ADC) informing about the existence of this condition, in order to alert the pilots (hot spot), increasing the situational awareness.
