Technical report

IN-014/2019

Incident involving a Boeing 737-800 aircraft,
registration G-TAWA, at Lanzarote Airport on
25 March 2019

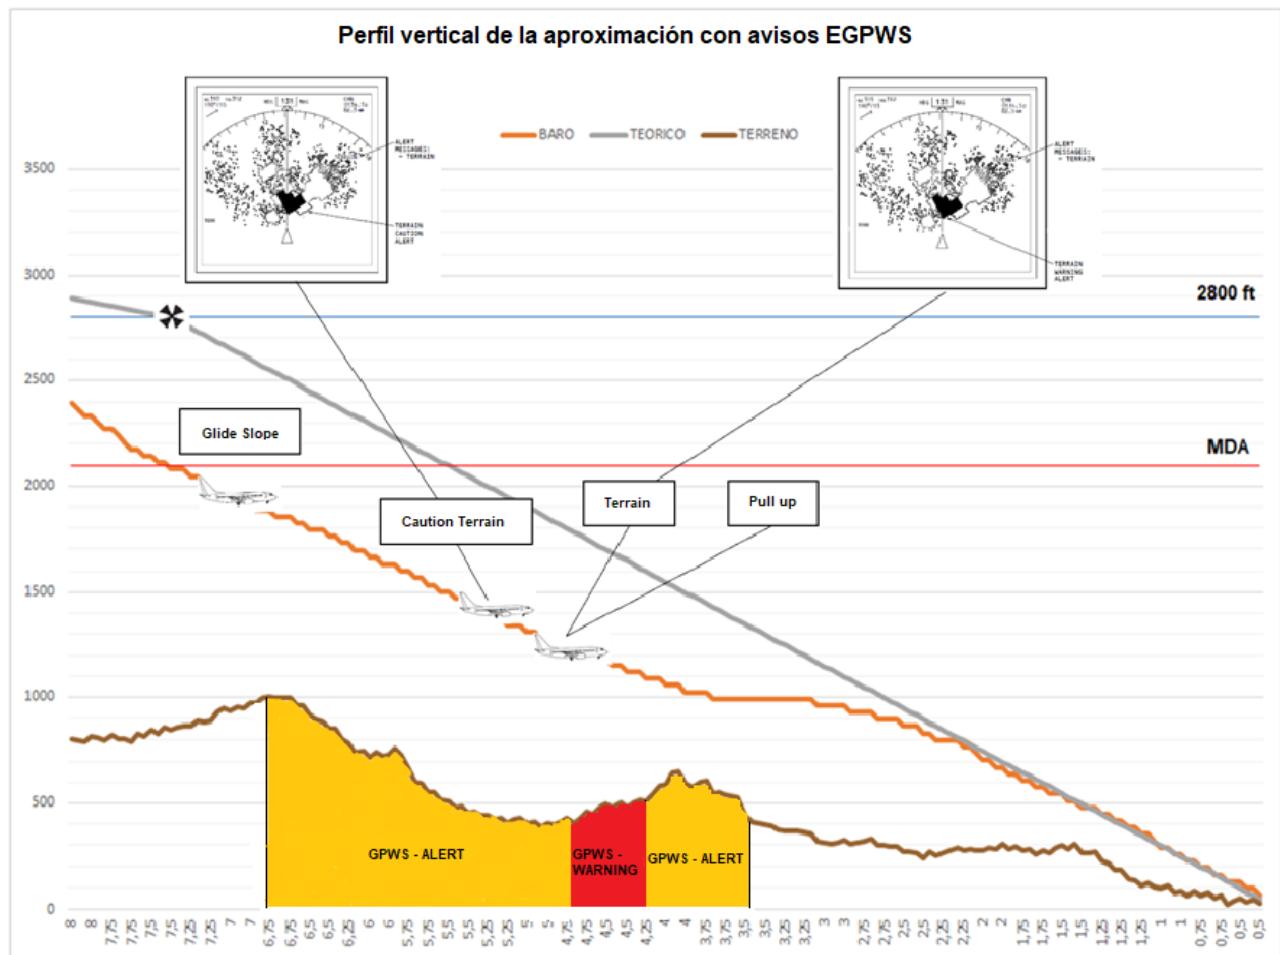
Illustration 7: Vertical profile of the approach with the EGPWS warnings

At 13:47:27 h, when the aircraft was at 5.25 NM from the DME LTE, the enhanced ground proximity warning system (EGPWS) sounded the “CAUTION TERRAIN” alert. When the aircraft was 4.75 NM from the DME LTE, the “TERRAIN, TERRAIN, PULL UP” warning was also activated.

- At mile 3.75 DME LTE and an altitude of 1,024 feet, the autopilot and autothrottle were disconnected and the aircraft levelled-off for 15 seconds. The descent was then resumed.

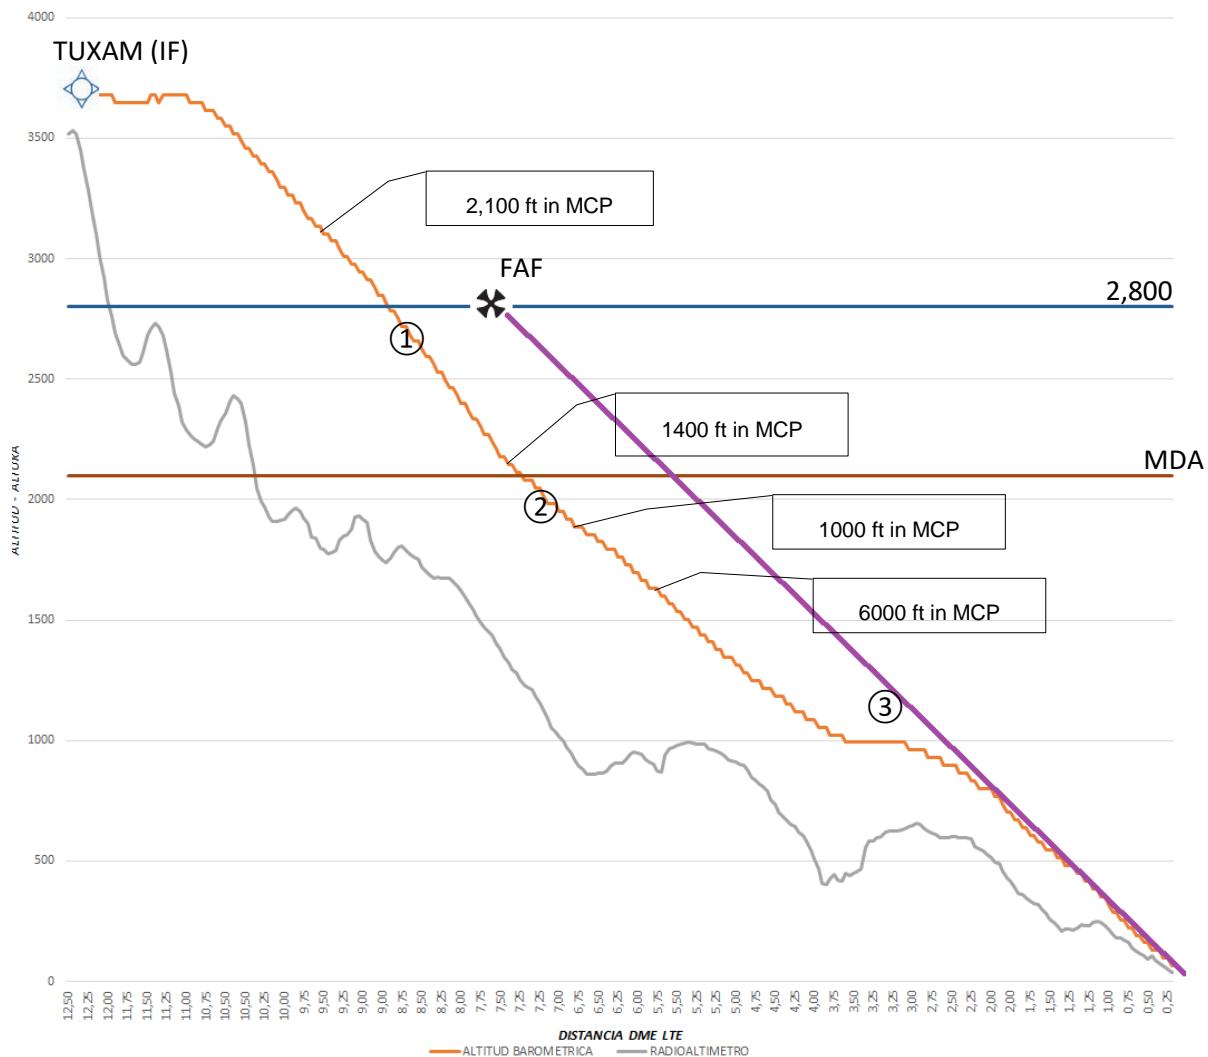
ANNEXE IV: ALTITUDES GRAPH

The illustration shows how the aircraft descended below 2,800 feet at mile 8.75 DME LTE (1.35 NM before the FAF), reaching the circling MDA of 2,020 feet around mile 7.4 DME LTE (approximately 1.8 NM before mile 5.6 DME LTE). It then stays below the descent profile until, after levelling and halting the descent, it then joins it.

- ① The aircraft descends below 2,800 ft at mile 8.75 DME LTE.
- ② The aircraft reaches the circling MDA around mile 7.4 DME LTE.
- ③ The aircraft halts its descent, levels up and corrects to the 3.7-degree profile.

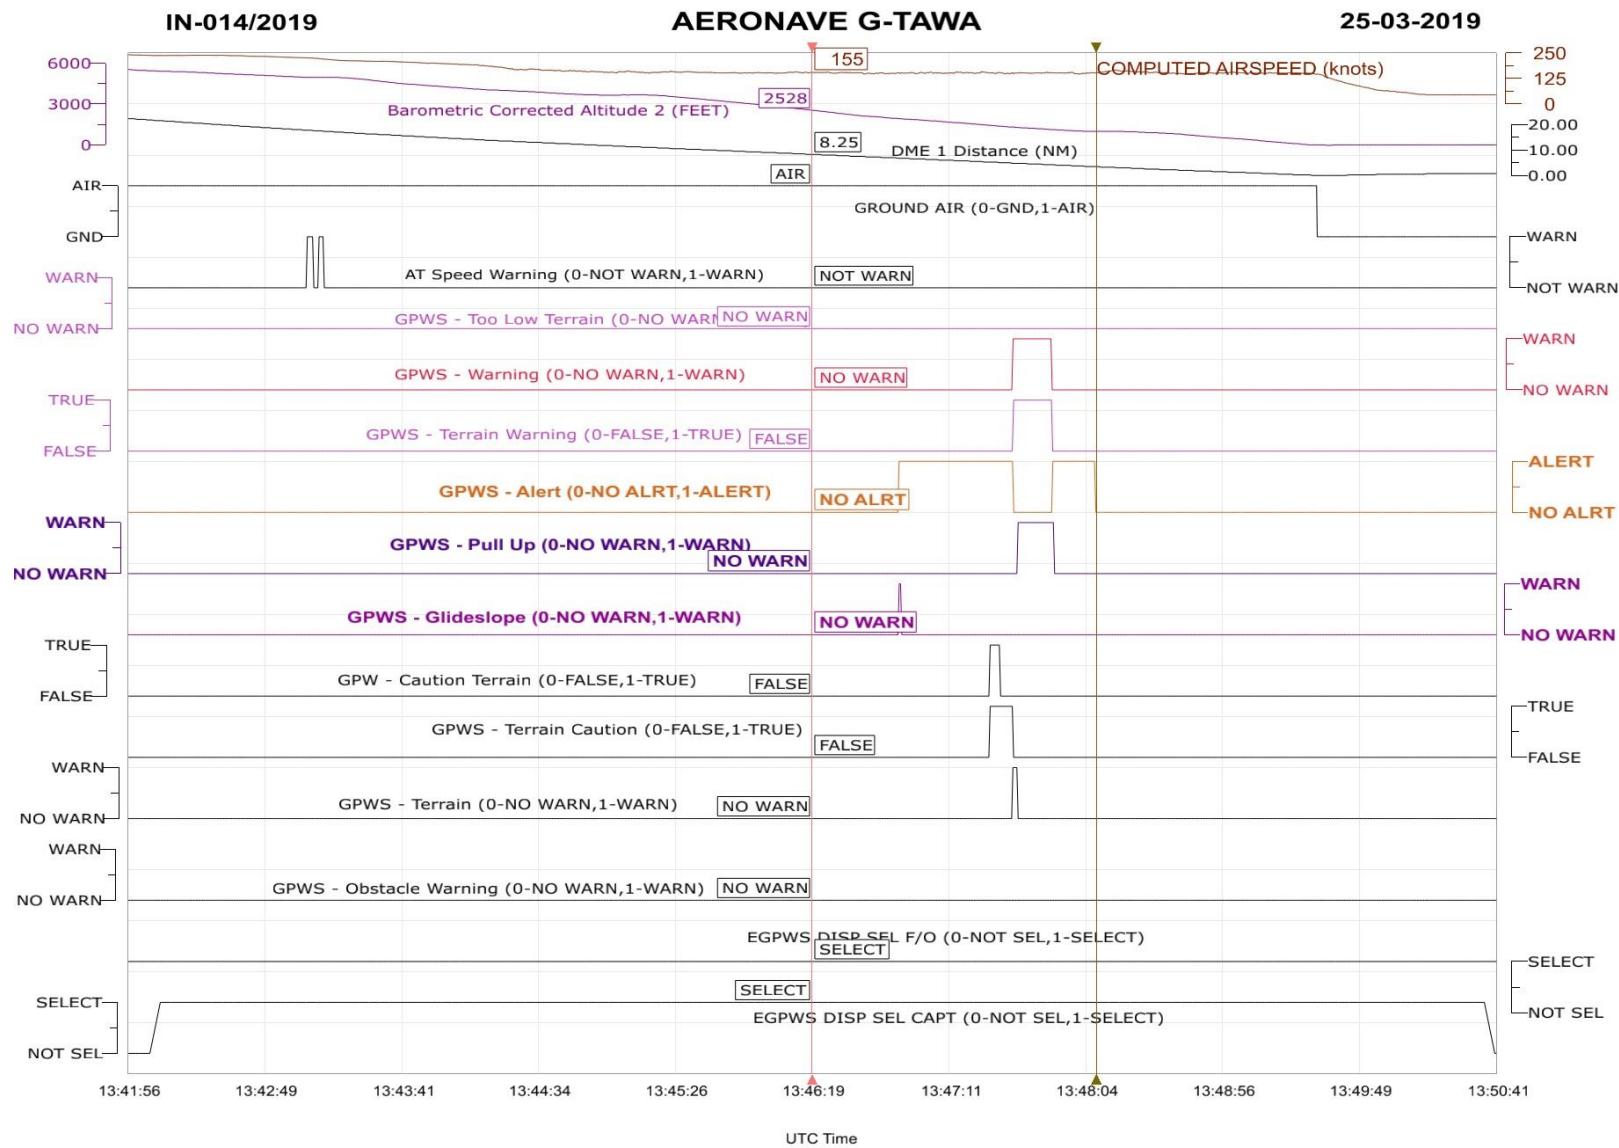
ANNEXE X: GRAPHICS FROM THE QAR

A graphical representation of these events is provided in both the following image and Annexe X.
