Investigation Report

Type of Occurrence: Serious Incident

Location: Cologne/Bonn Airport

State File Number: BFU20-0251-EX

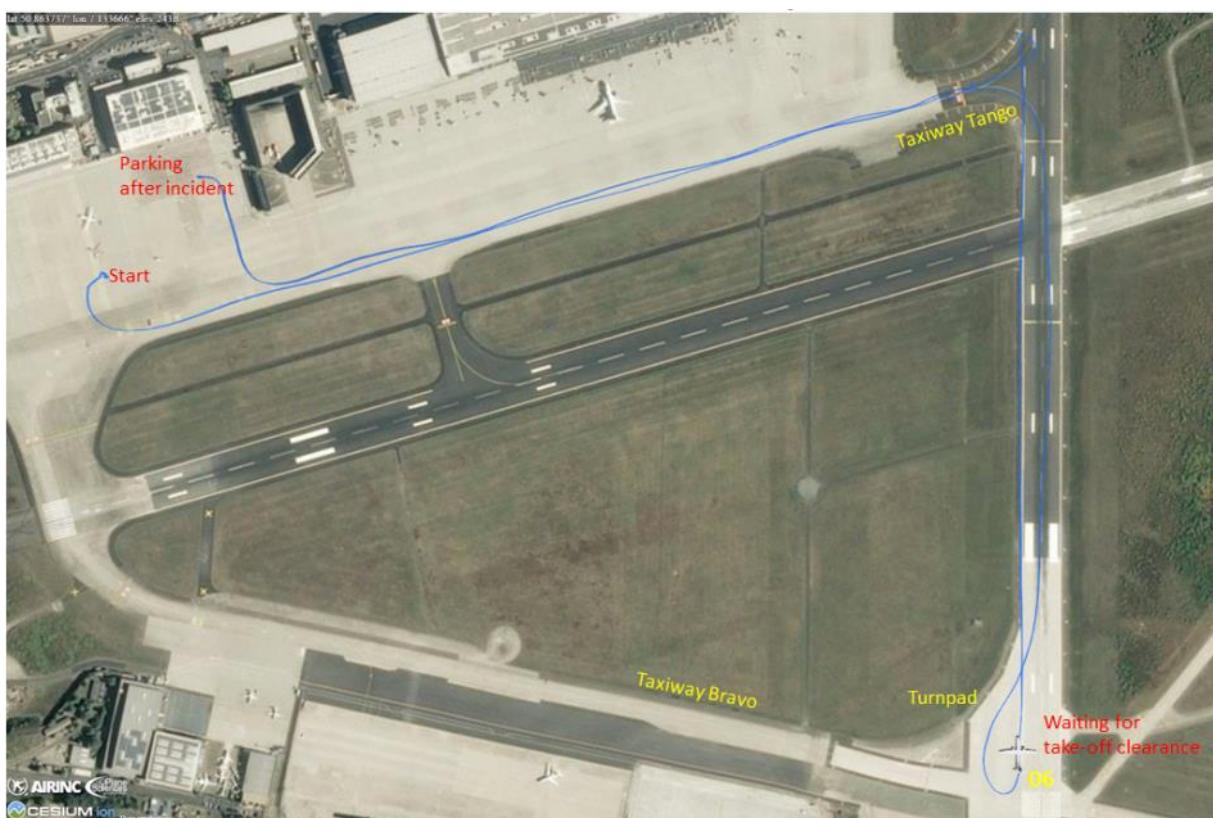
Fig. 1: Taxi route between the beginning and the stop, based on FDR data

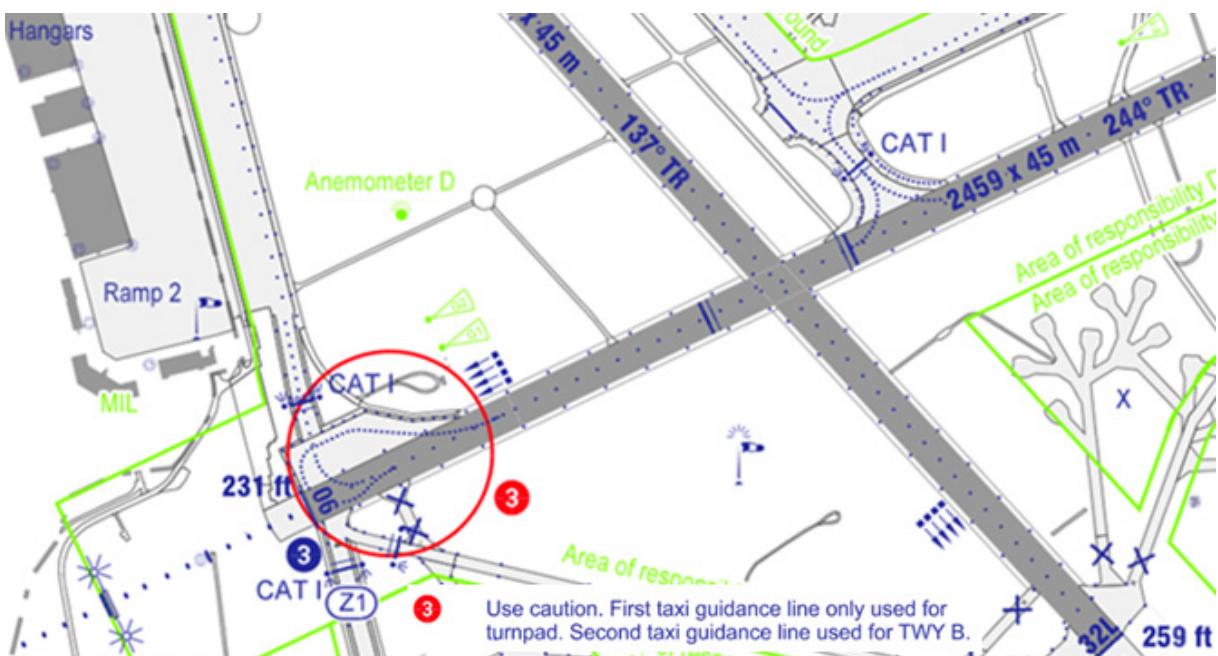
At the beginning of runway 06, there was a turnpad. Inclusive the runway it was 105 m wide. It was marked with 2 yellow taxi markings, which were equipped with green underfloor lamps (Fig. 2).

Fig 2: Overview runway 06, turnpad, and taxiway markings

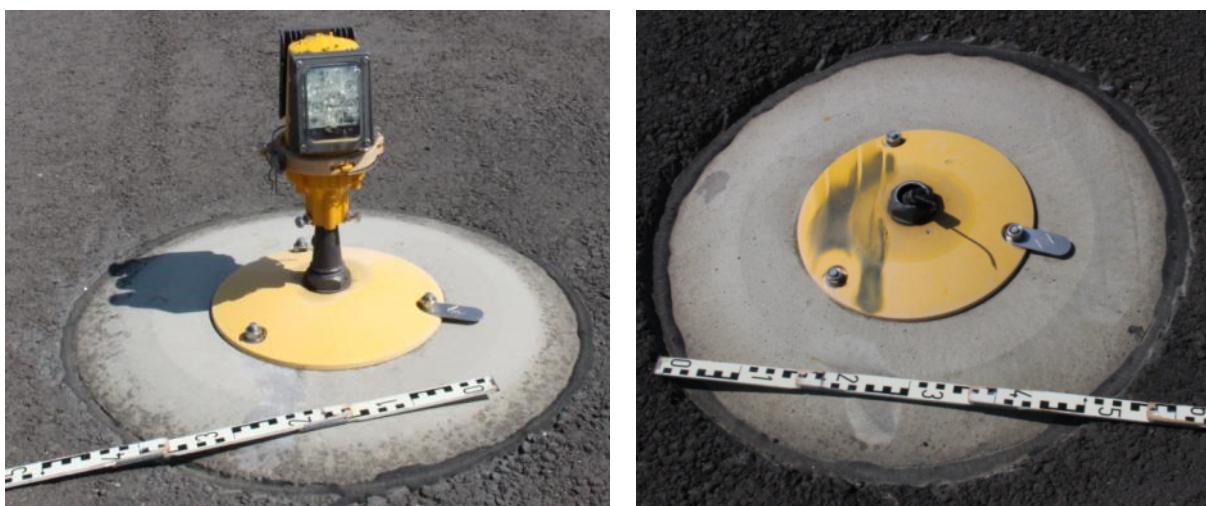
The subsequent runway inspection showed that a total of 9 lamps of the left runway edge lighting had been torn off or destroyed and one taxiway lamp was damaged.

The overfloor lamps of the runway edge lighting were 36 cm high (including mounting) and had a mass of 3.36 kg.

Fig. 3: Example of an overfloor lamp of the runway edge lighting, intact and torn off

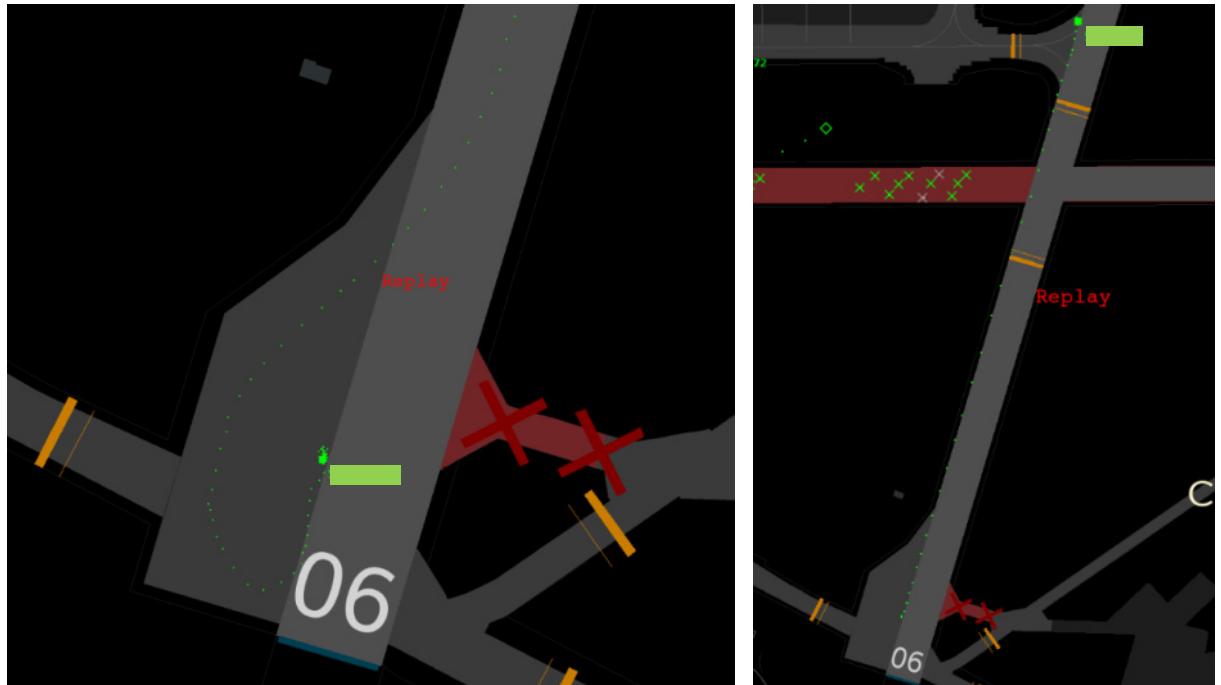
The airport was equipped with surface movement radar, which showed and recorded the turn and the take-off run (Fig. 4).

Fig. 4: Enhanced section of the ground radar recording of the turn and the take-off run (green points)

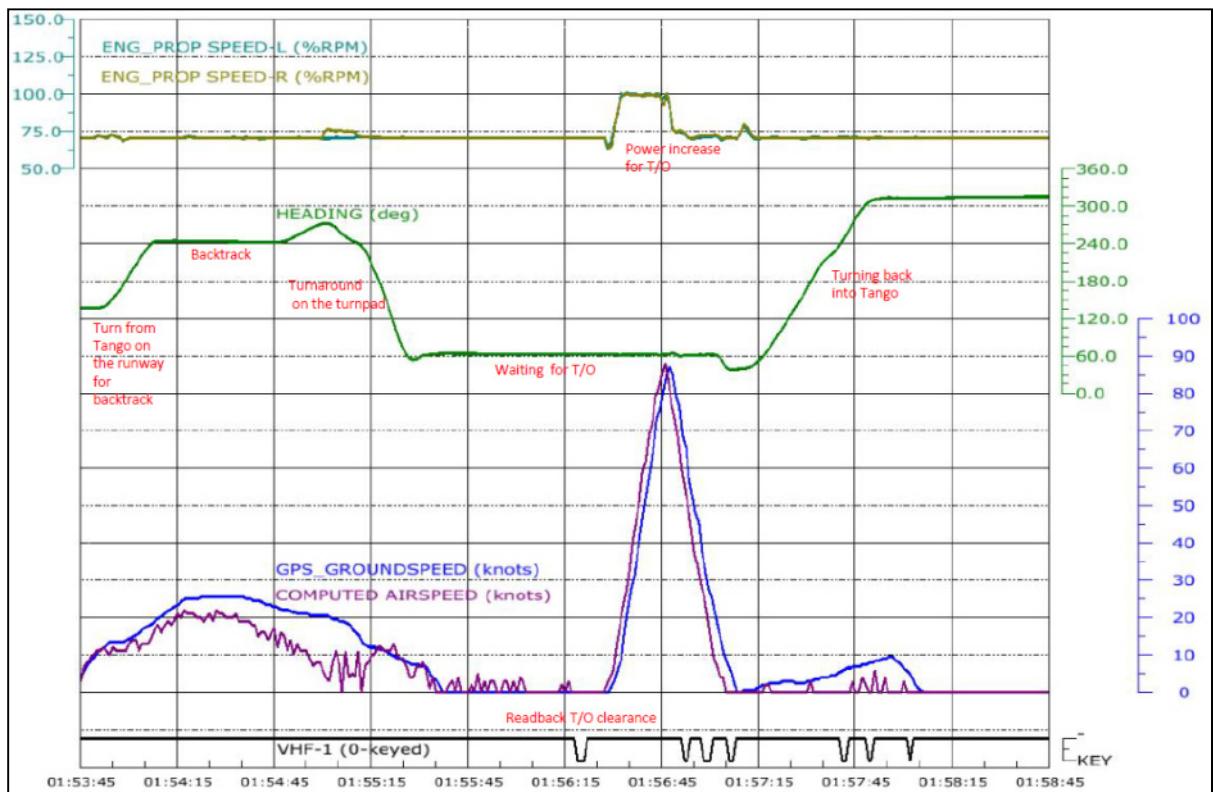
Based on the FDR data, the statements of the flight crew made after the occurrence could be verified. Take-off run was terminated with a ground speed of about 86 kt.

Fig. 5: Excerpt of relevant FDR data (times UTC)

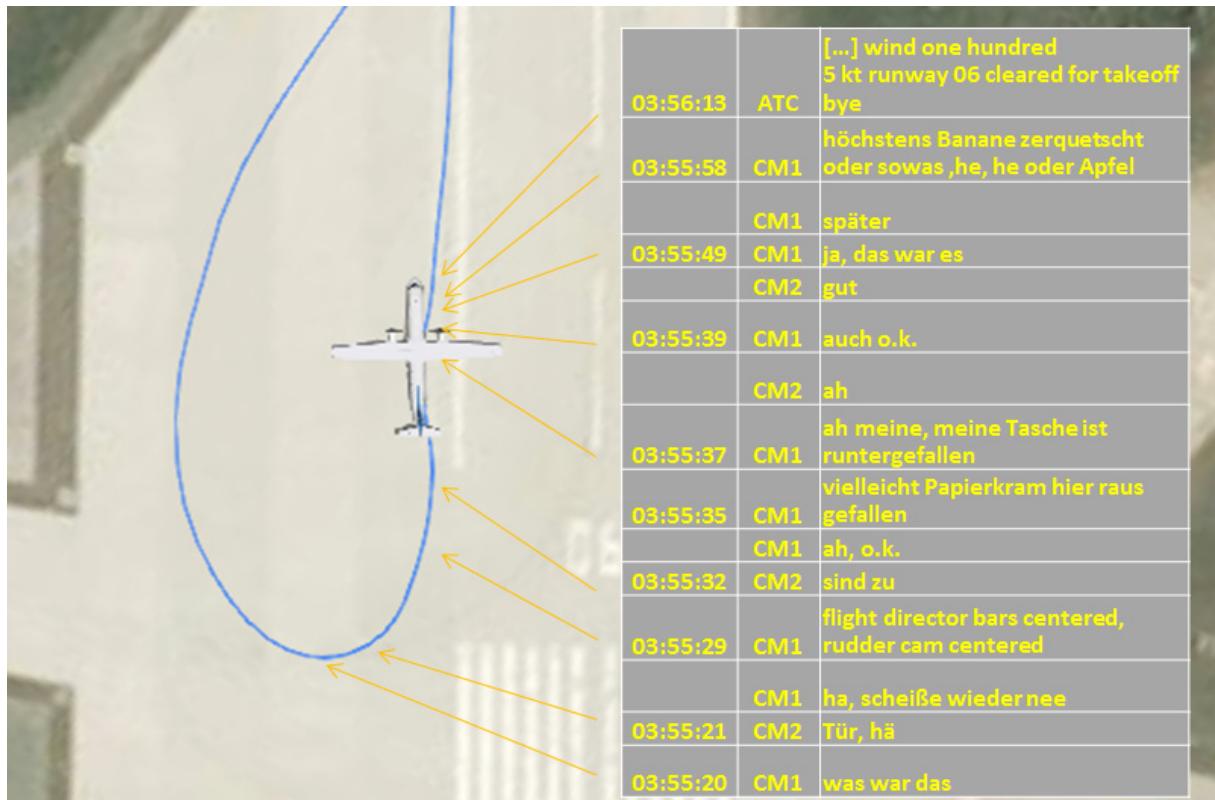
According to the CVR, a sound was heard in the cockpit during the left-hand turn. The crew tried to identify the cause of the sound. Initially, the crew assumed that the cockpit door had opened, but then determined that the PIC’s bag had fallen down behind the seat.

Fig. 6: Cockpit conversation during the turn

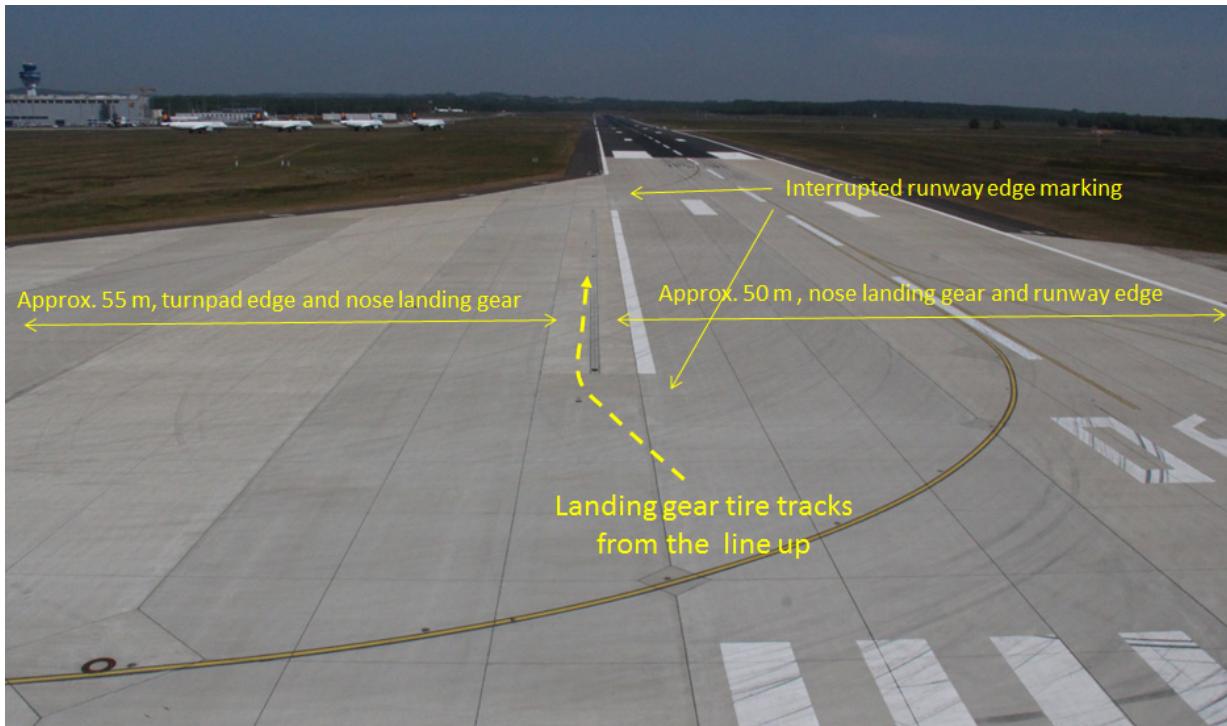
According to the wheel tracks the take-off run occurred from the turnpad along the paved left shoulder of runway 06. The shoulder was about 7 m wide. The wheel tracks showed that the airplane had been aligned almost central with the runway edge lighting, in regard to the total width of turnpad and runway (Fig. 7).

Fig. 7: Taxi traces of the landing gears, which originate from the alignment with the runway edge lighting

Due to the taxiway markings from runway to the turnpad, the white line of the runway edge marking on the turnpad was not a continuous line and therefore showed similarities with centre line markings (Fig. 7). The BFU noted that the alignment for the Misalignment Take-Off occurred along the intermittent runway edge marking and approximately in the centre of the total width of turnpad and runway 06. Therefore, a mix-up is understandable.

The International Civil Aviation Organisation (ICAO) should modify the standard and recommendations regarding runway edge lighting in Annex 14 Volume 1 Aerodrome Design and Operations to ensure clear distinction of other airport lightings.

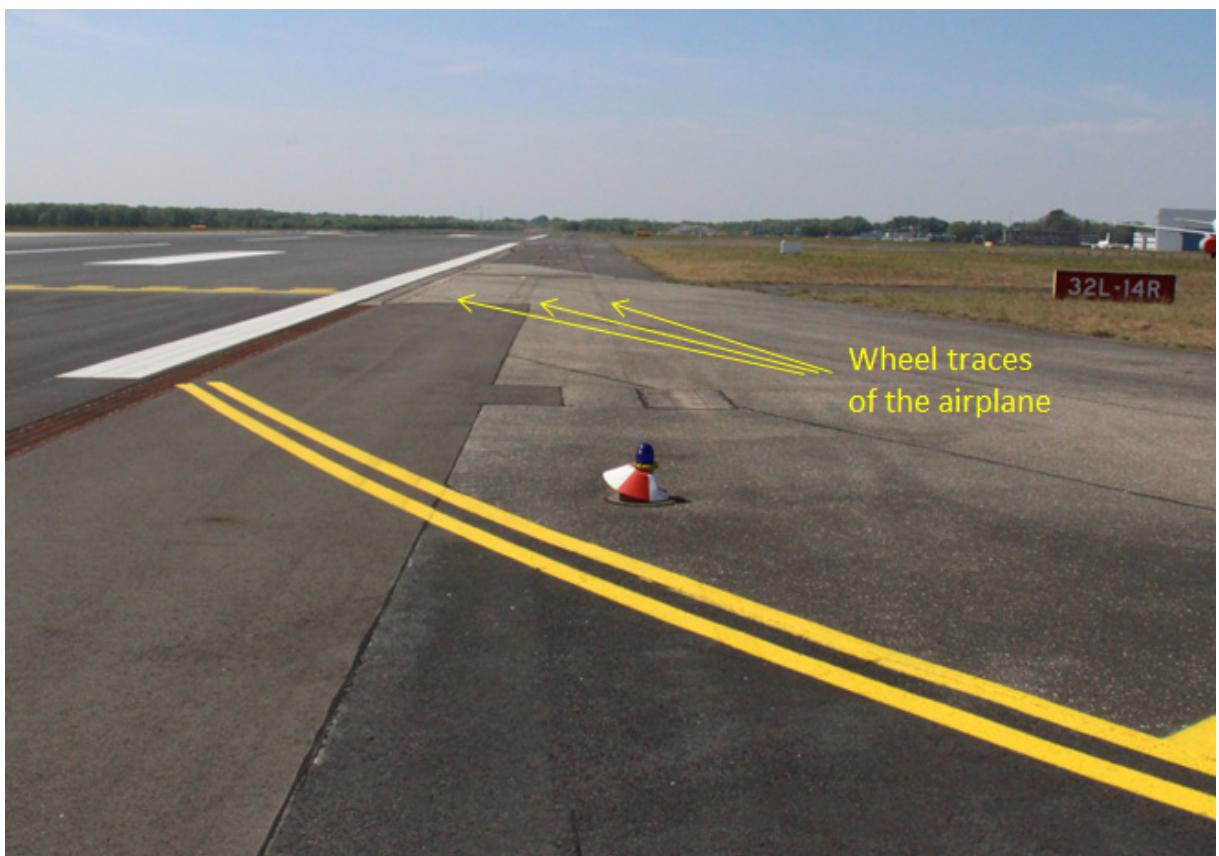
Up until the crossing runway 14R/32L all 7 overfloor lamps of the runway edge lighting had been torn off and between runway 14R/32L and taxiway Tango 2 others. In addition, one taxiway edge lamp was damaged at the intersection with taxiway Tango (Fig. 8). The damaged foundations and lamps had been scattered across the runway.

Fig. 8: Left shoulder (opposite the take-off direction of runway 06)

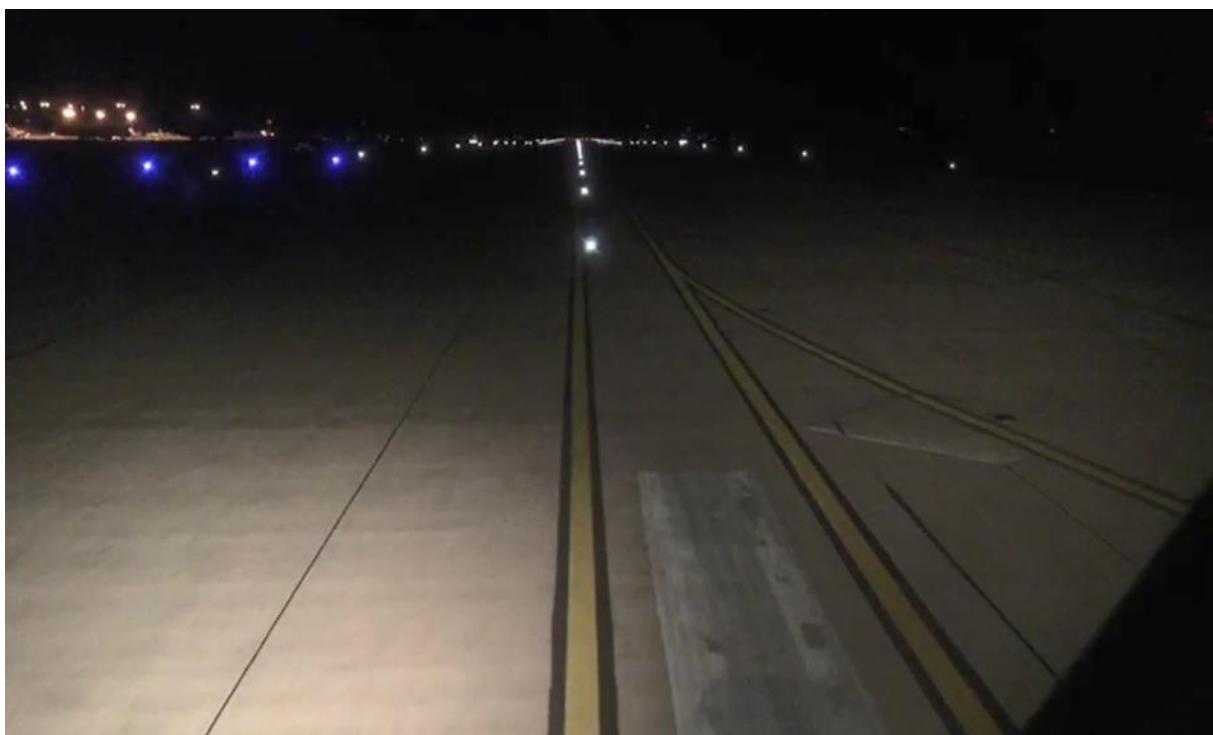
Fig. 9: View from the cockpit of an ATR 72 at night with runway lighting turned on, aligned for take-off with the centreline of runway 06

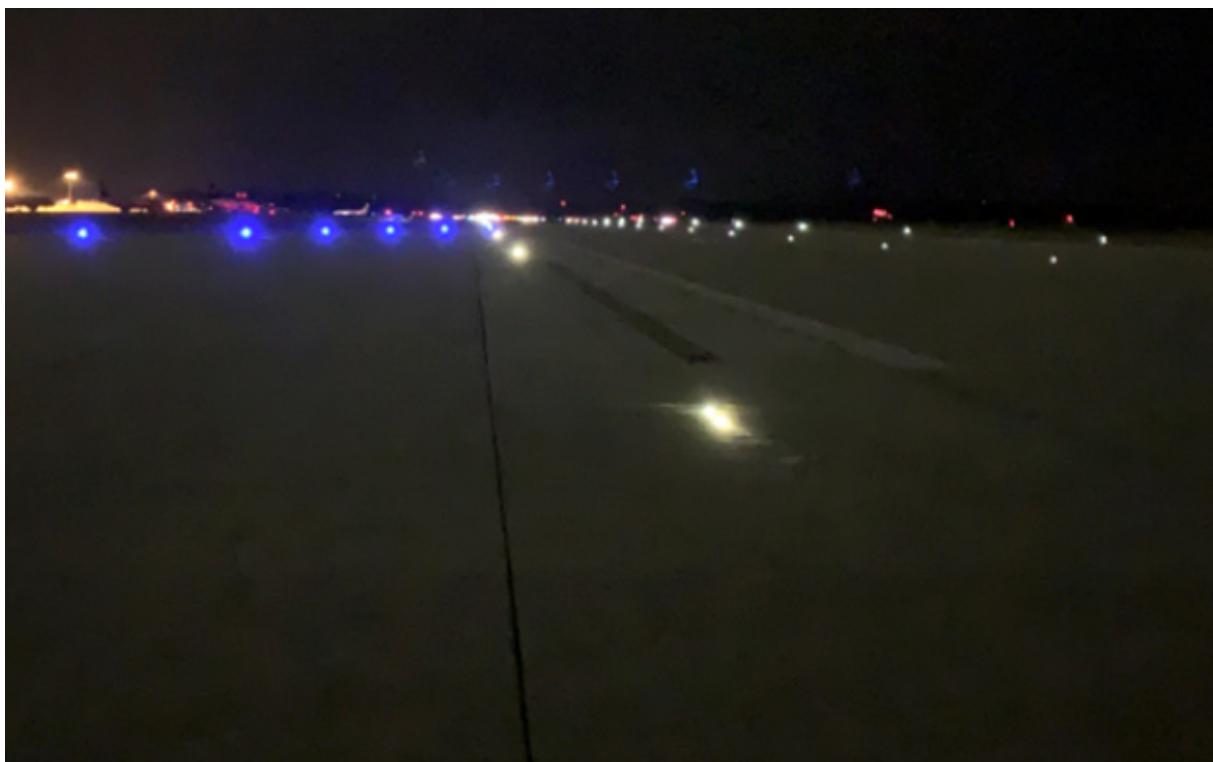
Fig. 10: View from the turnpad along the left runway edge lighting
