# Investigation Report

Type of Occurrence: Serious Incident

Model: Jetstream 3200

State File Number: BFU19-1422-EX

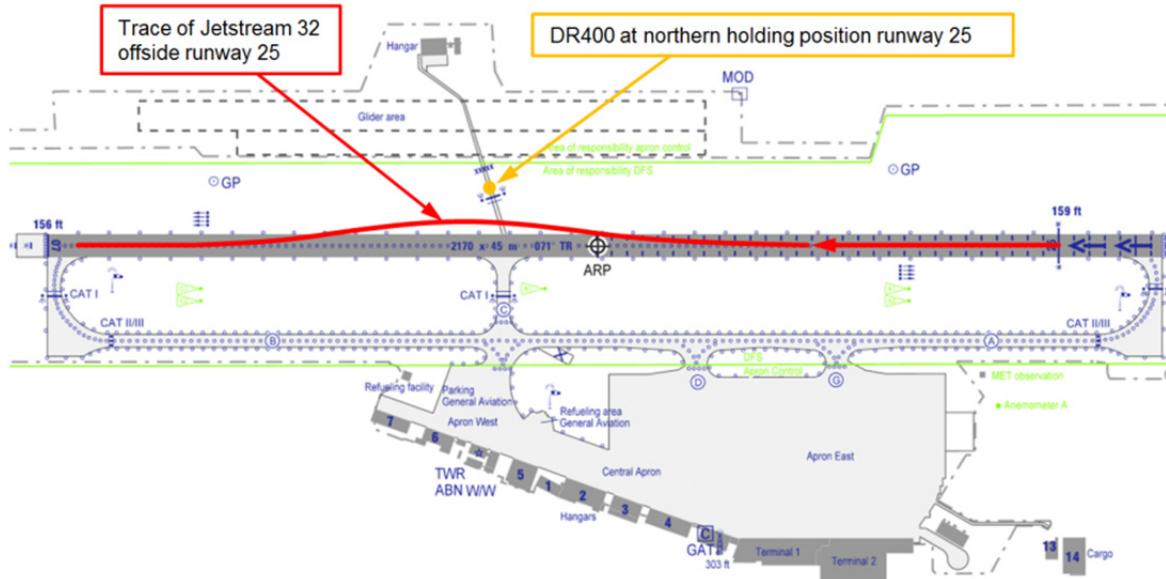
During the aborted take-off the aircraft veered north off the runway after about 1,080 m (Fig. 2). Offside the runway, the aircraft crossed the northern taxiway (connection with the flying club) of runway 25. At that time another airplane (DR400) ready for take-off waited at the holding position of the northern taxiway. The Jetstream 32 passed the DR400 with about 119 kt IAS. After about 530 m on unpaved ground the aircraft returned to the runway.

One runway edge light and an information sign (for the glider area) were damaged in the process. The maximum distance to the runway edge was 23 m.

Fig. 2: Sequence of the aborted take-off on runway 25

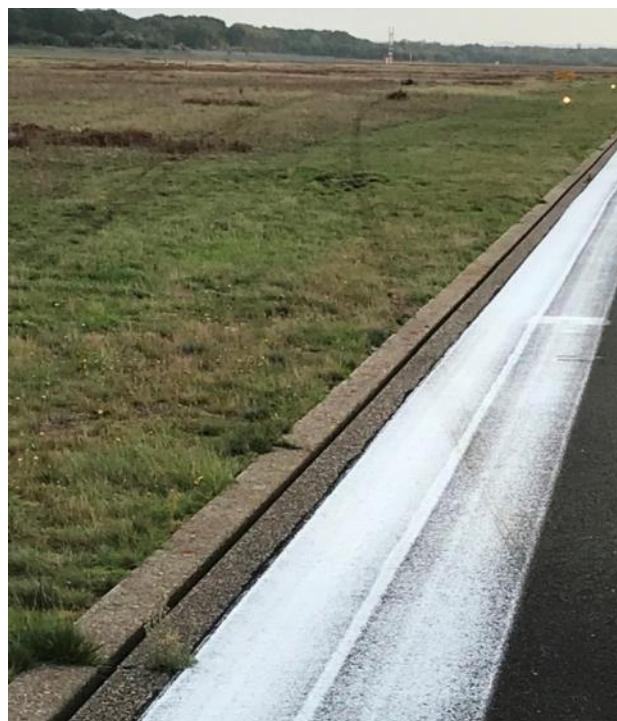
Fig. 3: The end of the traces next to runway 25 (view direction 070°)

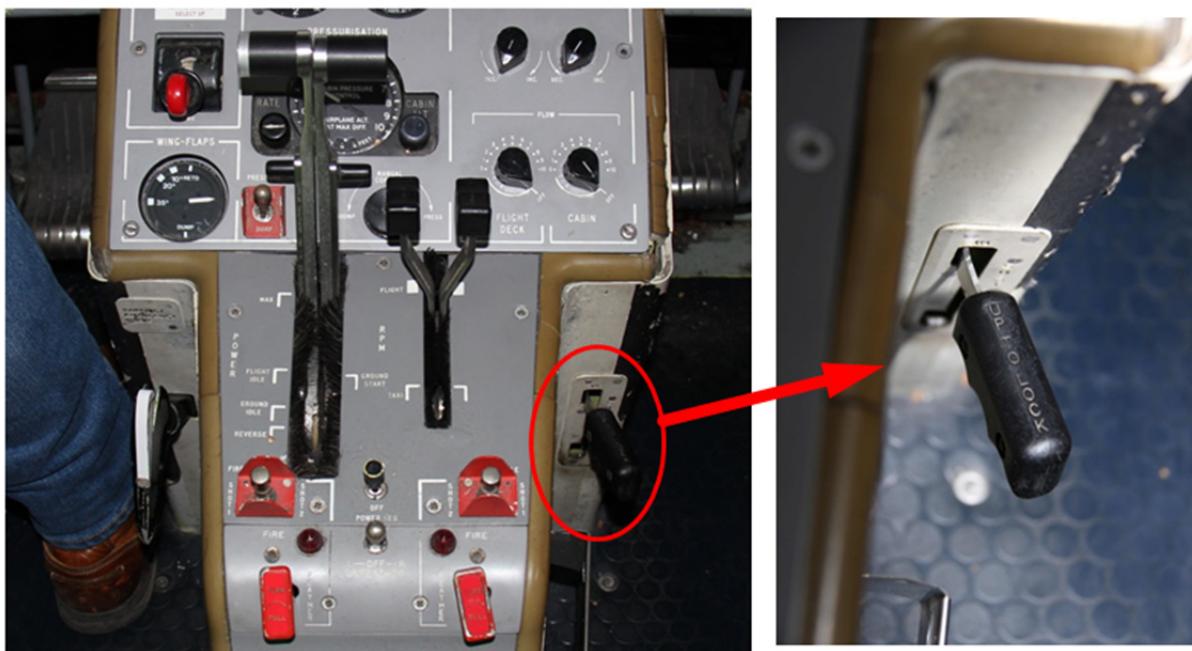
The control surfaces are locked in their neutral positions via a gust lock lever. This lever is located on the right-hand side of the center console (Fig. 6). If the lever is in the upper position (IN) (Fig. 6 and 7), spring-loaded locking pins lock, via corresponding cables and levers, the aileron, rudder and elevator controls. In order to prevent take-off with locked flight controls it is normally not possible to move both power levers simultaneously beyond the flight idle position. This is mechanically prevented through a special locking mechanism of bars and levers. Individually the power levers can be moved to the MAX position.

Fig. 6: Cockpit view of the Gust Lock lever

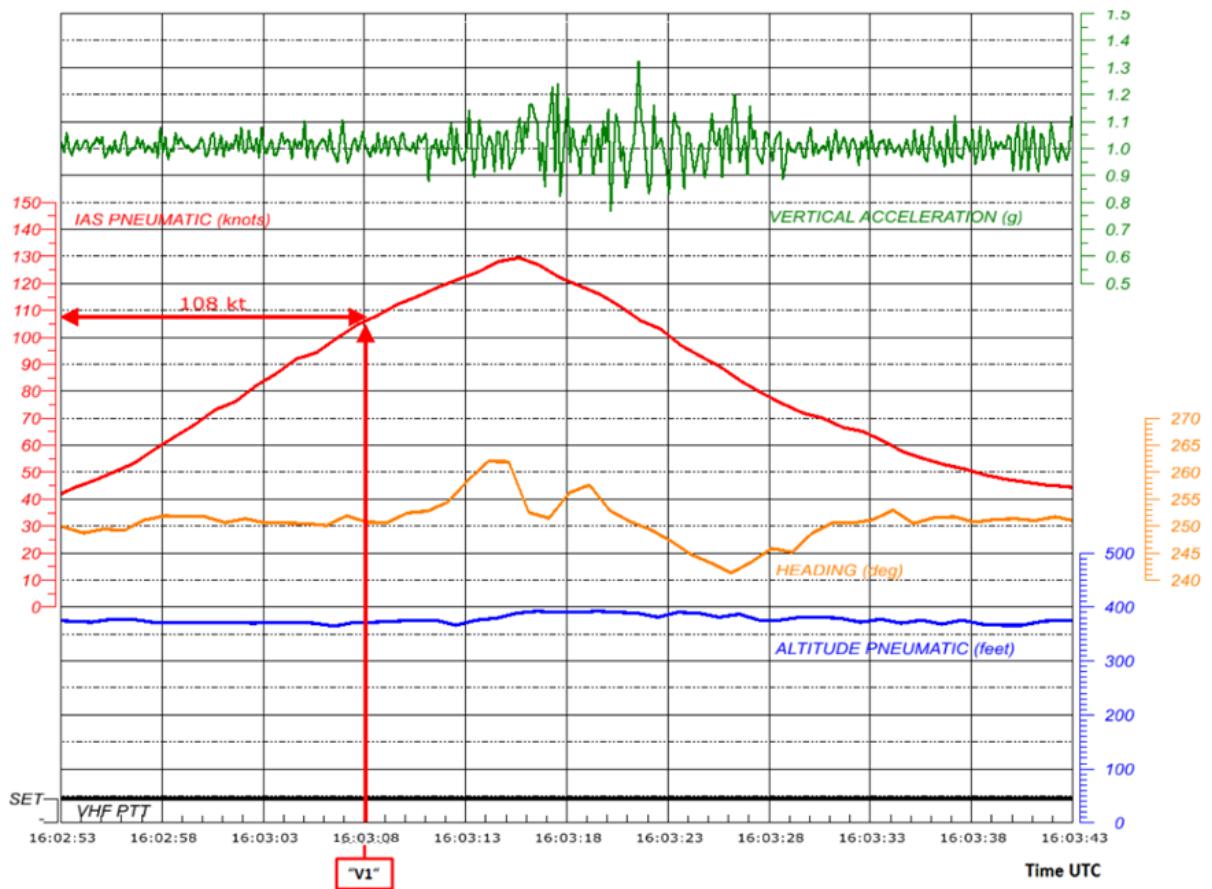
The speed (IAS) curve shows the acceleration phase until the rejected take-off at 1603:15 UTC at about 130 kt and the subsequent deceleration.

The heading parameter shows that from 1603:09 UTC on, within approximately 5 s the aircraft veered right by about 11° off the runway heading. At 1603:15 UTC, at the time of the rejected take-off, heading decreased within the next 11 s by 21°. At that time, the PIC counteracted with the nose wheel steering, according to his own statement. At 1603:26 UTC heading changed from 241° back to the runway heading.

Between 1603:13 UTC and 1603:27 UTC vertical acceleration increased significantly up to 1.3 g.

Fig. 8: FDR parameter during the rejected take-off

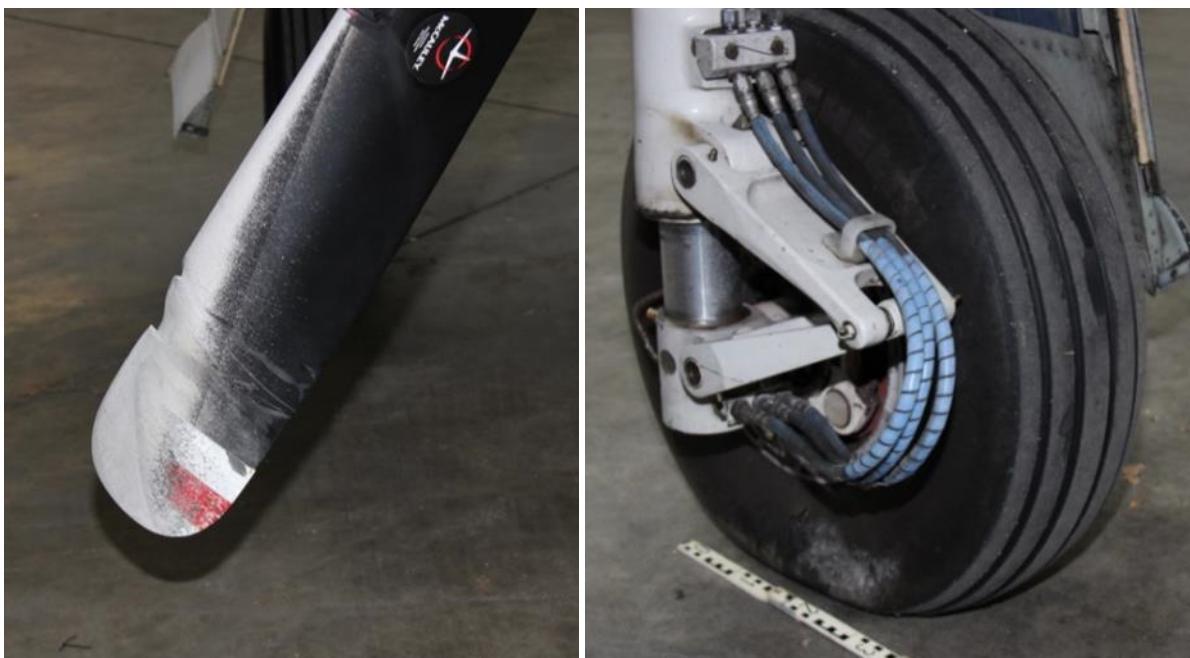
One propeller blade of the right engine (Fig. 9), the left main landing gear tire (Fig. 9), and a small area of the right lower side of the cargo compartment (Fig. 10) were damaged.

Fig. 9: Damage of the propeller blade and left main landing gear tire

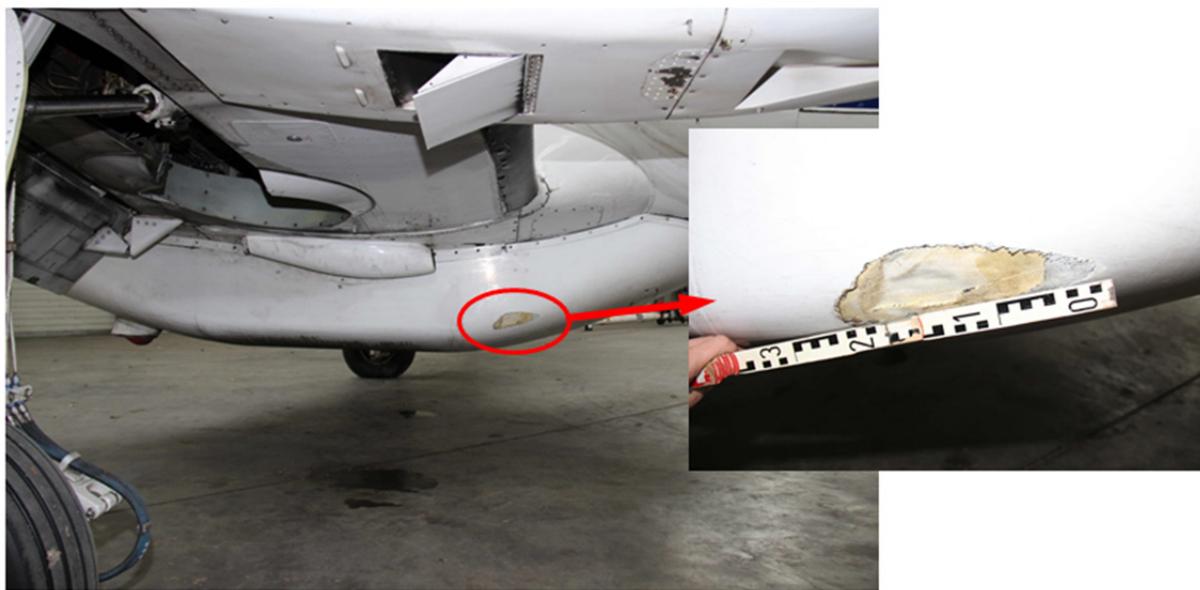
Fig. 10: Damaged area at the lower right side of the cargo compartment

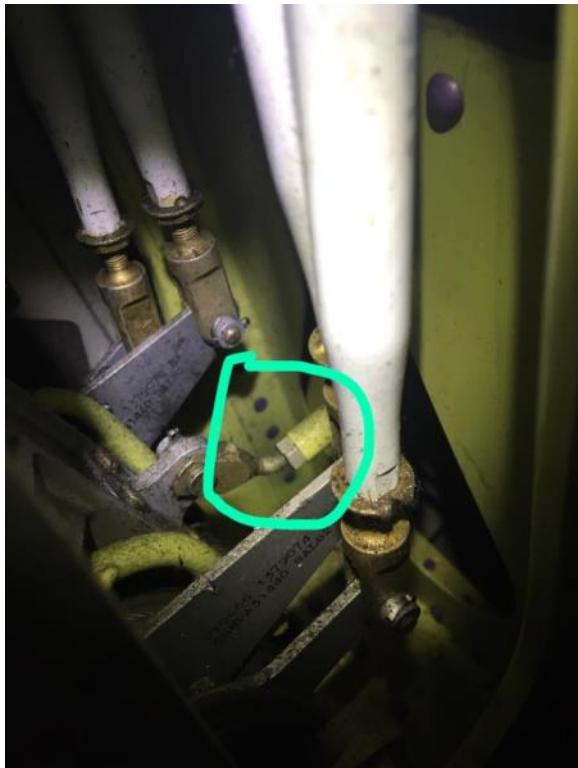
blocked mechanically. At the lower area of the center console the fork end of a control rod to block the power lever was located. This fork end was bent by about 45° in relation to the control rod (Fig. 11). For comparison reasons Fig. 12 shows an undamaged connection of another aircraft of the same type. The bent connection made it possible to move both power levers simultaneously to the MAX position, even though the Gust Lock lever was in the upper position.

Fig. 11: Bent Connection

The manufacturer assumed that the damage (Fig. 11) was caused by moving the Gust Lock lever into the locked position (IN) while both power levers were above flight idle. The description of airframe and flight controls in the BAE Systems MOM 2 contains the following Caution: "DO NOT TRY TO ENGAGE CONTROL LOCK WHEN POWER LEVERS ARE IN THE FLIGHT RANGE. THIS WILL RESULT IN DAMAGE TO THE MECHANISM".

The European Aviation Safety Agency (EASA) should convert the Highly Recommended Service Bulletin (SB) 27JM-5350 „Modified Push Rod Assembly at Gust Lock / Power Lever Baulk Mechanism” into a mandatory Airworthiness Directive in order to safe-guard the function and prevent take-offs with engaged Gust Lock for all aircraft of the type Jetstream 3100 / 3200.

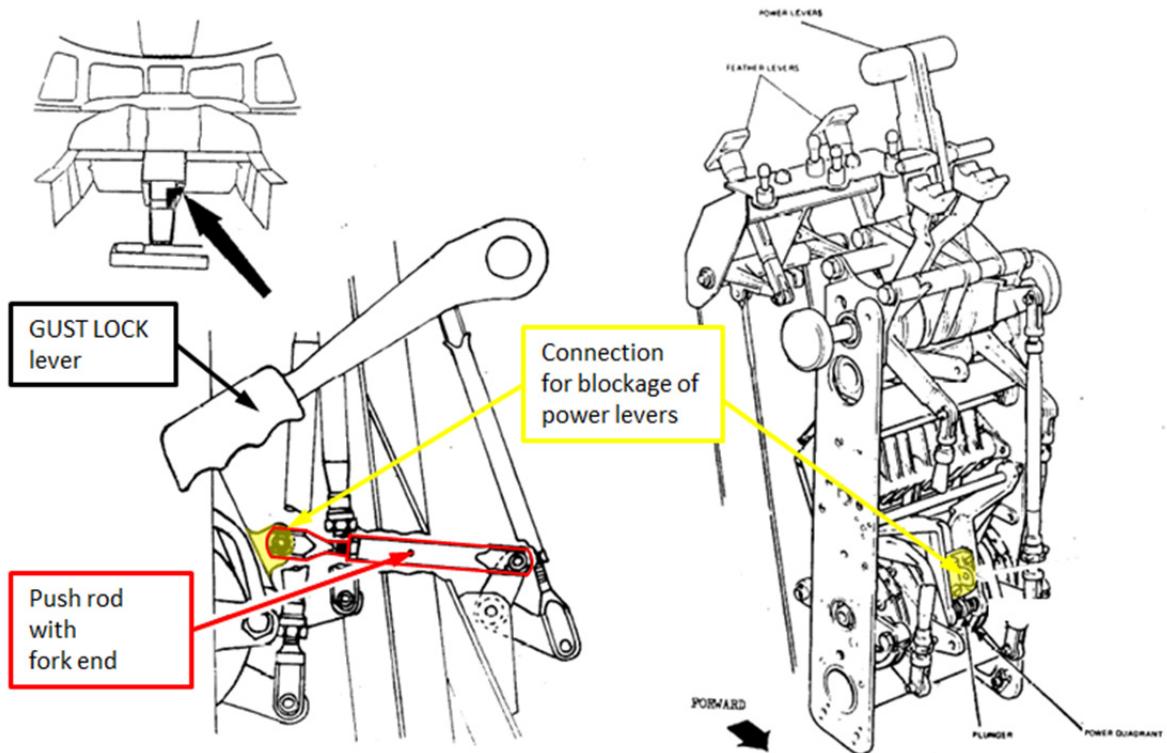
Due to these occurrences, in February 1992 the aircraft manufacturer had published the Service Bulletin (SB) 27JM-5350. With this SB the original control rod (Fig. 16, marked red) including the fork end was replaced by a reinforced version in order to prevent bending of the transition area at the fork end.

The maintenance organisation of the operator stated that the SB 27JM-5350 had not been implemented in the airplane involved (MSN 848).

Fig. 16: Control rod and connection to lock the power levers
