3 Conclusion

SUMMARY

1. Airplane Performance Evaluation:¹

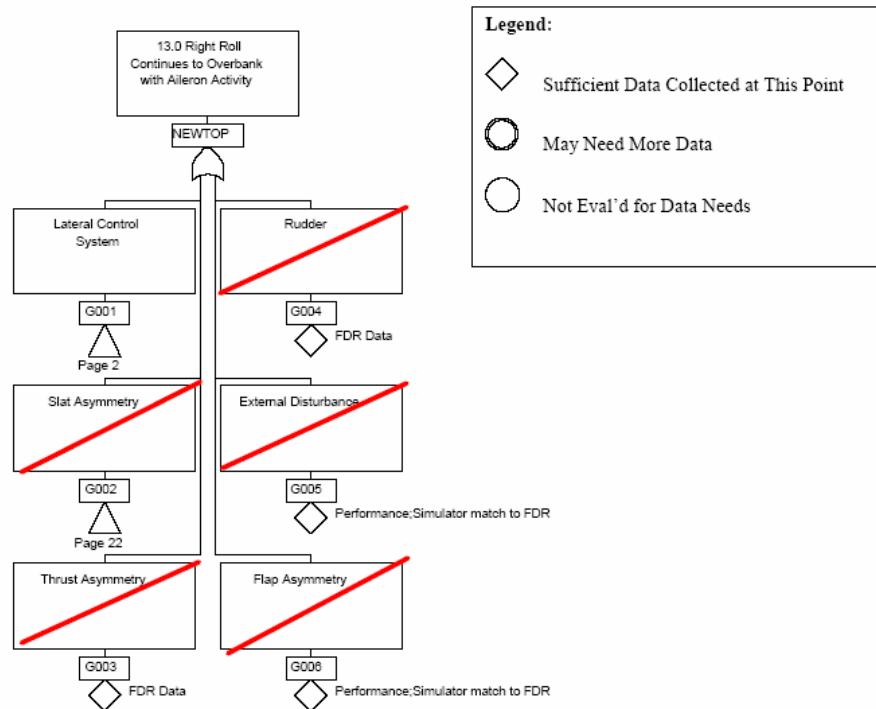
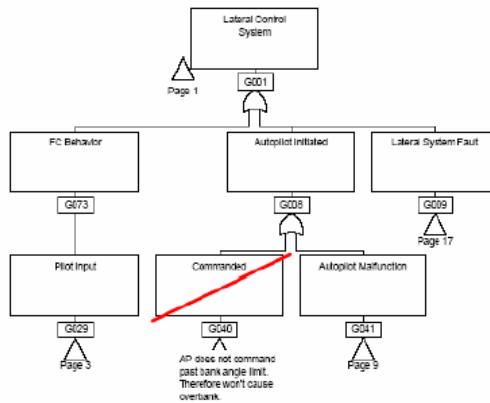
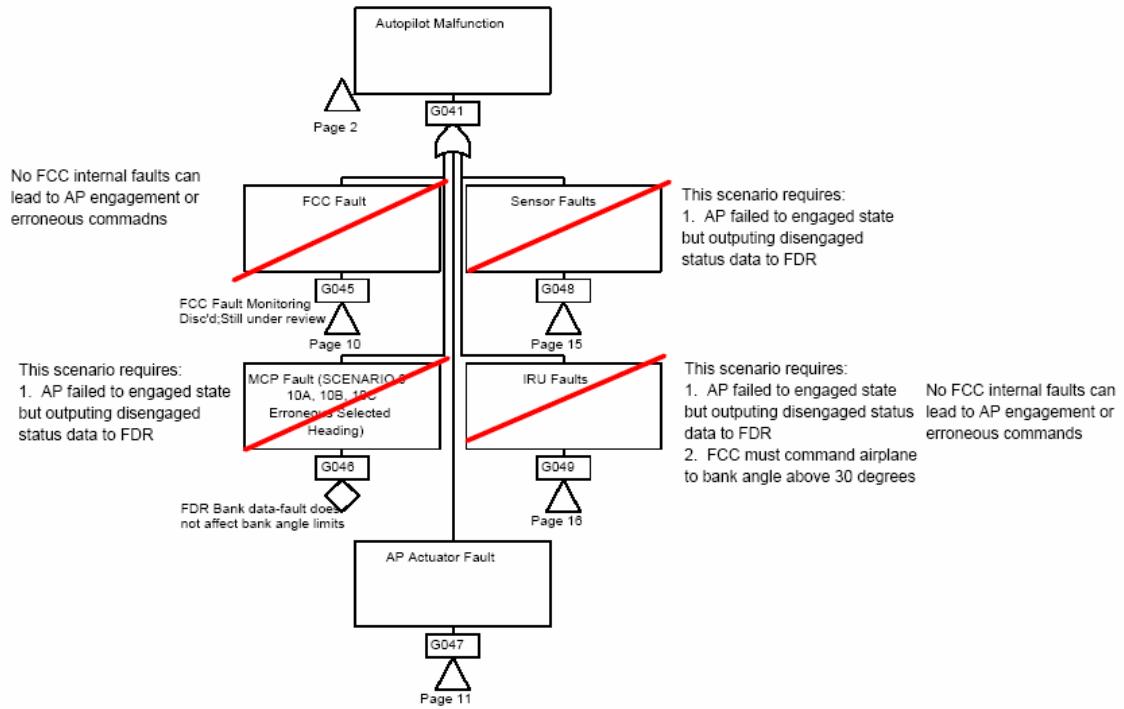
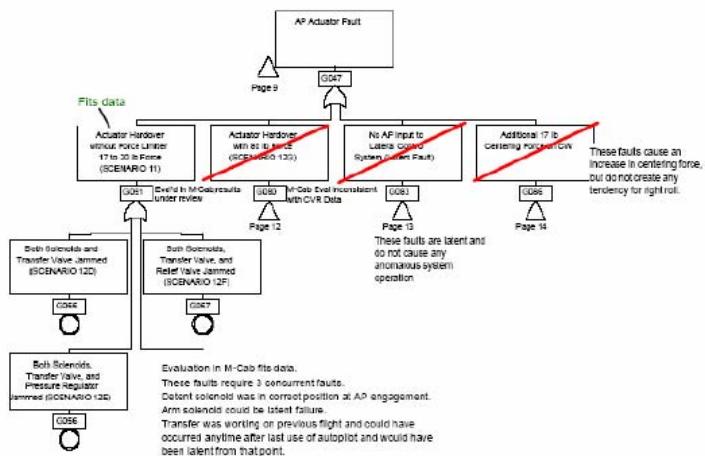
13.0 Right Roll Continues to Overbank with Aileron Activity

1- Autopilot Actuator Fault (Actuator Hardover without Force Limiter 17 to 20 lb Force) was not ruled out (refer to pages 1, 2, 9 and 11 of the fault tree)

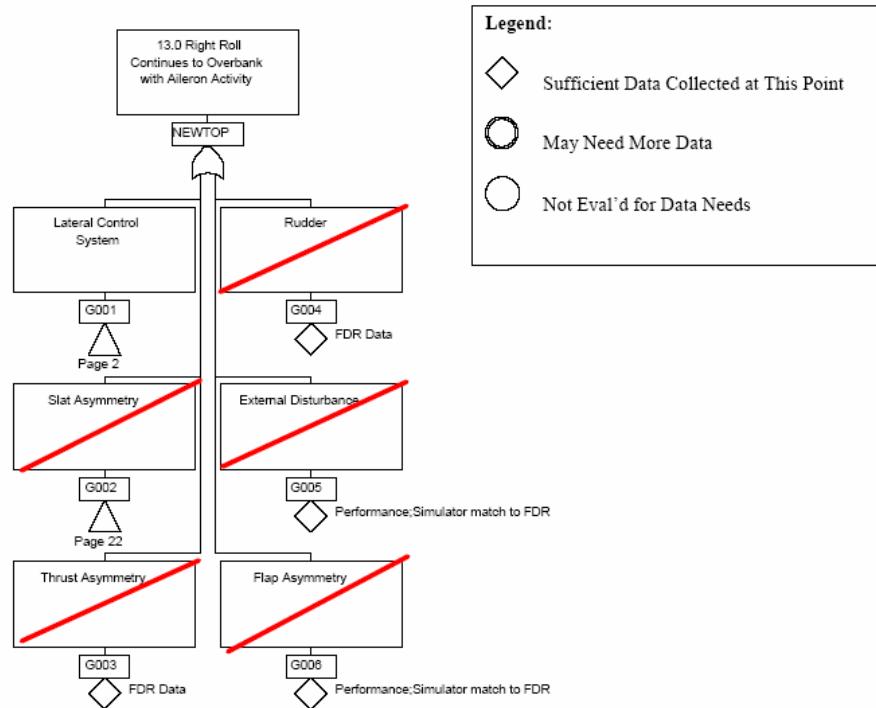
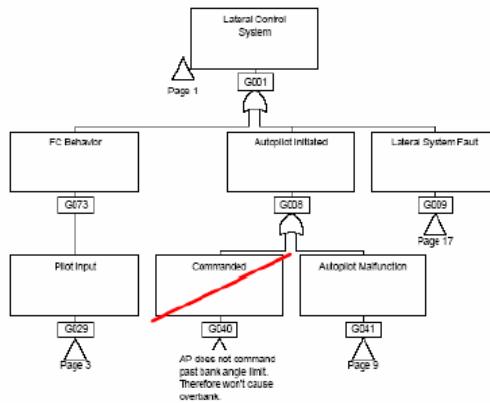
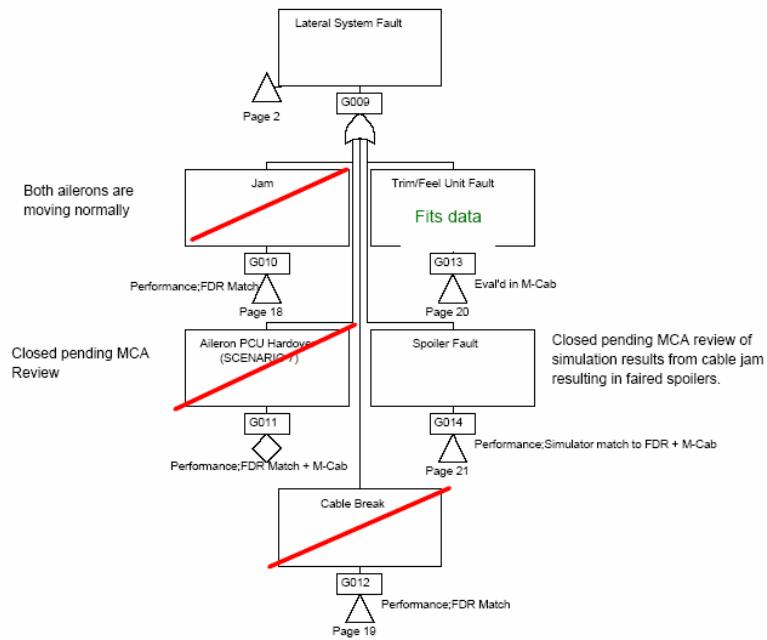
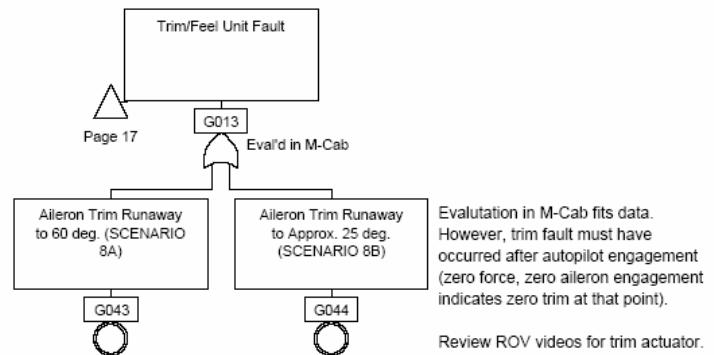
13.0 Right Roll Continues to Overbank with Aileron Activity

2- Trim/Feel Unit Fault was not ruled out (refer to pages 1, 2, 17, 20 of the fault tree)

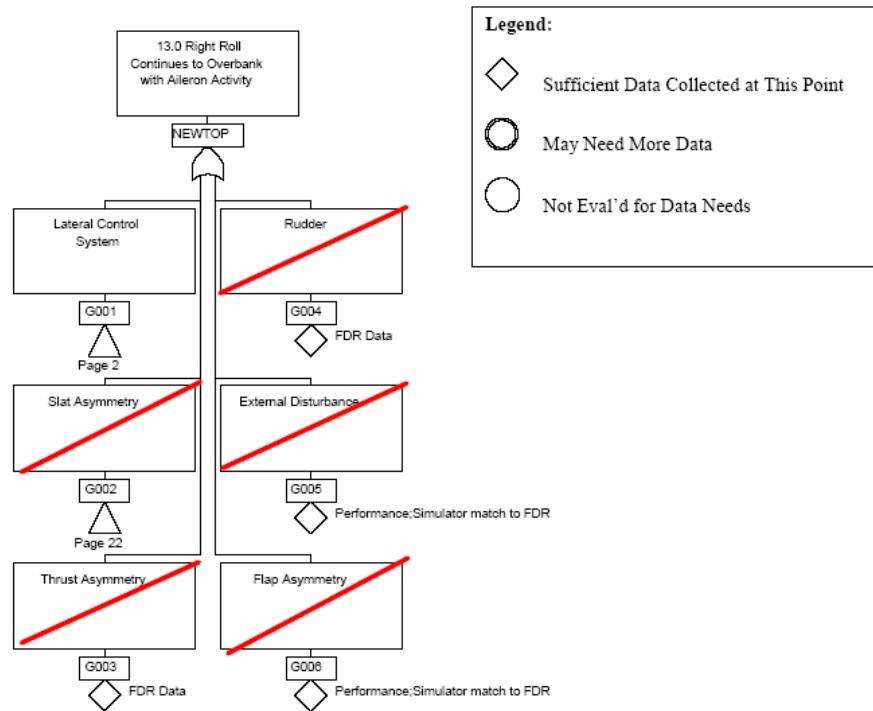
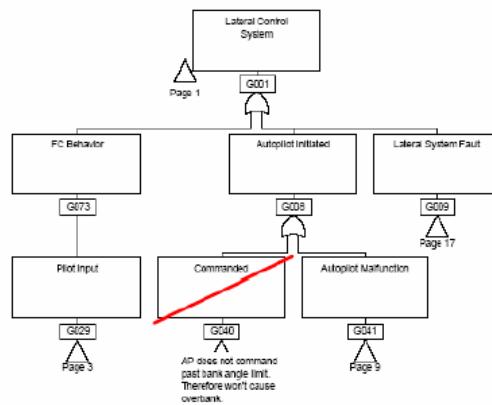
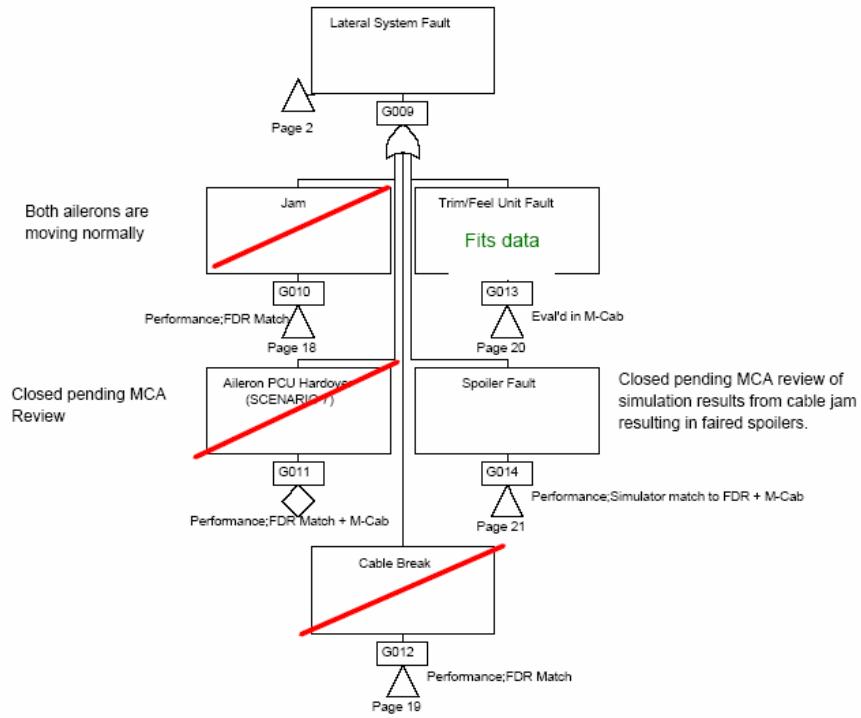
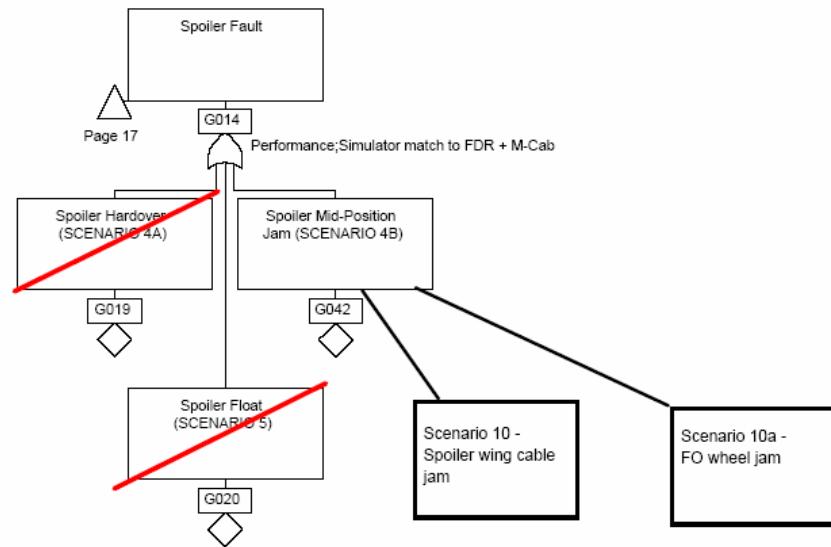
13.0 Right Roll Continues to Overbank with Aileron Activity

3- Spoilers wing cable jam and F/O wheel jam were not ruled out (refer to pages 1, 2, 17, 21 of the fault tree)

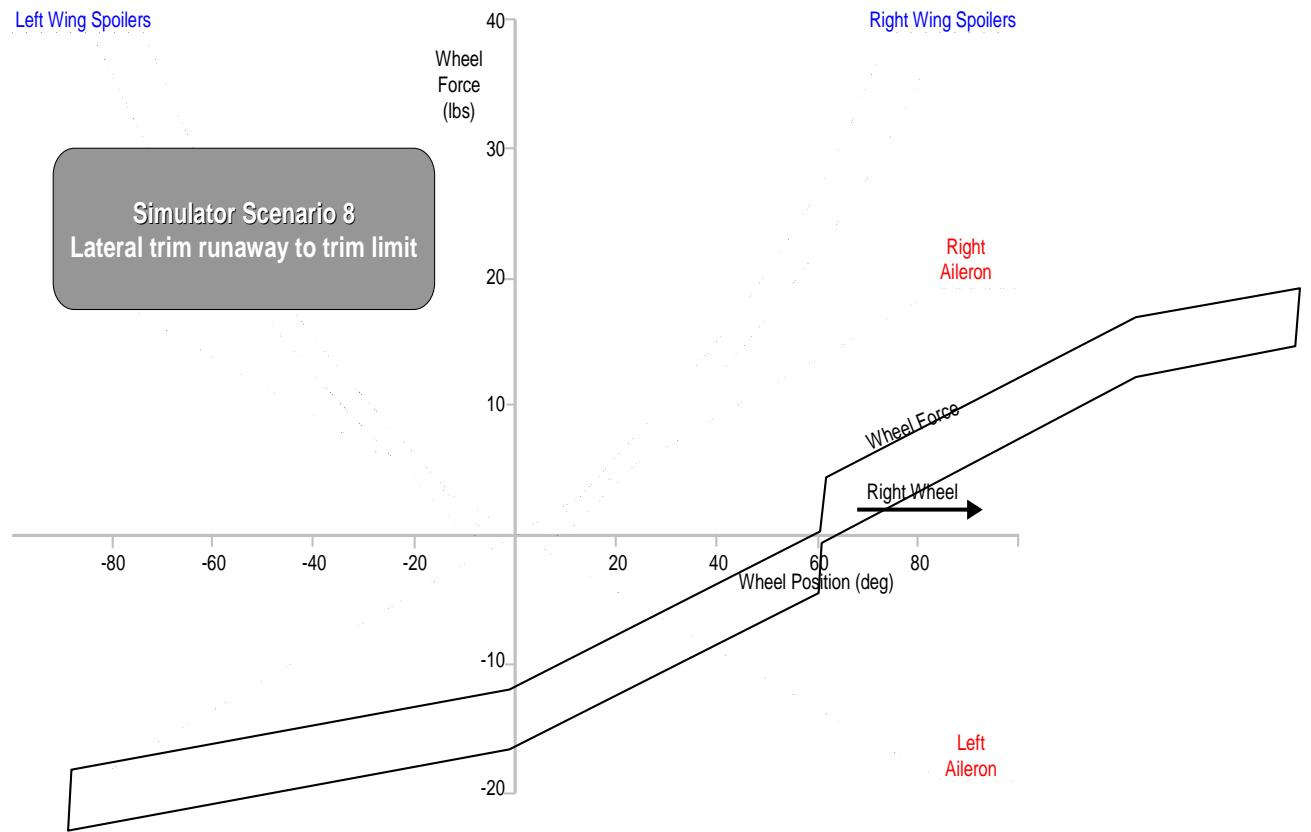
Figure 2.5.13.7 Ailerons and spoilers behavior with aileron trim actuator at its hardover position

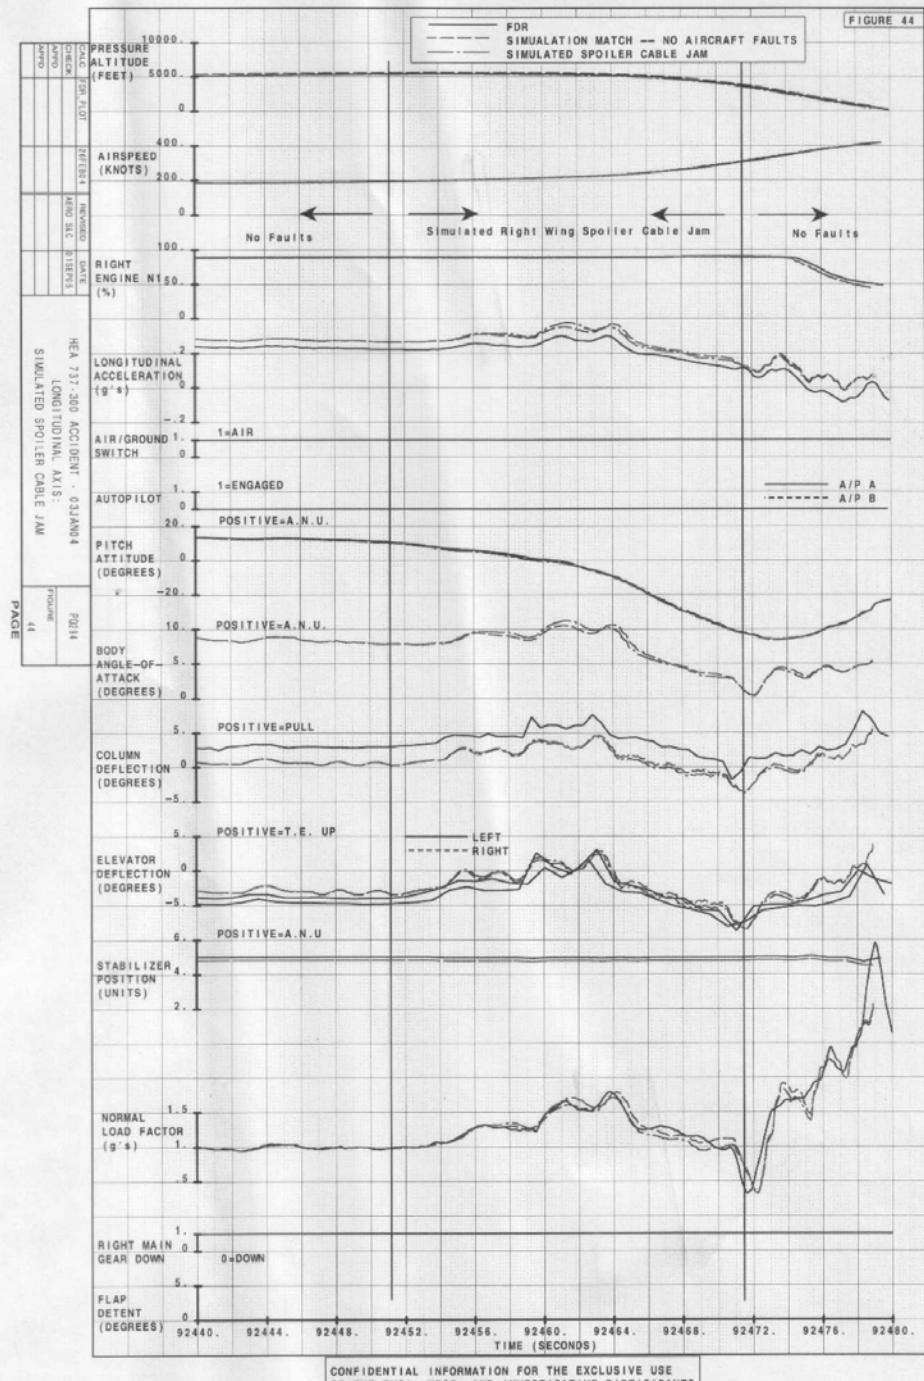
Figure 2.5.13.15a Scenario 10 - Spoiler wing cable jam (longitudinal parameters)

As shown from the two plots, the results obtained from the M-Cab test show a very close consistency with the FDR data which may explain this event. The estimated aileron wheel forces needed to move the wheel to correct for the right turn tendency is ~ 50 lbs.

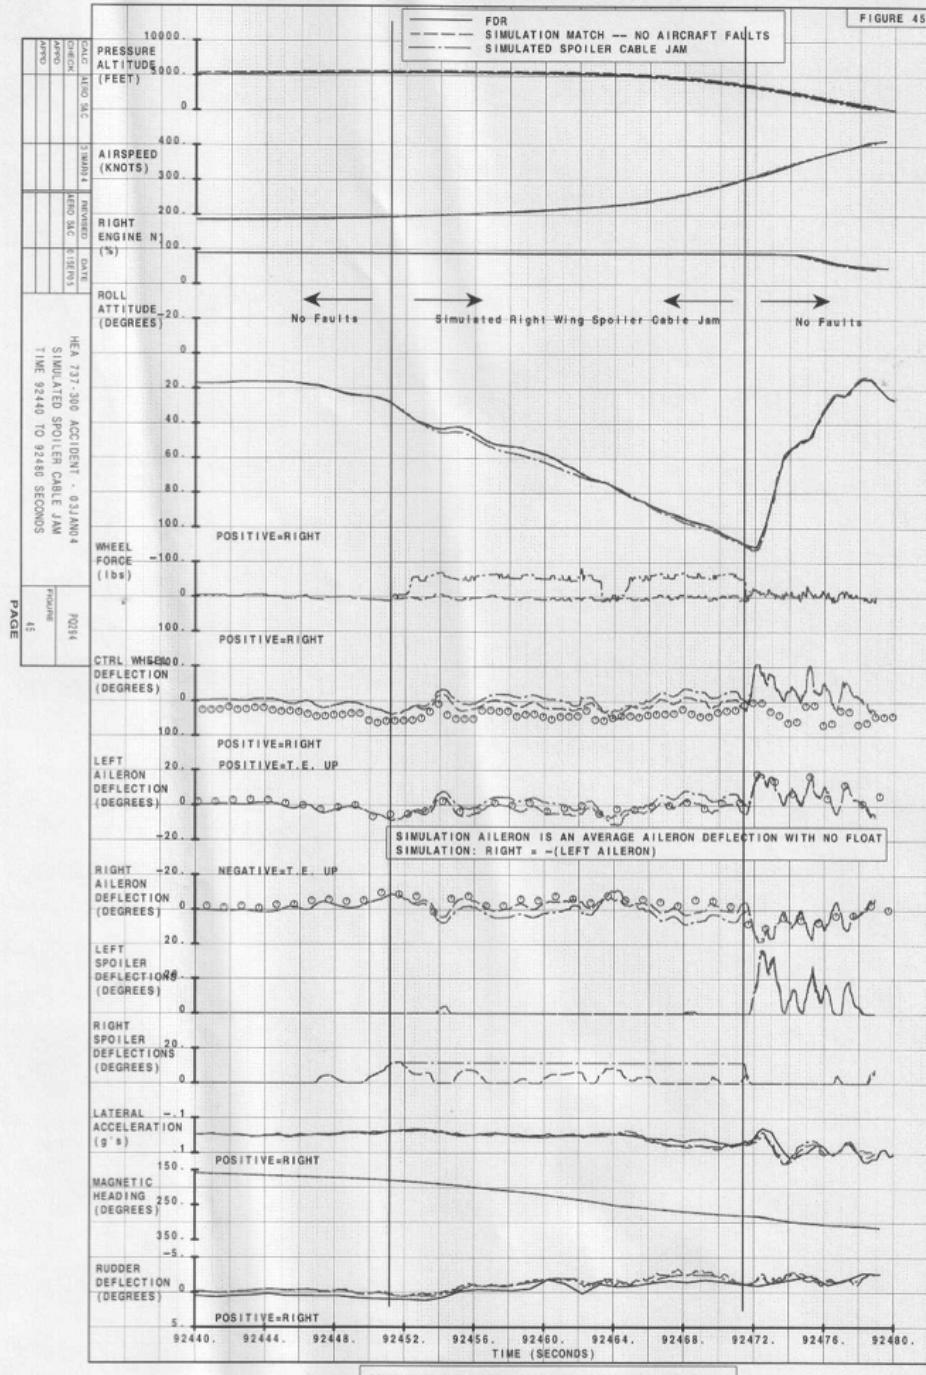
Figure 2.5.13.15b Scenario 10 - Spoiler wing cable jam (lateral parameters)

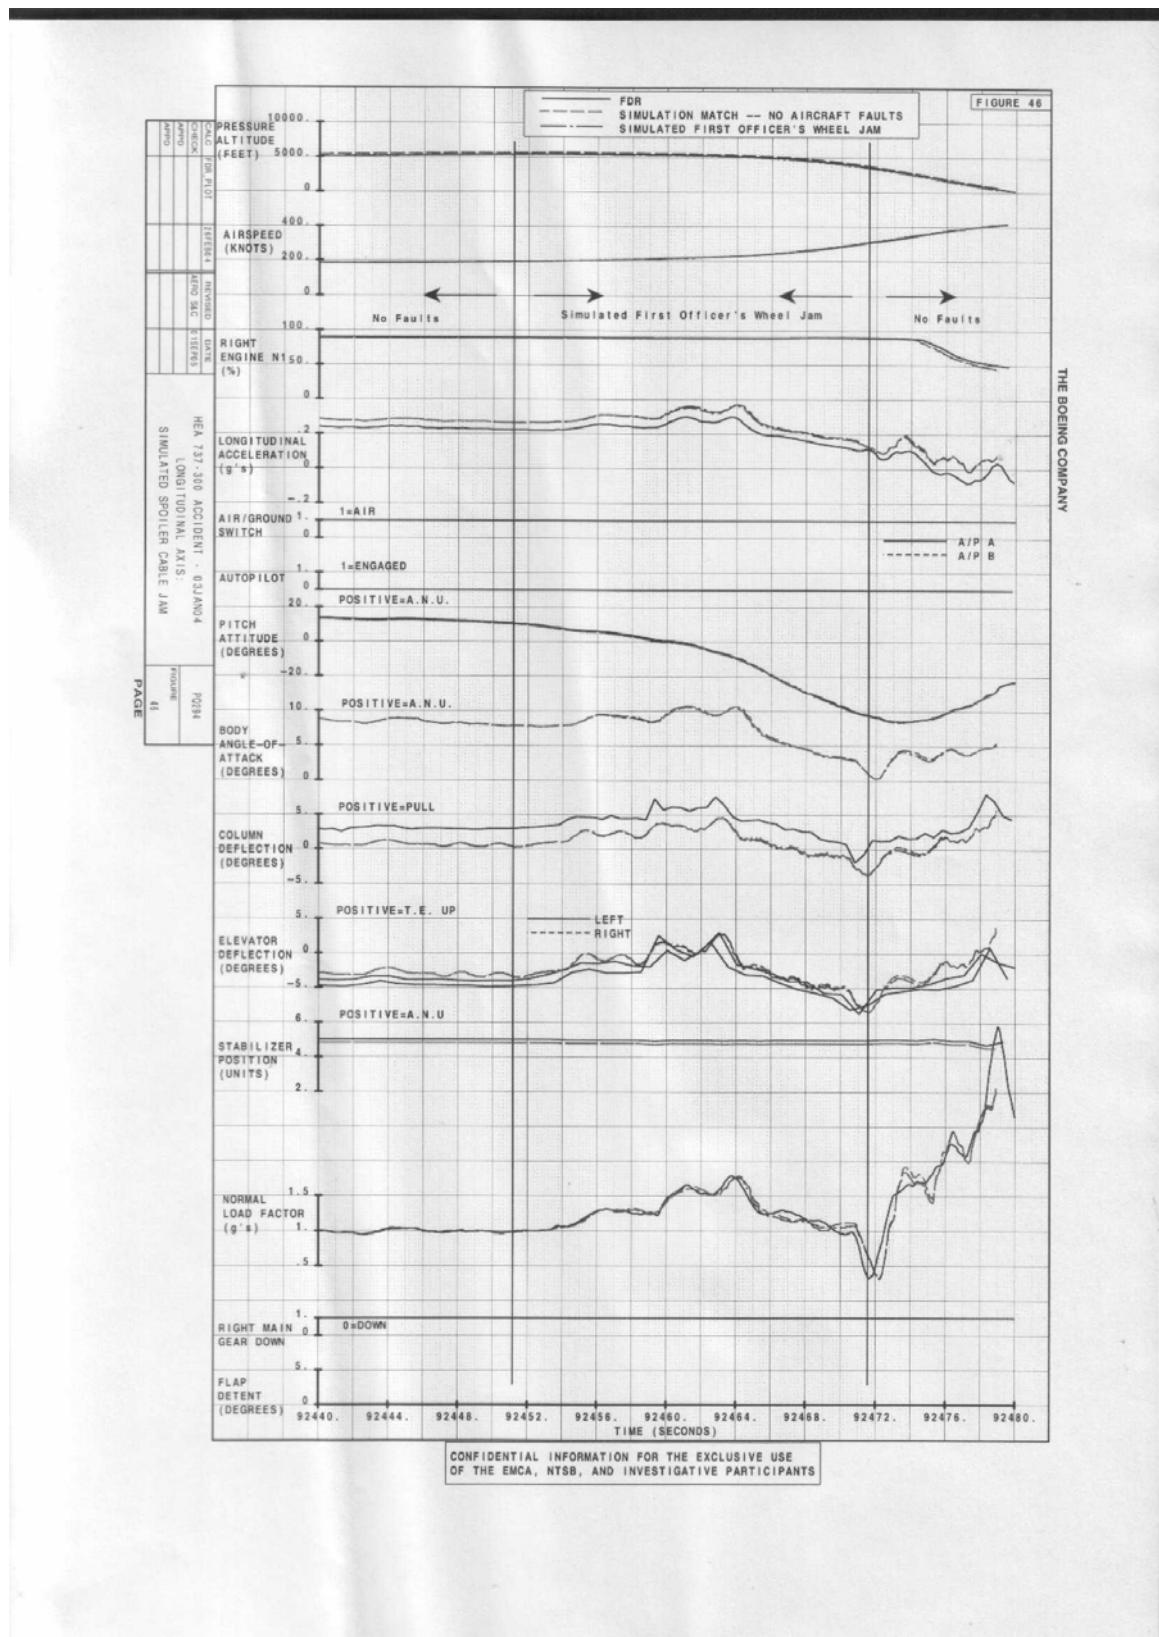
Figure 2.5.13.16a Scenario 10a - F/O wheel jam (longitudinal parameters)

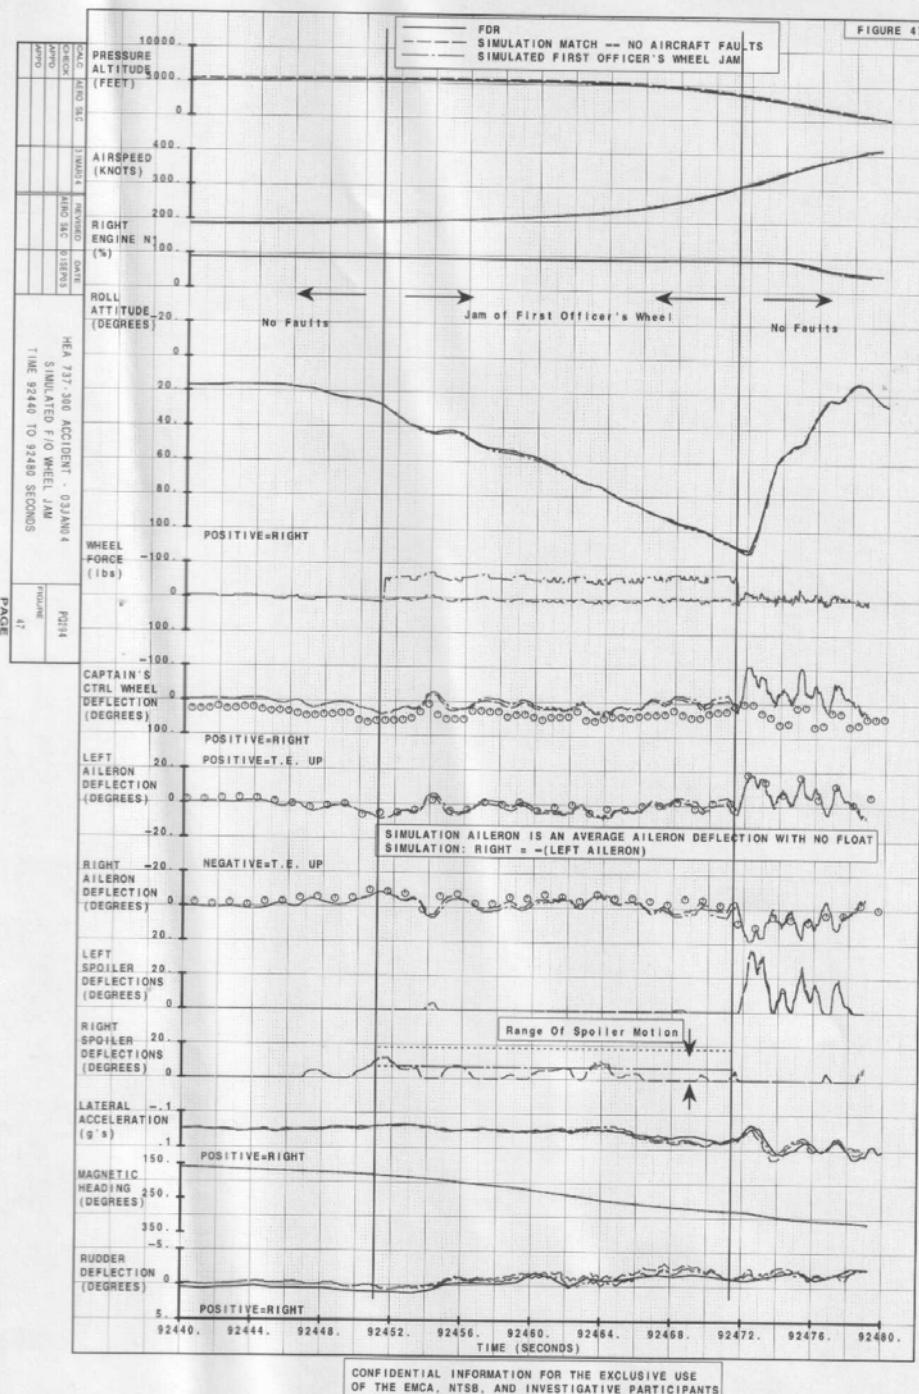
2.5.13.16b Scenario 10a - F/O wheel jam (lateral parameters)
