FINAL REPORT

HCL 37/02		Incident	
Aircraft Type:	Cessna 404	Aircraft Registration:	TF-JVG
Engine(s):	2 Continental GTSIO-520-M	Type of Flight:	Air Taxi, IFR
Crew:	2 – no injuries	Passengers:	9 – no injuries
Place:	App. 30 nm west of Kulusuk Airport (BGKK) at FL 130	Date and Time:	01.08.2002 1442 UTC

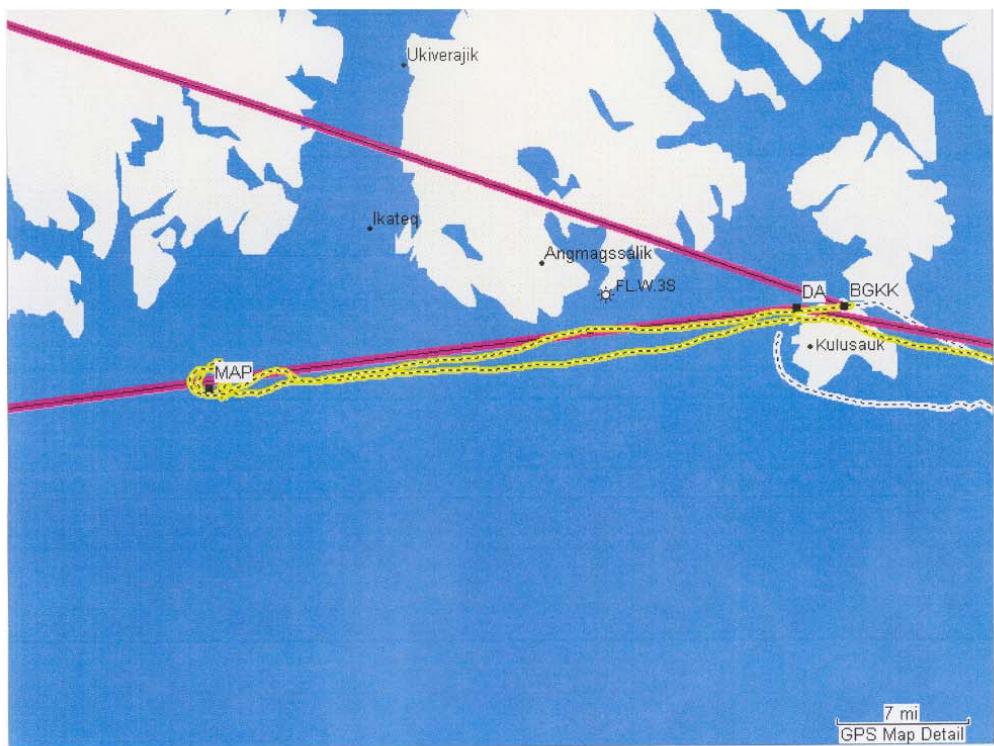
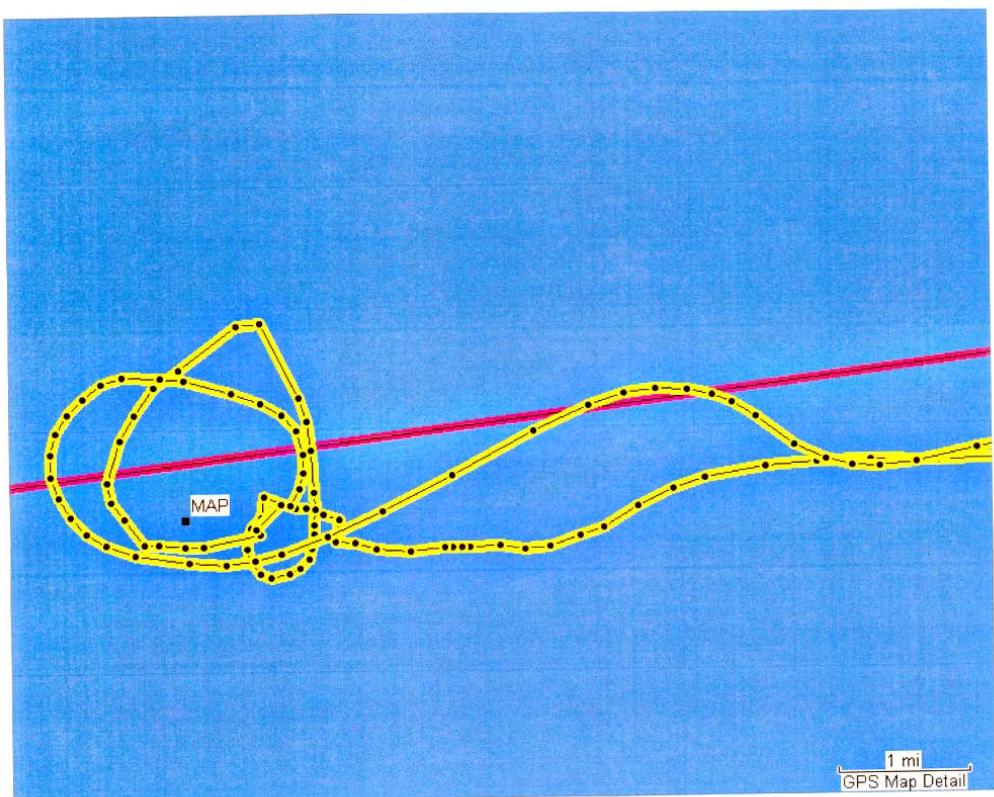
Enclosure 1

1.8.2.2 The Icelandic AAIB assisted the Danish AAIB in downloading data from the GPS. See enclosure 1.
