SL Report 2007/08

**REPORT ON THE SERIOUS INCIDENT AT OSLO AIRPORT GARDERMOEN ON 21  
SEPTEMBER 2004 INVOLVING FLIGHT KAL520 BOEING 747-400F REGISTERED  
HL7467 OPERATED BY KOREAN AIR**

SUBMITTED  
March 2007

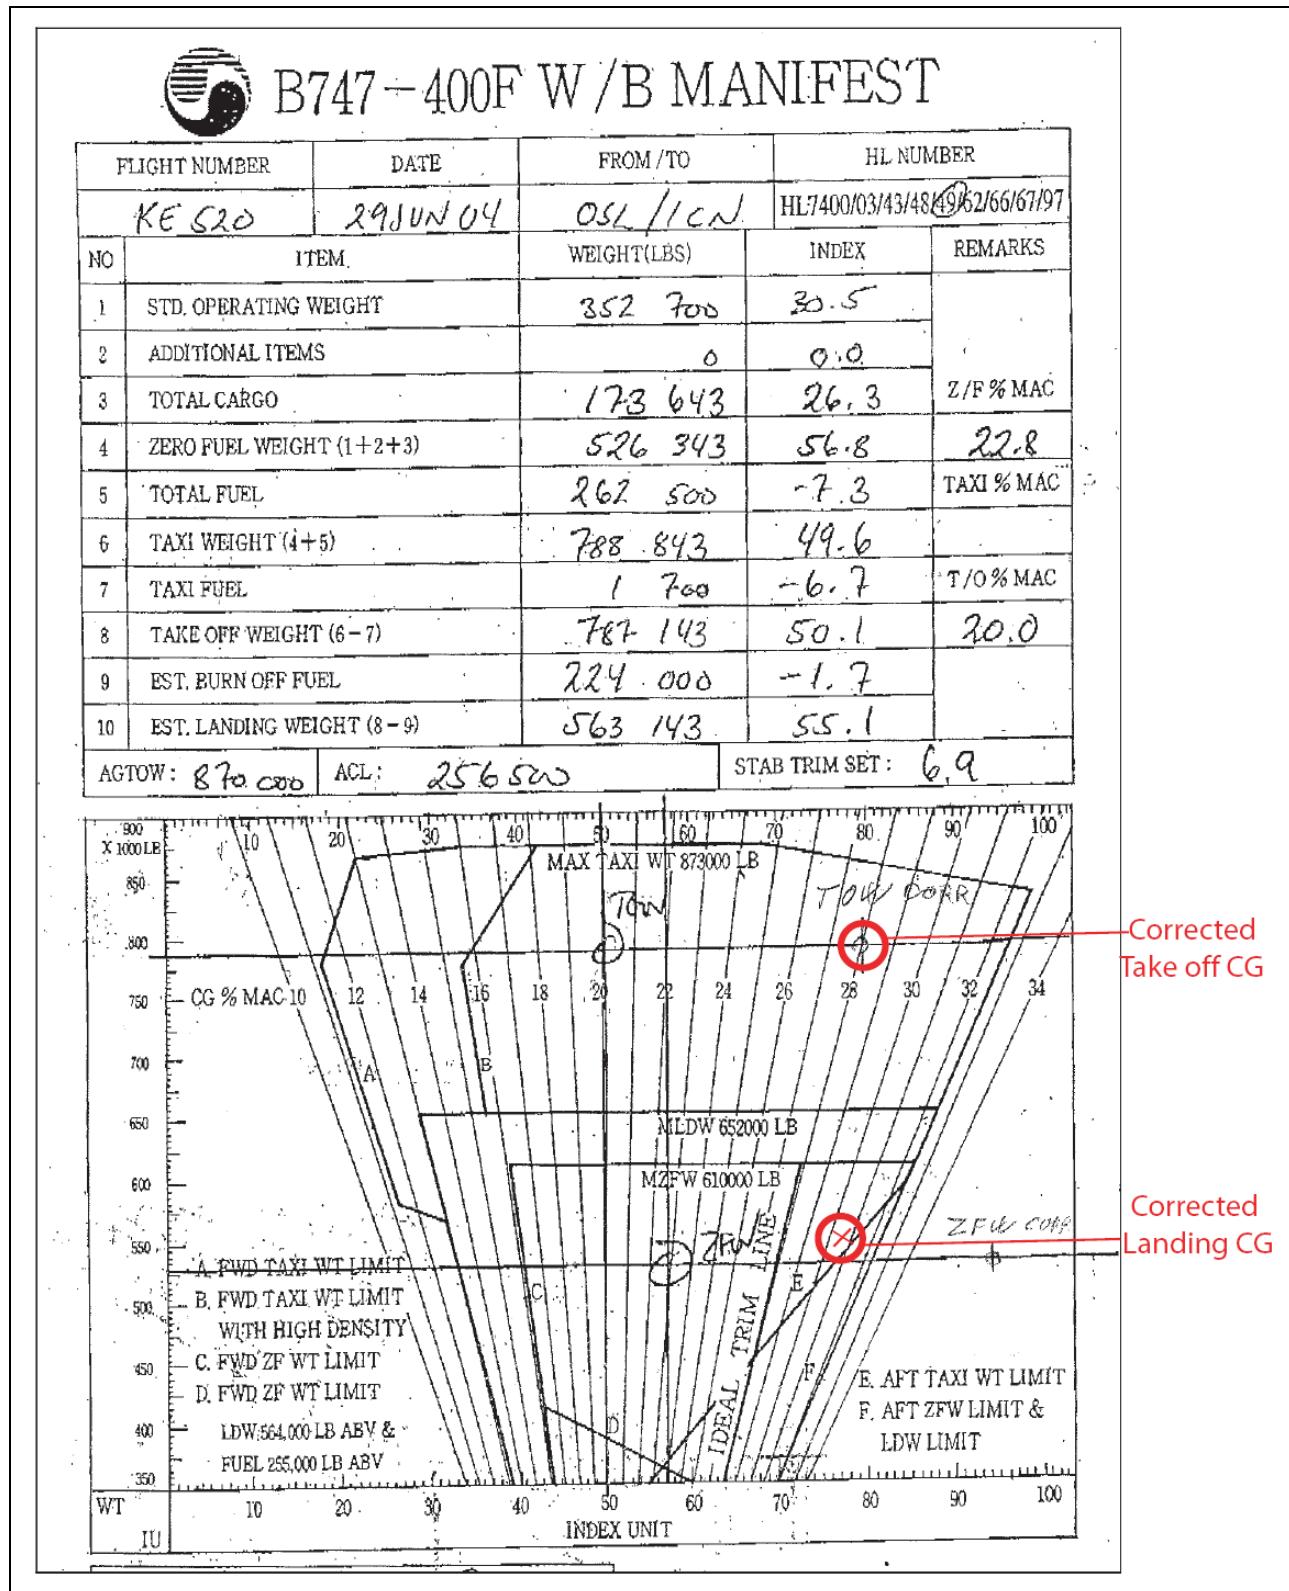
Fig. 5. M &amp; B Manifest of 29 June 2004

1.18.4.1 During the investigation following the KAL520 incident, SAS Cargo checked through the previous mass and balance manifests. It was then discovered that the same mistake had been made by the same Load Master on 29 June 2004. See M & B Manifest, figure 5.

1.18.4.2 In this incident the Load Master mistook the 30.5% MAC value for the correct UI of 67.3.
