FINAL REPORT

Date: 26.07.2006
SL Report: 20/2006

- Type and reg.: Boeing 737-800, TC-APH

Type of occurrence: Air traffic incident, attempted take-off from a taxiway

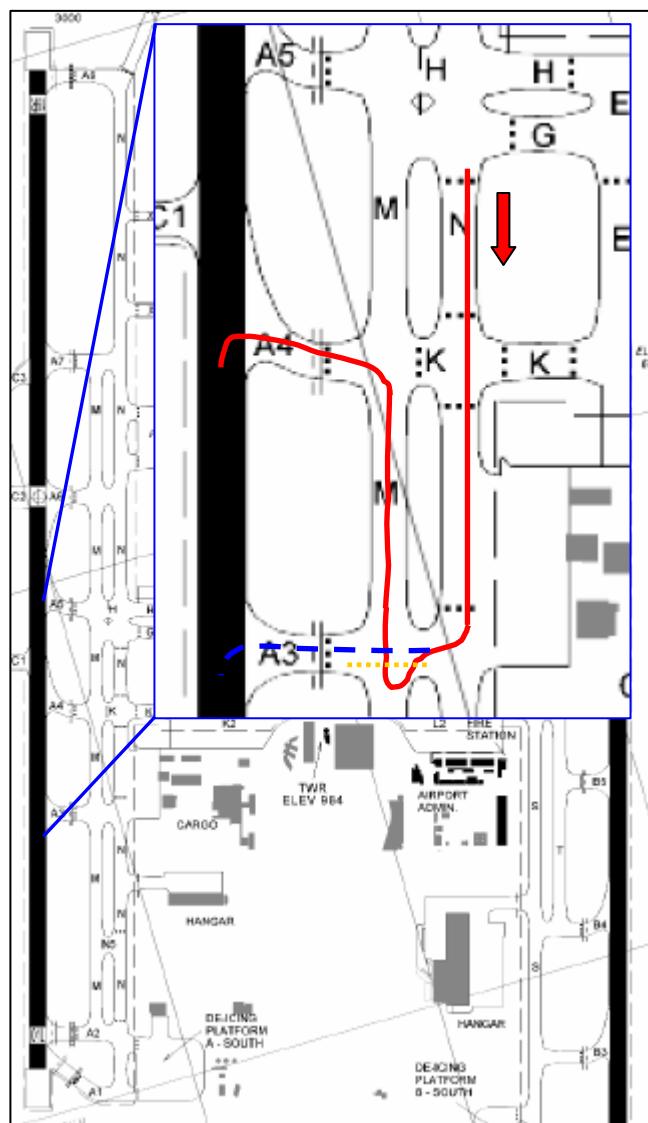
The crew taxied, in accordance with their clearance, in a southerly direction on taxiway (TWY) N (see map). The commander was pilot flying (PF) and the first officer was responsible for radio communication with Air Traffic Services. There was also a third pilot in the cockpit who had newly joined the airline and was being trained. He had no other tasks than to observe. While taxiing in a southerly direction on TWY N the crew was given clearance for take-off on RWY 01L via intersection A3. The first officer acknowledged this with the flight's radio call sign, and the air traffic controller followed up with clearance to taxi in a southerly direction on RWY 01L, if necessary. The crew had calculated that the runway available from A3 was sufficient for take-off. The stated TORA in AIP for RWY 01L from A3 is 2,696 metres. The red line on the map shows the aircraft's movement. The data source is the airport ground radar.

In her report, the commander says that when they were given clearance for take-off and turned to the right towards A3 she increased the engine rpm slightly and lit the landing lights. She then saw the yellow dashed line across TWY M, south of A3 which marks the intermediate holding point. The commander writes:

“When I saw the yellow dash lines on the left on taxiway, because of the notam, I misinterpreted the lines as if I am aligning on the runway centreline”.

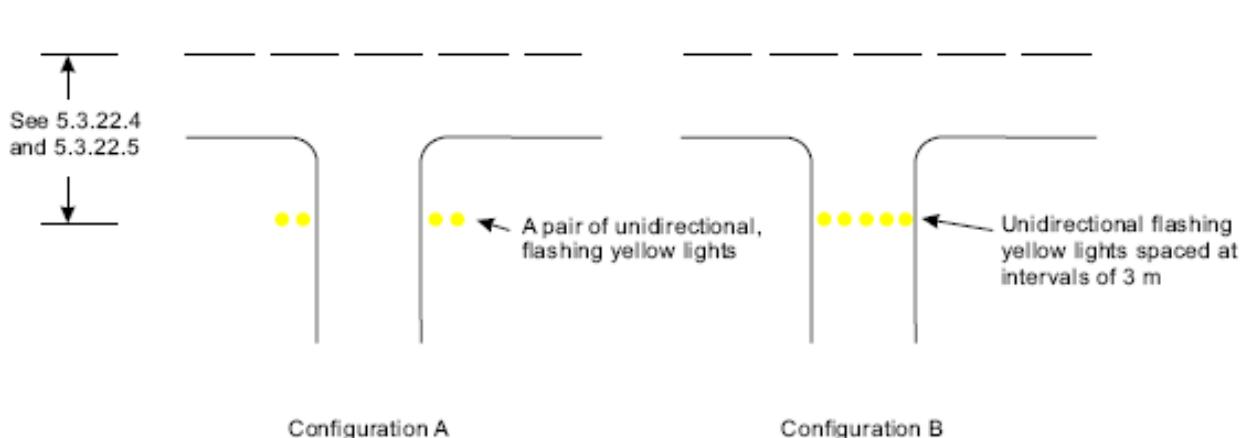
Figure 5-27. Runway guard lights

Note – The purpose of runway guard lights is to warn pilots, and drivers of vehicles when they are operating on taxiways, that they are about to enter an active runway. There are two standard configurations of runway guard lights as illustrated in Figure 5-27

At Oslo Airport Gardermoen, Norway, intensity of runway guard lights and taxiway centre line lights are adjusted simultaneously. This results in runway guard lights being subdued to low intensity during periods of good weather conditions during darkness, and their conspicuousness is partly lost. The AIBN recommends that the airport operator, OSL, installs a separate light intensity control for runway guard lights. (SL Recommendation 32/2006)

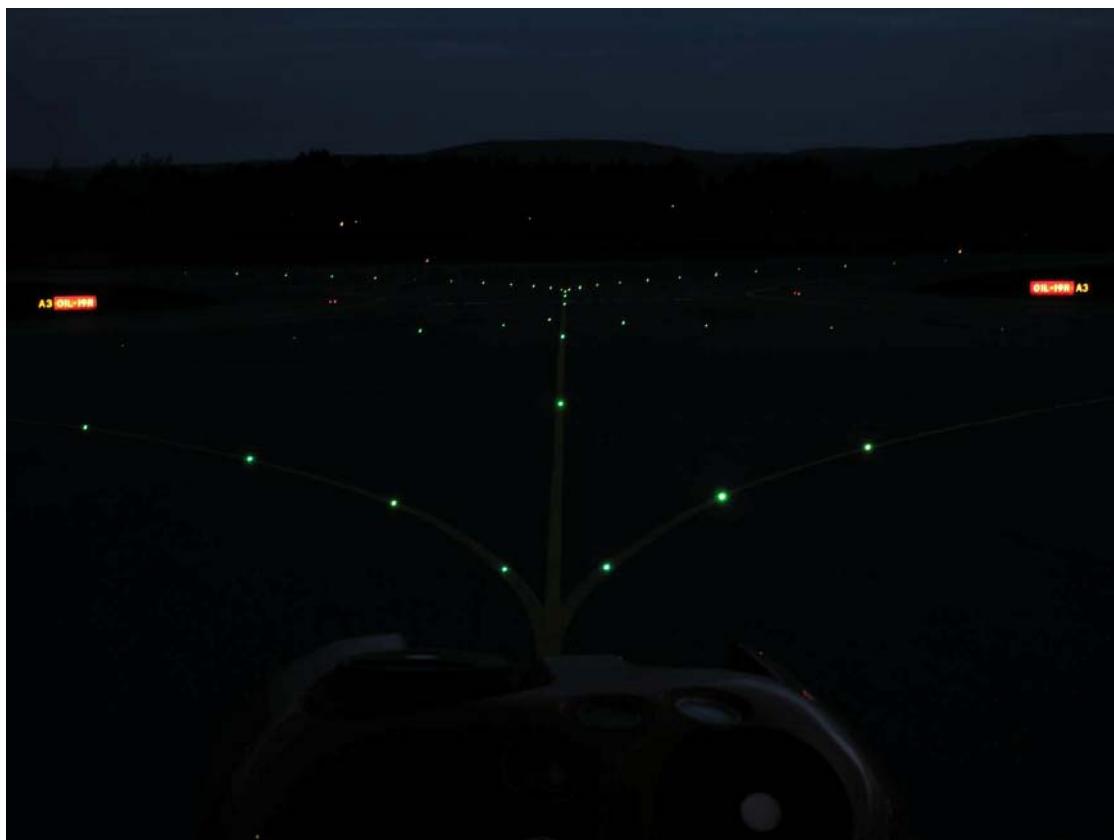
On TWY A3 at intersection TWY N.

To illustrate lighting of taxiways and the runway in use at the time of the incident, the AIBN has made photos and enclosed them with this report. The pictures are taken from 4 m above surface. They do not represent a reconstruction, as there is not enough information available from the incident. Further the pictures were taken during a Nordic summer night and ambient light is therefore artificially made darker using underexposure. Lights were set at 10%, as is common during darkness in good weather. On the picture taken from TWY A3, intersection TWY N, runway guard lights are barely visible, halfway between the instruction signs and taxiway centre lights.

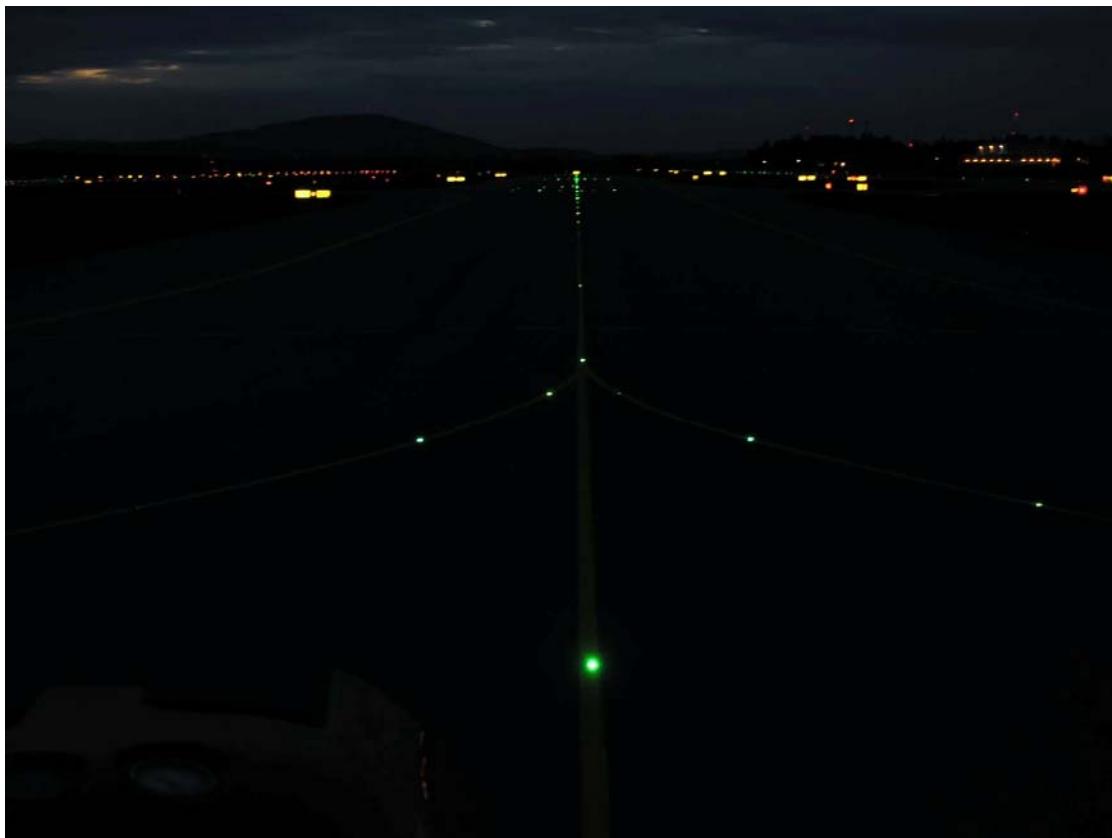
On TWY M at intersection TWY A3.

OSL has chosen to use the opportunity offered in ICAO Annex 14 not to mark taxiway edges with blue lights. It is possible that blue edge lights would have contributed to reducing the probability of misunderstanding, although this is not certain. The commander commenced take-off on a paved path having clear green centre line lights, which a runway never has. No runway lit in accordance

with Annex 14 exists without edge lights, but edges of the path on which the commander accelerated were unlit. The type of lighting and the colour of the lights were evidently not sufficient to make the commander doubt her own decision.
