SL Report 2007/25

**REPORT ON THE SERIOUS INCIDENT ON HARSTAD/NARVIK AIRPORT
EVENES ON 25 NOVEMBER 2004 INVOLVING FLIGHT MYT6286 AIRBUS
A320 REGISTERED G-CRPH OPERATED BY MYTRAVEL AIRWAYS UK**Submitted
August 2007

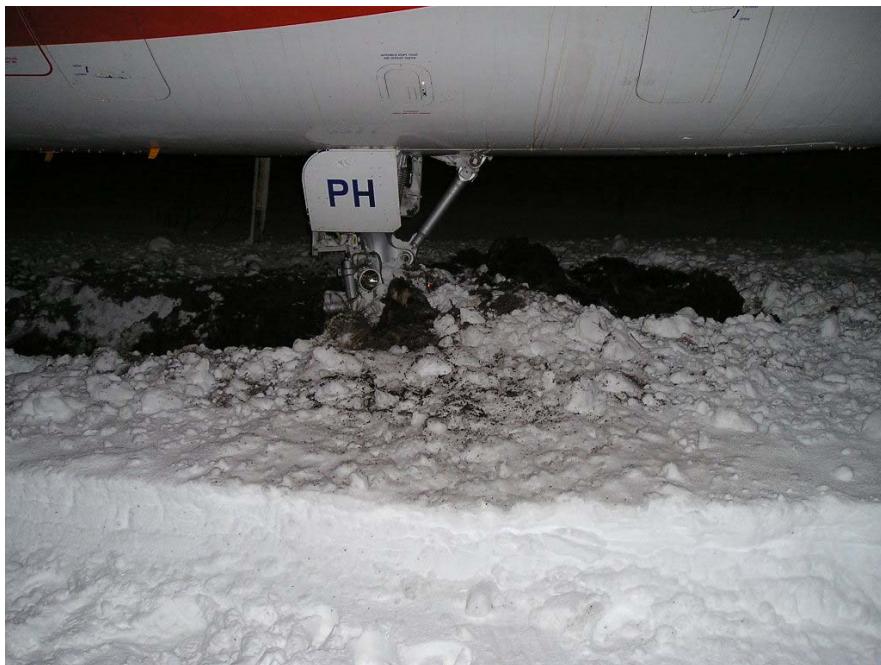
Figure 1. G-CRPH nose wheel sunk in the snow and soil.

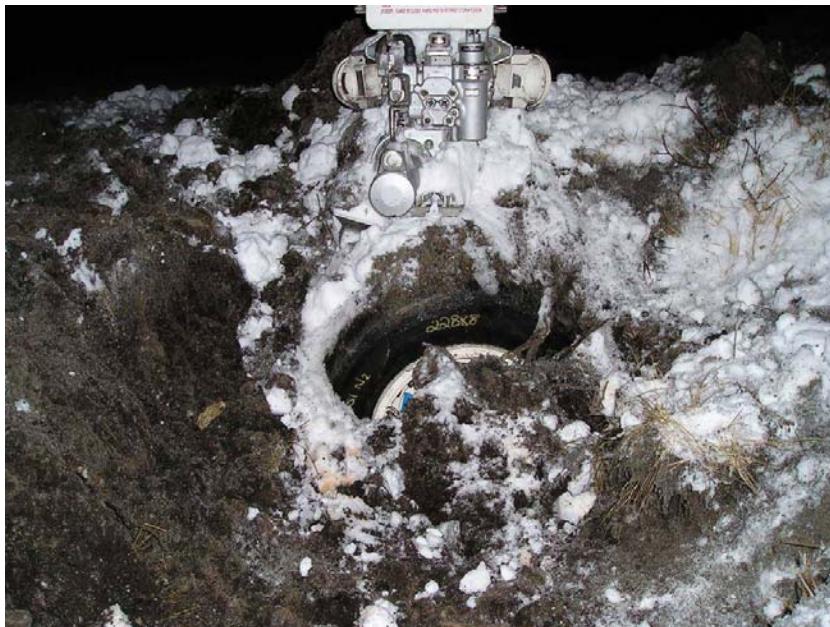
Figure 2. The nose wheel seen from rear.

The aircraft nose wheels ploughed an 8 m long, 1 m wide and 60 cm deep furrow in the soft soil adjacent to the runway. The furrow was caused by the nose wheel, which was twisted 90°, breaking through the frozen unpaved surface (Figures 2 and 5).

2.2.11 The maximum nose wheel steering angle on this type of aircraft is 6° by use of the rudder. According to ICAO Doc. 9137 a steering angle of 6° requires a typical side friction coefficient of 0.1. As the aircraft did not respond to rudder steering, AIBN considers the runway CF to be less than 0.1 at the runway 35 threshold. Hence, the crew's use of the hand tiller only contributed to deflecting the nose wheel to its full deflection causing the nose wheel to skid sideways in the direction of movement. However, the fully deflected nose wheel caused increased braking due to the ploughing effect through the snow and soil (see Figure 2 and item 1.12.2).

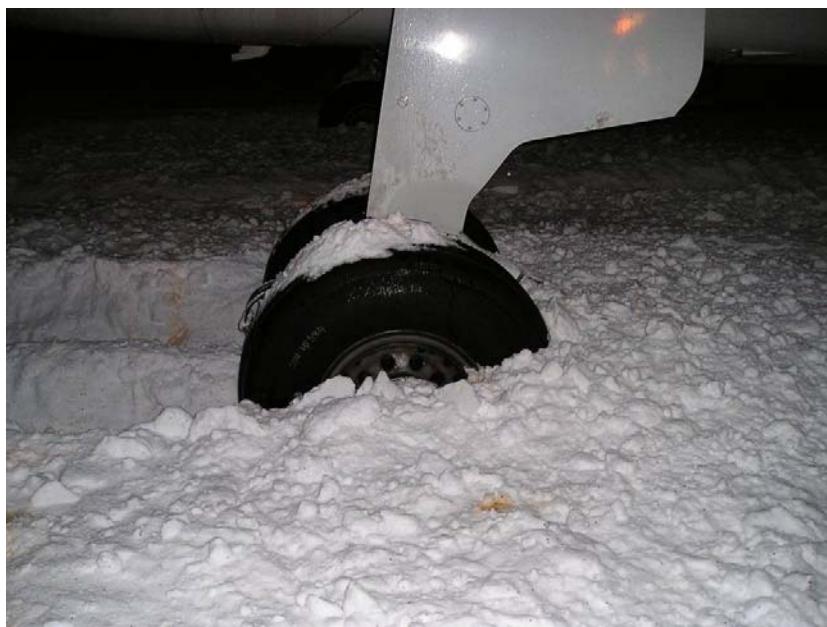
Figure 3. Right main wheels.

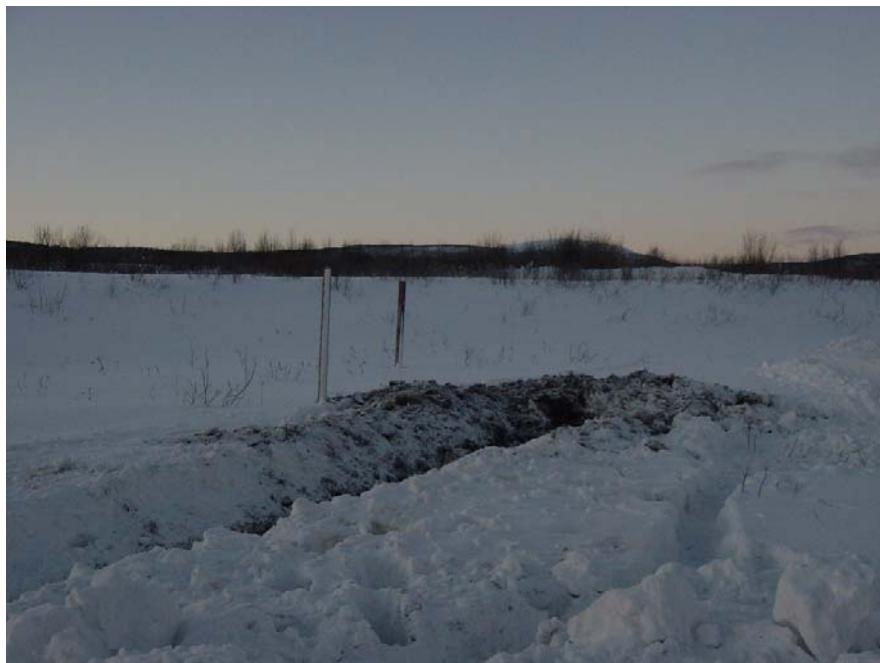
Figure 4. Furrow ploughed by the nose wheel.

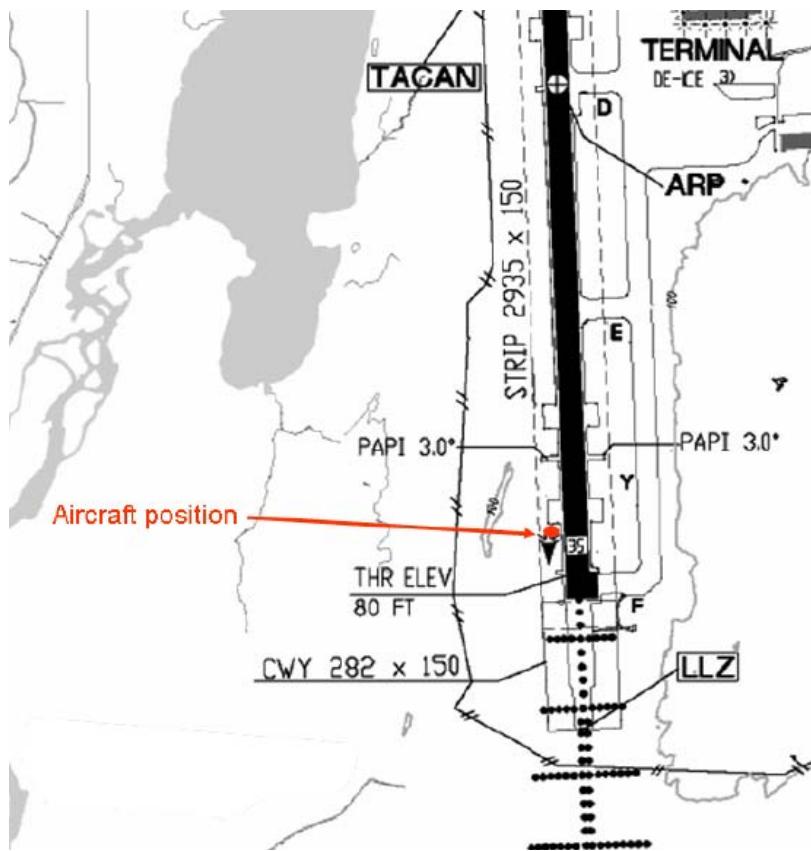
The take off threshold platform at the taxiway F intersection is made of concrete, while the runway and taxiways are made of asphalt. On the last 50 m of this platform Coefficient of Friction (CF) is not measured. This platform is usually more slippery close to the end due to less preparation because of turning restrictions of the sanding and measuring vehicles.

Figure 6. Runway 35 approach end.

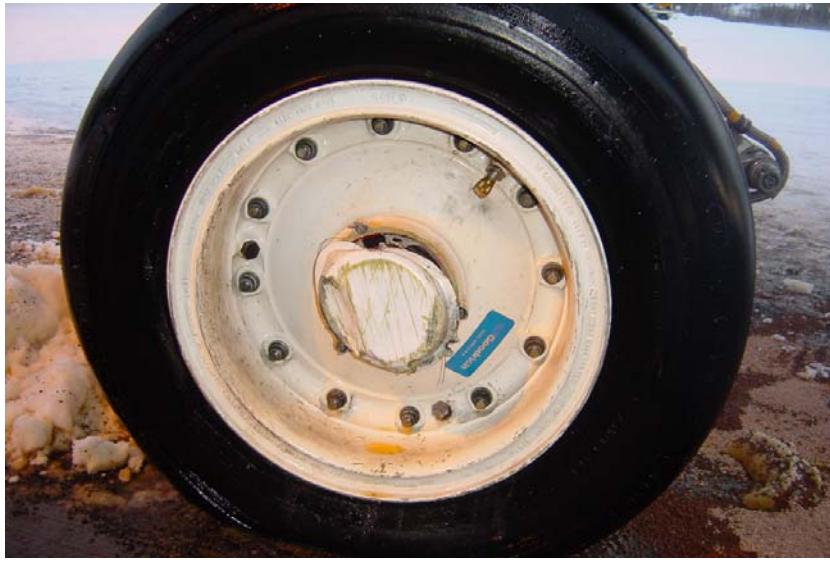
1.12.1 The damage to the aircraft was to non-structural items of the nose gear assembly. The left nose wheel tyre was punctured, the left nose wheel hubcap was deformed and one nose leg taxi light was broken.

Figure 7. Left punctured nose wheel with damaged hubcap.
