FINAL REPORT

ON THE ACCIDENT OF 6 NOVEMBRE 2002
AT LUXEMBOURG
TO THE LUXAIR FOKKER 27 MK050
REGISTERED LX – LGB

December 2003

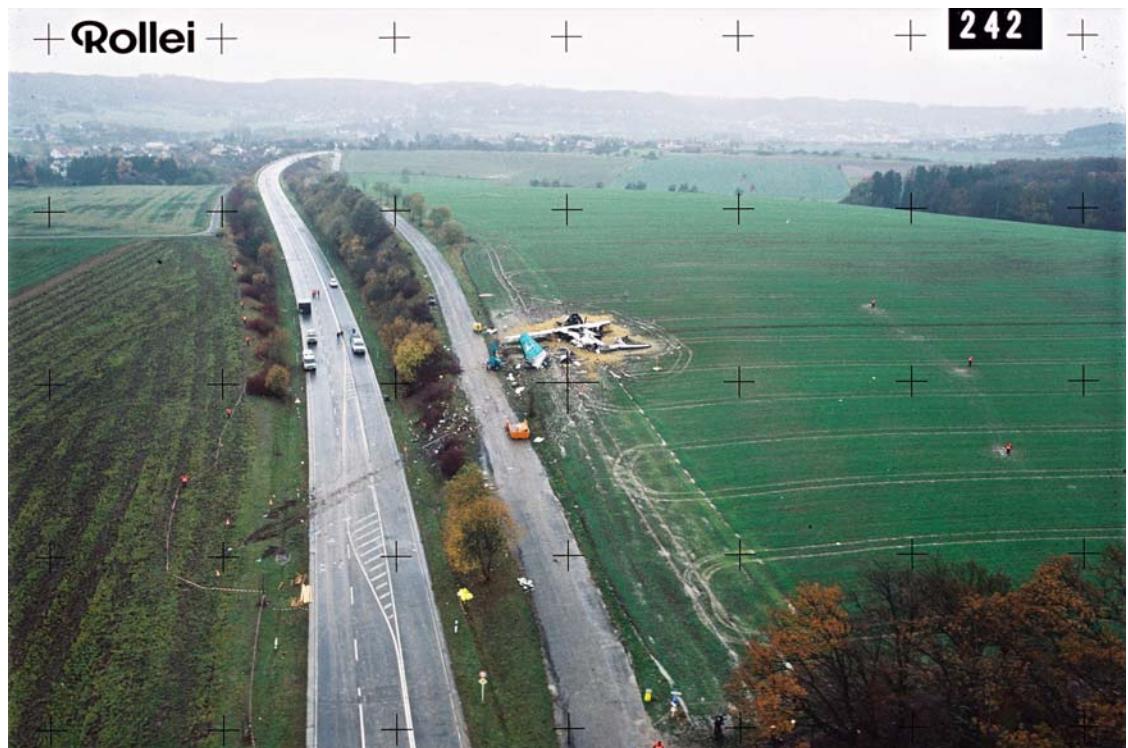
Aerial view of RN1 and the site

Scraping marks on the road, notably from the left wing tip show that the aircraft scratched across the road before hitting an embankment at the north side of the road RN1.

The major part of the damage results from this blow during which the aircraft lost three blades from the right propeller and two from the left propeller, wheels from the left and right landing gear.

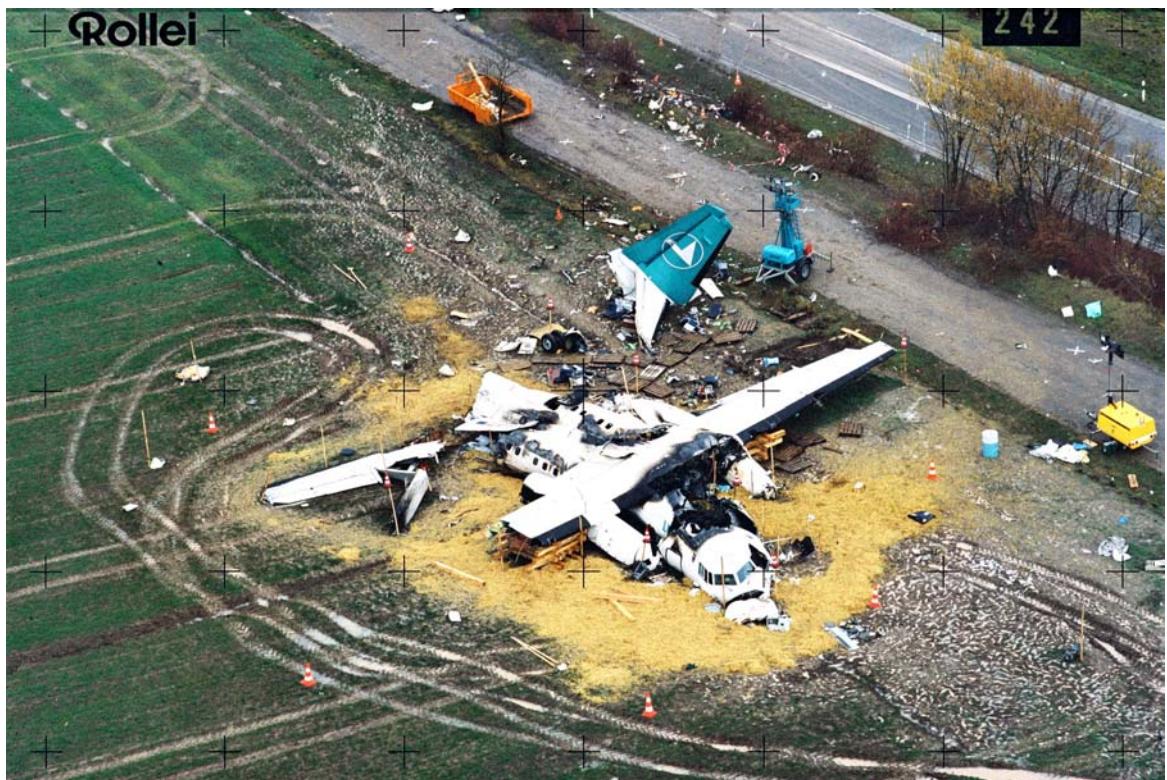
Aerial view of the right hand side of the aircraft

Furthermore, the aft portion of the fuselage was disrupted at the trailing edge of the wings by this shock.

After this bounce, the empennage and part of the right outboard wing broke away, the aft portion of the fuselage turned around and the aircraft came to rest 25 meters further away in a field.

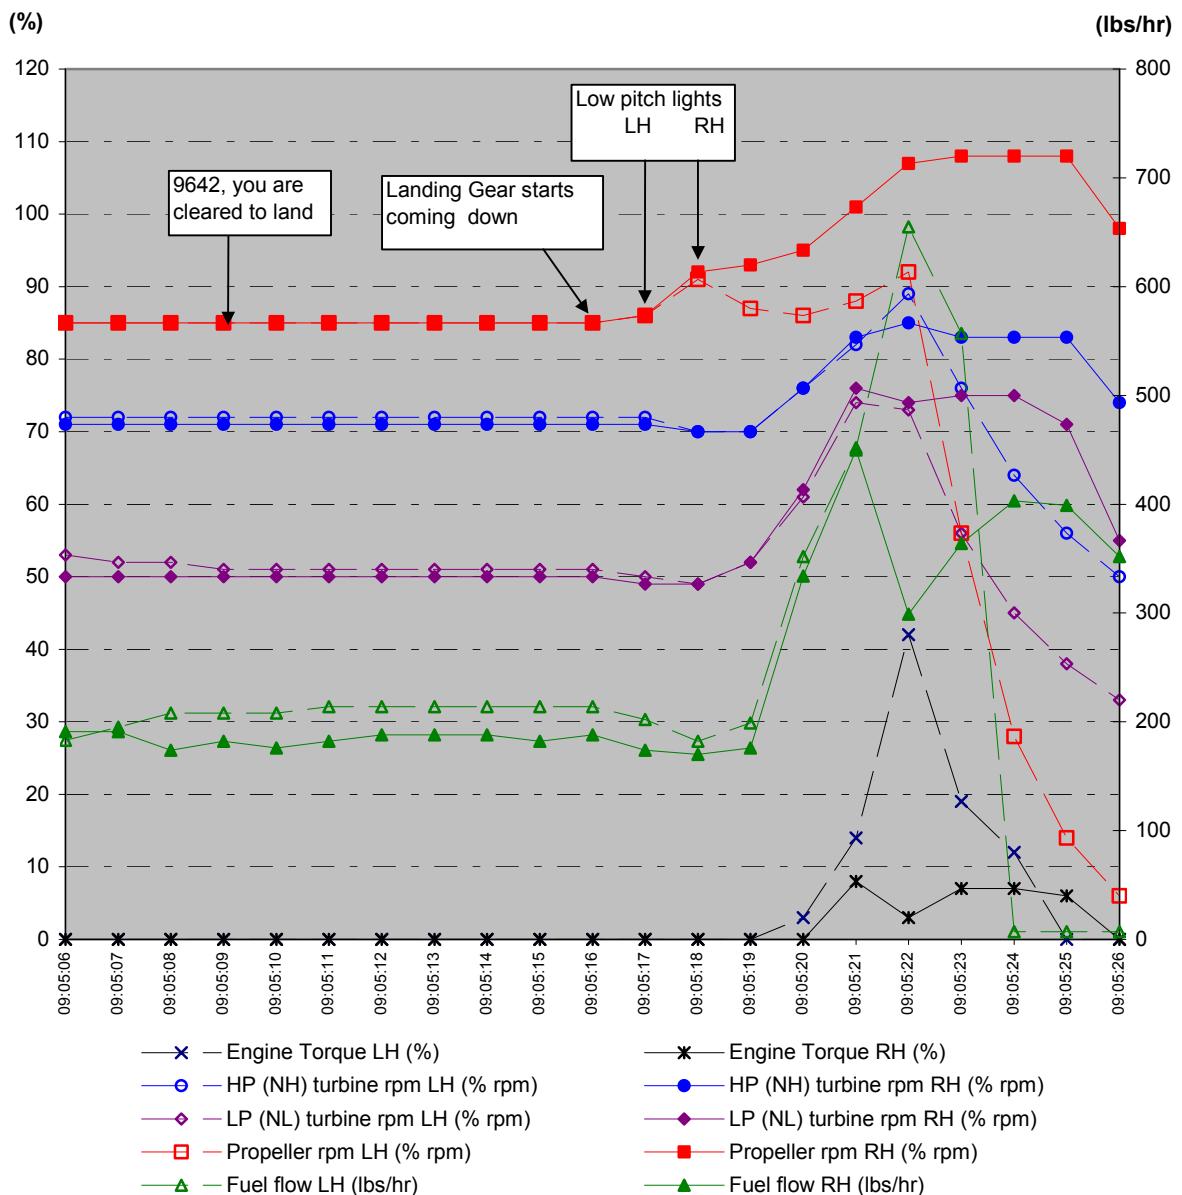
At 09:05:17, the low pitch parameter of the LH propeller switched to low pitch.

A second later, at 09:05:18, the low pitch parameter of the RH propeller switches to low pitch.

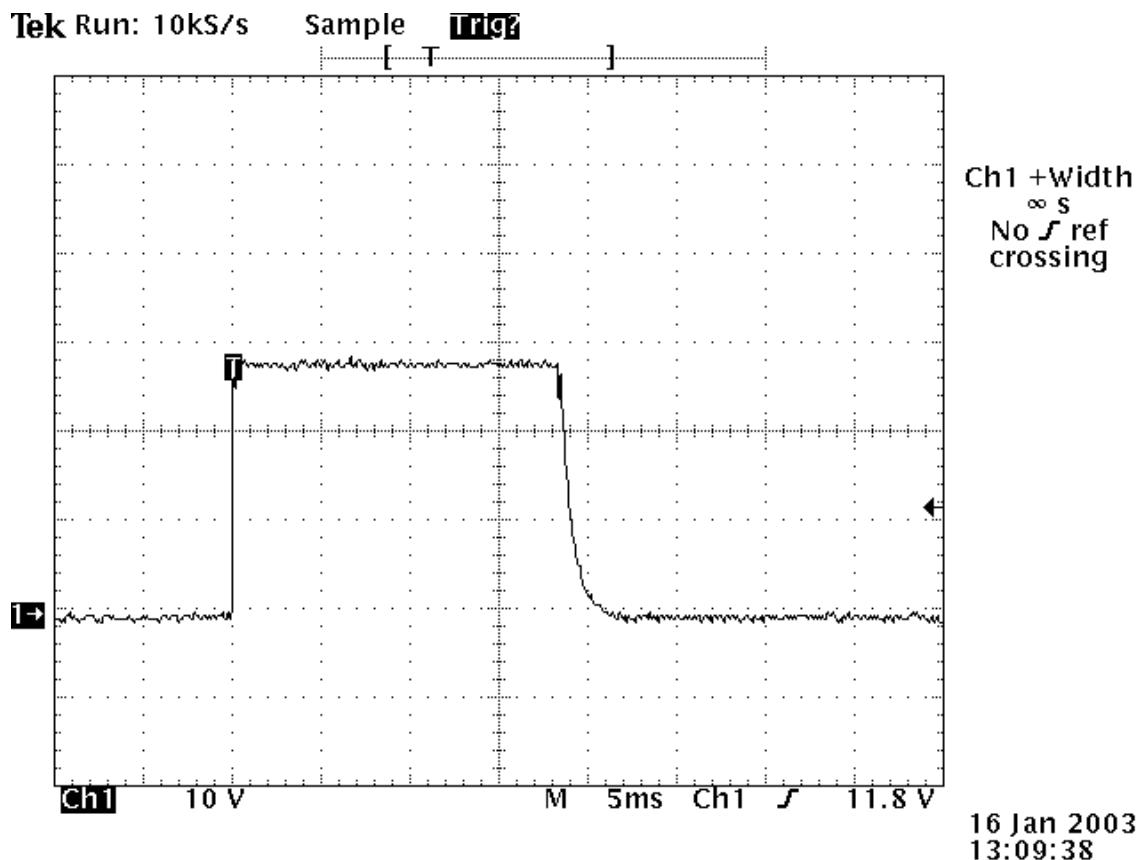
The four wheel speed discrete relays were tested separately in the modes FLT and GND in order to verify their power up behaviour. In mode FLT, the duration of the power up signal was found to be in the range from 13 ms to 20 ms for the four relays. In mode GND, the signal duration was slightly less in the range from 11 ms to 19ms. All signals looked identical, only the duration varied and repeated tests produced always the same results. The following illustration shows the signal from the right hand outboard relay.

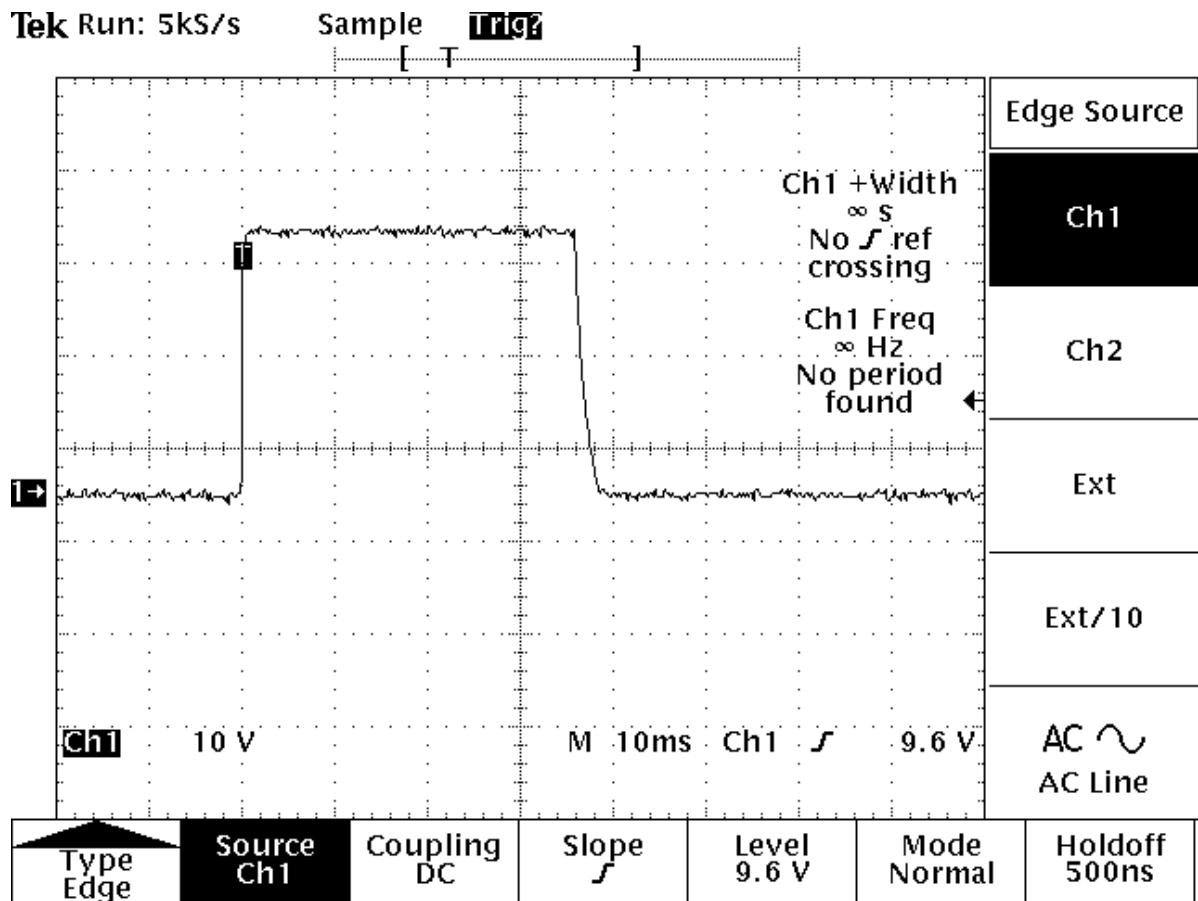
the power up signal was found to be 36 ms for both the right and the left hand side. The signal from the RH side being illustrated below. All signals looked identical and repeated tests produced always the same results.

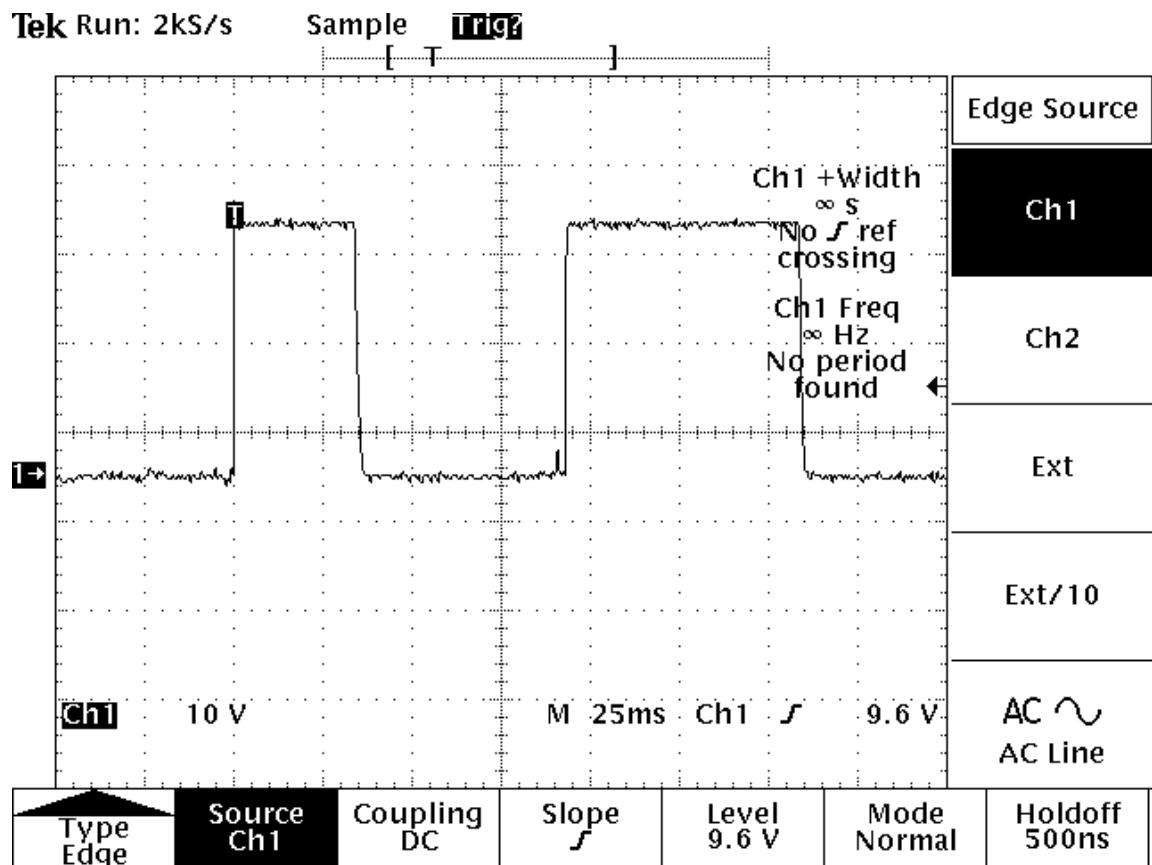
An electrical signal was introduced on the TEST button of the antiskid control unit, thereby inducing an EMI signal on power up. These tests were executed in mode FLT. It became apparent that a new signal was produced repeatedly on power up, showing a duration of around 65 ms. The tests were performed on the unmodified and the modified control unit. The following picture illustrates the signal output of the left hand wheels for the unmodified control unit.

The result was that the first impulse (~35 ms) was due to the power up of the unit through the release of the main gear up-locks and the second impulse (~65 ms) was triggered by the EMI signal.

The same tests were carried out on the modified unit (modified by ABSC SB F50-32-4) and it became apparent that the first impulse due to the power up of the system was suppressed, leaving only the EMI induced impulse.

The duration of the second pulse (EMI) was long enough to energize the flight idle solenoid under all circumstances, thus removing the secondary stop. There was however no reason to suspect that this was a condition of the accident.

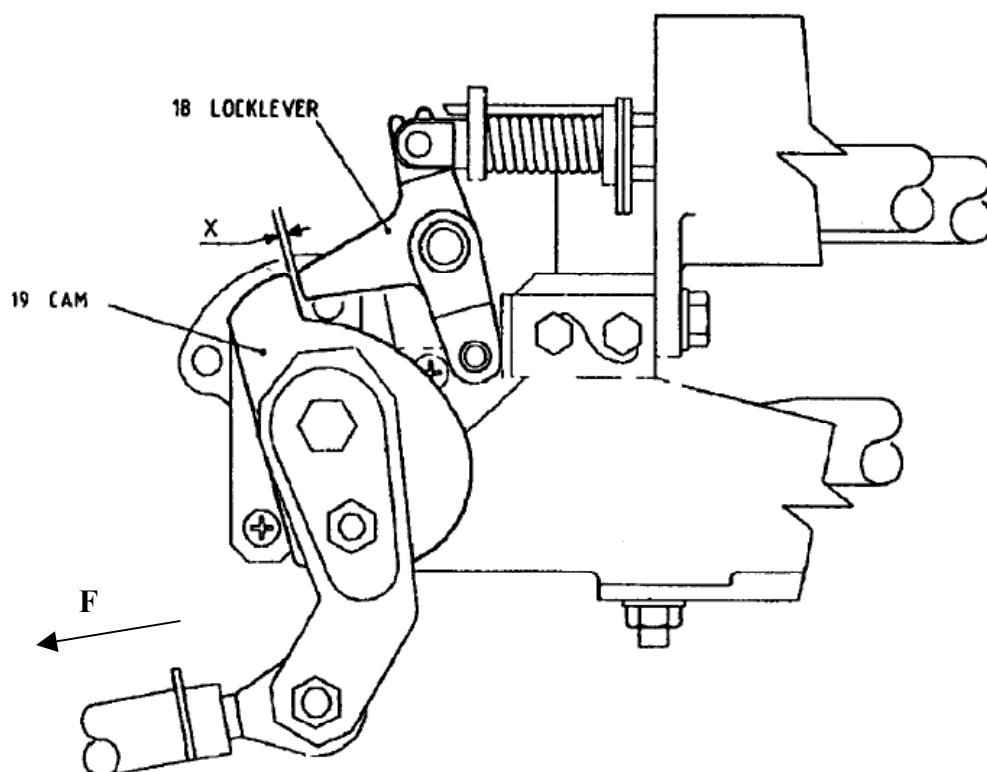
When the flight idle cam is pulled against the flight idle lock lever and the flight idle solenoid is energised, than the amount of force applied, determines whether the flight idle lock can disengage.

With a force (F) applied to the push-pull rod was lower than 44.5 N, the flight idle stop disengaged when the flight idle solenoid was energised. When higher forces were applied the flight idle stop remained engaged. The same value was found on both flight idle solenoid assemblies. It was thus demonstrated, that by pulling hard enough back on the power levers against the secondary stop and with the solenoids energised, the flight idle lock lever was prevented from disengaging.
