Investigation Report

AX001-0/04
November 2005

Kind of occurrence: Accident
Date: 5 January 2004
Location: near Munich Airport
Type of aircraft: Transport Category Airplane
Manufacturer / Model: Fokker Aircraft B.V. / F28 MK0070
(Fokker 70)
Injuries to persons: Three minor injuries
Damage to aircraft: Aircraft severely damaged
Other damage: Field damage
Source of Information: BFU Investigation

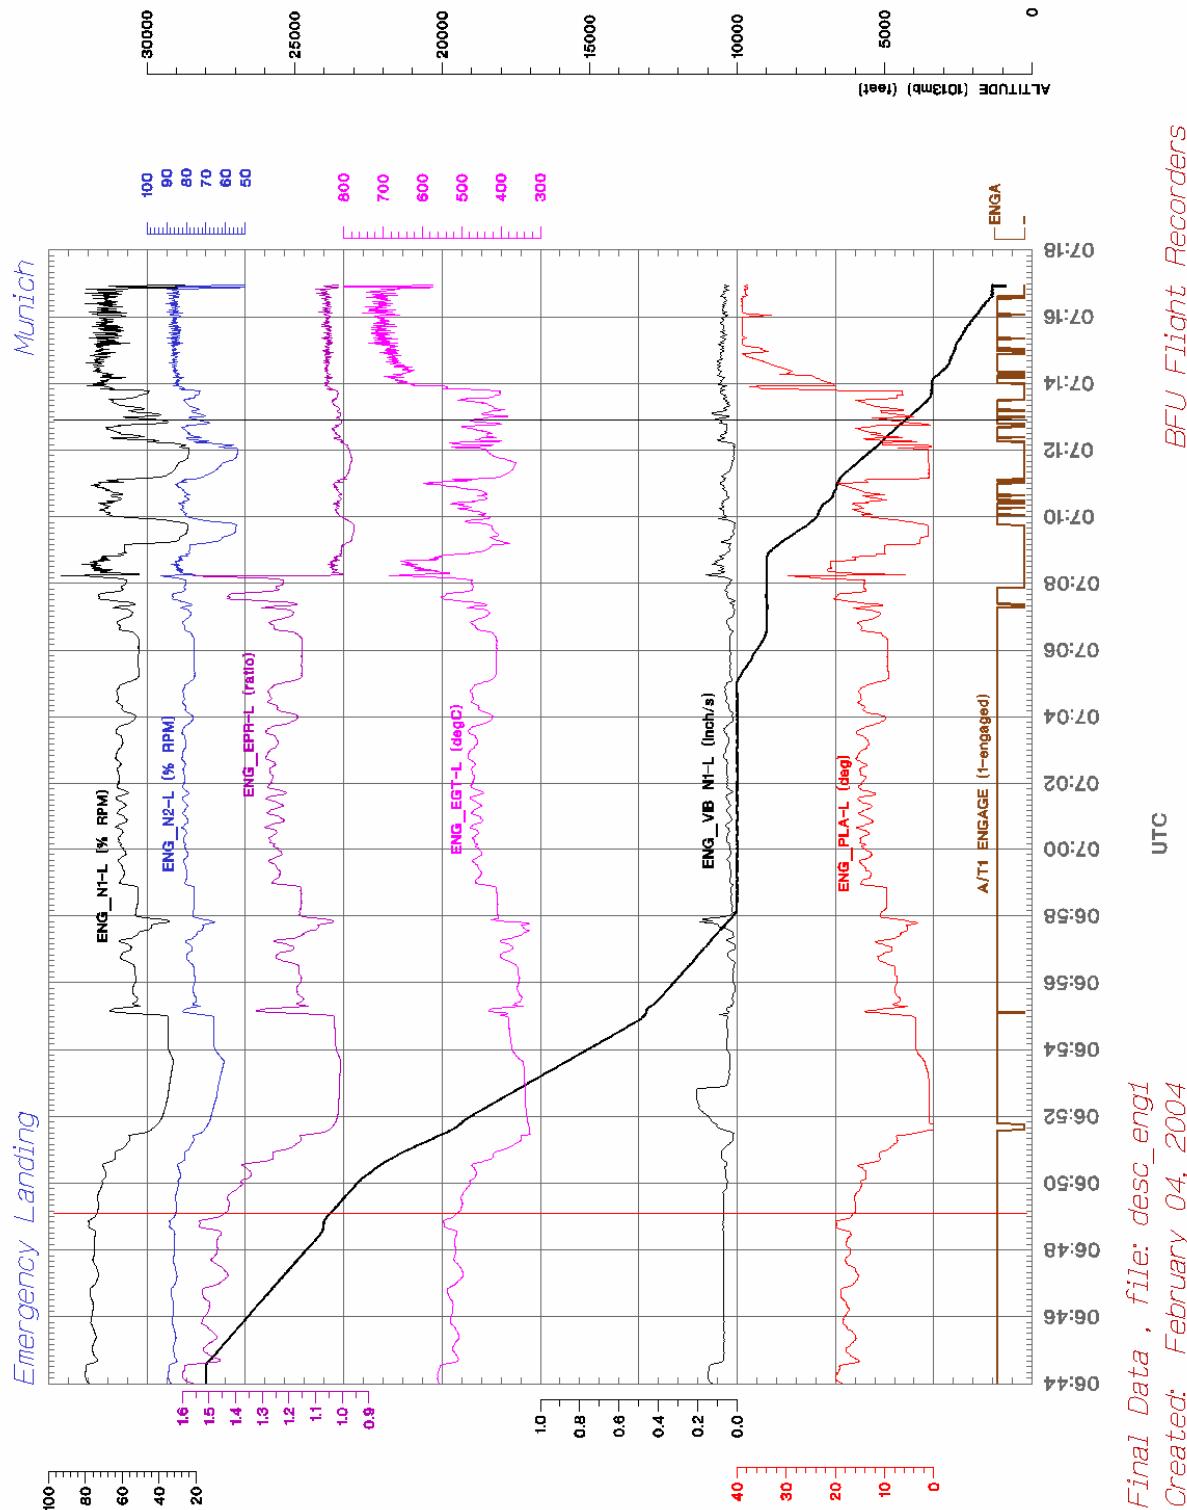
Attachment 3: Changes on the LH engine at 08:08:14 hrs (07:08:14 UTC)

In addition to the conversations between the pilots, the CVR also recorded radio communications and cockpit ambient noises. At 08:07:14 hrs, a short humming noise, which reoccurred at 08:07:31 hrs, was recorded. At 08:08:10 hrs, the CVR recorded a clattering noise and the co-pilot asked for the causes of this noise. After the declaration of an emergency at 08:08:22 hrs the flight attendant notified the flight crew at 08:08:48 hrs of a clattering noise in the cabin ("... there is a super rumble on the left ...").

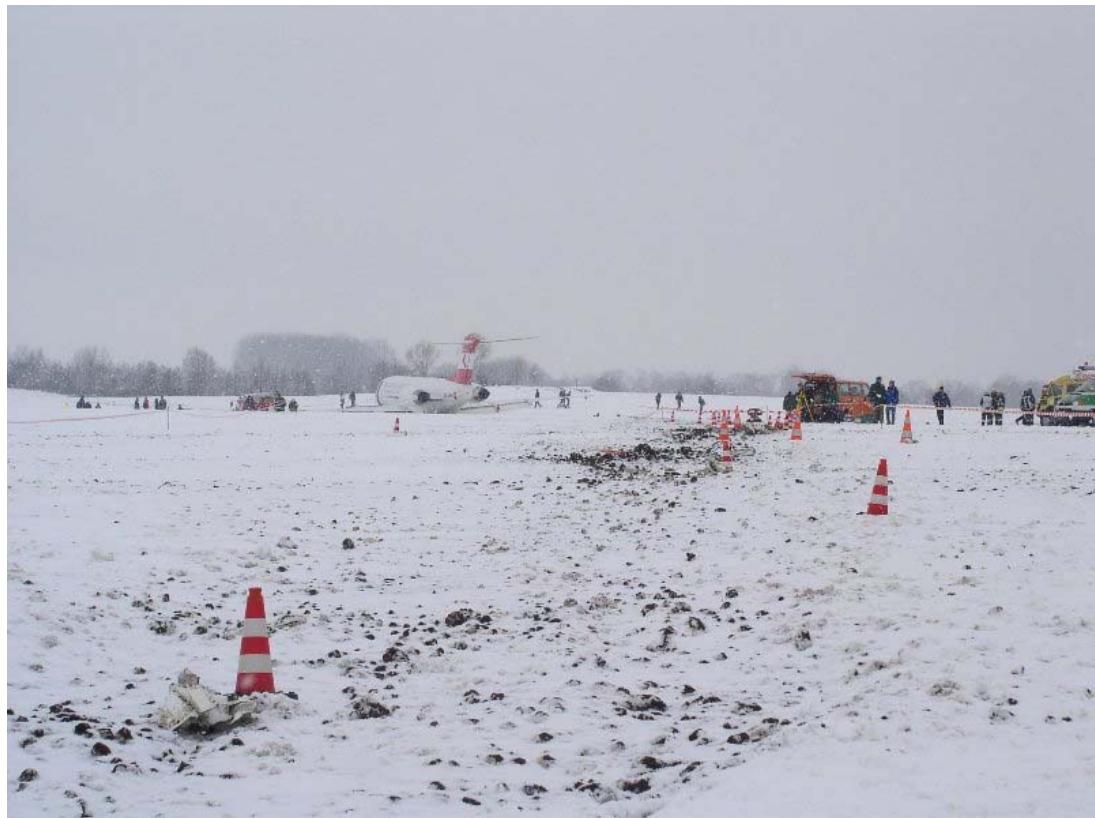
Attachment 7: Accident site

The airplane lay on its fuselage. The nose landing gear which had been torn off lay at a distance of approximately 120 m from the airplane in the skid mark described above. The nose landing gear doors were damaged. The main landing gear was retracted but not locked. The main landing gear doors had been torn off. The flaps were extended in a position between 25° and 40°. The flaps on the left-hand side were damaged. The inner flap on the right-hand side was slightly bent and the outer flap was undamaged. The wing fuselage transition fairing was severely damaged on both sides. The ailerons were in neutral position, the rudder was slightly deflected to the right and the elevator was deflected downward. The horizontal stabilizer trim was set to -4.5° (ANU).

Except for the severe damage to the wing fuselage transition fairing on both sides, the airplane fuselage did not show any further deformed areas. This shows that the damage to the airplane was not due to the impact load but to the characteristics of the ground. The switch settings found in the cockpit basically corresponded to the condition one would find after completion of the Ground Emergency Checklist.

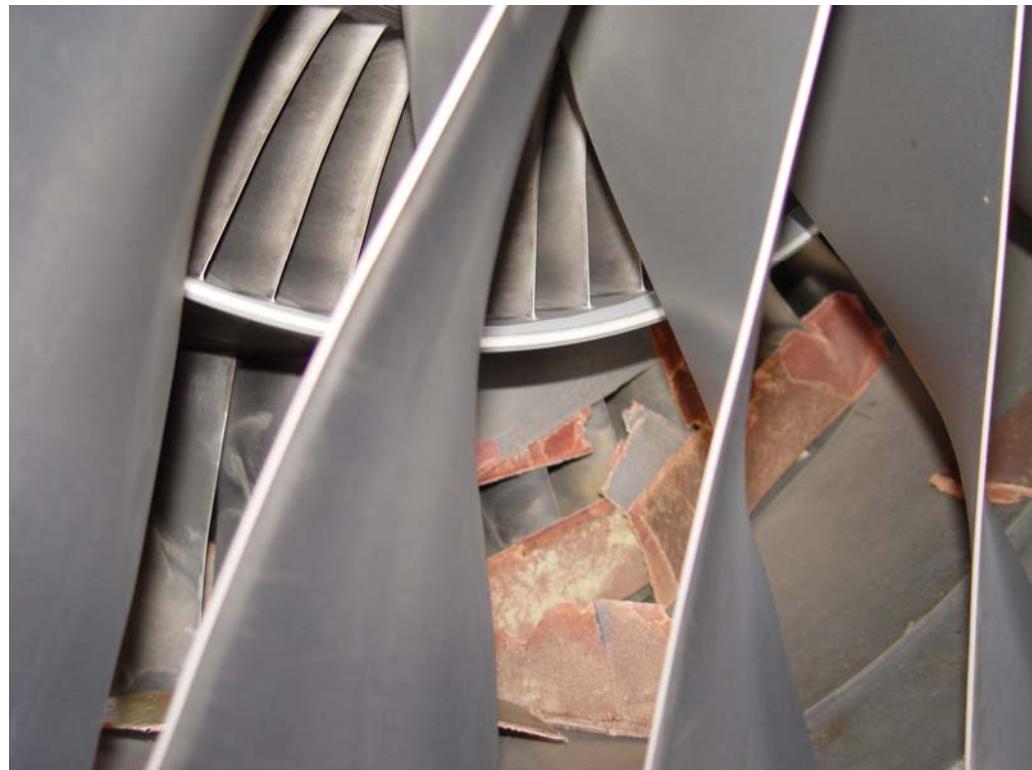
Attachment 9: Loose ice impact panels in the LH engine intake

On both engine fan casings all six ice impact panels had detached. Almost all of the loose panels were lying crossways in front of the outlet guide vanes of the low pressure compressor (see attachments 9-12). They matched the version described in the SB 72-1326 of January 1998 consisting of six segments made of glass-fibre reinforced foam. Further mechanical damage on the engines was not found.

The fan case of the LH engine (S/N 17116) had been modified in July 2001 pursuant to SB 72-1326 in one of the organisations of the engine manufacturer in Great Britain. Since this modification the engine had been in service for 5,823 hours and 4,221 cycles. According to the technical report of the manufacturer ice impact damage in the area of the acoustic liner had not been found. The bonding surfaces of the ice impact panels in the fan case did not show any residual adhesives. The surface was very smooth. A few brown patches on the steel surface of the fan case were found. At the lowest point there was a semicircular dark patch. The metal surface of the case behind the ice impact panels showed some smear markings. The bonding surface of the ice impact panels was almost completely covered with adhesive. The surface of the adhesive was very smooth. On three panels, clearly defined areas with brown discoloured adhesive were found.

The investigation of the ice impact panels and the associated bonding surfaces on the engines clearly showed an adhesion failure. This means that neither the adhesive nor the materials to be bonded failed but that the bonding between the adhesive and the materials was insufficient. In this case the reason for it could only be an insufficient preparation of the bonding surfaces.

The smooth surfaces on the fractured surface of the LH engine's fan case and of the adhesive on the panels prove that the fan case was not prepared correctly prior to the application of the adhesive. The brown discolorations on the bonding surfaces of the fan case and on the surface of the adhesive indicate that the bonded joint had separated some time ago and that ingress of moisture had taken place.

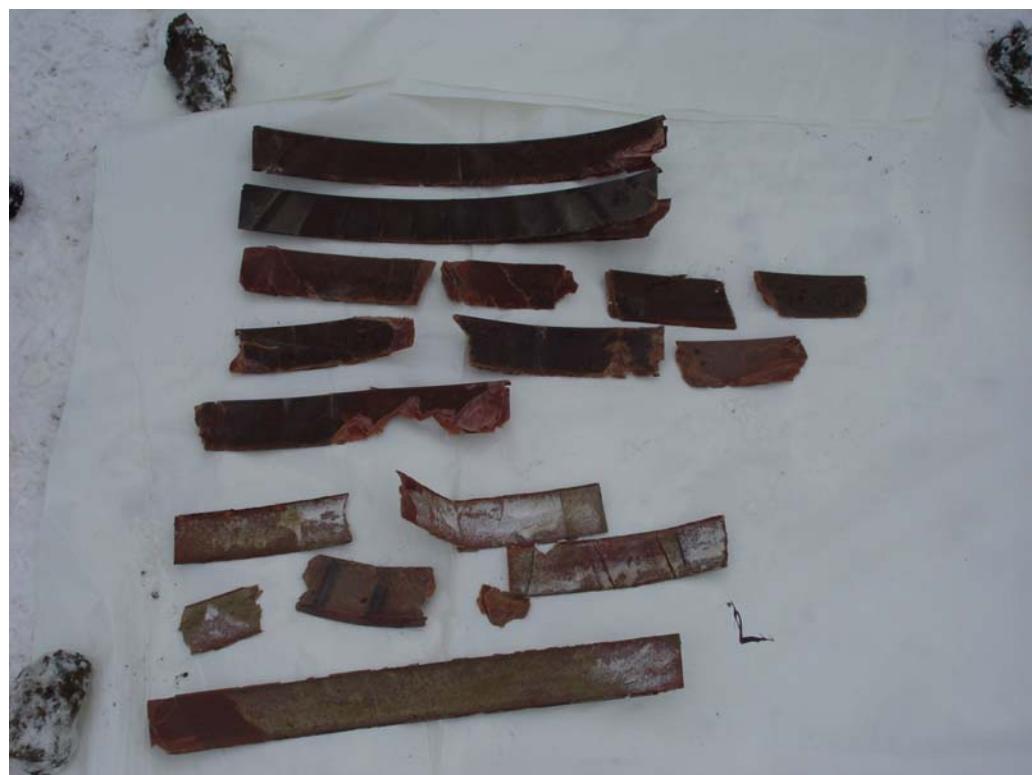
Attachment 10: All loose ice impact panels of the LH engine

The panels of the LH engine were generally more heavily fragmented than those from the RH engine. Most of the fragments were still present and could be assigned to their original positions. The panels did not show any damage caused by foreign objects.

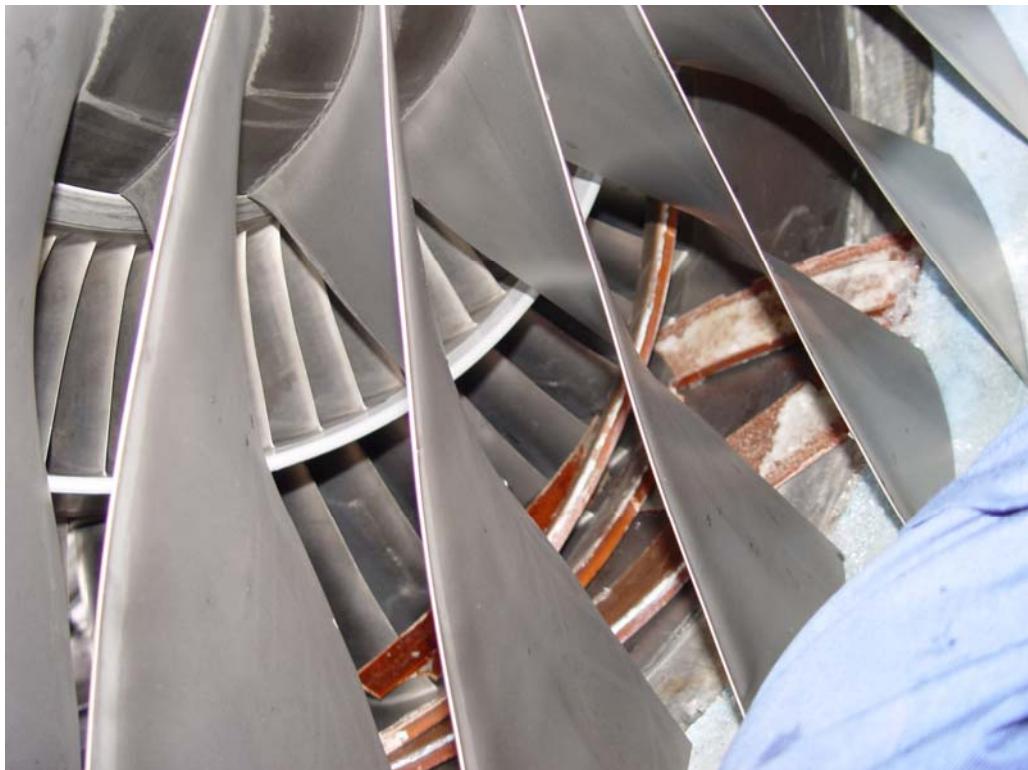
Attachment 11: Loose ice impact panels in the RH engine intake

The fan case of the RH engine (S/N 17103) had been modified in August 1999 pursuant to SB 72-1326 by an organisation in the USA. Since this modification the engine had been in service for 9,224 hours and 7,825 cycles. According to the technical report of the manufacturer ice impact damage in the area of the acoustic liners were not found. The bonding surfaces of the ice impact panels in the fan case showed adhesive residues in a few locations. The steel surface was very smooth and showed marks produced by a rotating abrasive wheel in some places. Some isolated brown patches were found on the steel surface of the fan case. The bonding surfaces of the panels were very smooth without any residual adhesives.

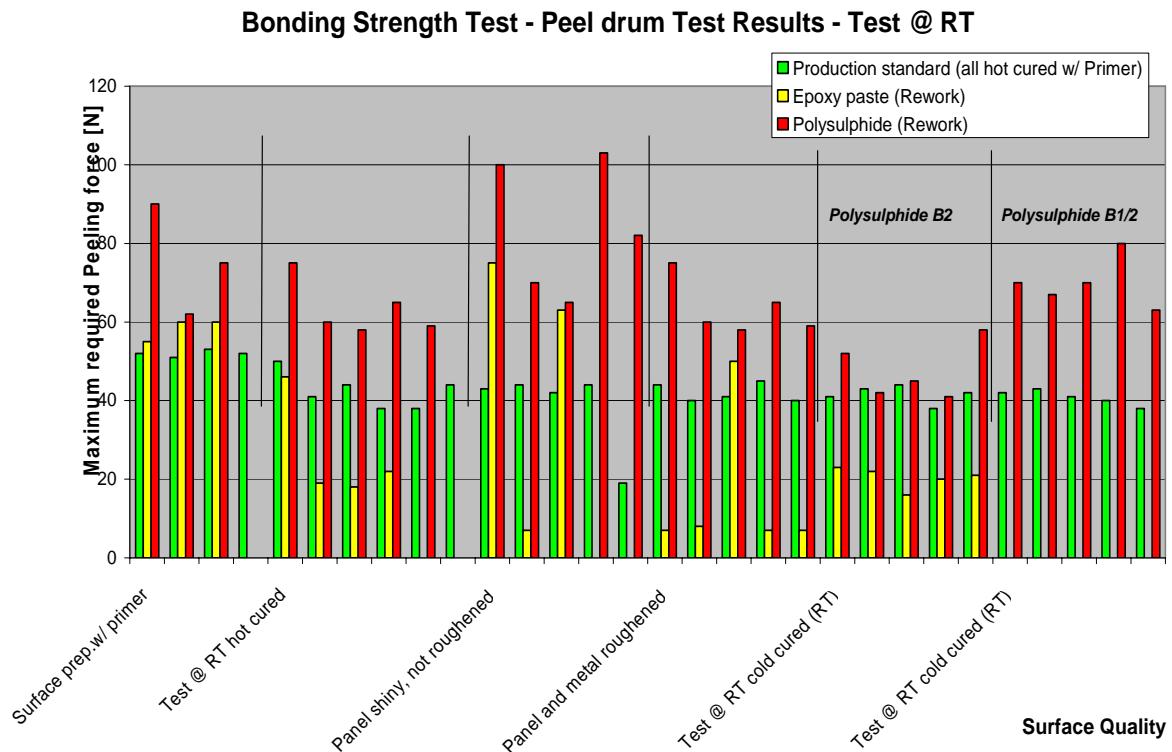
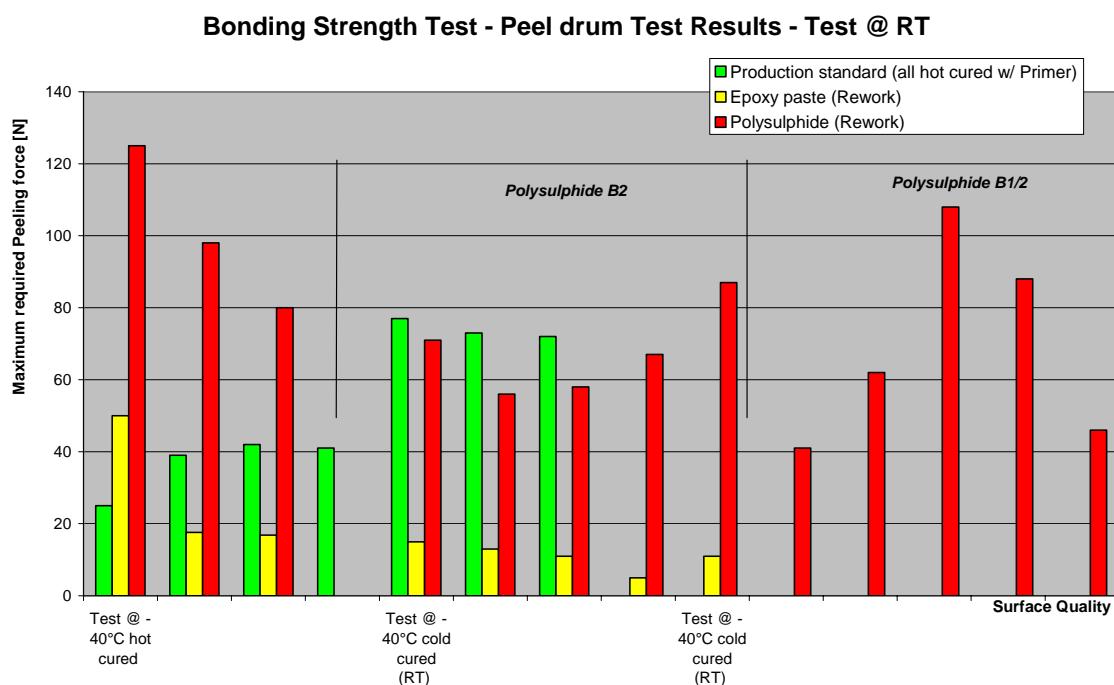
Attachment 13: Peel drum test results

Based on the residual adhesive found on the bonding surfaces of the ice impact panels of both engines it could be determined that the cured epoxy adhesive was very inelastic. Deformation of the separated ice impact panels led to further flaking of the residual adhesive and to cracking of the adhesive film. This explains why in the RH engine no residual adhesive was found. The determined brown discolorations on the fan case can be attributed to water embedding. Freezing water pushes the ice impact panels away from the bonding surfaces and generates a peeling load of the bonded joints. Such a peeling load is also to be expected with a deformation of the fan case.

Mechanical load tests have shown that for the strain on bonded joints caused by peeling loads a polysulfide adhesive is better suited than an epoxy adhesive. Additionally, there were considerable differences in strength between the "film" and the "paste". Since epoxy paste adhesive has shown unacceptable strength with low temperatures it follows that this adhesive is not suited for this application.
