دُولَةِ الْإِمَارَاتِ الْمُهَرَّبِيَّةِ الْمُتَّدَّلَةِ
الْهَيْئَةُ الْعُلَامَىُّ لِلطَّيْرَانِ الْمُهَرَّبِيِّ
UAE General Civil Aviation Authority

AIRCRAFT ACCIDENT 01/04

***FINAL REPORT
ON THE ACCIDENT INVOLVING
KISH AIRLINES FOKKER F27 MK.050,
IRANIAN REGISTERED AS EP-LCA ON
APPROACH TO
SHARJAH INTERNATIONAL AIRPORT,
UNITED ARAB EMIRATES
ON 10 FEBRUARY, 2004***

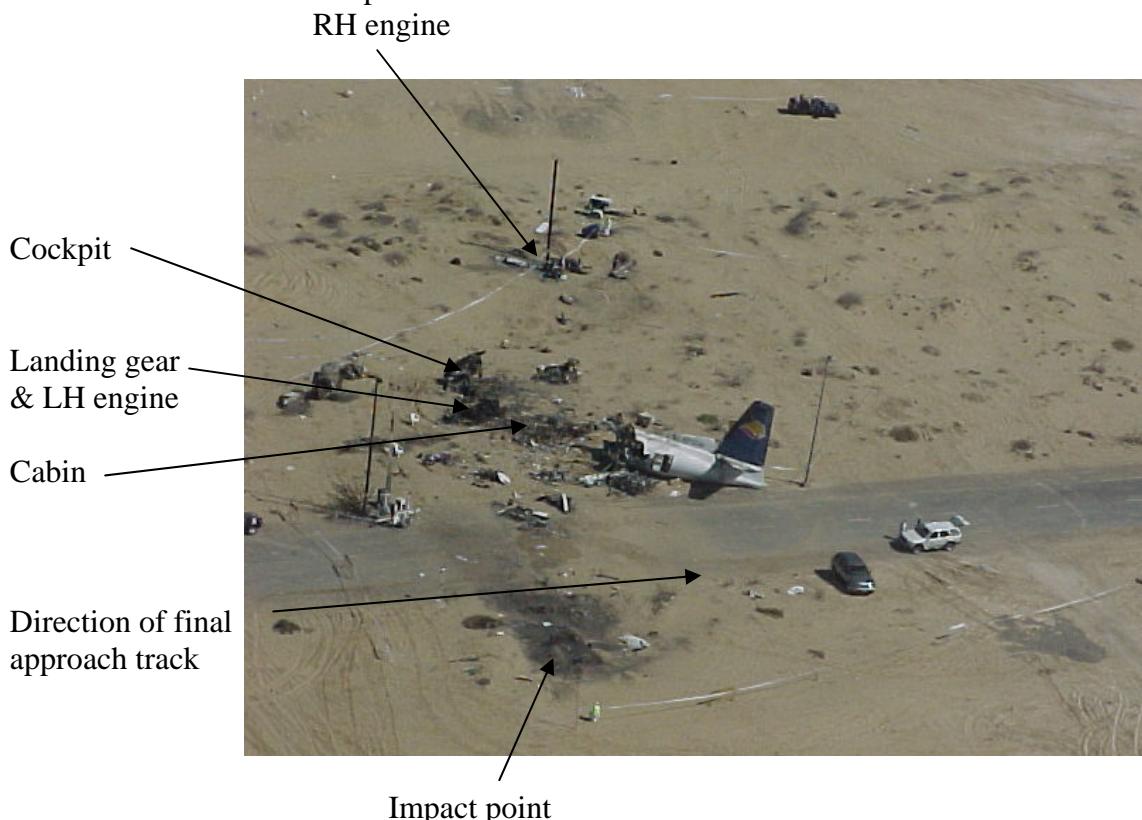
1.12.1 There was a single crater found in a flat sandy area on the opposite side of the road to where the majority of the wreckage was found. The scorched sand crater indicated an impact explosion but no impact information such as aircraft attitude or heading could be determined. As the wreckage of the cockpit, fuselage and tail section was located within 30m of the initial impact crater, it could be determined that the aircraft had a low horizontal velocity at the time of impact. There was evidence of scraping across the road in the direction of where the burnt out cabin was located indicating that the momentum of the aircraft on impact was towards 050° M. The severed tail section was aligned 330° M. whilst the burnt out fuselage wreckage indicated that the aircraft came to rest on a heading of 340° M. No aircraft components were found outside this small debris field.
