## ***Report RL 2007:12e***

### **Aircraft accident to LN-RDA at Kalmar airport, H county, Sweden, on 6 April 2006**

Case L-08/06

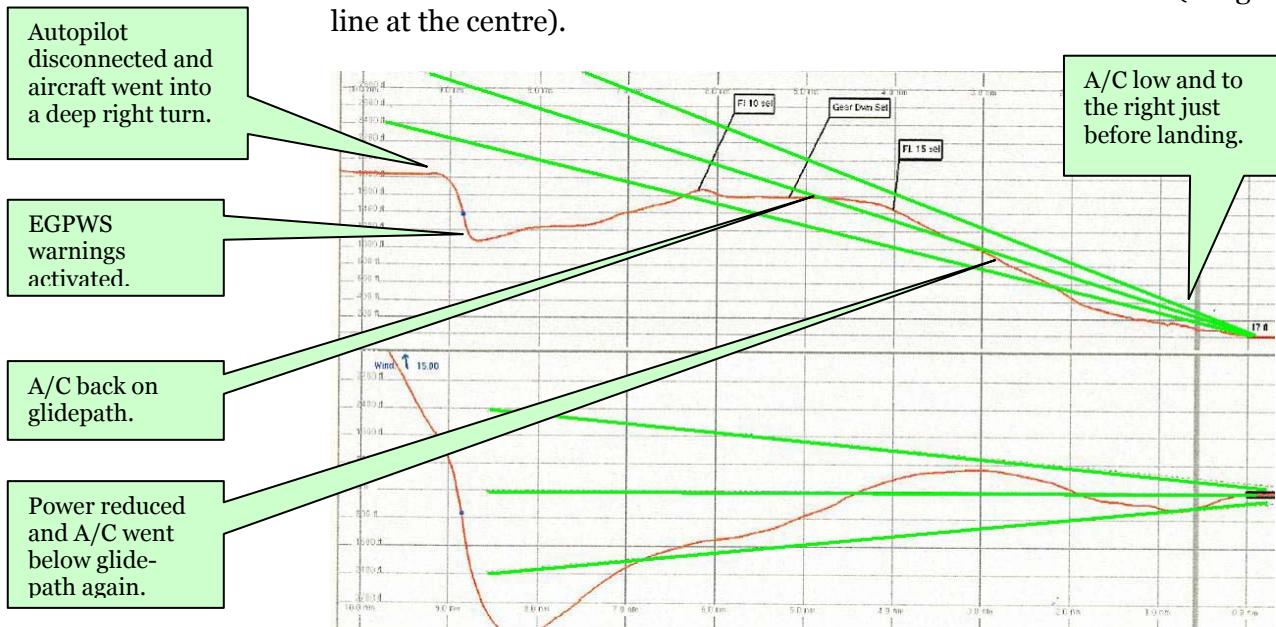
Fig. 1. The approach

The illustration shows that there were major deviations in both height and direction during different phases of the approach. When the aircraft

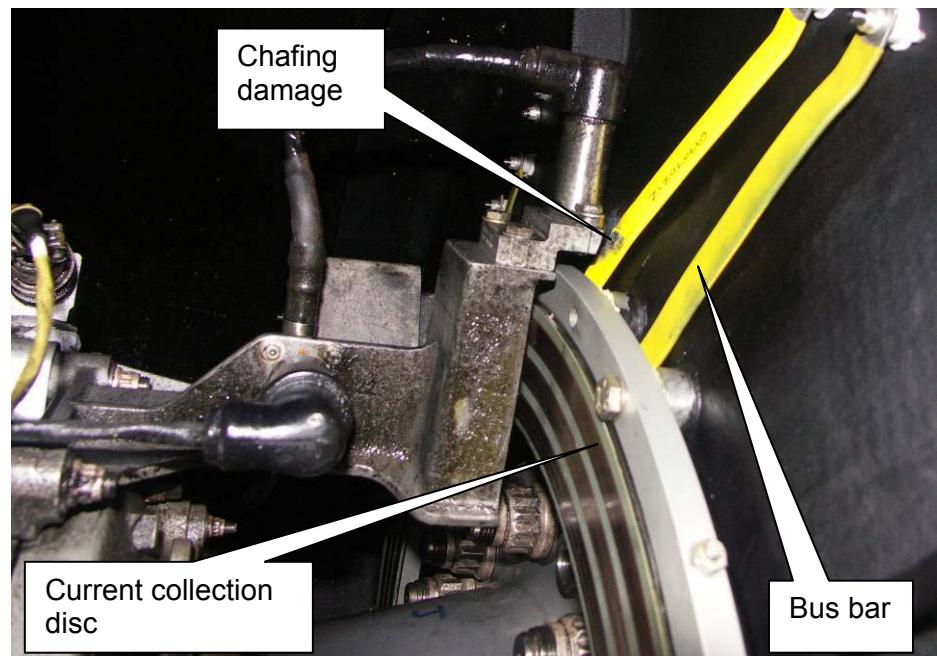
Fig. 8. Chafing damage to the bus bar after contact with the MPU securing fixture

During the technical investigation that was carried out on the right-hand propeller's pitch adjustment system after the incident it was found that chafing damage had occurred to the de-icing system bus bar. The damage showed that mechanical contact and sparking had taken place between the bus bar and the fixture in which the MPU was mounted. (See fig. 8 below.) After the bus bar was repaired, the system operated normally.

All the indications are therefore that the overspeeding that occurred in this flight was caused by interference to the signal from the MPU, whereby the automatic propeller speed regulation was made inoperable.

The fault messages recorded in the PEC during the period before the incident were probably caused by the same fault, that arose intermittently.

The propeller manufacturer Dowty recommended in SB D8400-61-38 that the MPU fixture should be modified (edge bevelled) to minimise the risk that contact between the fixture and the propeller hub bus bar could take place during operation. This modification was carried out on the propeller in question on 23 January 2003.
