## ***Report RL 2008:01e***

### **Aircraft incident to SE-DSP in airspace south-west of Stockholm, AB county, Sweden, on 22 March 2007.**

Case L-04/07

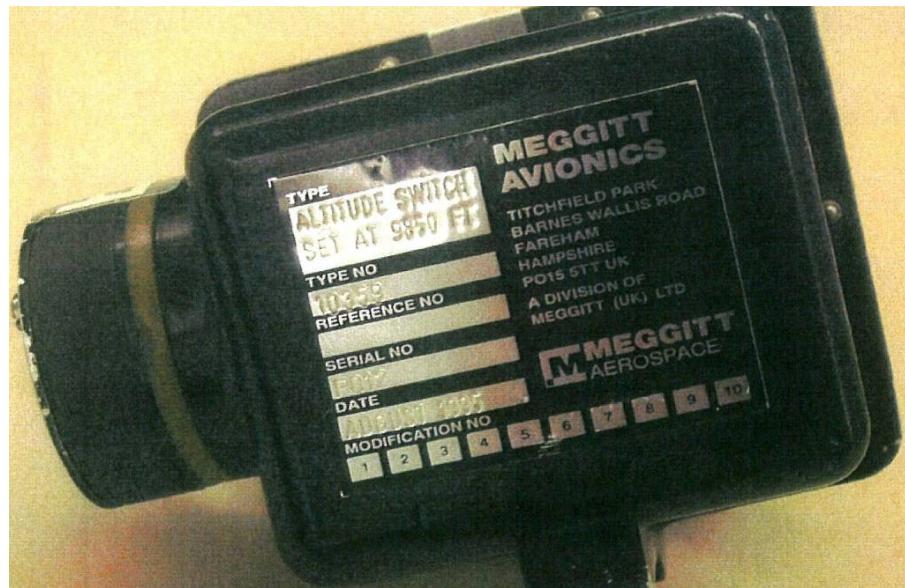
Fig. 6. The pressure sensor

The air leakage tests on the unit showed a great deal of leakage at the damaged ventilation screw. An overload test, to be carried out to a simulated pressure altitude of 40 000 feet, was not carried out, because it was adjudged that the unit would not be able to operate at that pressure altitude with the amount of leakage that had been detected.

According to the manufacturer's opinion, the leaking ventilation screw had no effect on the function of the unit. The final assessment was that the pressure sensor operated in accordance with the specifications during testing.

During testing it was found that the unit was physically damaged and that there was a major leakage of air at a ventilation screw.

Even though the damage did not in a laboratory environment show any measurable effect on the tests, it is not unlikely that in its operational environment in the aircraft, this contributed to incorrect functioning of the unit. It cannot be considered very surprising that a 12-year-old unit that does not need to be functionally tested more often than every 15 000 flying hours, and that does not normally operate in the outer pressure area where

the warning should activate, does not perform its intended function when in a damaged condition.

SHK has not been able to find out how the damage to the sensor occurred, or how long ago, but considers that a shorter inspection interval for these units probably provides a greater possibility for discovering damage and thereby preventing incorrect operation.
