Investigation report

C1/2007L

Serious incident at Seinäjoki Airport on 1 January 2007

Aircraft type and model: ATR 42-500

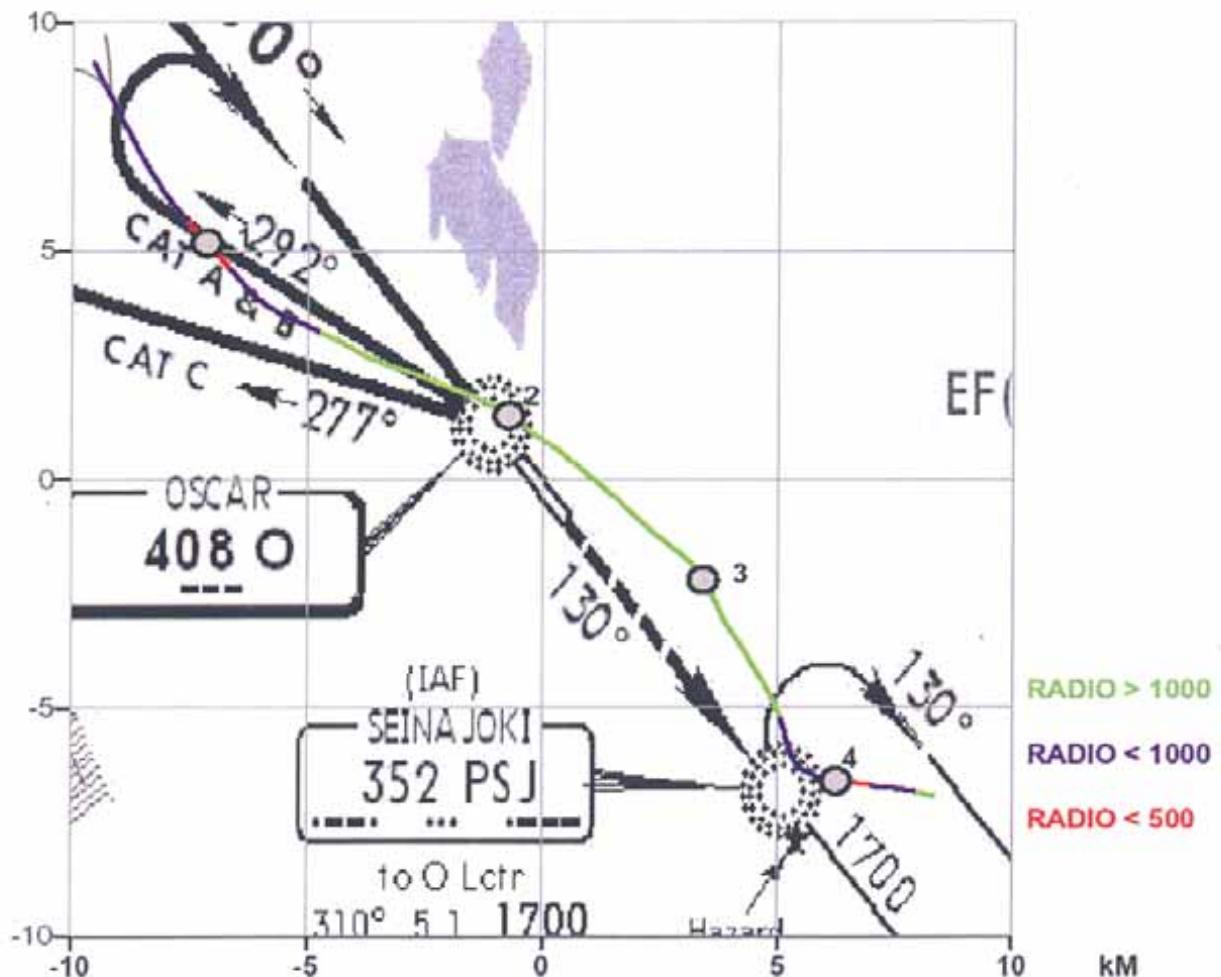
4.1. First approach and go-around, map figure

The manually flown go-around ended when they were abeam locator O, at which time the co-pilot had reached 3000 ft and steered towards the outer marker PSJ. They continued climbing to 3500 ft. According to DFDR data (appendix 4.1) the climb was unsteady during the missed approach and their airspeed, heading and power settings varied. The co-pilot later said that he found it difficult to fly the missed approach. After having completed the go-around they engaged the autopilot and consulted the runway 32 IAL chart (appendix 2) for procedure-specific headings and altitudes. The captain told the co-pilot to descend back to 1700 ft towards PSJ, which the co-pilot did. The FMS indicated that the wind at this altitude was 160 deg and 30 kt. They crossed over PSJ at 17:58, which the captain reported to the AFIS officer, who then requested them to report PSJ inbound. The co-pilot descended until his altimeter read 1700 ft, maintaining the heading 100 deg. Then, at 17:59:30, the EGPWS sounded "FIVE HUNDRED", followed by "TERRAIN AHEAD, PULL UP". The autopilot also disengaged (appendix 4.1, section 4). The co-pilot commenced a go-around and told the captain that he would climb to 2500 ft. Simultaneously, the captain noticed that his lower attitude and heading reference display had gone blank. The co-pilot's instrument displays, however, were nominal.

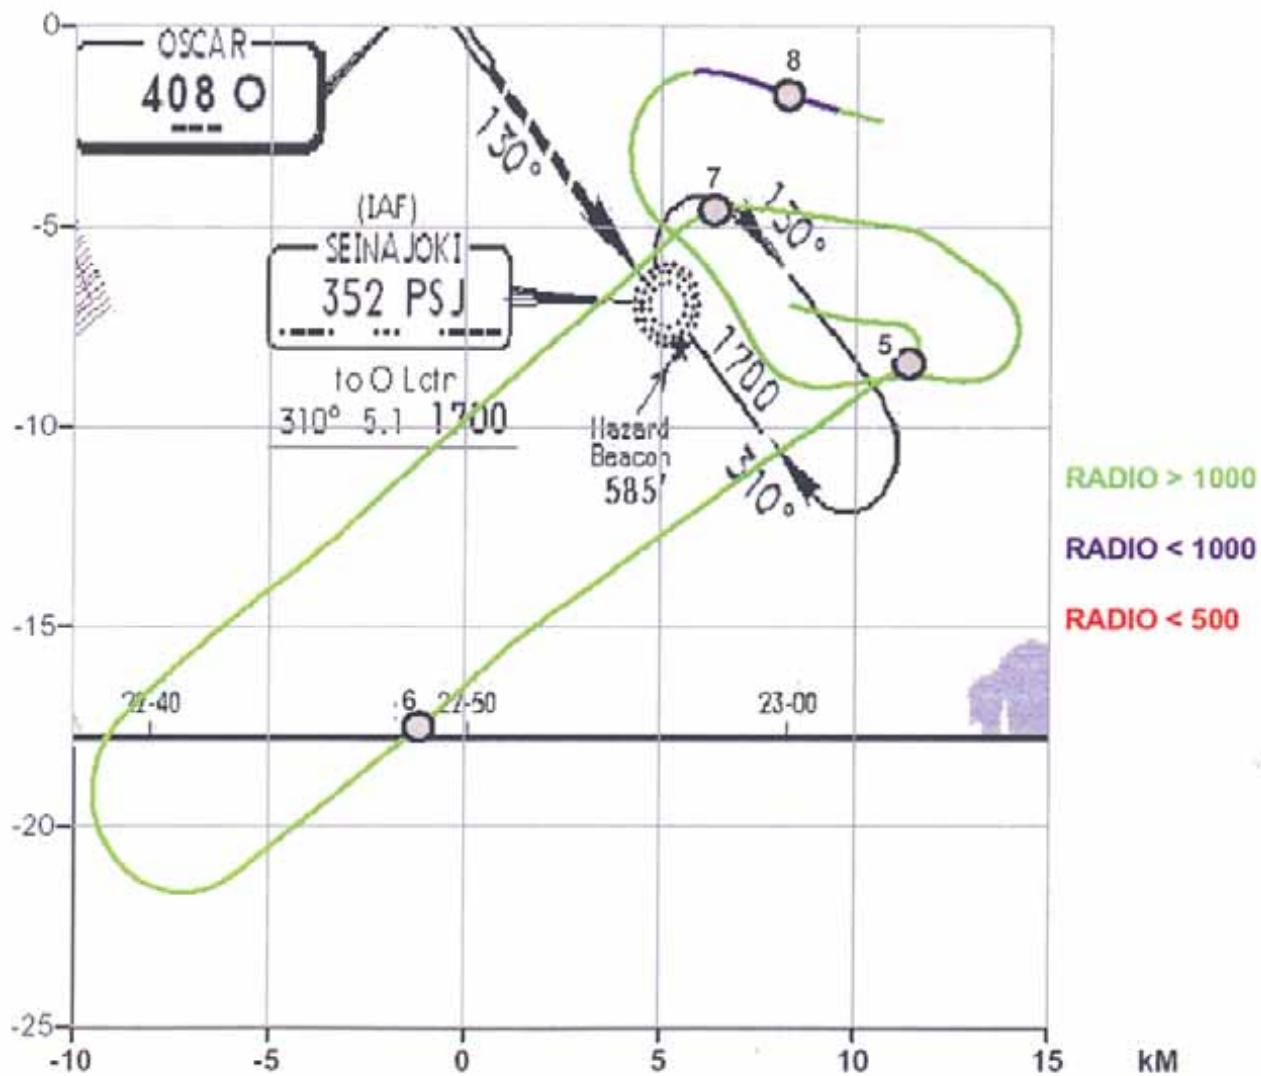
4.2 Climbing to FL 70 and return to the racetrack, map figure

autopilot disengaged. The co-pilot changed over to manual control. DFDR recordings show that two fairly large tailplane deflections caused the angle of attack to increase by 10 degrees within less than 10 seconds (appendix 4.2, section 5). The MC sounded again, the stick pusher activated twice within 5 seconds and the aircraft began to lose altitude. According to the DFDR, airspeed was 130 kt and altitude 1500 ft AGL. The aircraft lost approximately 250 ft during this occurrence. The DFDR indicated no icing. The co-pilot selected full power and started a climb, maintaining 180 kt. Maximum power was momentarily exceeded during the climb.

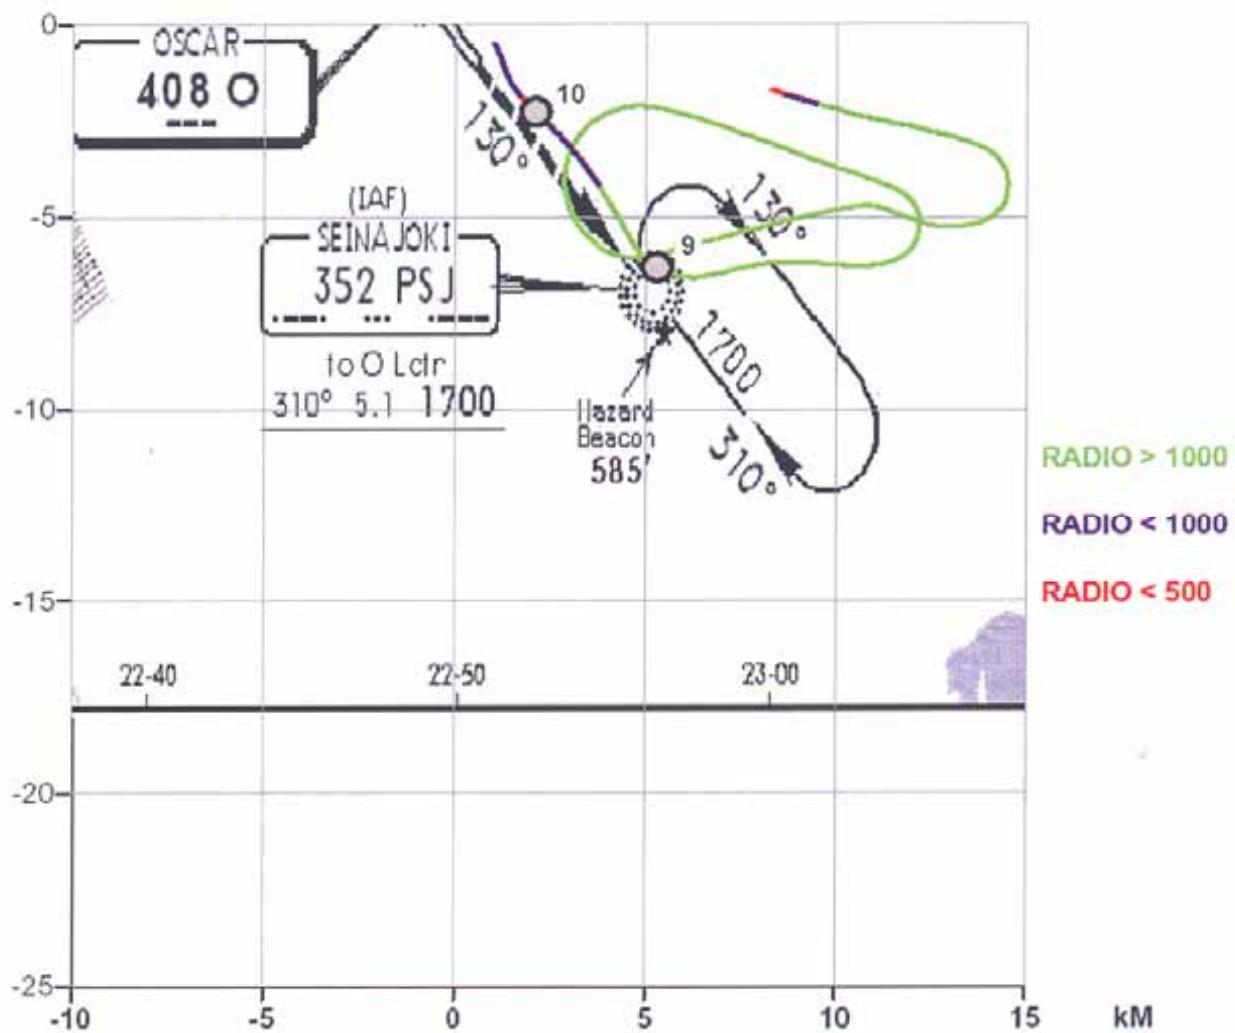
4.3 Second approach, map figure

When they reached the initial approach altitude 1700 ft at 18:14:30, they received yet another warning: "FIVE HUNDRED, TOO LOW, GEAR". Their actual altitude according to DFDR was 460 ft. The co-pilot pulled up and decided to climb to 2700 ft, staying within the holding pattern. This was not reported to the AFIS officer. The crew were still in the dark with regard to the cause of the low altitude warning.

The warnings seem to have been generated by EPGWS Mode 4 (Unsafe Terrain Clearance) activation. This occurs when the aircraft descends too low when not in landing configuration.

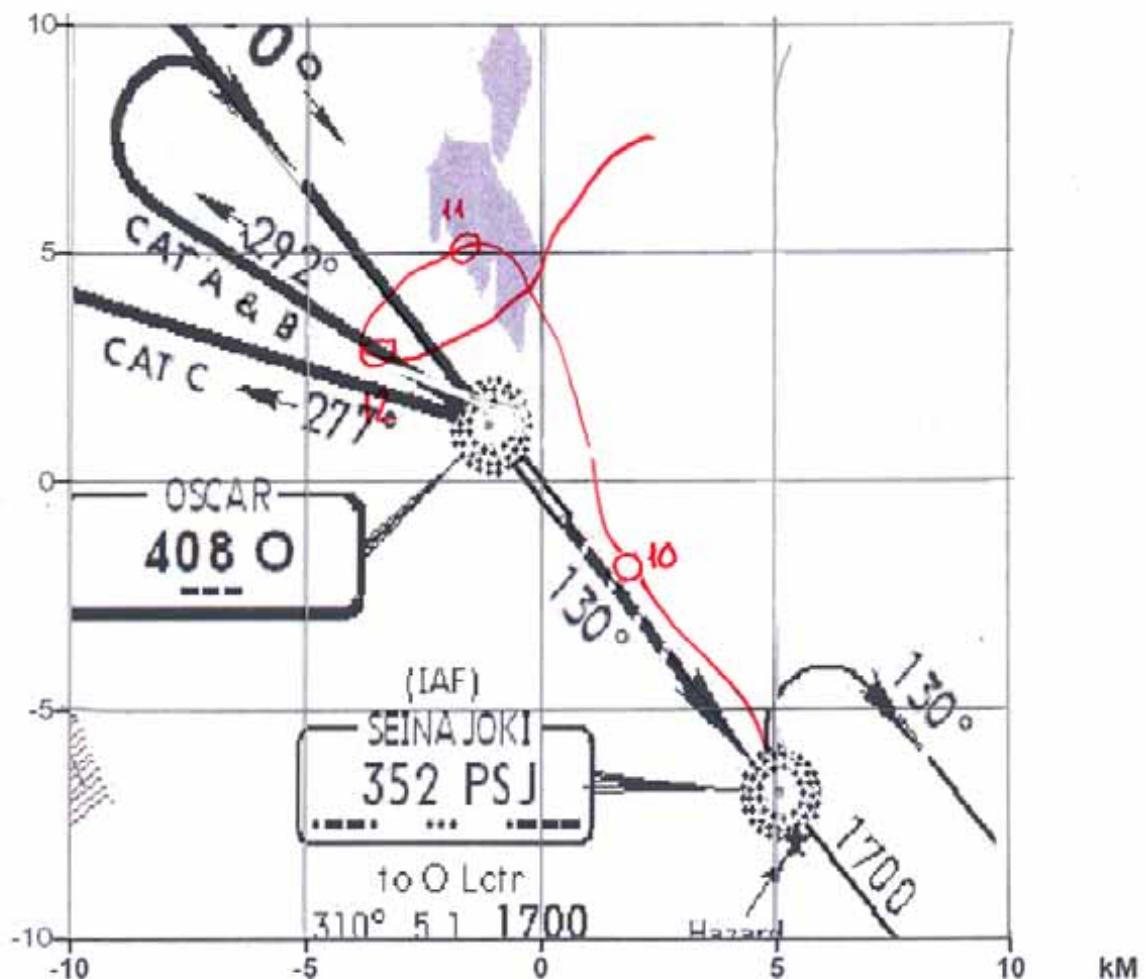
4.4 Circling approach and diversion to Vaasa, map figure

The co-pilot hand-flew the aircraft to ca. 1000 ft and, at 18:23, commenced a right turn into a left hand circling approach. Hence, the co-pilot was on the outside of the circling pattern and thus lost sight of the runway. When asked, he said that he only remembered the OM-B's illustration, showing a left turn approach. Furthermore, the configuration illustrated in the manual does not correspond with the text, which is why the co-pilot had the wrong configuration on the downwind leg, which in turn caused the warning.
