REPORT IN-008/2007

Date and time	Thursday, 8 February 2007; 2:30 h UTC
Site	At FL410 over the Atlantic Ocean, 130 NM from the Canadian coast (approximate coordinates 48N 50W)

Registration	EC-KBC
Type and model	GULFSTREAM G-200; S/N 145
Operator	TAG Aviation España (TAG Aviation E.)

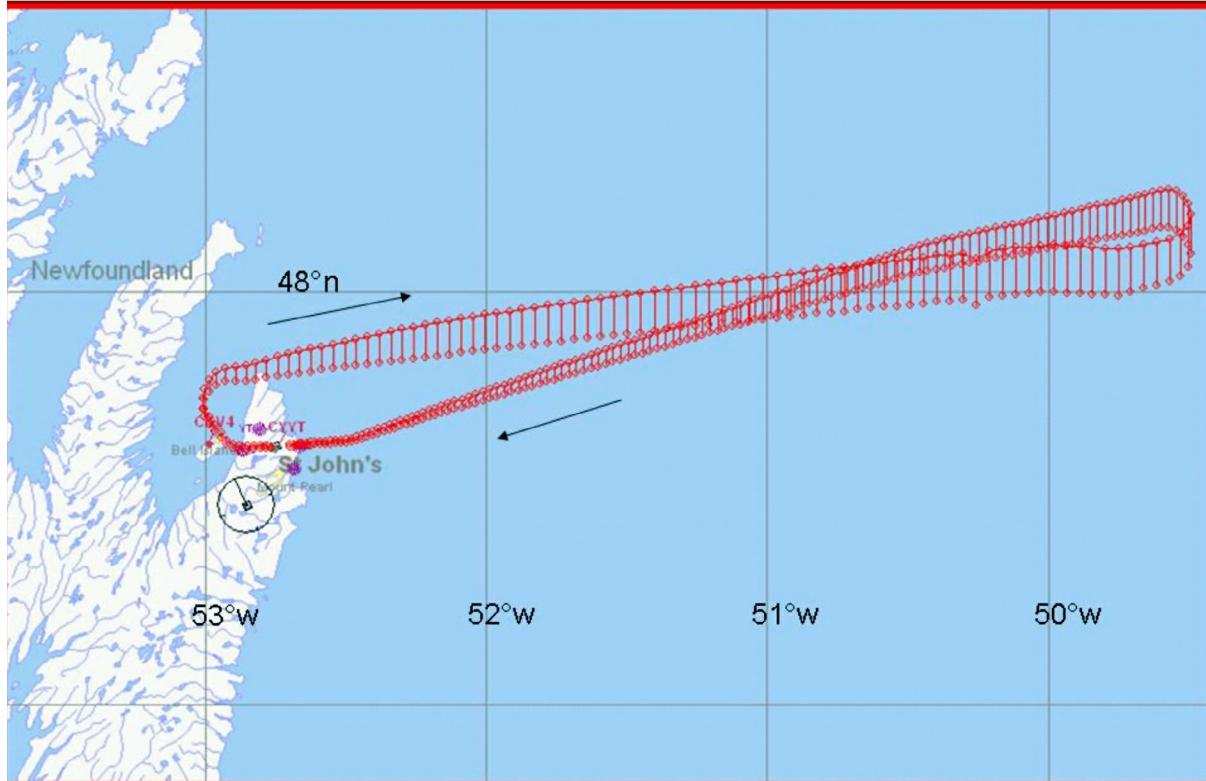
Canadian authorities provided the radar track data of the flight, together with a graph of the trajectory followed by the aircraft compiled from these data (see Figure 1).

Figure 1. Flight path of the aircraft prepared by Canadian authorities using radar data

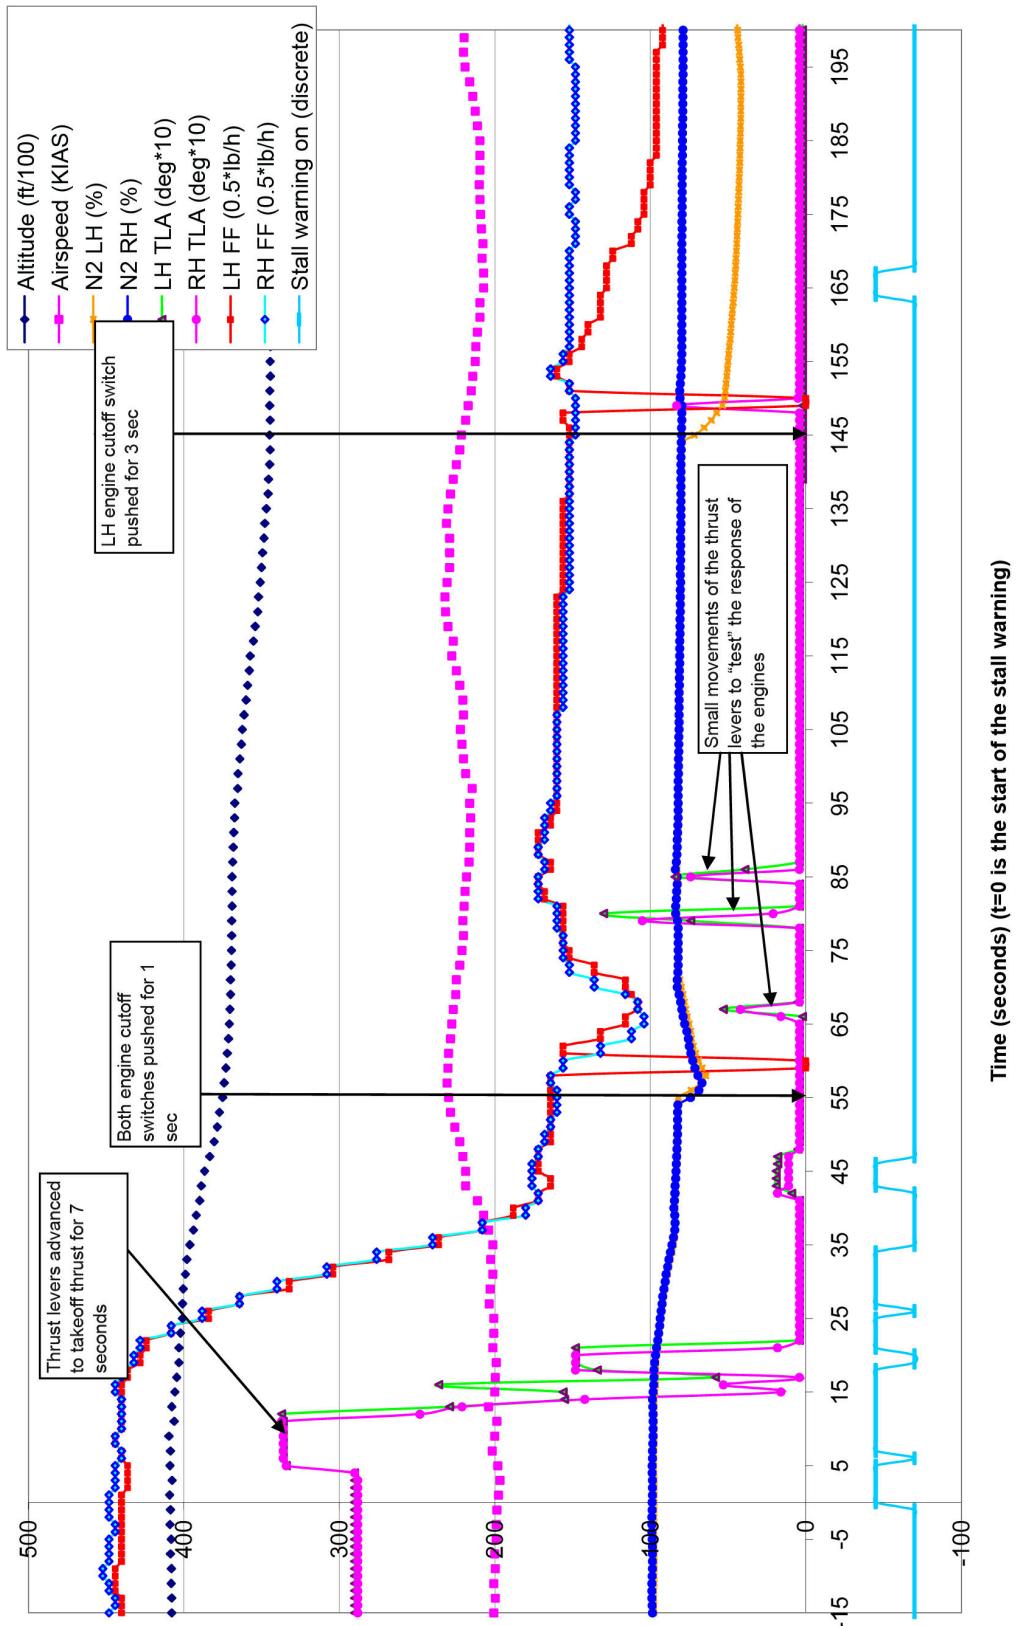
At second 56 the engine cut-off switches for both engines were pushed for 1 s. This caused the LH engine fuel flow to go to zero and the RH engine fuel flow to decrease noticeably also. Both N2 also fell. The manufacturer interpreted those values as meaning both engines were shut-down.

After a few seconds the engines recovered fuel flow and N2 and afterwards there were three movements of the thrust levers forward and backwards in what seemed to be a check of the status of the engines.

Figure 2. Qualitative variation of various DFDR parameters after the start of the stall warning. The scale of the curves has been adjusted to have all the data on the same graph

At second 145, with both thrust levers still at idle, the LH engine cut-off switch was pressed for 3 s, which caused the LH fuel flow to go to zero and the LH N2 to drop down to 41.7% in what was considered a complete shut-down of the engine. After several seconds, the fuel flow and N2 recovered and the engine re-started again.

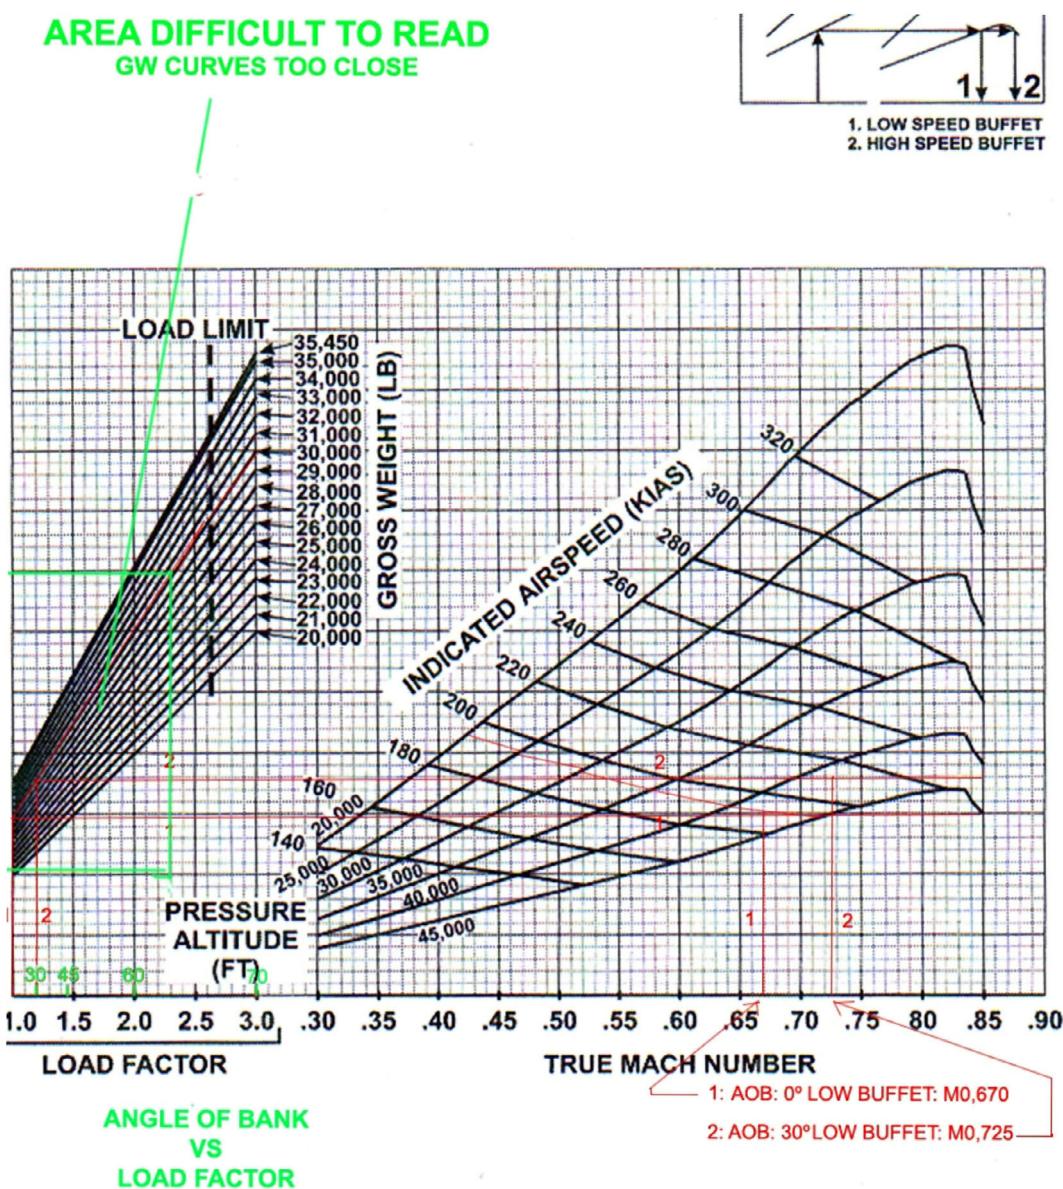
Figure 7-19. Buffet Boundary; Clean Configuration

The performance information of the G-200 provided by the manufacturer was reviewed. The buffet boundaries are provided in Figure 7-19 of the AFM. However, the curves on this graph are closely spaced and are very difficult to read. The graph does not show bank angle (only load factor, which is less intuitive to the flight crews) (see Figure 3). Additionally, it would be useful for operational purposes if this graph were also included in the Quick Reference Handbook. A recommendation is issued in this regard.

Figure 3. Modified composition of the buffet onset graph from the G-200 AFM

REC 40/07. It is recommended that Gulfstream revise the buffet boundaries graph provided in Figure 7-19 of the AFM in order to improve readability of the gross weight curves and to include the bank angle in addition to load factor. Additionally, it is recommended that this graph also be included in the Quick Reference Handbook.
