# NEAR-COLLISION AT LOS ANGELES

Asiana Airlines AAR204, a Boeing 747-400 that had been cleared to land on runway 24L [at Los Angeles International Airport (LAX)], initiated a go-around and overflew Southwest Airlines flight SWA440, a Boeing 737 which had been cleared into position and hold for takeoff on runway 24L. Radar reconstruction of the event found that AAR204 passed over SWA440 at 200 feet during the go-around. At the time of the incident, a controller change for the LC2 position had just occurred and the relief controller was responsible for the air traffic control handling of both AAR204 and SWA440.

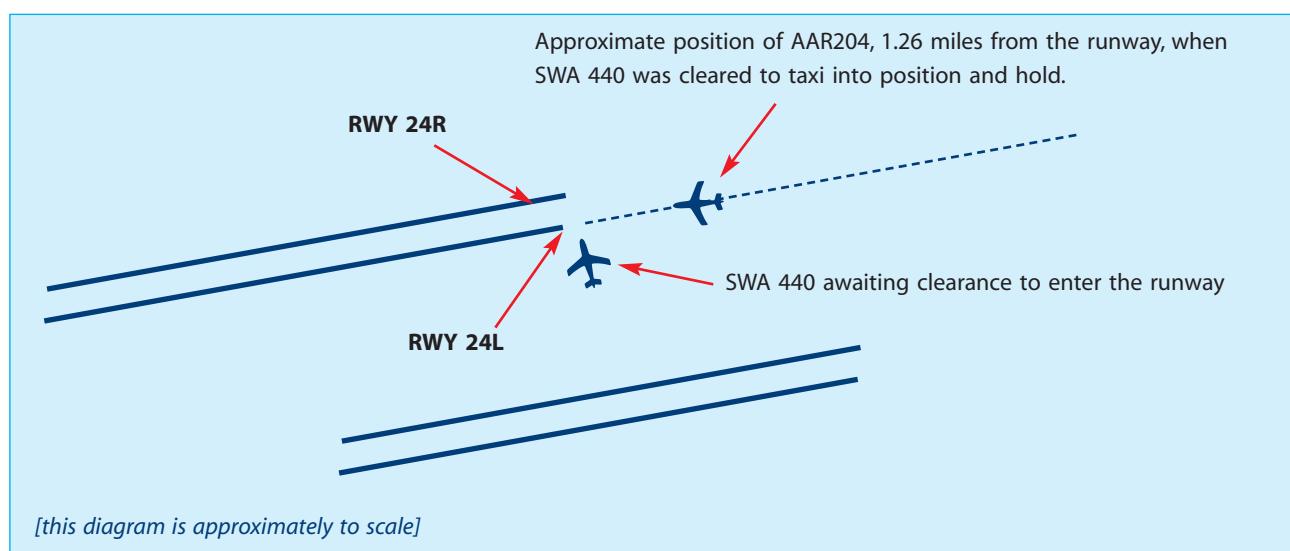
The relief controller said that contrary to the recorded relief briefing where he clearly acknowledged that AAR204 was cleared for the left runway, he fully believed AAR204 was landing runway 24R, and was therefore unaware of the conflict. He first became aware of the problem when the Airport Movement Area Safety System (AMASS) generated an alarm. At this point, AAR204 was only about 12 seconds from colliding with SWA440. Without the prompt action of the Asiana flight crew a collision would in all likelihood have occurred. When the relief controller recognized the problem, he cancelled SWA440's takeoff clearance and AAR204's landing clearance. However, AAR204 had already overflew SWA440 on the go-around, clearing the aircraft by about 200 feet. Although the relief controller believed AAR204 was

landing runway 24R, this did not alleviate his responsibility to properly monitor the operation and ensure separation was maintained.

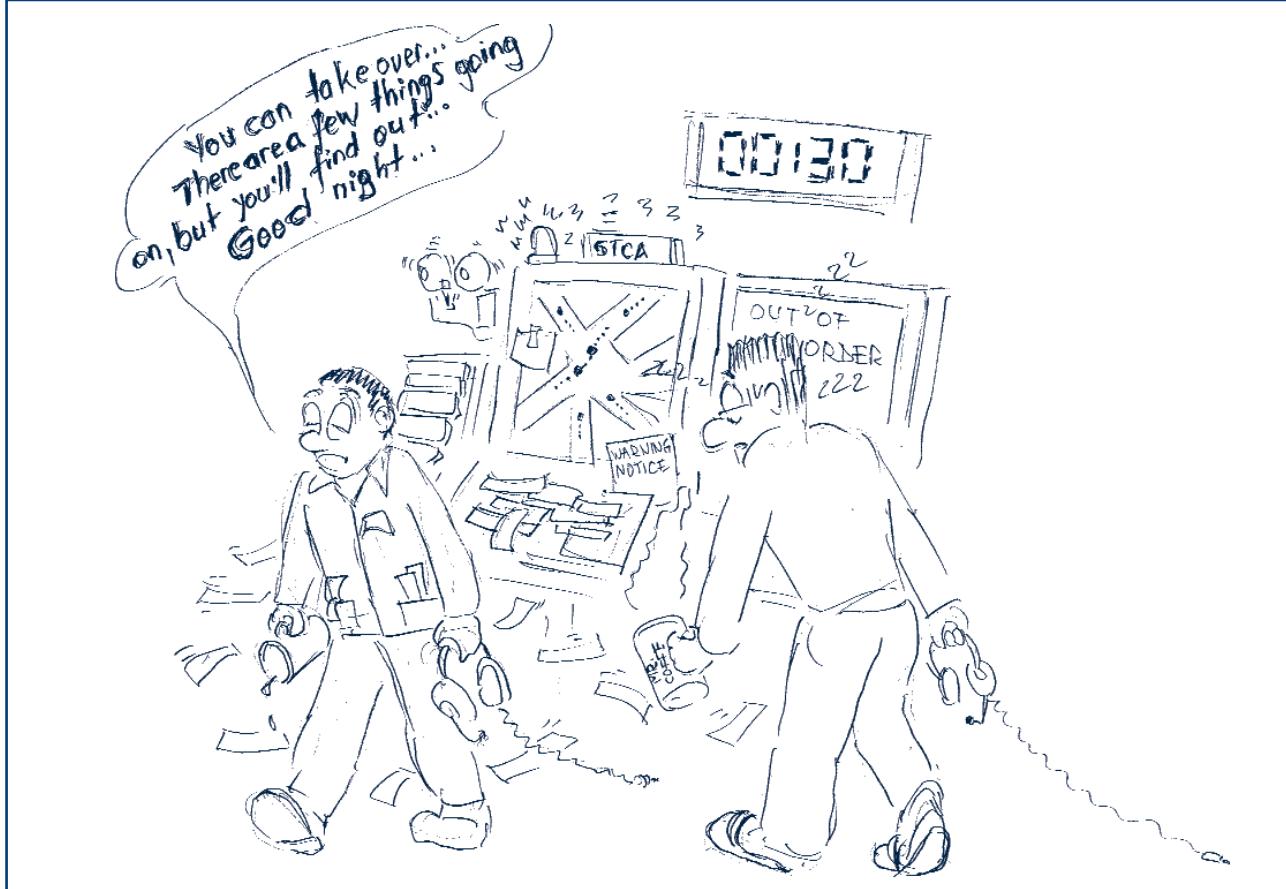
The National Transportation Safety Board determines the probable cause(s) of this incident as follows:  
a loss of separation between Southwest flight 440 and Asiana

flight 204 due to the LC2 relief controller's failure to appropriately monitor the operation and recognize a developing traffic conflict. Contributing factors included the FAA's position-relief briefing procedures, the formatting of the DBRITE radar displays in the LAX tower, controller fatigue, and the tower supervisor's staffing decisions on the day of the incident.
