Investigation Report

EX006-1-2/04
February 2009

Type of Event: Serious Incident
Date: 3 May 2004
Location: Munich Airport
Aircraft: 1. Commercial Air Transport
 2. Commercial Air Transport
Manufacturer / Type: 1. Boeing / B737-306
 2. Aerospatiale / ATR 42-500
Injuries to persons: None
Damage to Aircraft: None
Third Party Damage: None
Source of Information: Investigation by BFU

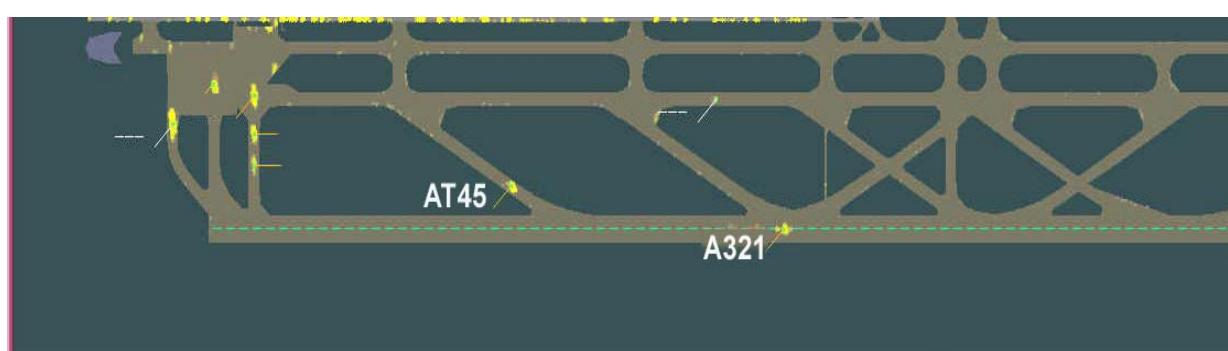
Illustration 2: Radar Trace Record 21:39:00: A 321 take-off run, shortly before rotation.

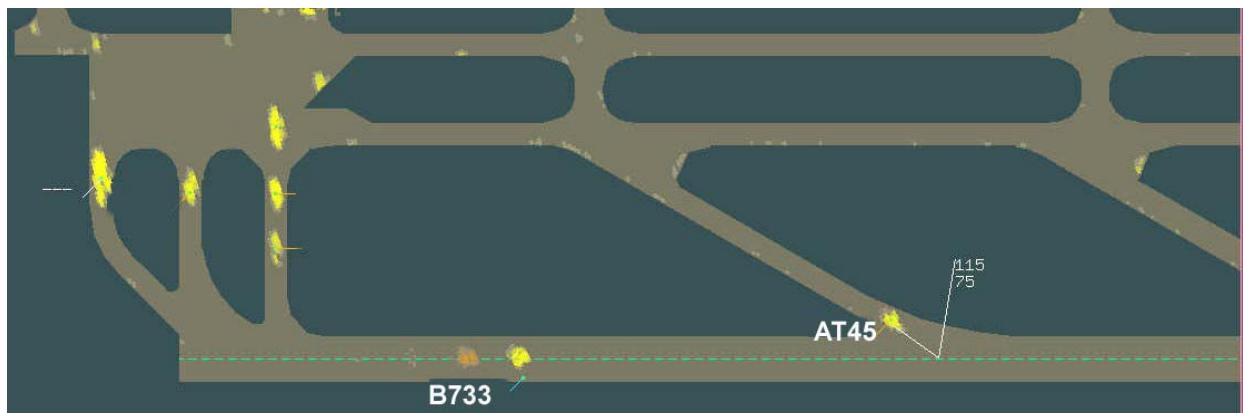
Illustration 4: Radar Trace Record 21:39:18: The B 733 was in the flare/touchdown on Runway 08R, while the AT 45 was still about 40 metres from the Runway centreline.

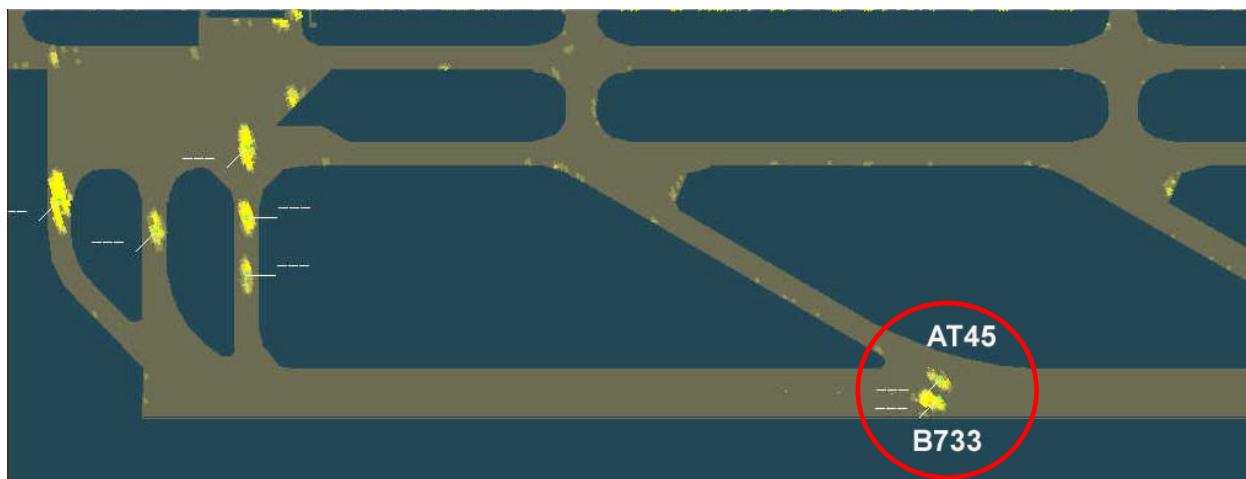
Illustration 6: Radar Trace Record 21:39:26: The AT 45 was about 10 metres from the Runway centreline. The B 733 passed the AT 45 on the right side at a speed of about 110 knots.

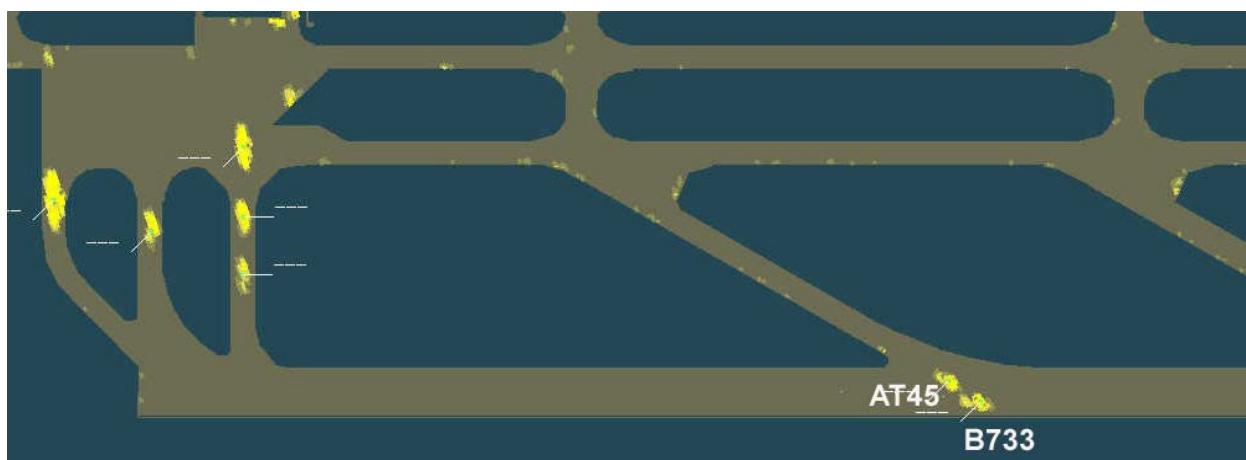
Illustration 7: Radar Trace Record 21:39:27: The B 733 has passed the AT 45.

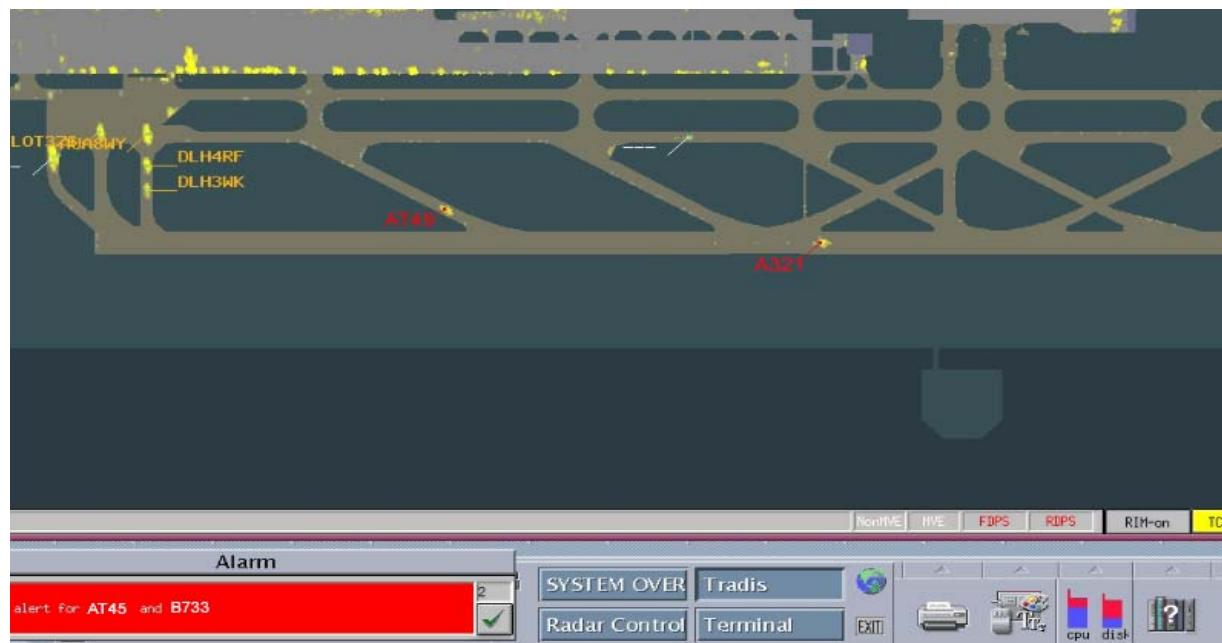
At the time of the incident, the RIM (Runway Incursion Monitor) alert function at the Air Traffic Controller's workstation (PL1S) was not switched on.

In discussions with DFS personnel in Munich, they reported that the RIM function was not in regular use because it gave an unacceptably high number of erroneous warnings.

Illustration 8: Radar Trace Record 21:39:09. The RIM threat alarm between the AT 45 and B 733. The B 733 was on short final to land. Shortly afterwards, it was detected by the Airport Surface Monitoring Radar.

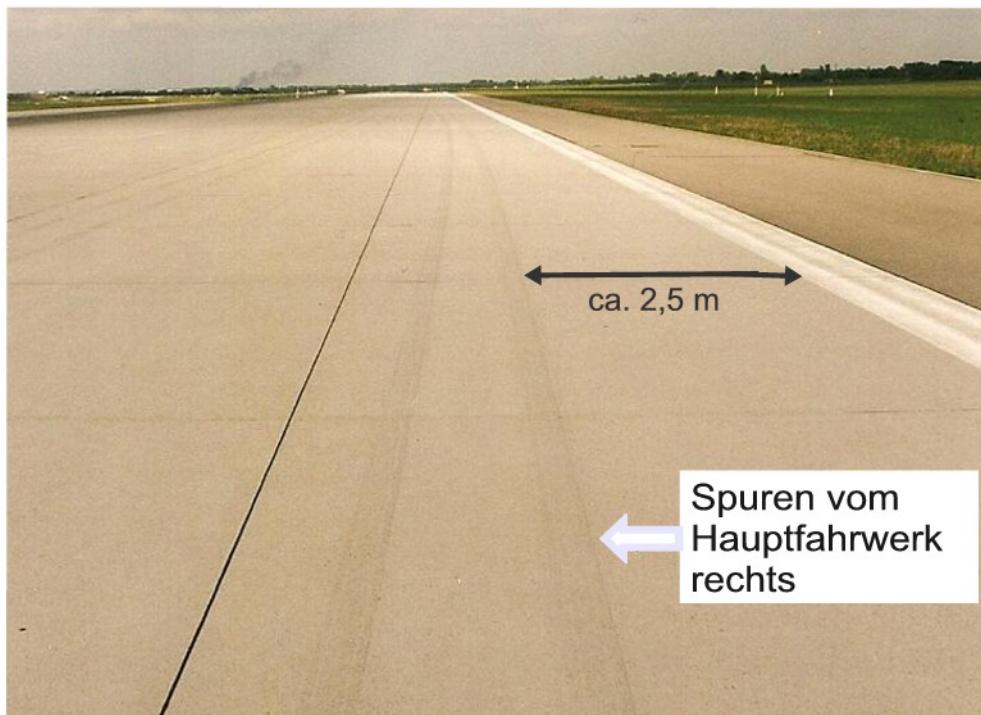
The B 733 left tyre marks on Runway 08 R adjacent to the junction with Taxiway B4.

Illustration 12: Marks left by Right Main Landing Gear

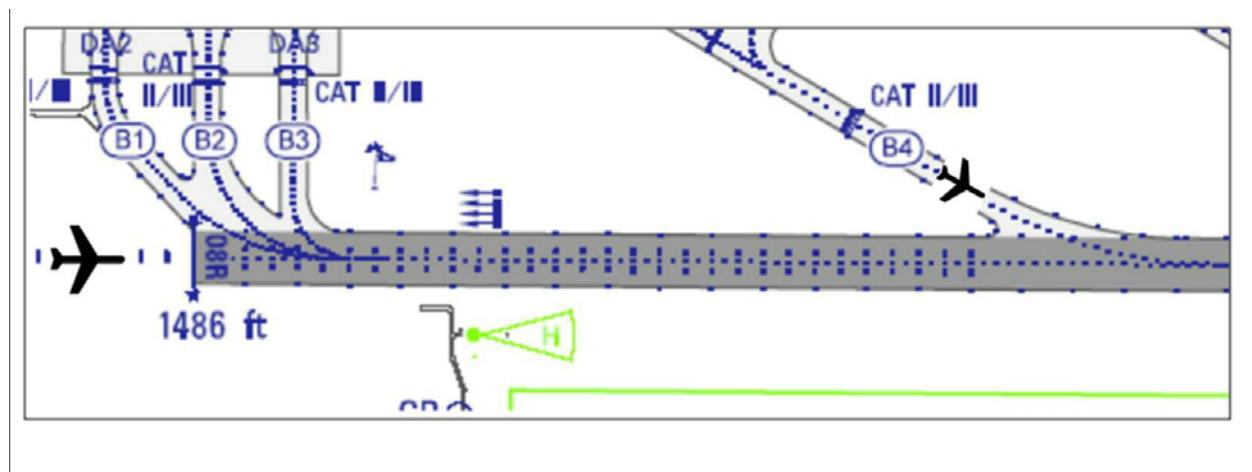
Illustration 13: Entry Point of Taxiway B4 to Runway 08 R

From the planning point of view, Taxiway B4 was built as a fast exit taxiway from Runway 26L. Although the aerodrome Standard Operating Procedures (BAO) explicitly state the taxiway may be used by departing aircraft, the BFU judges this represents acceptance of higher risk. Taxiway R4 intercepts the Runway at an acute angle of 30°, giving a very restricted view to the right of the approach to Runway 08 R, especially as seen from the flight deck of a shoulder-wing aircraft.

As far as the BFU is aware, there has been no risk analysis undertaken, either in the context of the formal Airport Planning Approval Process or the Standard Operating Procedures.

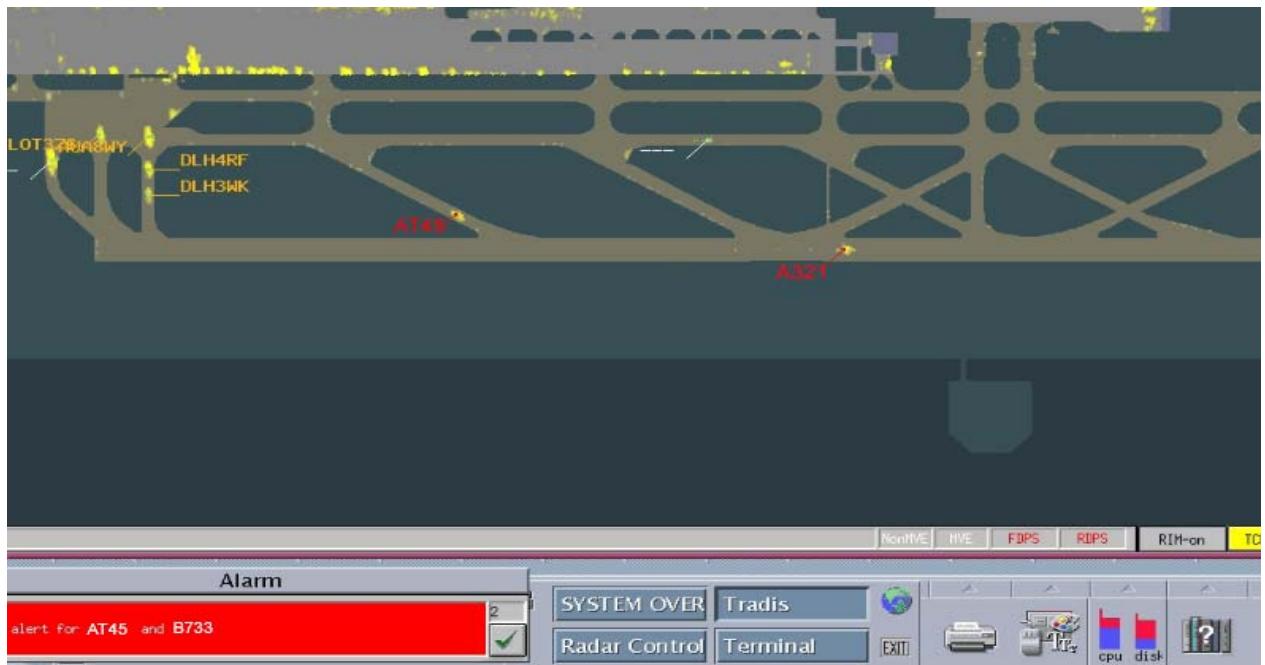
The BFU shares the view of the Air Traffic Controller who was on duty at the time, namely that if the RIM had been switched on, she would have received both acoustic and optical warnings of the threat situation. The RIM was switched off due to the unreliability of the system.

Illustration 14: Radar Trace Record 21:39:09. RIM alarm between the AT 45 / B 733. The B 733 was on short final and was presented on the ASMR screen a short time later.
