Incidents in Air Transport

Aerodrome Traffic

Runway Confusion at Montpellier

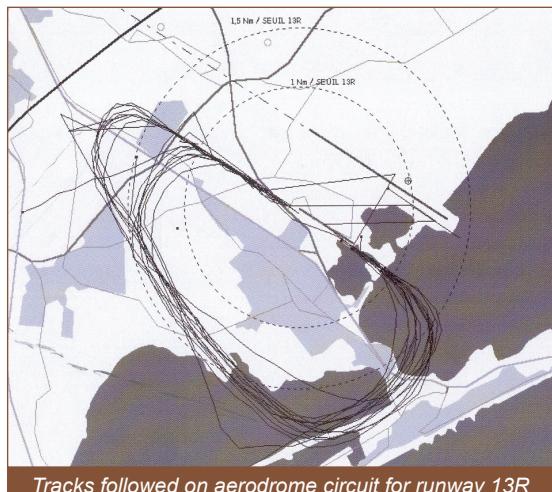
Aerodrome traffic circuit on runway 13R
As a general rule, aerodrome traffic circuits do not have strictly defined dimensions. For runway 13R they are performed using turns to the right. By agreement between all those involved, aircraft based at the airport perform a convergent downwind leg in order to avoid overflying villages. This causes aircraft to turn directly onto the final

Tracks followed on aerodrome circuit for runway 13R

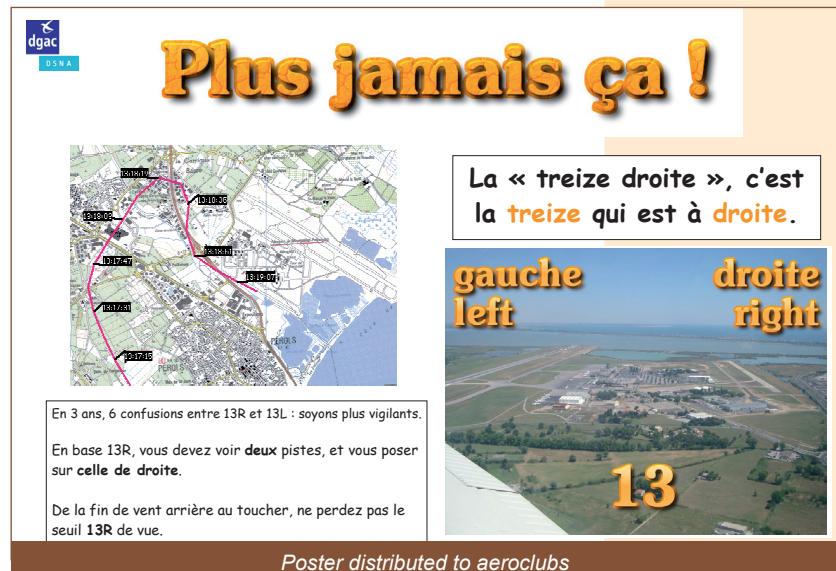
Poster distributed to aeroclubs

To make VFR pilots more aware of the environment encountered during approaches to runways 13L and 13R and in order to try and limit overruns of the flight path for runway 13R, the Air Traffic Services are asking pilots in clubs based at Montpellier airport to perform training flights on runways 13R and 13L with an instructor before being approved. Ground-based courses are also given in training organisations. The Air Traffic Service has also circulated a poster to clubs.

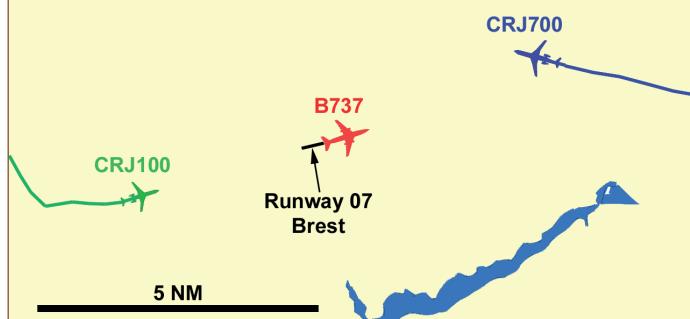
Figure 1

landing exercises and was returning to the downwind leg (figure 1).

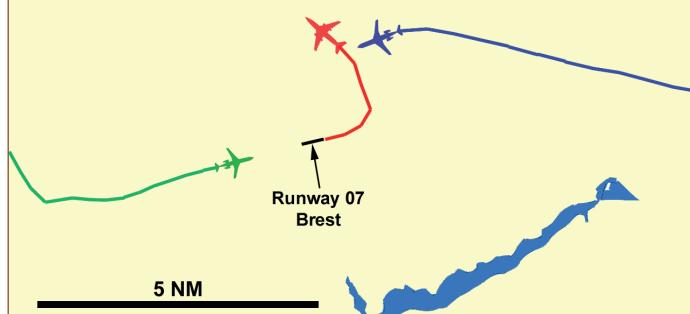
Figure 2

itself behind them on the downwind leg; it received a TA on its TCAS. The crew of the CRJ 700 performed an avoidance manoeuvre to the left (figure 2). Observing that there was insufficient separation⁽¹¹⁾ and that its speed was greater,

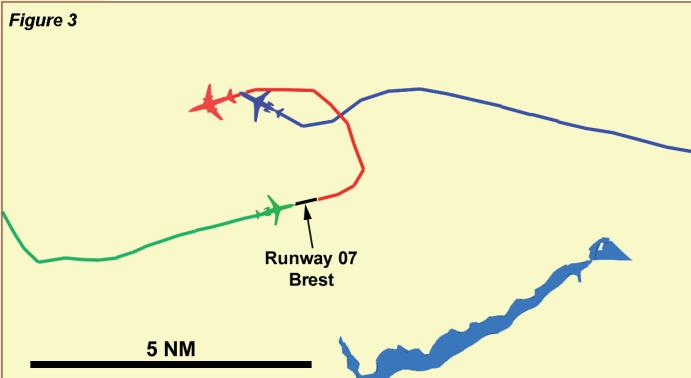
it requested authorisation to make a delaying «360» to the right (figure 3).

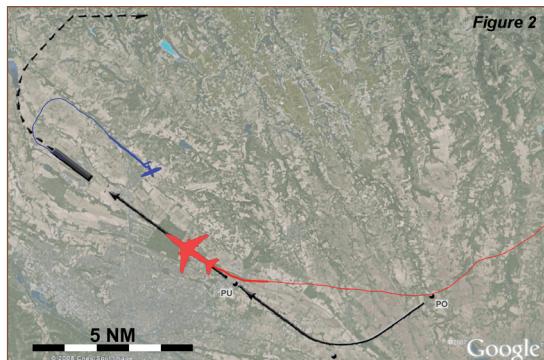
Figure 2

One minute later the B737, at 4 NM on final approach, was cleared to land. The DR 400 pilot, who thought he had flown the extension of the downwind leg far enough, turned onto the base leg (figure 2).

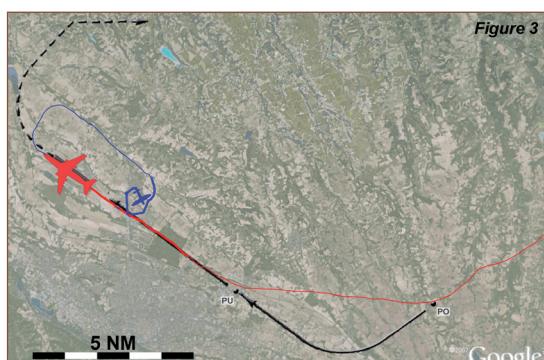
Figure 3

On seeing the B737, the DR 400 pilot performed an avoidance manoeuvre (figure 3).

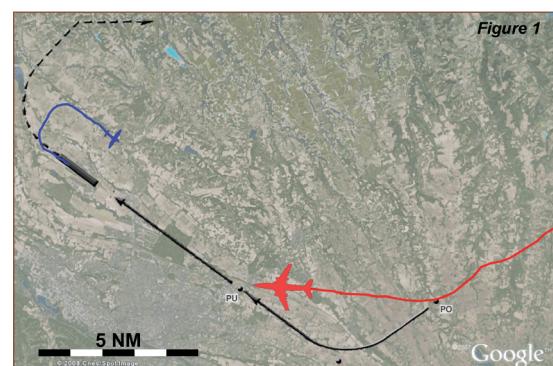
told the crew of the B737 that a DR 400 was on a right hand downwind leg (figure 1).
