AIRCRAFT INCIDENT REPORT

Reference:		CA18/3/2/0672	
Aircraft Registration	ZS-SFN	Date of Incident	07 Sept. 2008		Time of Incident	0453Z	
Type of Aircraft	Airbus A319-131 (Aeroplane)			Type of Operation		Scheduled Domestic Flight	
Pilot-in-command Licence Type		Airline Transport		Age	49	Licence Valid	Yes
Pilot-in-command Flying Experience		Total Flying Hours		15591.0		Hours on Type	1951
Last point of departure		Cape Town International Aerodrome (FACT), Western Cape					
Next point of intended landing		O.R. Tambo International Airport (FAJS), Gauteng					
Location of the incident site with reference to easily defined geographical points (GPS readings if possible)							
During cruise at 37000ft from FACT en-route to O.R. Tambo International Airport (FAJS).							
Meteorological Information	The weather was fine, en route; the wind 350°/17kt and visibility: CAVOK.						
Number of people on board	2+4+59	No. of people injured		0	No. of people killed	0

Manufacturer : AIRBUS
Model : A319-131
Nationality : South African
Registration Marks : ZS-SFN
Place : En route FACT to FAJS
Date : 07 September 2008
Time : 0453Z

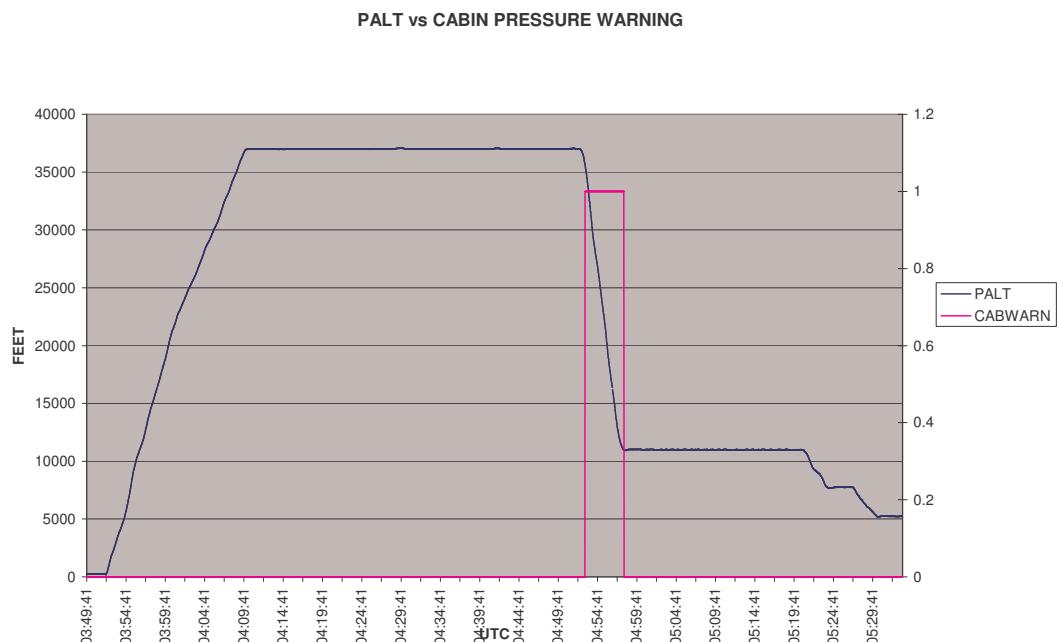
1.11.4.1 The Pressure Altitude (PALT) indicated on the blue line shows the aircraft during takeoff at 03:52Z and how it climbed to 37000ft above mean sea level (AMSL). During cruise at this altitude, the crew made an emergency descent at approximately 0451Z to 11000ft AMSL.

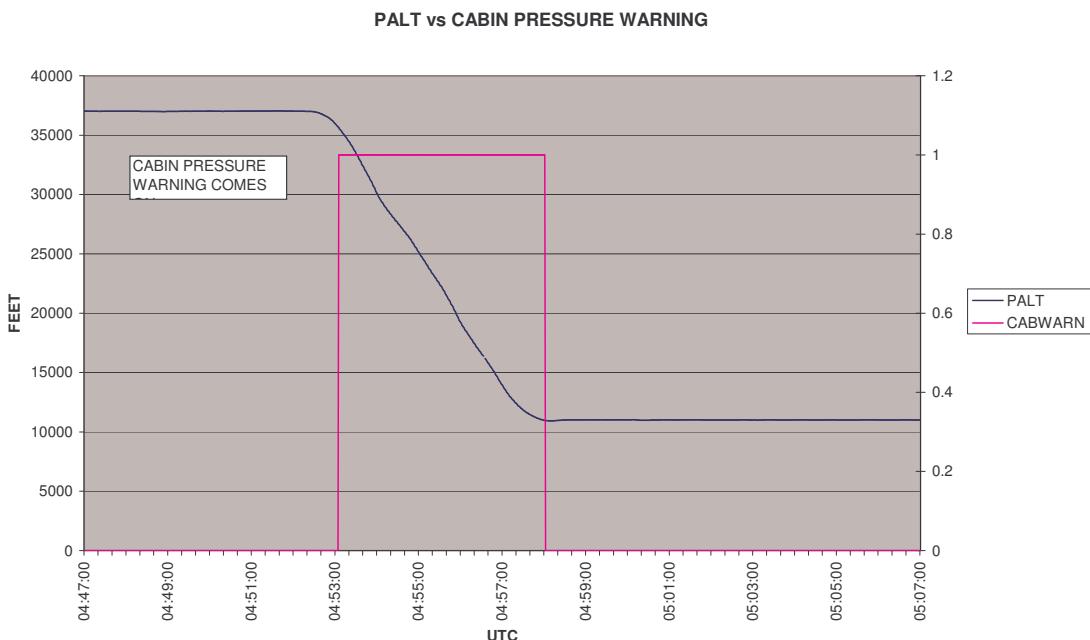
11.4.2 The red line on the PALT versus CABWARN graph shows that the cabin altitude

warning came on at 33000ft AMSL at 0453Z until 0458Z during descent from 37000ft to 11000ft AMSL.

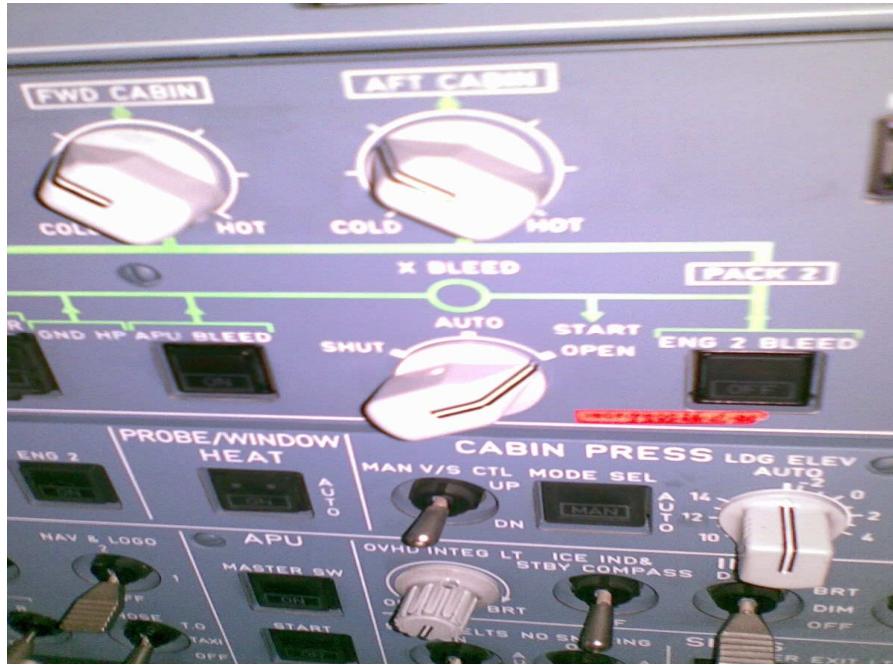
PHOTO 1: VIEW OF OVERHEAD PANEL IN COCKPIT WITH DECAL STUCK AT ENG 2 BLEED

1.16.3 It became obvious during the investigation when the aircraft arrived back at FAJS after the flight from FACT, that the 'INOP' decal was placed at the No 2 engine bleed (ENG BLEED) pb switch and not placed at the No 1 engine bleed pb switch.

flight from FACT to FAJS, the INOP placard was found placed (stuck) on the No. 2 engine bleed that was the serviceable bleed at the time. The maintenance supervisor stated that he did not check whether the decal was placed at the defective bleed system on the overhead panel.

- 3.1.6 It became obvious during the investigation when the aircraft arrived back at FAJS after the flight from FACT, that the 'INOP' decal was placed at the No 2 engine bleed (ENG BLEED) pb switch and not placed at the No 1 engine bleed pb switch when the aircraft was dispatched as per MEL.
- 3.1.7 The cockpit crew members on board the aircraft were appropriately licensed and type-rated on the aircraft type.
- 3.1.8 The weather was not considered to have been a contributory factor in this incident.
- 3.1.9 According to available records, the aircraft was equipped and maintained in accordance with existing regulations and approved procedures.

- 4.1 It is recommended that South African Airways Flight Operations and Technical issue a briefing notice regarding the importance of strictly adhering to requirements stipulated in the MEL, where failure to do so could adversely affect the safe operation of a flight. It is also recommended that the briefing should include the importance of reading the TL/36 / GT/83 and cross-checking whether the aircraft configuration agrees with the MEL dispatch conditions.
- 4.2 Although it is not always practical that the TL 36 remains in the cockpit at all times as suggested by SAA Flight Operations, it is suggested that the TL 36/GT83 be available to the cockpit crew when they start with their pre-flight inspections approximately one hour before departure time.

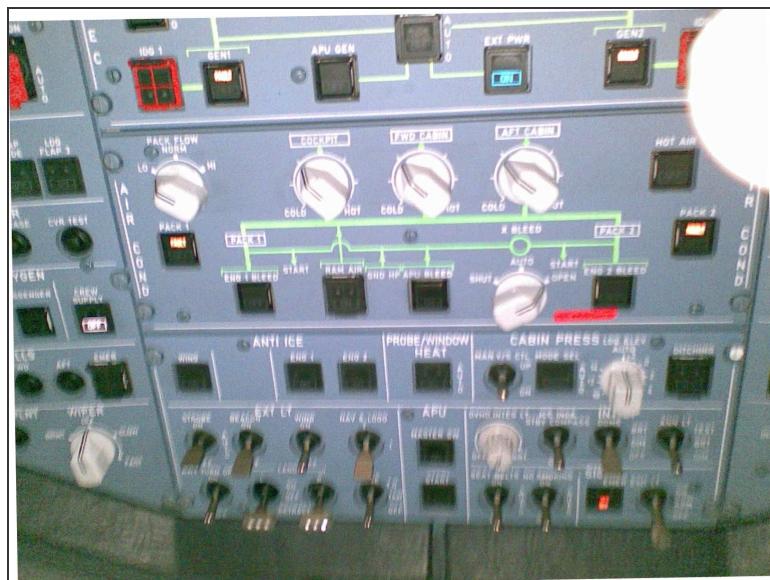
PHOTO 2: VIEW OF FULL OVERHEAD AIR CONDITIONING PANEL IN COCKPIT
