ATSB TRANSPORT SAFETY REPORT
Occurrence Investigation Report AO-2007-036
Final

Fuel-related event – 50 km NW of
Swan Hill, Vic.
11 August 2007
VH-TJE
Boeing Company 737-476

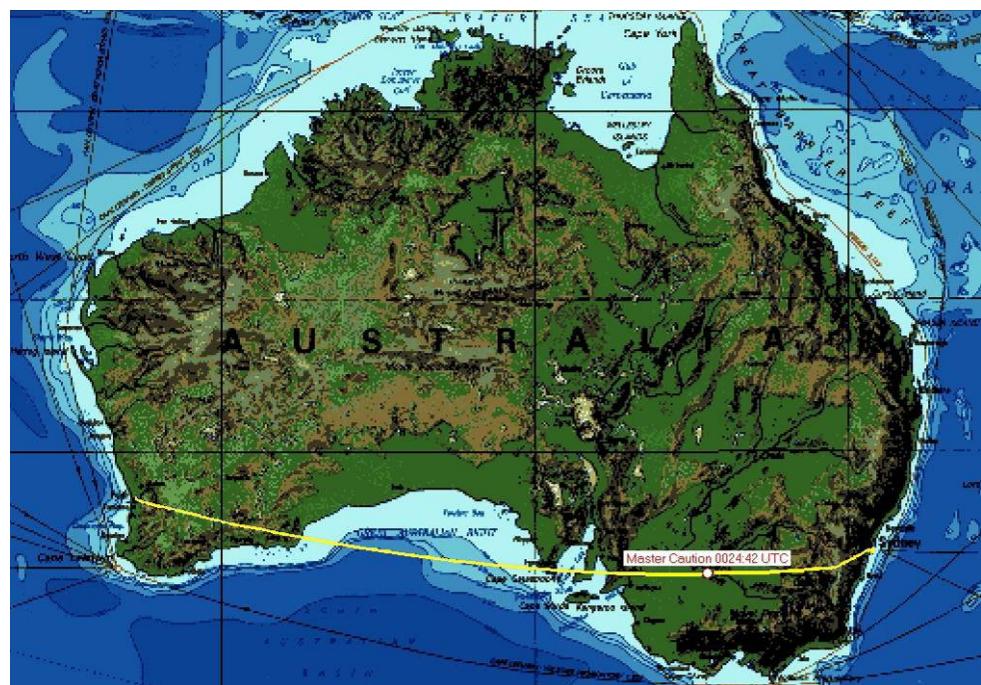
About 2 hours 40 minutes after takeoff, at 0824.42² (Figure 1), the master caution light illuminated, associated with low output pressure of the main tank fuel pumps. The main fuel tanks in the Boeing 737 series aircraft were located in each wing. A centre fuel tank, located in the wing centre section, was used for carrying additional fuel on longer flights, such as from Perth to Sydney.

Figure 1: Route flown with illumination of the master caution light indicated

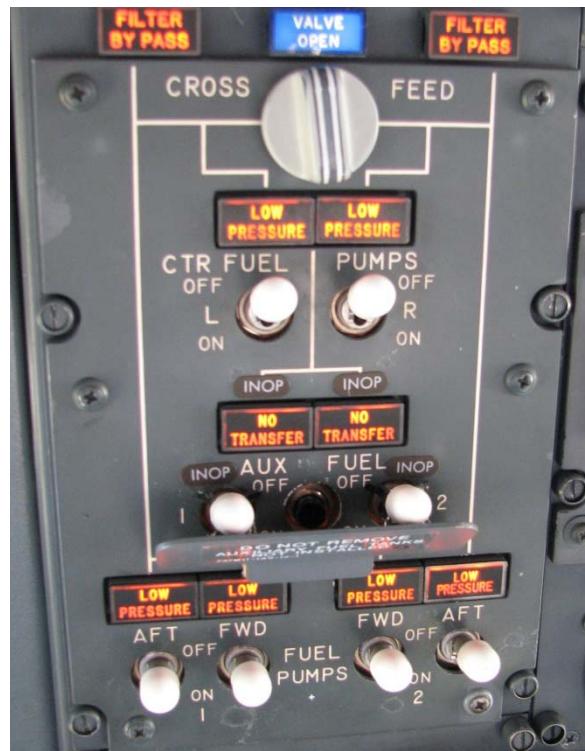
The pilot in command observed that the centre tank fuel pump switches on the forward overhead panel were selected to the OFF position (Figure 2) and he immediately selected them to the ON position. The main fuel tanks were low on fuel and the investigation estimated that there was about 100 kg in each of the main tanks. The centre fuel tank contained about 4,700 kg of fuel when the master caution occurred.

Figure 2: Overhead fuel control panel of VH-TJE photographed from the pilot in command's seat

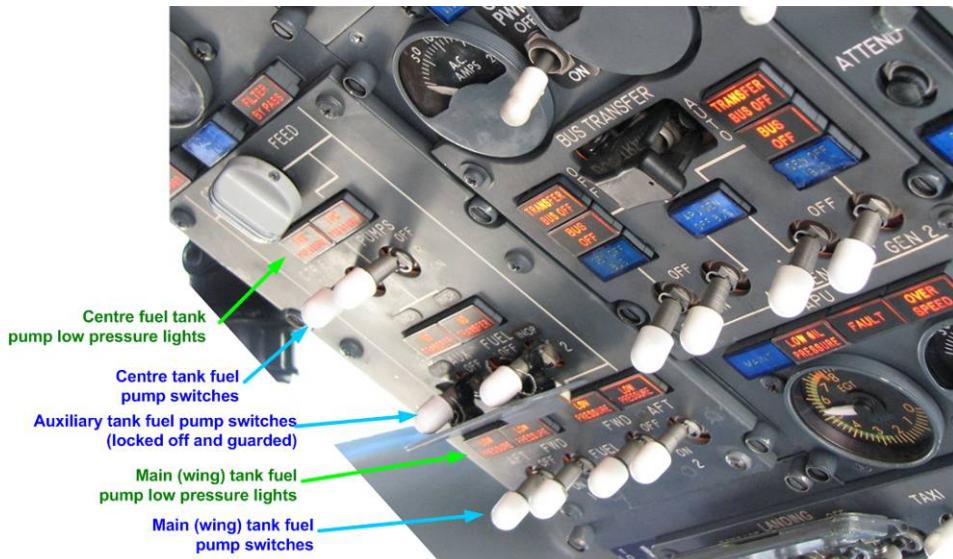
copilot reported that he called '13,000 kilograms, pumps on' and looked up at the fuel control panel. The pilot in command reported that he was probably focussed on the fourth item on the checklist at this time (as this required his response), which was to confirm that his cockpit window was closed and locked.

Figure 3: Overhead fuel control panel of VH-TJE photographed from the copilot's seat

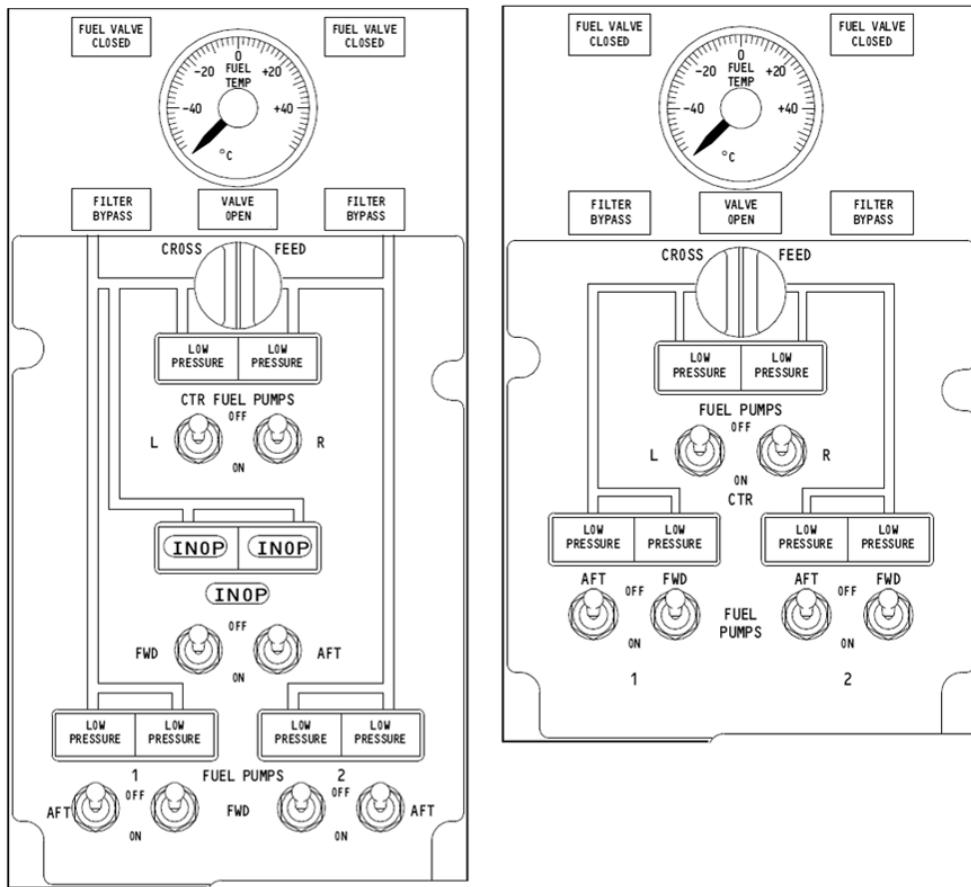
The crew reported that the aircraft's overhead fuel control panel was different from some of the operator's other 737-400 aircraft and from all 737-800 aircraft used by the operator, due to the fitment of auxiliary tank fuel pump switches. The centre tank fuel pump switches on those other 737 aircraft were located in a similar position to the auxiliary tank fuel pump switches on VH-TJE (Figure 5).

Figure 5: Fuel system control panel for 737-400 series with inoperative auxiliary tank (left) and fuel system control panel for other 737-400 and later model aircraft (right)
