**Statens haverikommission**  
Swedish Accident Investigation Board

## ***Report RL 2009:14e***

### **Incident involving aircraft OE-LRW at Åre/Östersund airport, Z län (Jämtland county), Sweden on 9 September 2007**

Case L-27/07

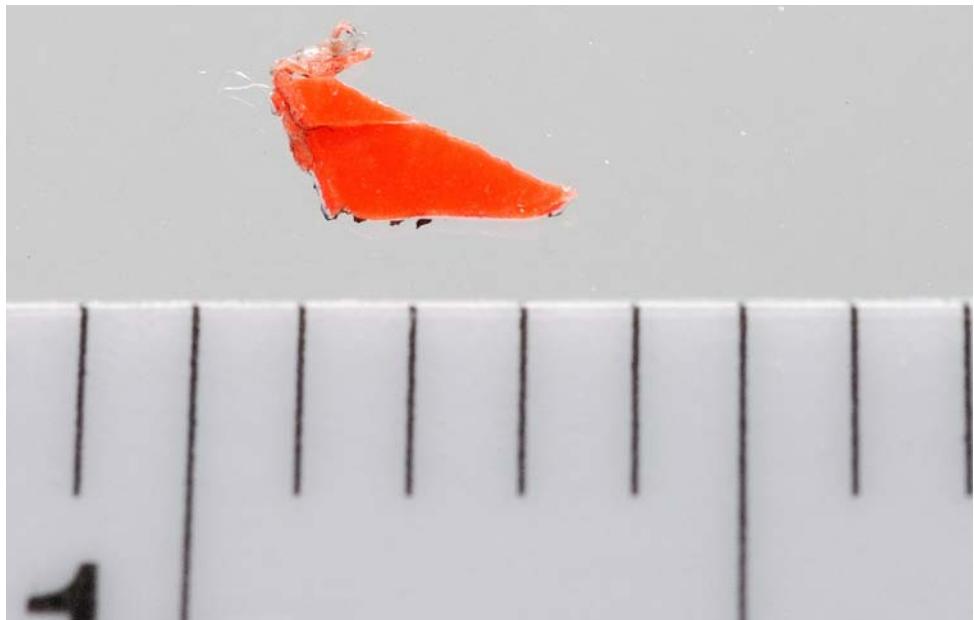
Fig.1. Particle found at the landing gear.

This foreign object consisted of an unknown piece of plastic material coloured orange, measuring about 2.8 x 1.5 mm. The particle was retrieved and sent, together with one of the damaged reflective poles from the airport to SKL<sup>5</sup> for examination and analysis (see Section 1.16.1)

No damage was found to the aircraft. The only evidence that could be found was the paint particle discovered in the landing gear and that could be identified as part of the reflective tape from the snow poles next to the approach lights.

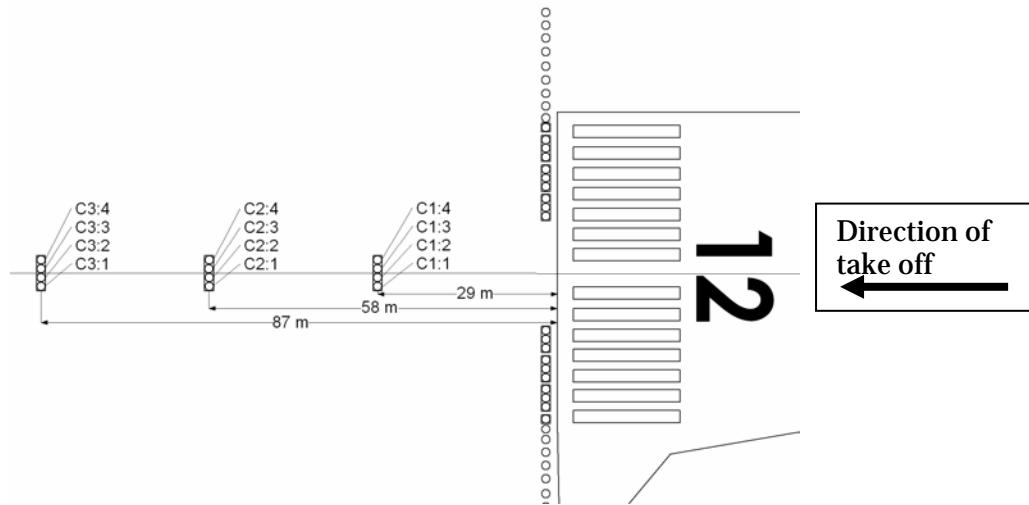
During inspection of the runway on 10 September damage was discovered to the approach lights for runway 12. This lighting was of the Barrette CL Cat I international standard type, and consisted of a 720 m long centreline with the approach lights located at right angles to the runway. There was also a long horizontal transverse light bar located further from the runway end. Damage had occurred to the three approach light bars nearest to the runway, C1, C2 and C3.

Fig.2. Part of the approach lighting to runway 12 at Åre/Östersund airport

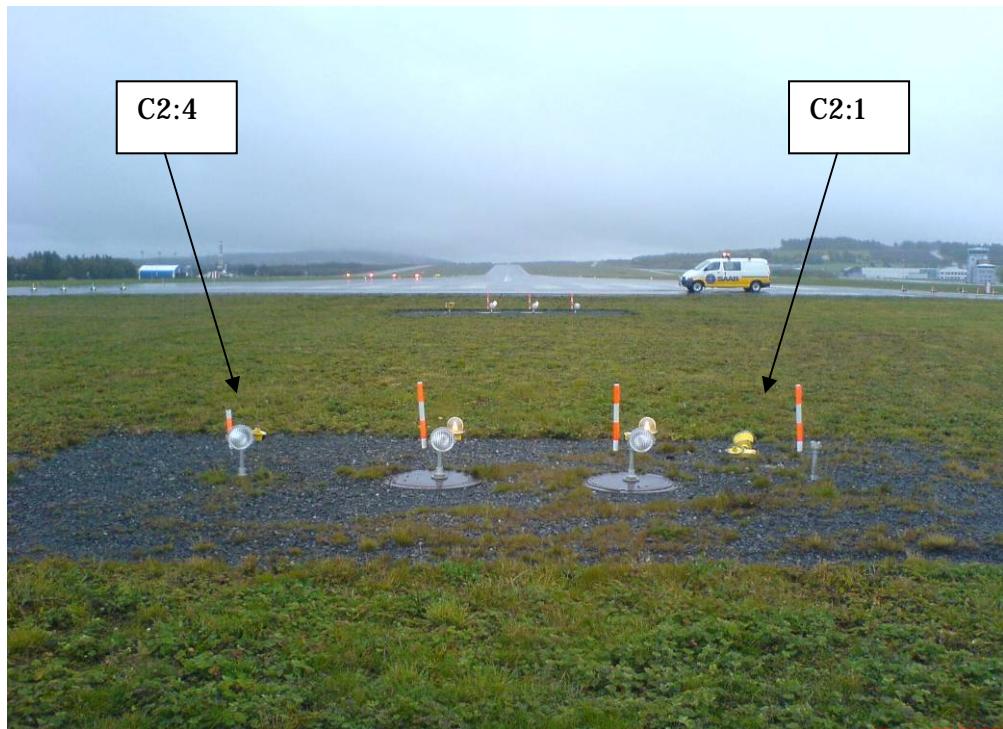
- C1:1: glass housing for low intensity lighting broken, and high intensity light fitting twisted,
- C1:4: lamp housing for high intensity lighting deformed, with two longitudinal scores, broken lens in the high intensity light fitting, reflective snow pole broken off, glass housing for low intensity lighting broken and light fitting direction twisted,
- C2:1: High and low intensity light fittings detached from the upright, lamp housing for high intensity lighting deformed with longitudinal scoring and broken lens, glass housing for low intensity lighting broken,
- C2:4: glass housing for low intensity lighting broken, light fitting twisted, reflective snow pole broken off and connection box cracked,
- C3:1: reflective snow pole bent, low intensity lighting broken, reflective snow pole detached from upright.

Fig.3. Second row of approach lights.

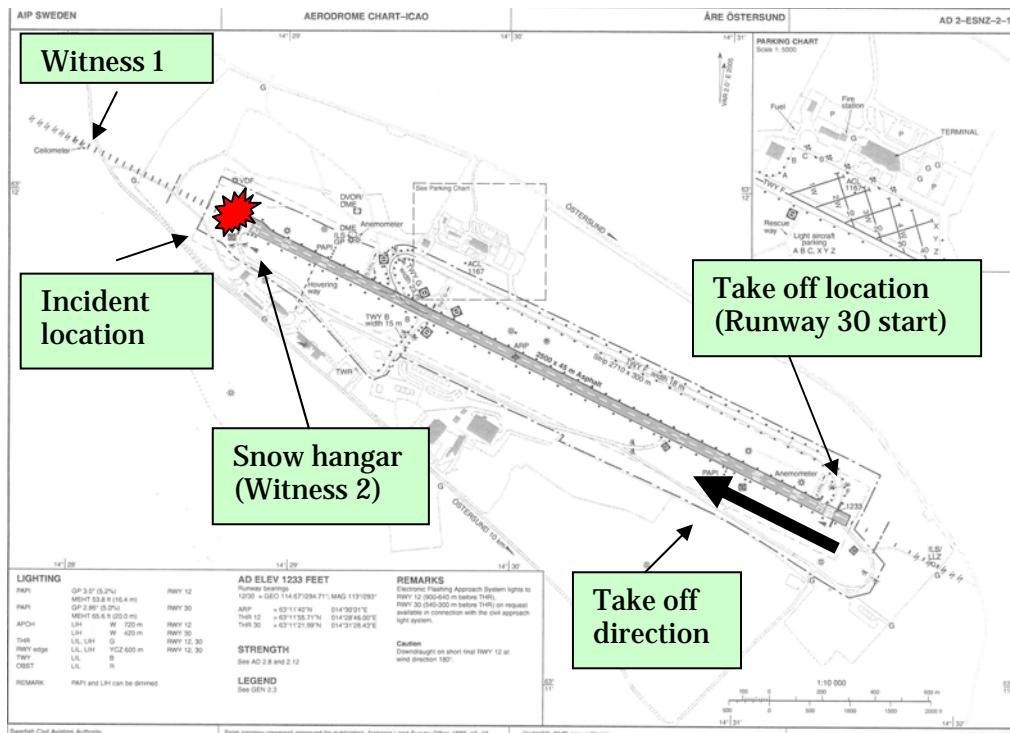
The incident occurred at Åre/Östersund airport, ESNZ, in connection with a take off to the north-west on runway 30. The incident, during which the air-

craft landing gear struck the opposite runway's approach lighting, took place at the gravel surface beyond the end of the asphalted runway.

Fig. 6. Map extracted from AIP-Sweden showing Åre/Östersund airport with annotations for the incident sequence.

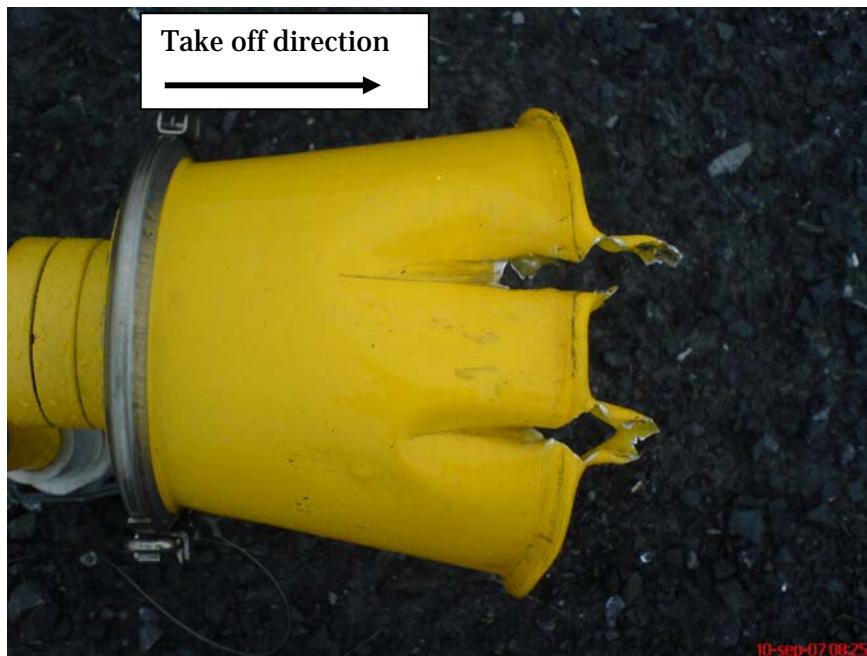
Fig.7. Lamp housing C1:4.

Figure 7 shows the damage to lighting fixture C 1:4. The lamp housing has two longitudinal parallel dents and tears. The sheet metal material at the front

edge of the lamp housing has been torn out in the direction of the runway where the aircraft took off.

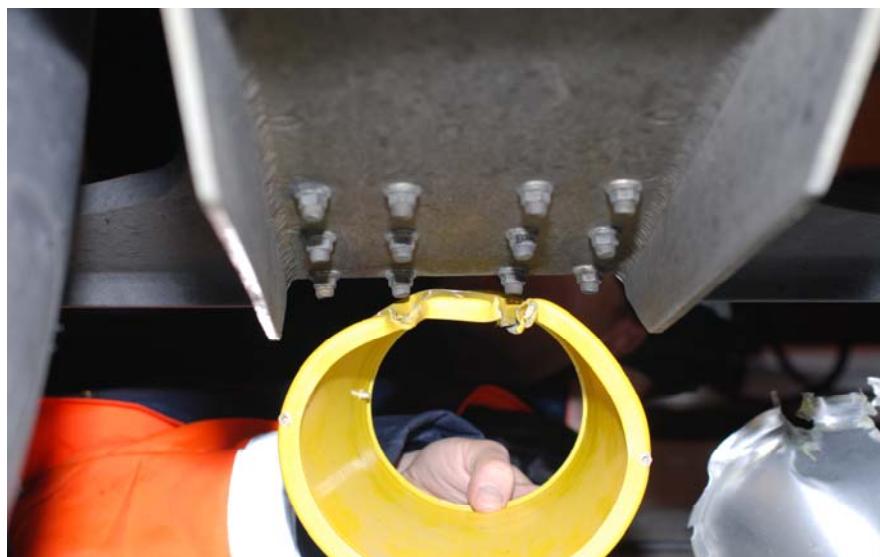
Figure 8 shows a detail view of part of the MD-83 landing gear. The distance between the inner pair of rows of the projecting bolts matches the damage to the lamp housing very well.

Fig.7. Detail view of part of the MD-83 landing gear and lamp housing C1:4.

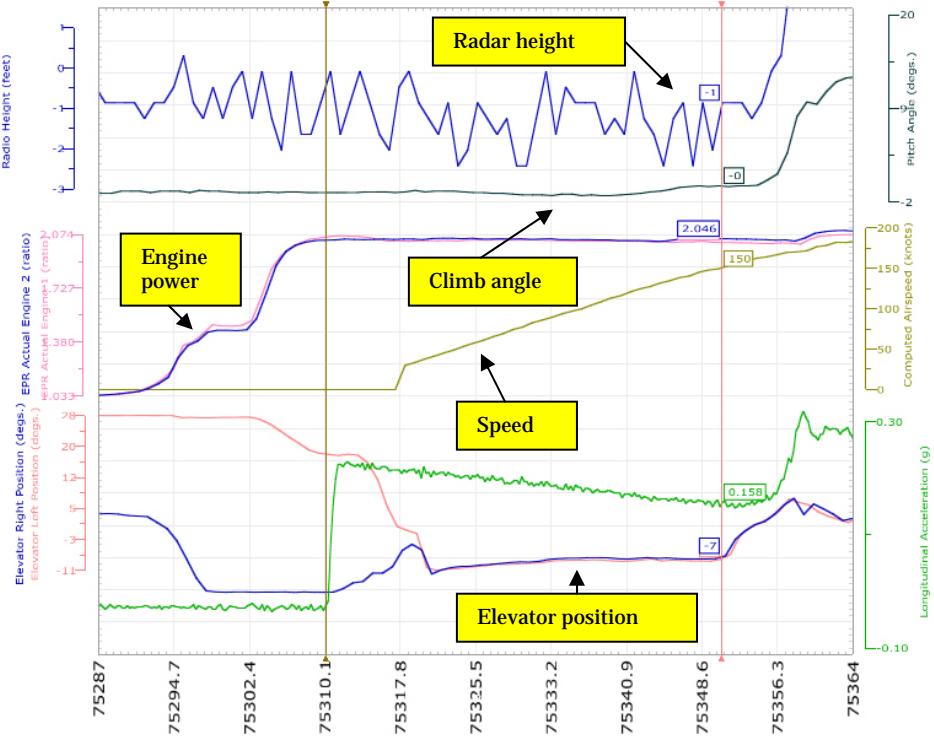
Fig.8. Extract from the flight data recorder during the take off sequence. The horizontal axis shows the time in seconds.

Figure 8 shows certain parameters taken from the flight data recorder during the take off sequence. The horizontal axis shows the time in seconds. The beginning of the take off sequence is indicated by a vertical line at 75 310.1, and the moment when rotation began is at 75350.6, i.e. when the elevators were moved to lift off the runway, with the speed at that time being 151 knots Computed Airspeed, CA. The difference between CA and the speed that the pilots could see on the instruments, the indicated air speed (IAS) is negligible. According to the flight data recorder rotation took place at about 2° per second, up to about +14° pitch angle.

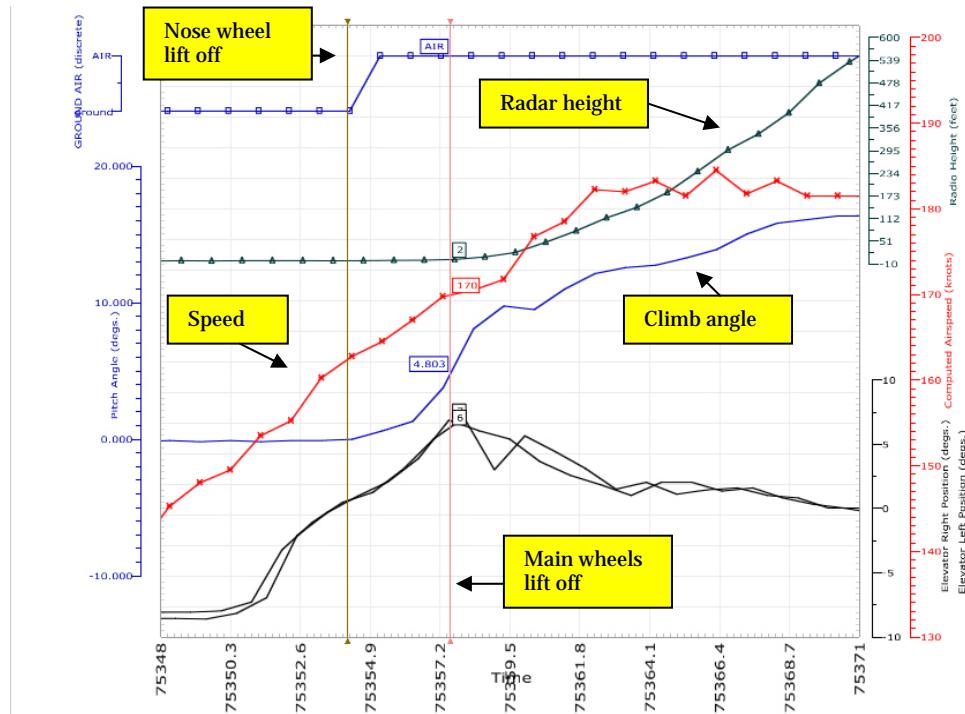
Fig. 9. Extract from the flight data recorder during the later part of the take off sequence. The horizontal axis shows the time in seconds.
