# Air Accidents Investigation Branch

Aircraft Incident Report No: 5/2007 (EW/C2005/03/02)

**Aircraft Type and Model:** Airbus A321-231

**Location:** On final approach to Runway 36, Khartoum Airport, Sudan

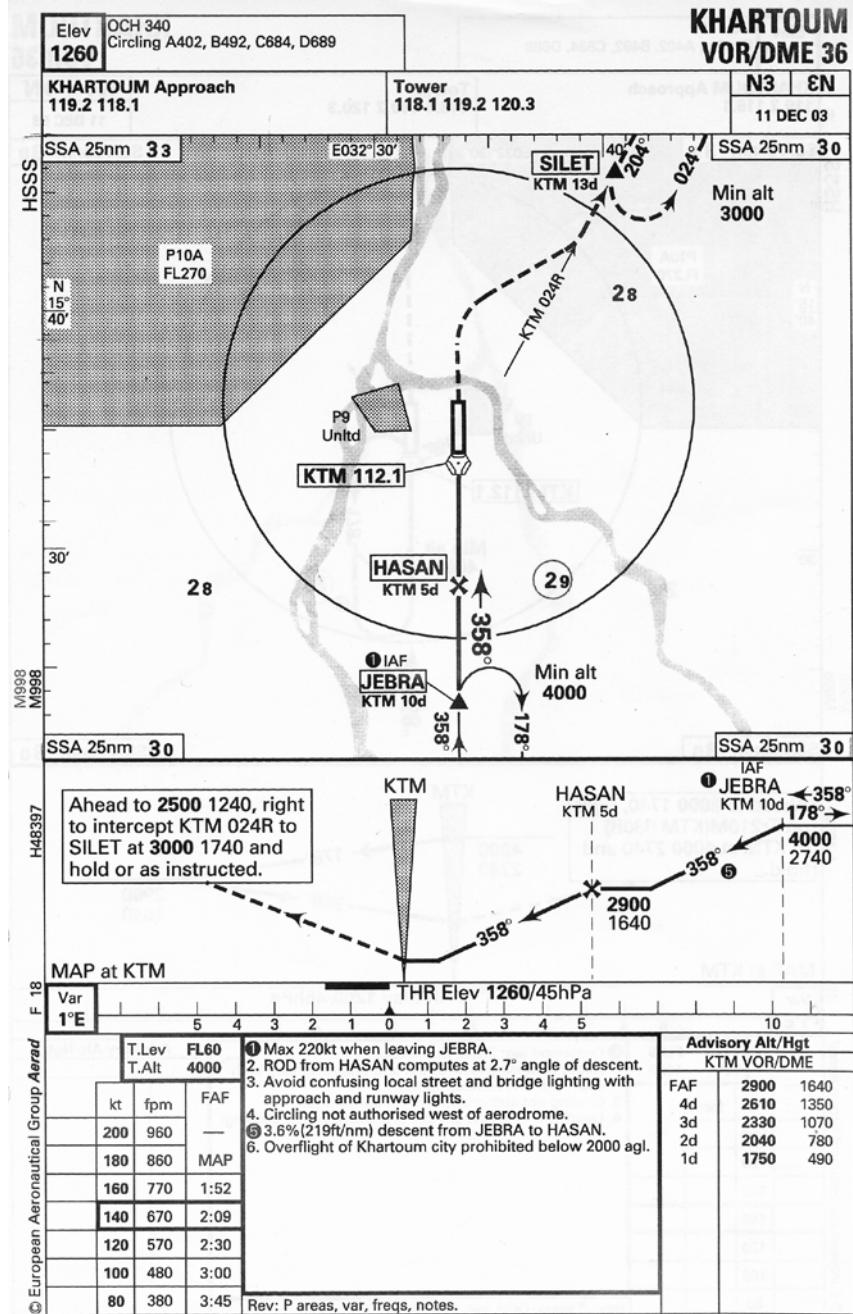
**Figure 1**  
VOR/DME 36 Approach Chart

The pilots followed the procedure and stated that upon reaching the Final Approach Fix (FAF) shown on their chart and identified by the waypoint HASAN at KTM 5 DME<sup>2</sup>, the aircraft was level at 2,900 ft QNH, fully configured for landing, and stabilised at the appropriate airspeed. They also checked the latest

visibility with ATC which was reported to be between 1,000 m and 1,200 m. The commander had programmed the autopilot to intercept and capture the final approach course and to descend in accordance with the final descent path. On the chart the final descent path is shown as commencing at 5 DME from the KTM VOR.

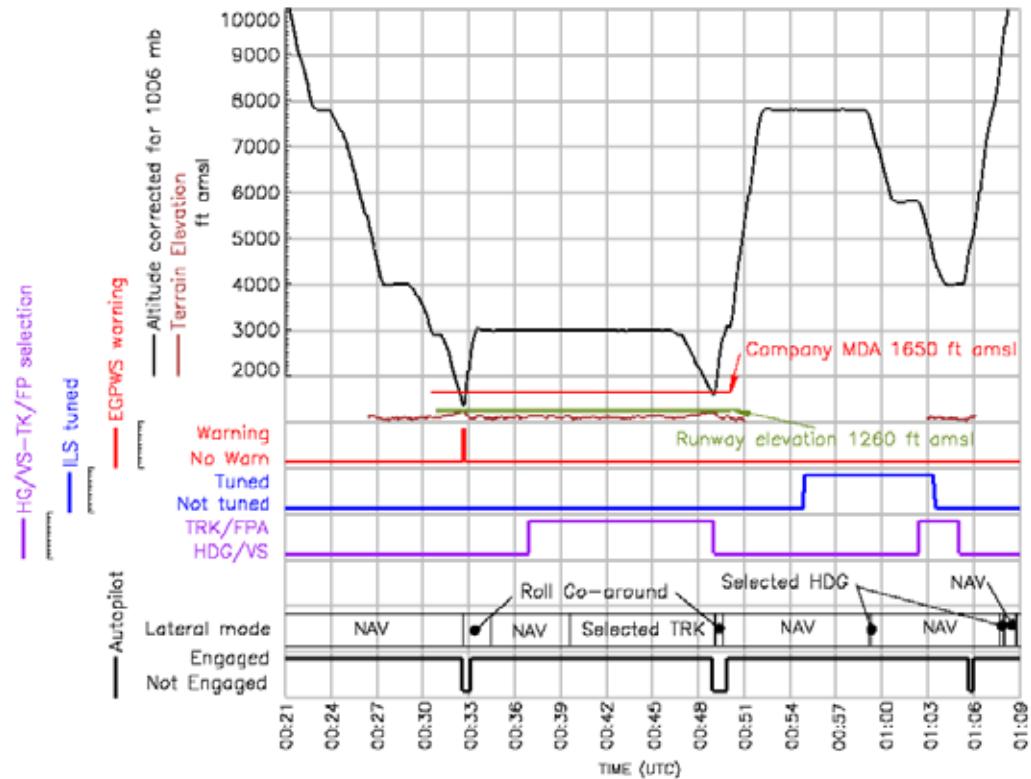
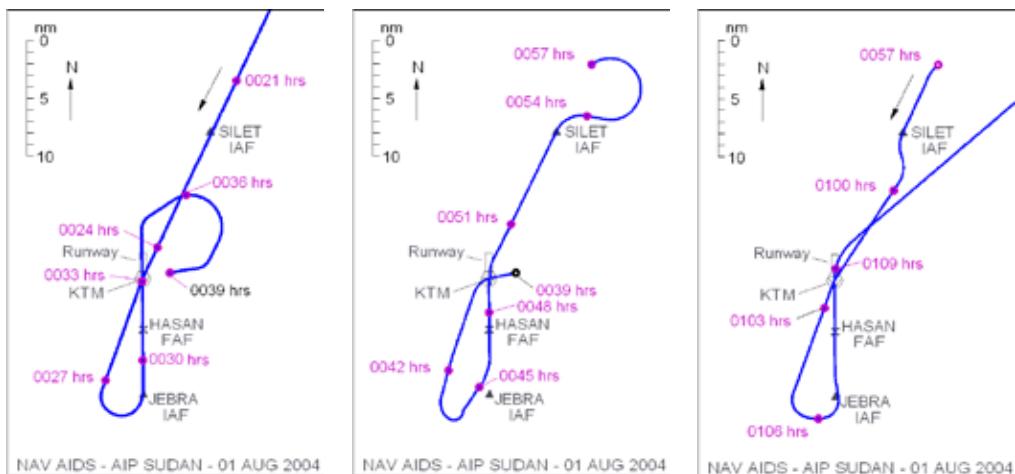
**Figure 4**

General overview of the flight path in the vicinity of Khartoum

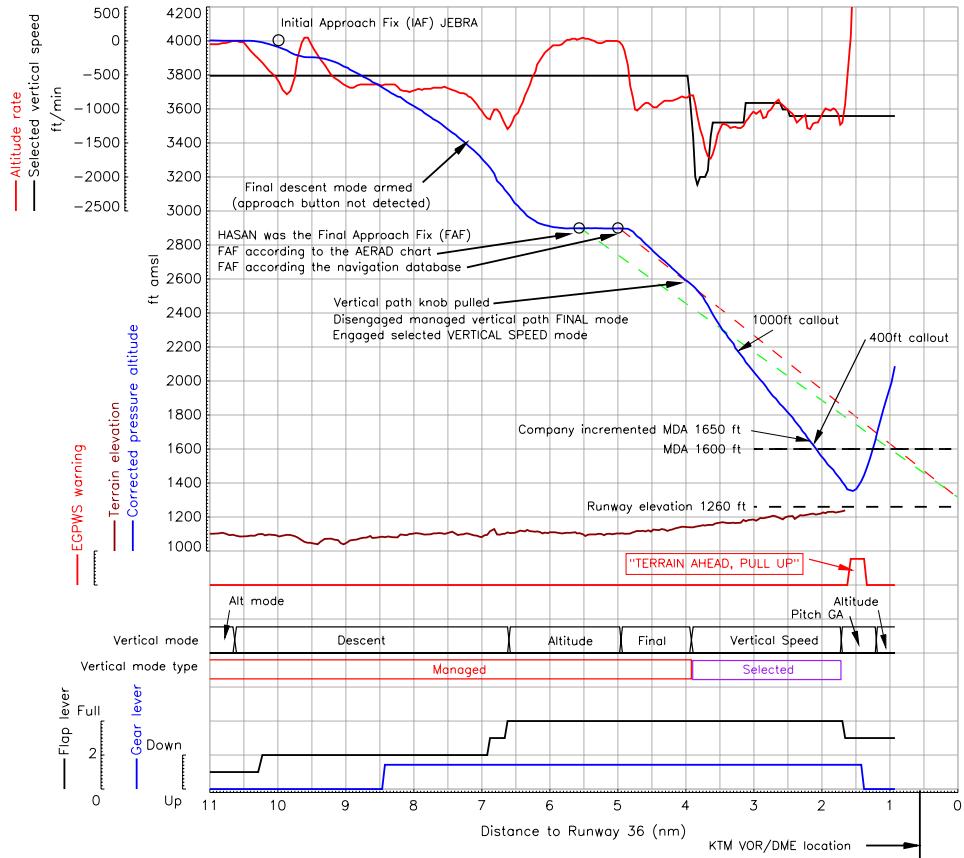
**Figure 5**

First approach shown relative to distance to the runway threshold, KTM VOR/DME and different reference points for the final approach fix

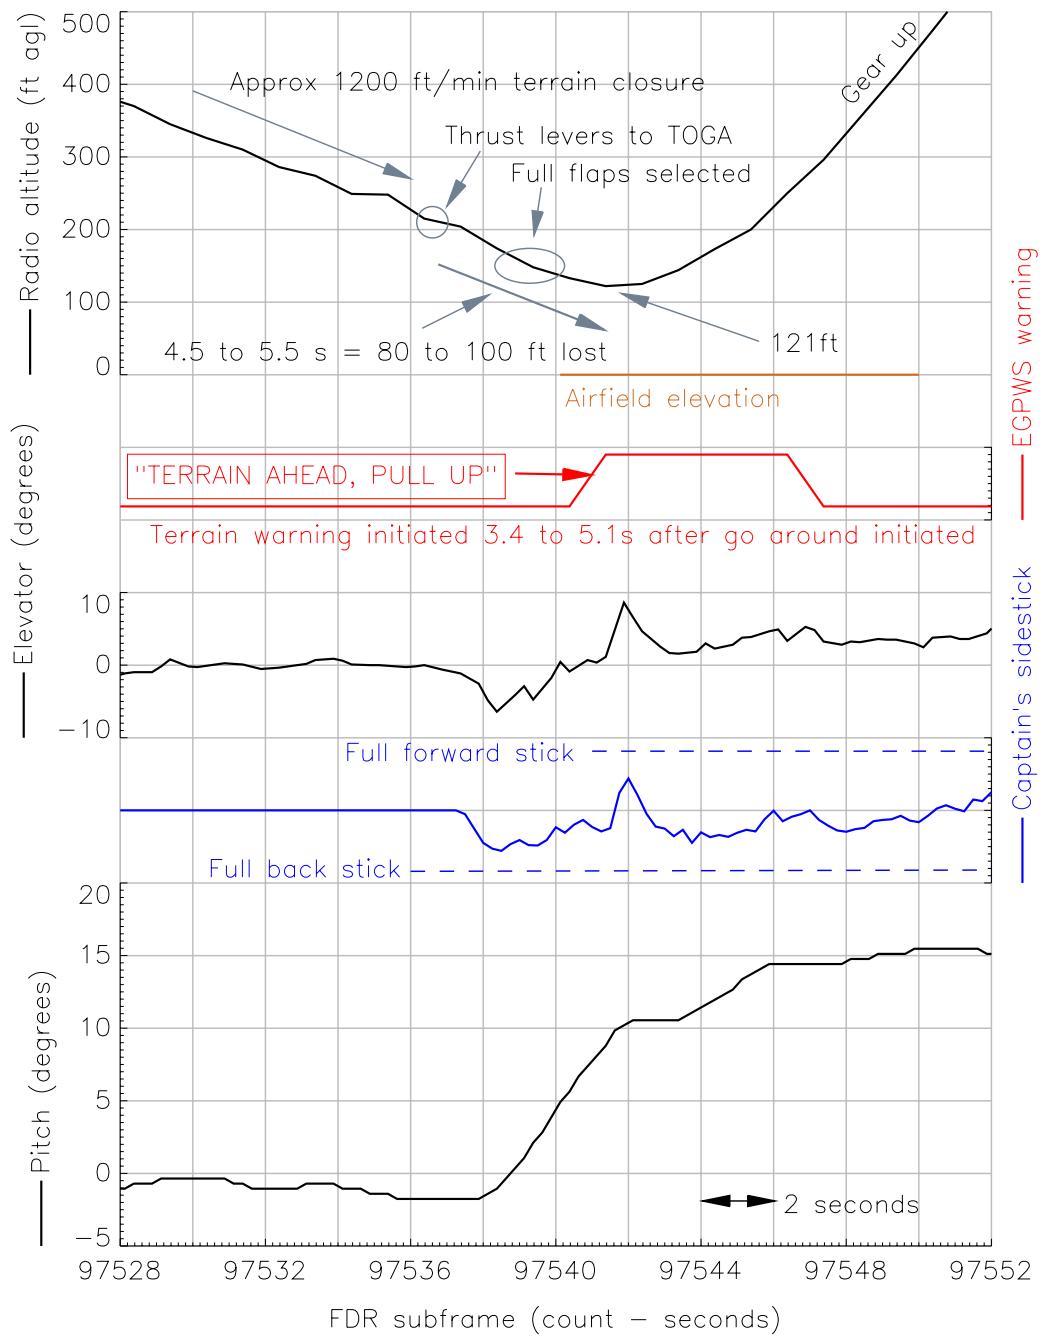
**Figure 6**  
EGPWS warning during the first go-around

The commander stated that with the autopilot still engaged, he selected the thrust levers to TOGA<sup>5</sup> and that almost simultaneously the EGPWS (Enhanced Ground Proximity Warning System) sounded a “PULL UP” warning. The commander reported that he noted the aircraft’s attitude was 5° nose-up and so he pulled back on his sidestick with sufficient force to disengage the autopilot and increase the pitch attitude to between 17° and 20° nose-up. Thereafter he relaxed the back pressure once he was sure the EGPWS warning had stopped. He then instructed the co-pilot to re-engage the autopilot.

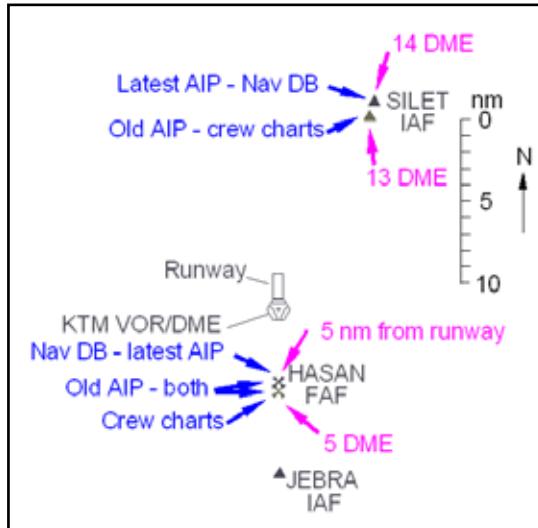
**Figure 7**

On the pilot's approach chart, which was also commercially supplied but from a different supplier, the final descent point was depicted at 5 nm from the threshold of Runway 36 whereas the FMGC's navigational database had been correctly updated with a recent change

to this position published by the Sudanese CAA which placed it at 4.4 nm from the threshold. The discrepancy amounted to a difference in descent point of 0.6 nm from the Khartoum VOR/DME beacon, the primary navigation aid for the non-precision approach.

Comparison of waypoint locations as shown in the Sudanese AIPs, the Navigation database and the crew charts

The UK CAA should publish guidance to pilots regarding the appropriate action when faced with a conflict in approach parameters between their approach charts and an FMS database authorised for managed non-precision approaches. (Safety Recommendation 2007-046)

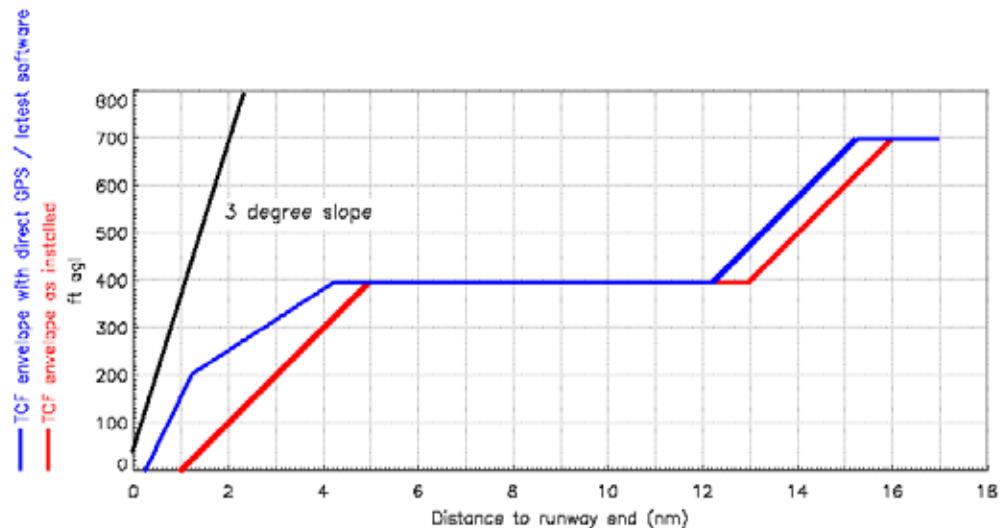
**Figure 11**

The actual boundary is shown in more detail in Figure 11 together with the alert envelope that would have been active had the latest software and a GPS direct link been installed in G-MEDG. These were not current requirements and were not available at the time of initial installation. Penetrating below these alert envelopes would result in a “TOO LOW TERRAIN” alert.

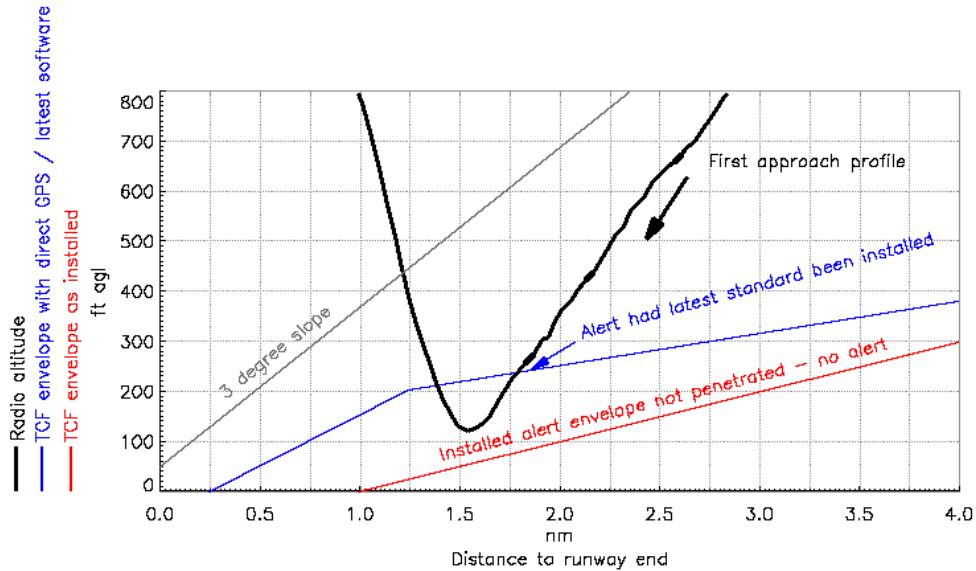
**Figure 12**

The fact that the GPS, GPIRS and FMC positions were close and correlated with the recorded DME distance showed that navigational accuracy was not a factor in the ineffectiveness of the EGPWS in this instance. No anomalies with other sources of data were identified and the EGPWS was fully operational as established by analysis by the manufacturer. The lack of a timely alert was a factor of the design of the system.

The navigation system as installed included a GPS source and so provided accuracy that exceeded the applicable TAWS requirements even though the GPS did not directly feed the EGPWS. Further manufacturer analysis of the data highlighted that had a direct link between the GPS and the EGPWS been installed and the latest software used, the TCF alerting envelope would have triggered a “TOO LOW TERRAIN” with a radio altitude of approximately 240 ft as shown in Figure 12. The “PULL UP” warning trigger point would not have changed. The alert at 240 ft radio altitude would have served as an earlier, systematic alert whereas none was given by the system installed at that time.

The TCF alert envelope as fitted compared to the latest certified alert envelope with a direct GPS feed to the EGPWS

The European Aviation Safety Agency, in conjunction with industry, should review the current TAWS system design criteria (ETSO-C151a), and installation certification criteria, with particular emphasis on the timeliness of alerting when close to the runway. Revisions to these standards arising from this review should apply retrospectively to all aircraft currently covered by the TAWS mandate. (Safety Recommendation 2007-044)
