# WORK IN PROGRESS

A Boeing 737 was due to depart Manchester on a flight to Greece with seven crew and 190 passengers on board. The scheduled departure time was 1355. At the time, there was work in progress on runway 06L. This involved several large vehicles removing rubber deposits from the 24R threshold. This had the effect of reducing the available runway length for take-off. This information was contained in a NOTAM and also broadcast on the ATIS.

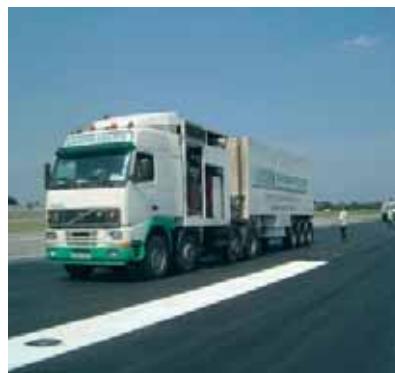
way and continued its departure. ATC did not comment on the incident either then, or on their return to Manchester. Consequently, as they believed nothing untoward had occurred on the take-off, no report was made. In fact, subsequent calculations suggest that the aircraft passed within 56 ft (17 m) of a 14 ft (4 m) high vehicle (see illustration).
