Investigation Report

EX001-1/2/06
March 2009

Type of Occurrence: Serious Incident
Date: 12 January 2006
Location: Frankfurt/Main
Aircraft: 1) Transport Aircraft
 2) Transport Aircraft
Manufacturer / Model: 1) Airbus / A320-214
 2) Boeing / B747-200B
Injuries to Persons: None
Damage: Aircraft not damaged
Other Damage: None
Source of Information: Investigation by BFU

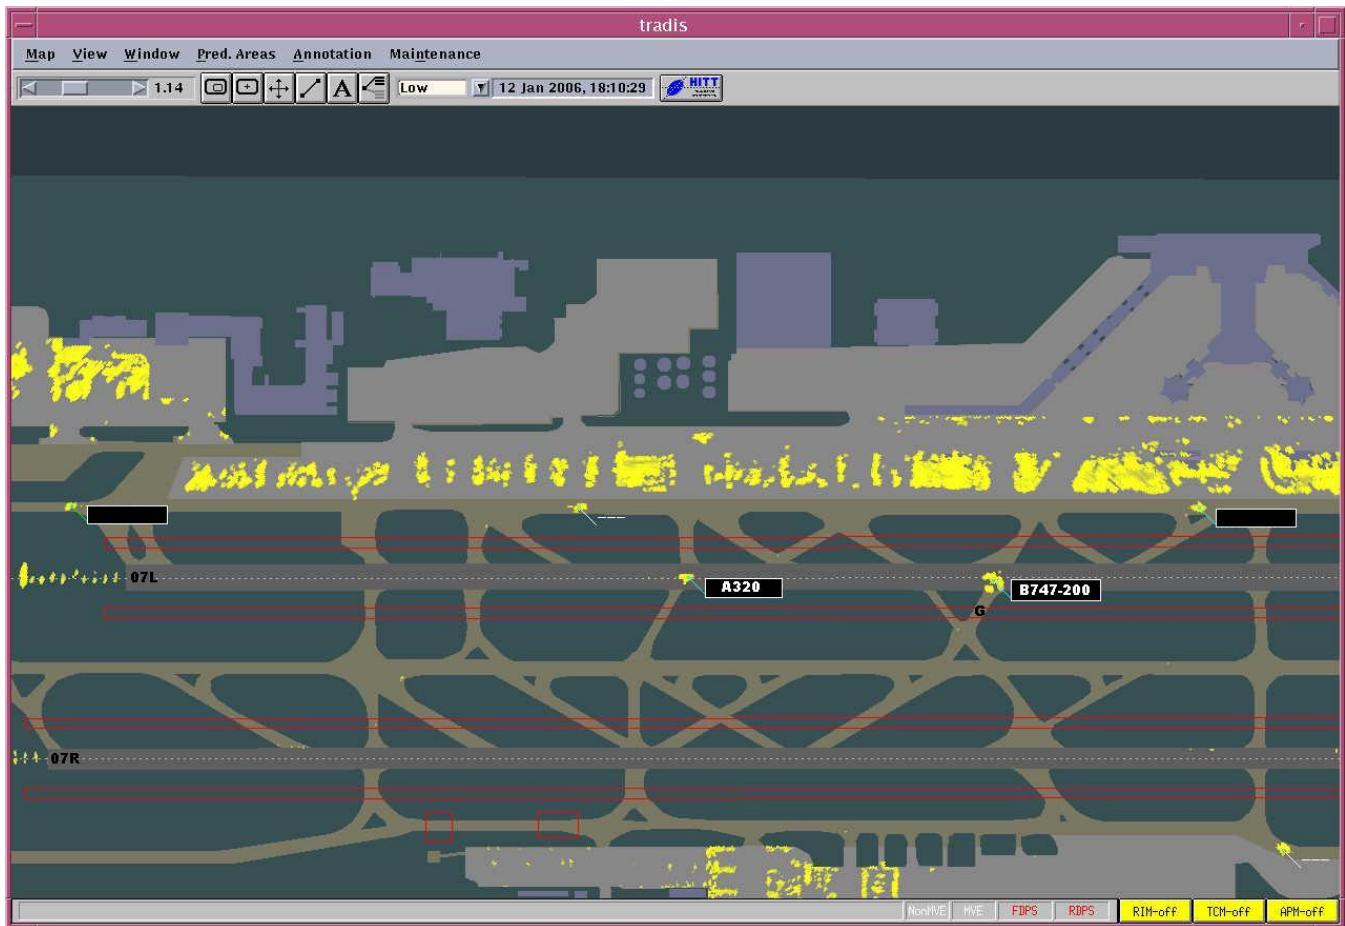
Taxiway G joins Runway 07L about 2,600 m after the Runway threshold. The Taxiway intersects the south side of Runway 07L/25R at an angle of about 56° (see drawing).

When the B747 entered the runway it was on taxiway G, which intersects the runway at an angle of about 56°. At the time of touch down and during landing roll, the A320 was about 124° to the left of the Boeing's longitudinal axis; in other words, to the left rear. This area cannot be seen by the co-pilot in the right-hand seat, and is very difficult to see for the pilot-in-command in the left-hand seat.
