ALERT CONTROLLER PREVENTS CFIT ACCIDENT

The incident described below involved an Airbus A310 passenger flight to Birmingham Airport in November 2006. The account of the incident is reprinted from UK AAIB Bulletin 4/2007, omitting only the introductory information.

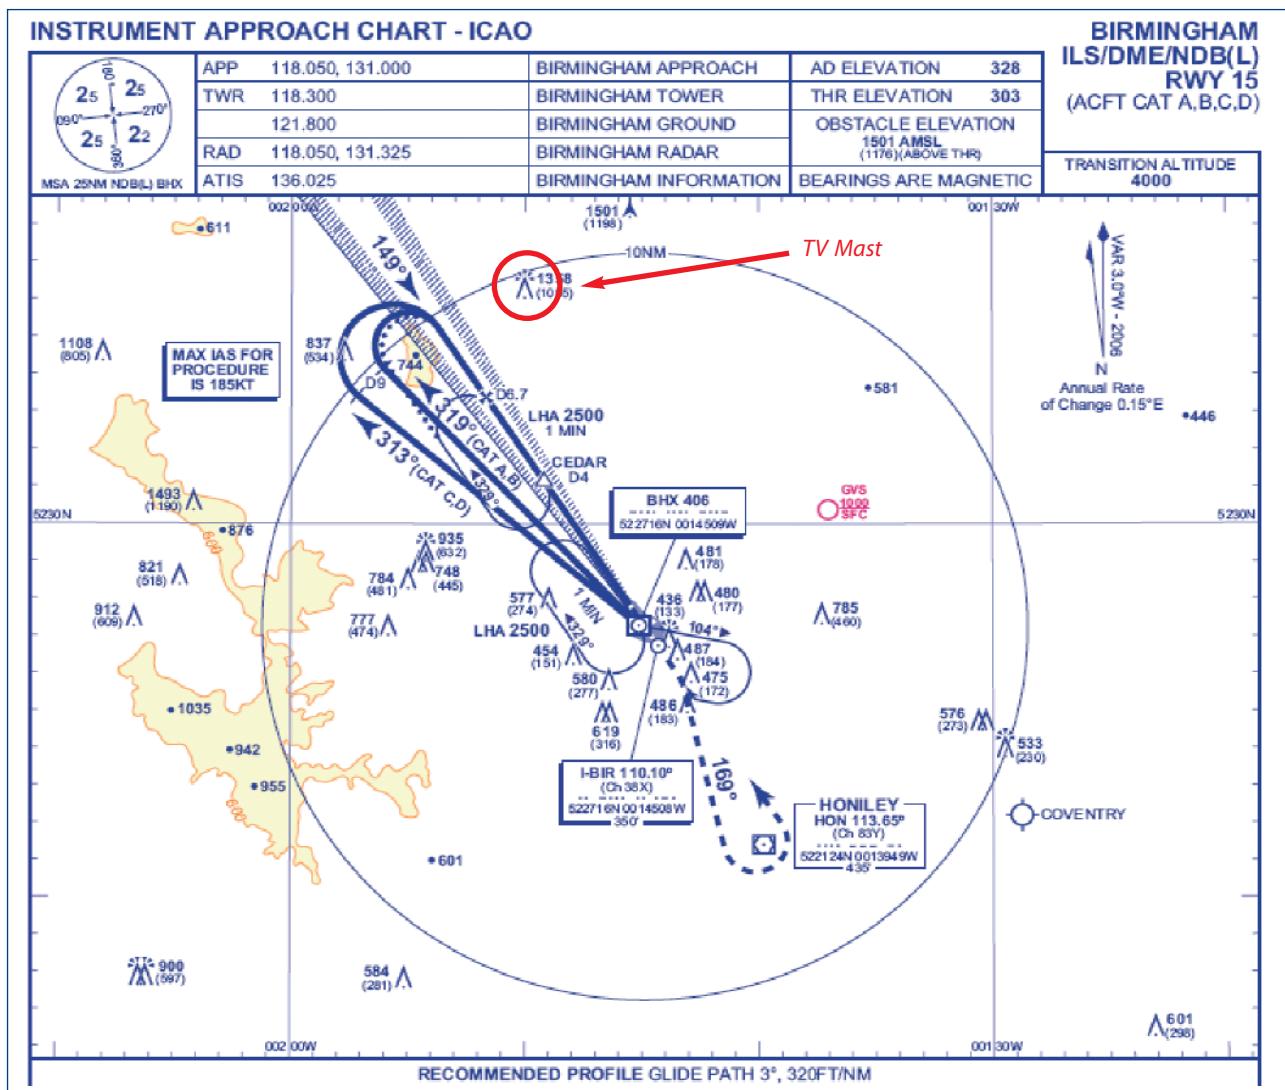
Extract from the UK AIP, published with the permission of UK CAA, showing the ILS approach procedure to RWY 15 at Birmingham Airport. The television mast is circled in red.

and that indicated on the altimeters. Consequently, thus when the altimeters were indicating 2,500 ft the aircraft had actually descended to 1,570 ft. As the aircraft continued its descent below its cleared level of 2,500 ft the radar controller notified the crew and warned them of the mast ahead. Having realised that the altimeter sub scale setting was incorrect the crew
