**UK AIRPROX BOARD**

# **Analysis of Airprox in UK Airspace**

**Report Number 21  
July 2008 – December 2008**

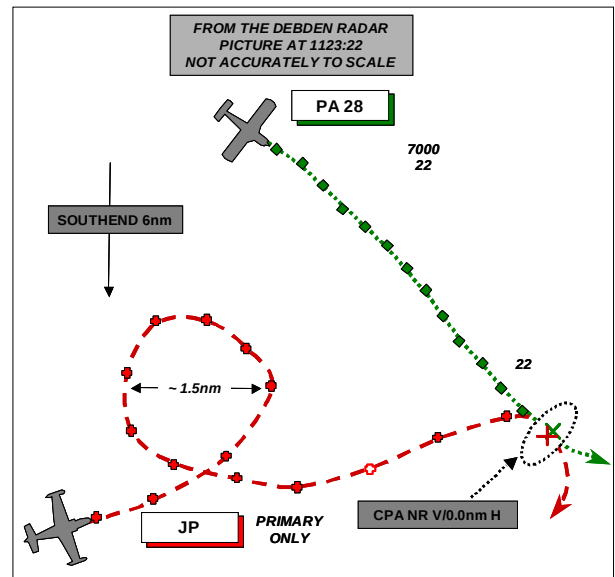
Date/Time: 12 Jul 1123 (Saturday)  
Position: 5140N 00042E (5nm N Southend  
 - elev 203ft)  
Airspace: London FIR (Class: G)  
Reporting Ac Reported Ac  
Type: PA28 Jet Provost  
Operator: Civ Pte Civ Trg  
Alt/FL: 2000ft NR  
 (1008 QNH) (N/K)  
Weather VMC NR VMC NR  
Visibility: 30km NR  
Reported Separation:  
 0ft V/200m H NR  
Recorded Separation:  
 NR V/0nm H

Cause: A non-sighting by the Jet Provost crew compounded by late avoiding action by the PA28 pilot.

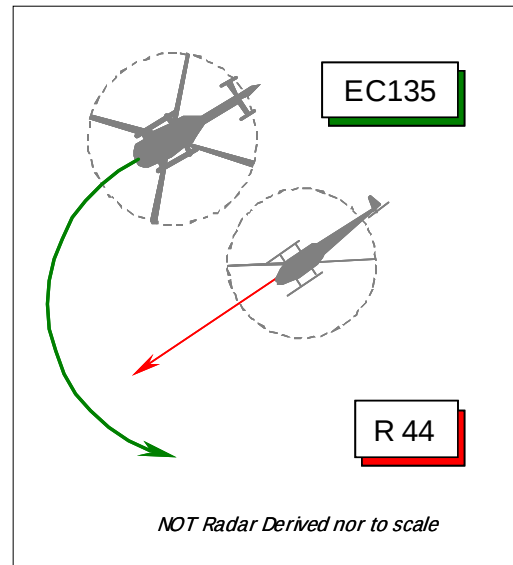
Date/Time: 19 July 0953 (Saturday)  
Position: 5019N 00449W  
(10nm SSE St Mawgan)  
Airspace: London FIR (Class: G)  
Reporting Ac Reported Ac  
Type: EC135 Robinson R44  
Operator: Civ Comm Civ Pte  
Alt/FL: 500-600ft 900ft  
agl RPS (1004mb)  
Weather VMC CLBC VMC NR  
Visibility: 10km+ >10km  
Reported Separation:  
100ft V/nil H 400ft V/1-2km H  
Recorded Separation:  
NR

In the Board's view the R44 pilot could have given the EC135 a wider berth when he first saw it and concluded that the cause of this Airprox was that the R44 pilot's chosen flight path caused the EC135 pilot concern. However with the R44 pilot visual with the EC135 throughout and able to afford wider separation if need be then the Members agreed unanimously that no risk of a collision had existed in these circumstances.

Cause: The R44 pilot's chosen flight path caused the EC135 pilot concern.

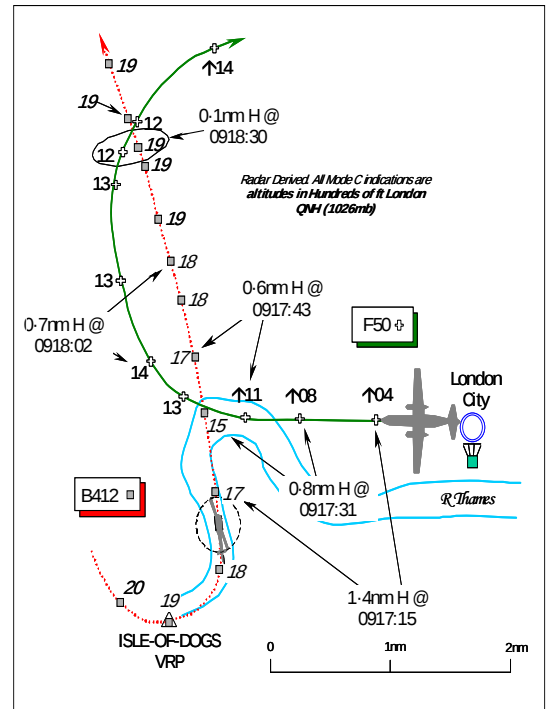
Cause: Having passed the Isle of Dogs VRP, the B412 Griffin crew did not comply with TOWER's instruction to pass behind the Fokker 50 and flew into conflict with it.

Safety Recommendation: In concert with the MoD, the CAA should, for the benefit of controllers and pilots alike, review references to the term 'clearance limit' in MATS Pt 1; CAP413 and the applicable JSPs to ensure consistency both of meaning and usage of this RT phraseology.

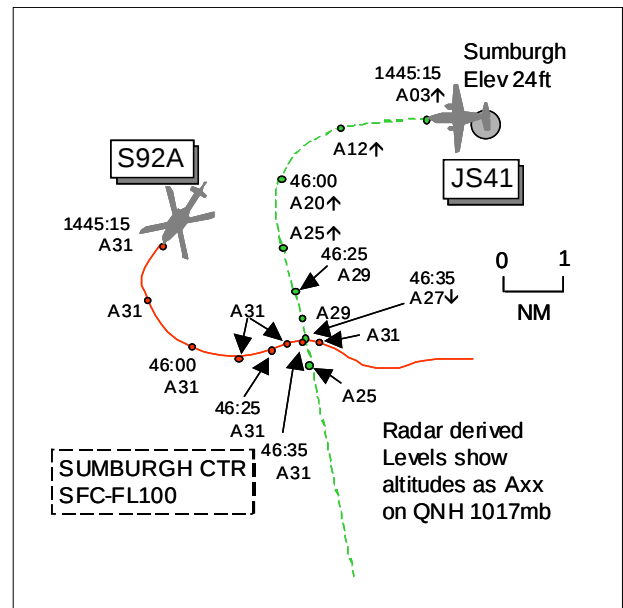
Date/Time: 22 Jul 1446  
Position: 5949N 00123W (4.5nm SW Sumburgh  
 - elev 24ft)  
Airspace: CTR (Class: D)  
Reporter: Sumburgh Radar Controller  
First Ac Second Ac  
Type: JS41 S92A  
Operator: CAT Civ Trg  
Alt/FL: 3000ft↑ 3100ft  
 (QNH 1022mb) (QNH)  
Weather VMC CLAC VMC CLAC  
Visibility: 10km >10km  
Reported Separation:  
 800ft V/0.5nm H 500ft V/0.5nm H  
Recorded Separation:  
 >400ft V/Nil H

Cause: Sumburgh Radar Controller released the JS41 into conflict with the S92A.

The NATS Advisor informed Members of actions taken by the ANSP since the Airprox. Two Safety Notices have been published, one highlighting procedures to be taken by controllers when they are concerned about lack of operational currency and a second highlighting safety risks caused by inappropriate distractions of controllers at operational positions. A Supplementary Instruction was also produced detailing the production and use of extra fps when the level box of a fps becomes cluttered, usually occurring when an ac is on a training flight. Sumburgh controllers are now required to read back any level given to them by Radar, even if it is the Standing Agreement level, and appropriate refresher training was undertaken by the radar controller involved.
