AIRCRAFT ACCIDENT REPORT 5/2000

Air Accidents Investigation Branch

**Report on the accident to
Boeing 767-322ER, N653UA
at London Heathrow Airport
on 9 January 1998**

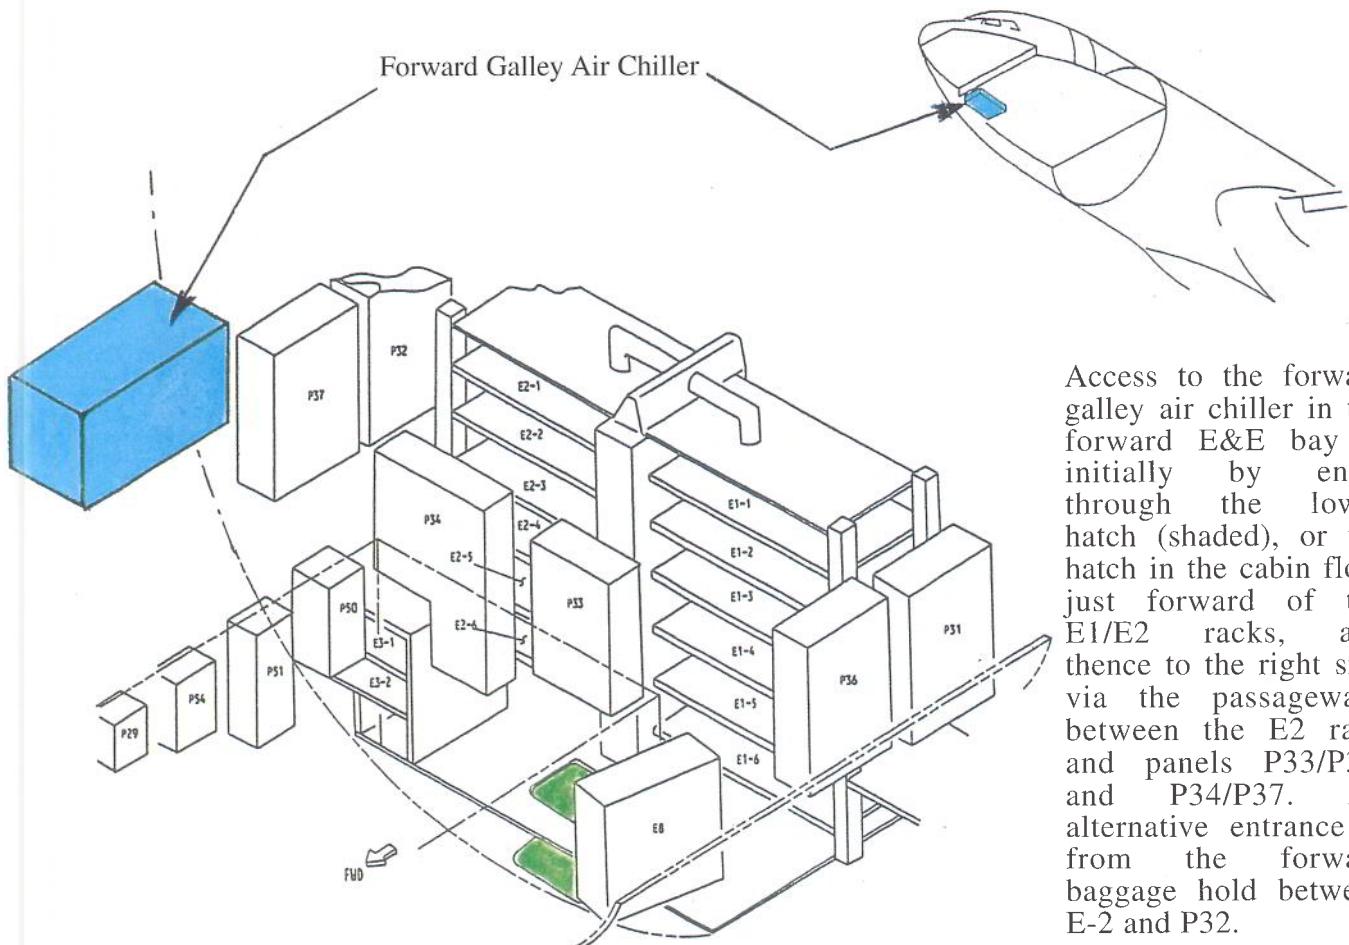
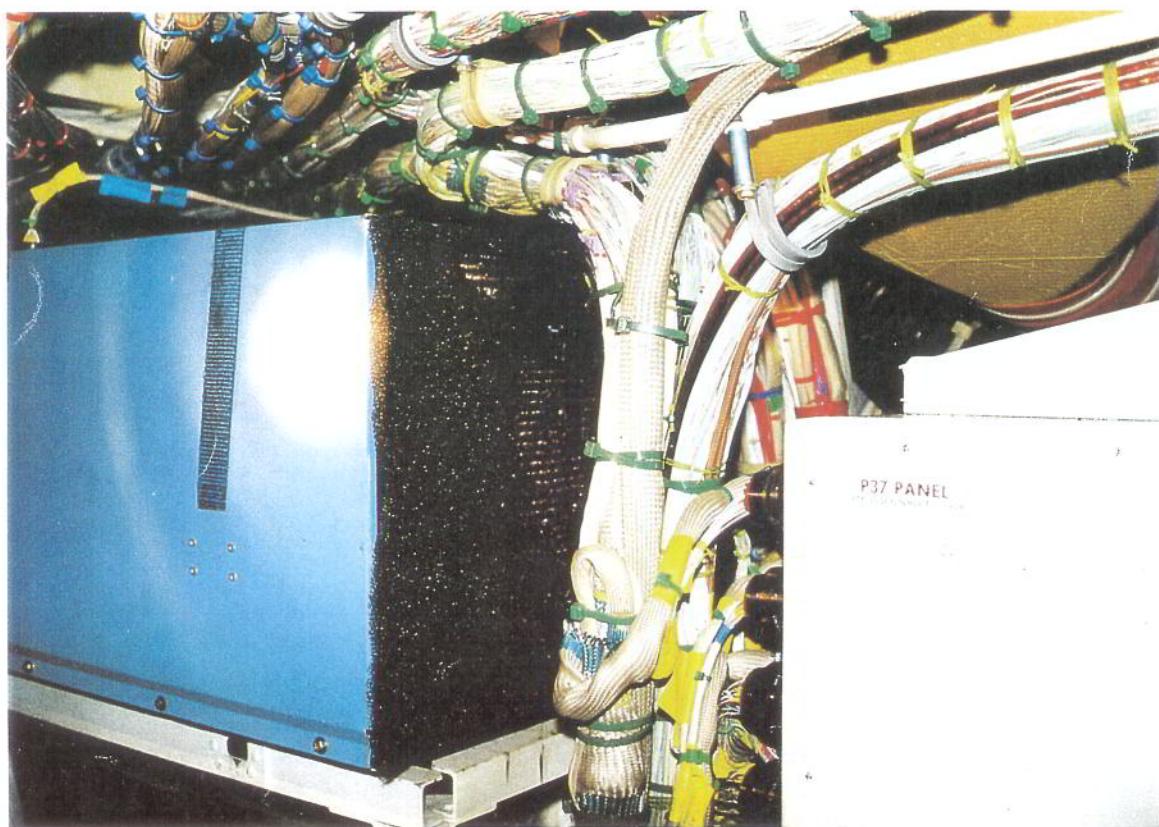
General view, looking forward and outboard, of the aft inboard corner of the galley chiller unit (blue) in relation to the wiring looms. Crew emergency oxygen bottle is located beneath chiller.

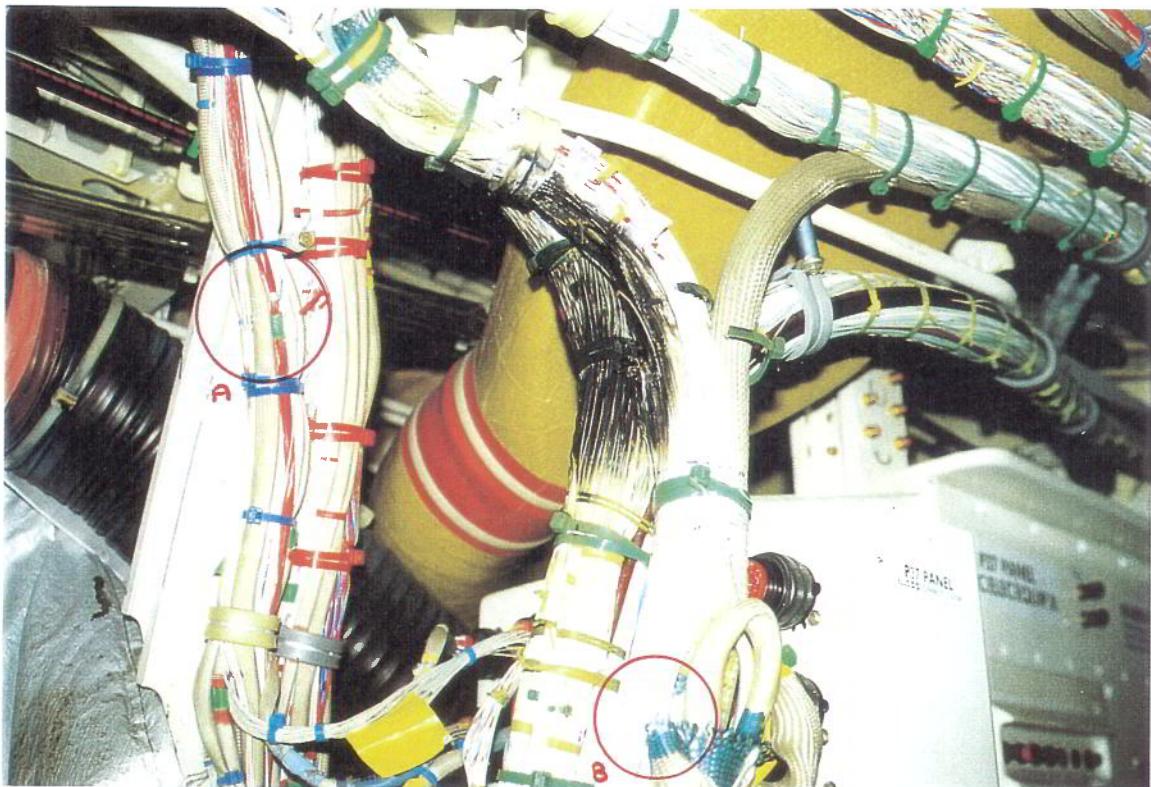
General view of damaged wires after chiller removal, with partially failed loom nearest the camera. Areas identified A and B exhibit wire damage not directly related to the loom failure (see Figure B-3). Of significance, damage at A is approximately at the same height as the failed section of loom.

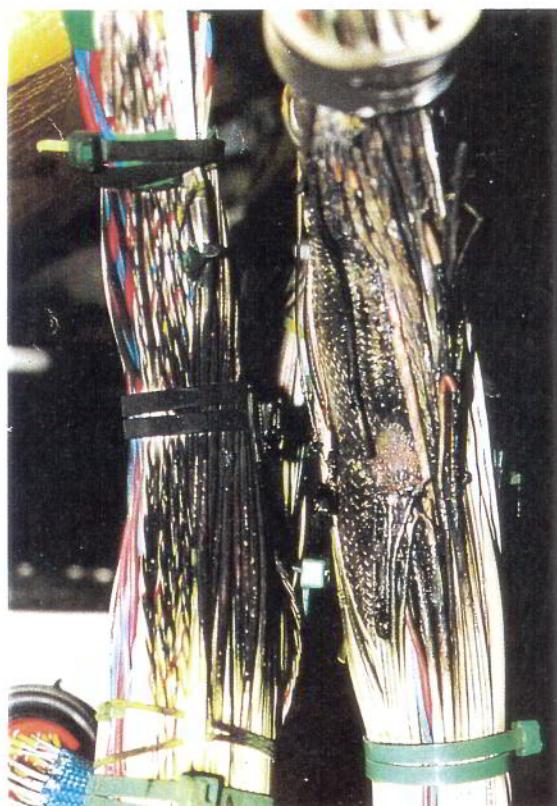
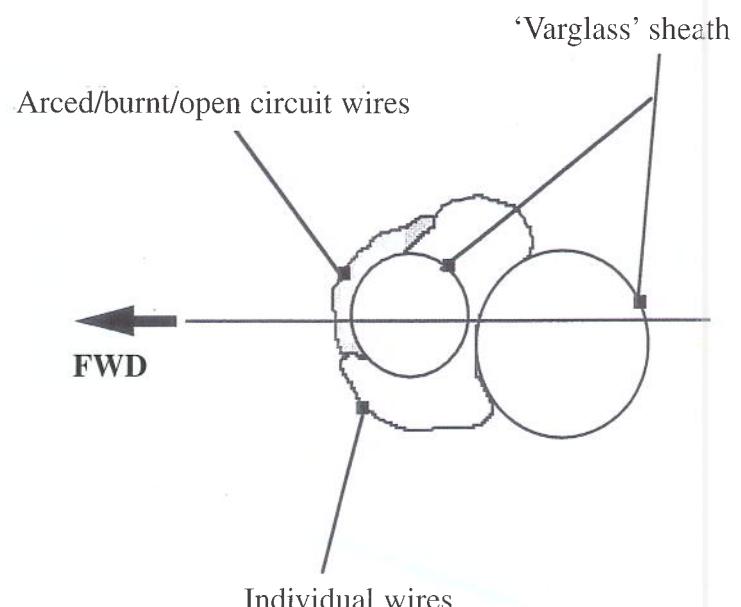
It was apparent that a failure had occurred within one of the looms adjacent to the inboard side of the aft face of the chiller unit and that the immediately adjacent loom exhibited evidence of heat distress. At the failure location, these looms were some 2.95 inches and 3.25 inches clear of the chiller aft face, at their closest point as installed. In addition, the thin foam plastic filter covering the chiller heat exchanger matrix facing these looms exhibited a small localised region of heat damage. There was evidence of copper spatter on this filter in this area and locally on the chiller top surface directly above. The location of this damage was several inches outboard from the loom containing the failure, but no evidence was observed to indicate that any wire had arced onto the chiller. No other areas of thermal distress were apparent in the E&E bay.

Removal of the light blue painted chiller allowed access for inspection. This indicated that the primary event appeared to have occurred within one loom and that arcing and burning of wires around the inner surface of the curved section of this loom had occurred over a length of some 6 inches, as shown in Figure B-2. There was also copious evidence of copper spatter from the failed wires on the filter, on other wires and also on airframe insulation blankets below this area. A general examination of the unaffected wiring looms above and around the chiller location revealed a few minor nicks and areas of insulation abrasion but in one area, on a loom directly outboard of the failed loom, the insulation of three wires had been sufficiently damaged to expose their underlying insulation. The surface of an adjacent glass fibre sleeve also showed signs of damage in this area. The damage, the location of which coincided with the plane of the chiller top surface, is illustrated in Figure B-3 where it may be clearly seen to have been caused by 'mechanical' rather than 'electrical' means.

Detail view of failed areas of loom, and the adjacent heat affected loom. Above is a sketch of a cross section of the failed loom at the identified position.

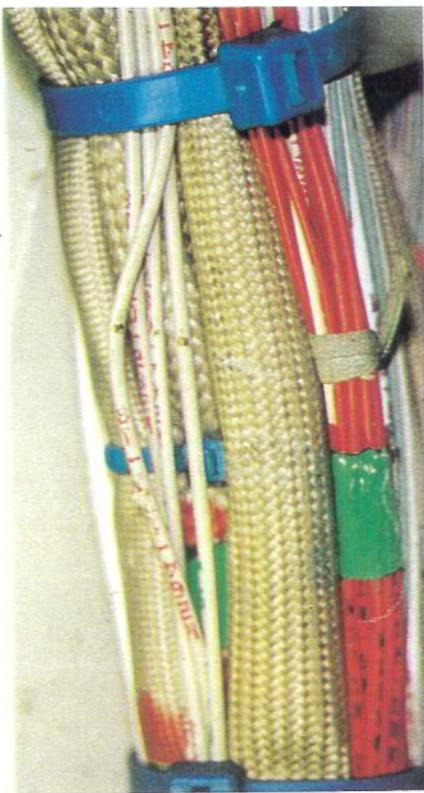
Wire damage at location A in figure B-2. Three wires affected in addition to scuffing of braided sheath.

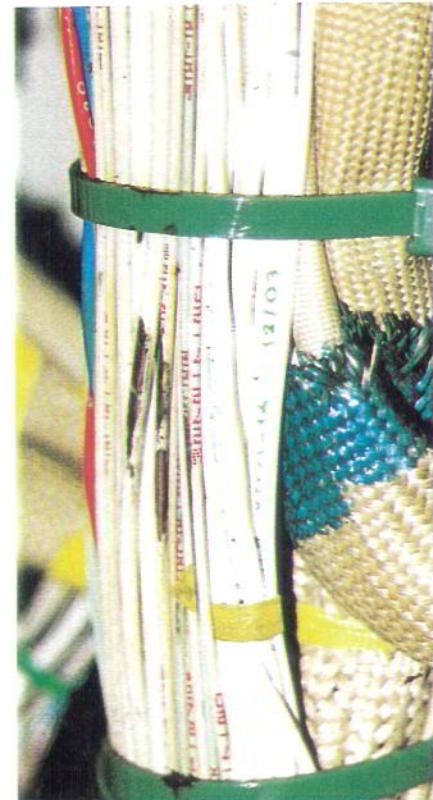
Abrasion of insulation topcoat at location B in figure B-2.

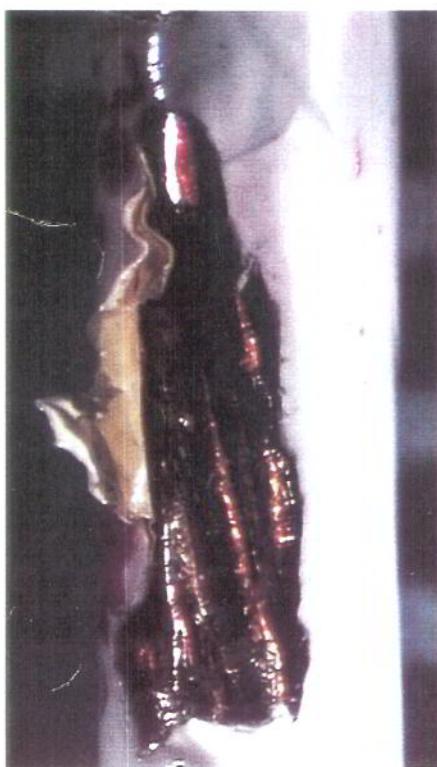
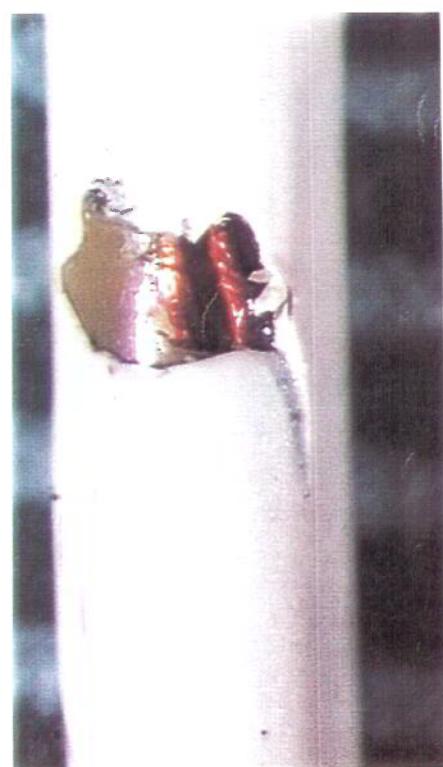
Details of 'cutting/slicing' damage to the outer insulation of two of the wires shown above left, leading to exposure of the polyimide insulation.

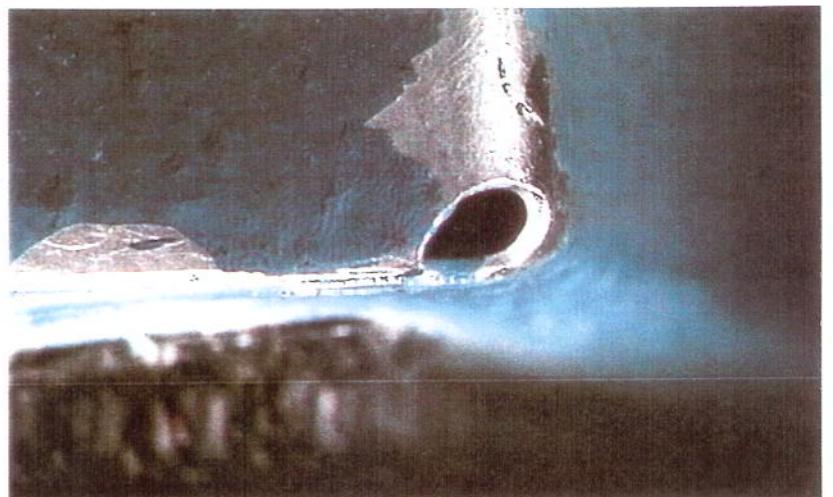
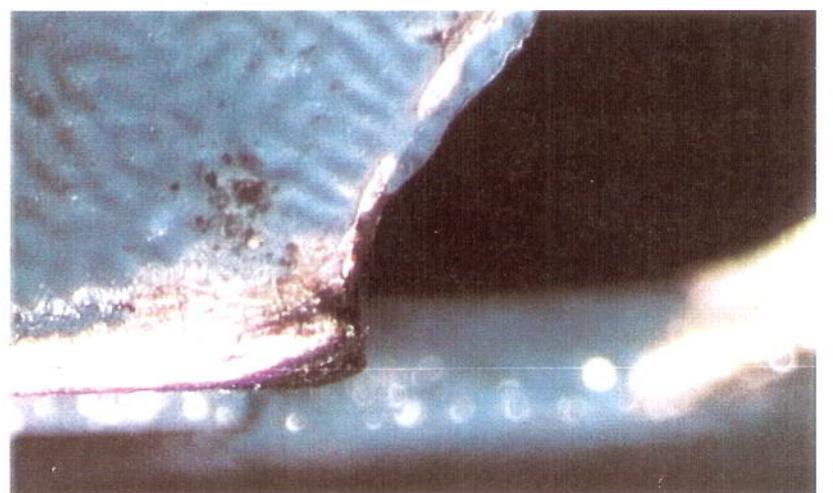
damage, with small areas of missing paint and bruised edges on the aluminium sheet. However, one edge of the sheet at the upper/aft outboard corner was 'burred' in such a way as to form a sharp edge, as illustrated in Figure B-4b. It was also evident that this edge would have been 'leading' whenever the chiller had been moved in an outboard direction, such as when being installed. It was also evident that the position of the damaged insulation on the wires illustrated in Figure B-3 was adjacent to this corner of the chiller when in the installed position.

General view, above, of the top aft outboard corner of the chiller box showing the chipped paint, nature of construction and general bruising and, below, a detail of the burred 'sharp' edge.

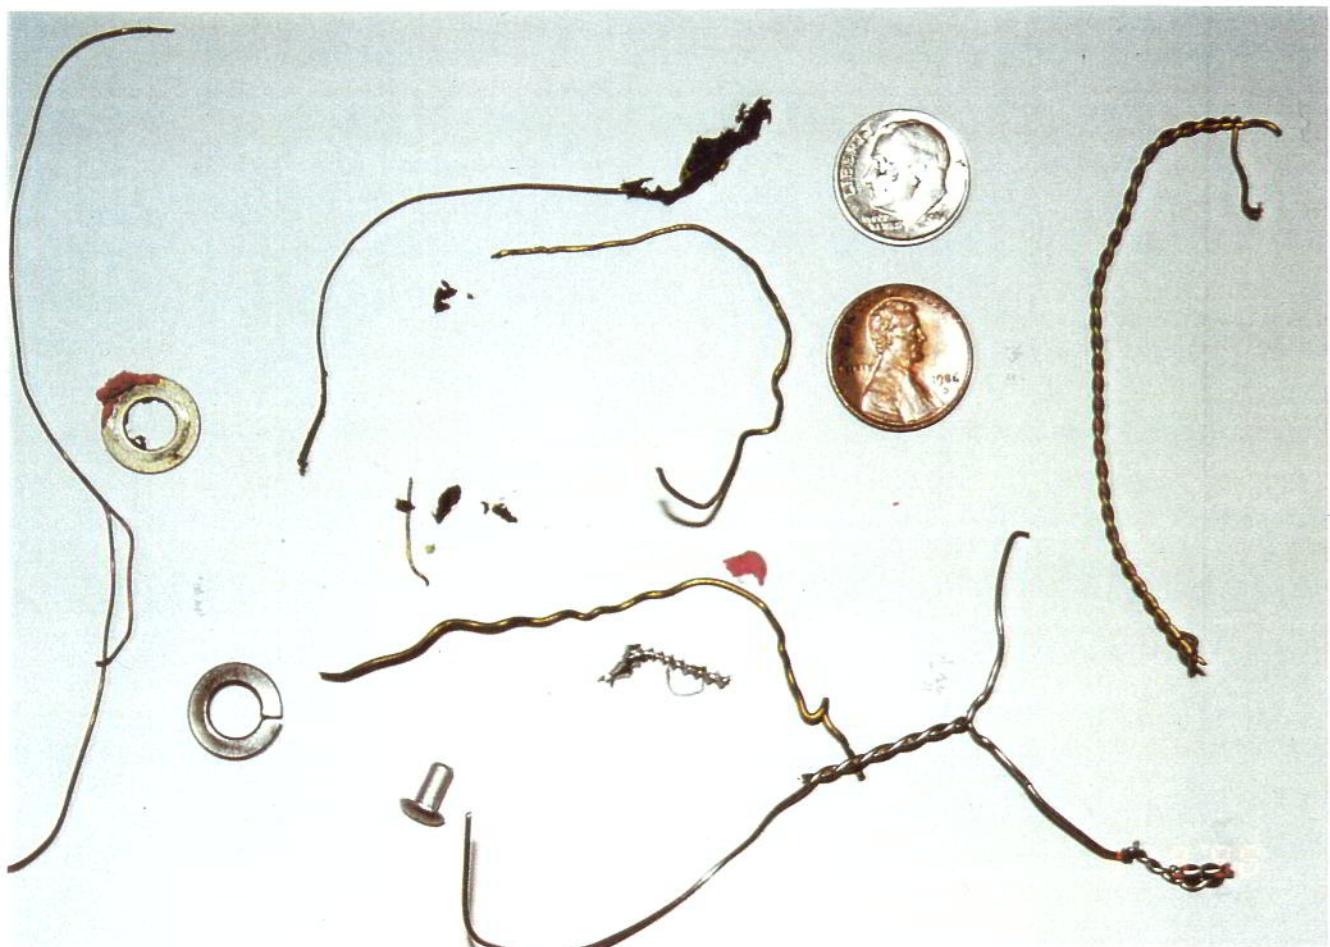
CONDUCTIVE DEBRIS SAMPLE

- 3 Aluminium alloy swarf was present within the E&E bay prior to the accident and had probably assisted the onset of arcing between adjacent damaged wires in the loom.

Above; Sample of conductive debris remove from immediate environment of chiller in the E&E bay of N653UA. Below: SEM analysis of typical swarf found in this region. (See also Figure D-1)

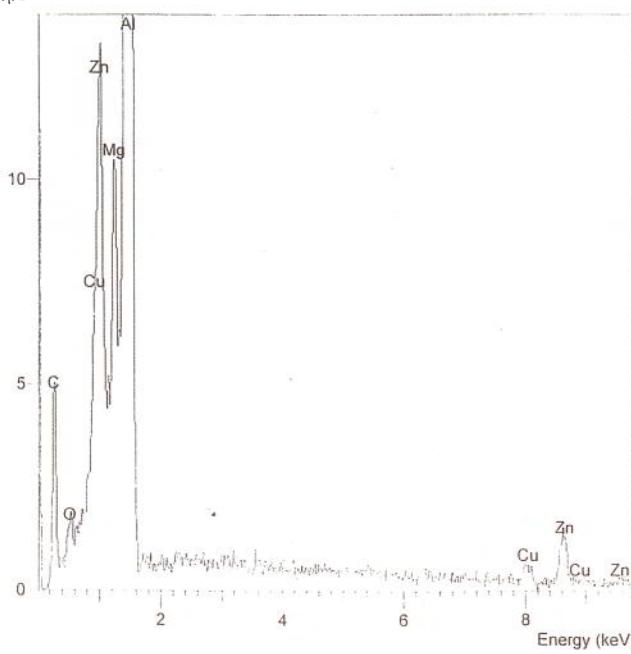
Debris from floor below damaged harness - micrograph and EDX spectrum of aluminium swarf 7/2

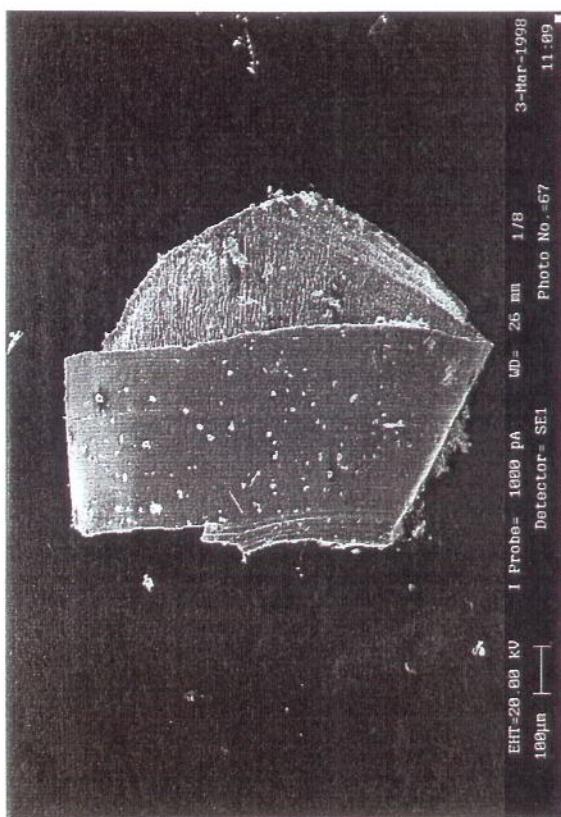
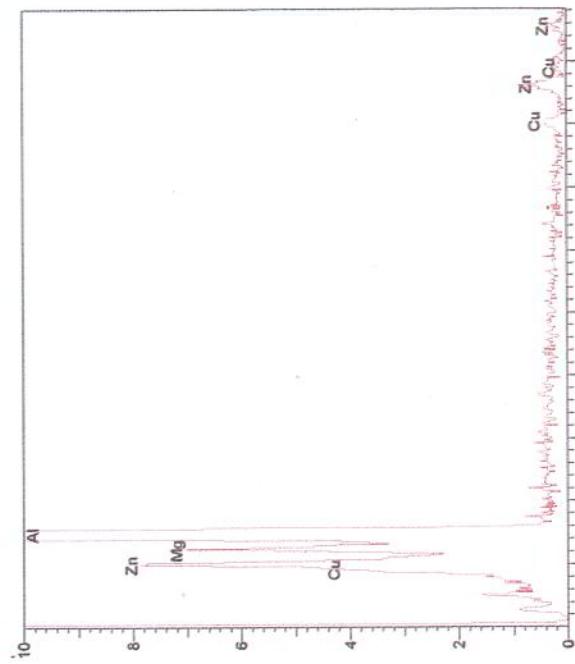
Debris from vacuum box - micrograph and EDX spectrum of aluminium swarf particle 1/8

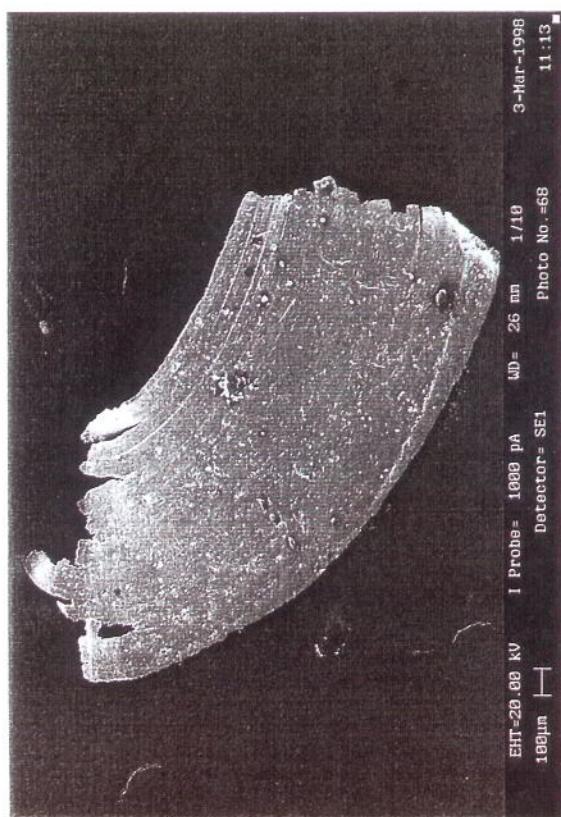
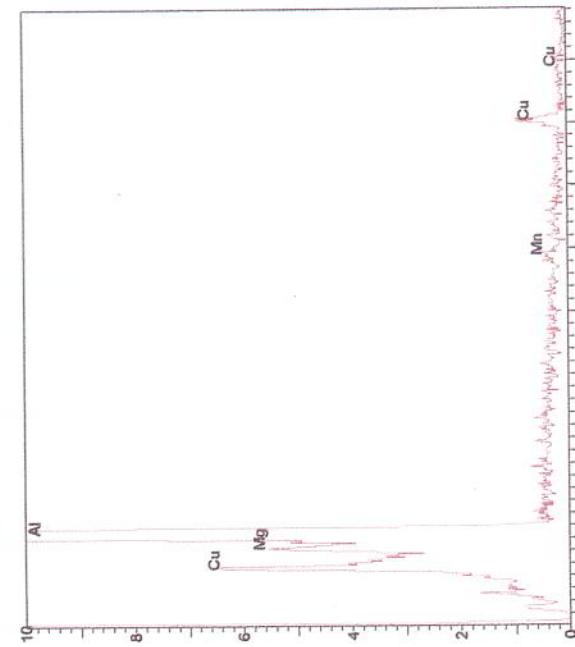
Debris from vacuum box - micrograph and EDX spectrum of aluminium swarf particle 1/10

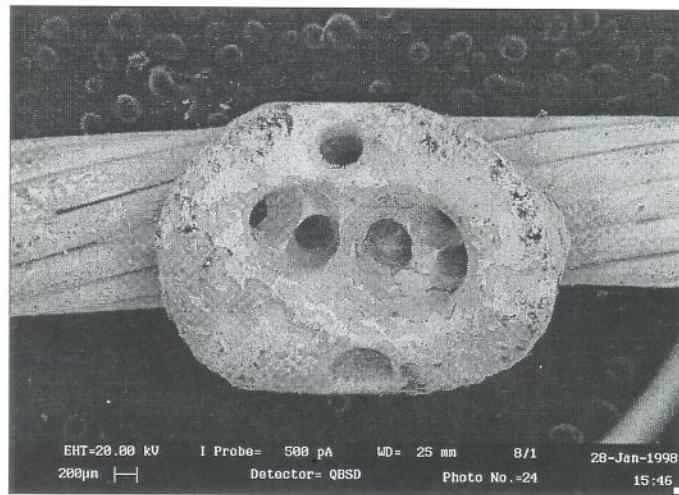
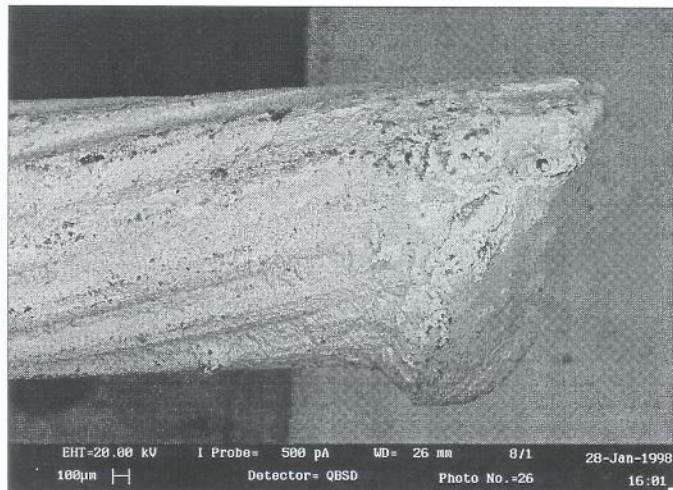
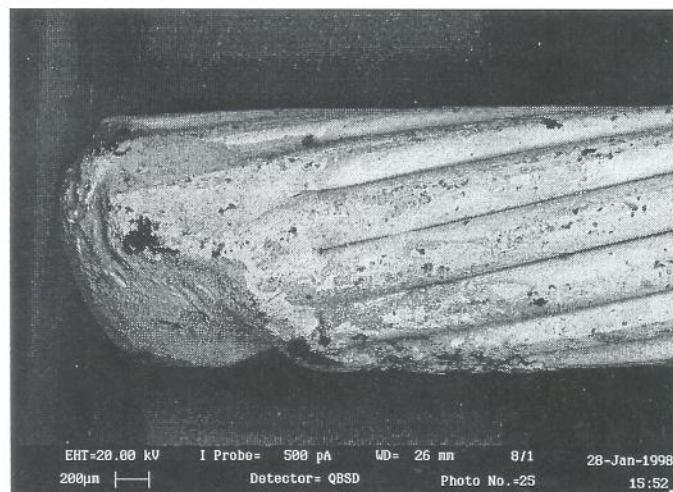
Debris from shelf below damaged harness - copper conductor

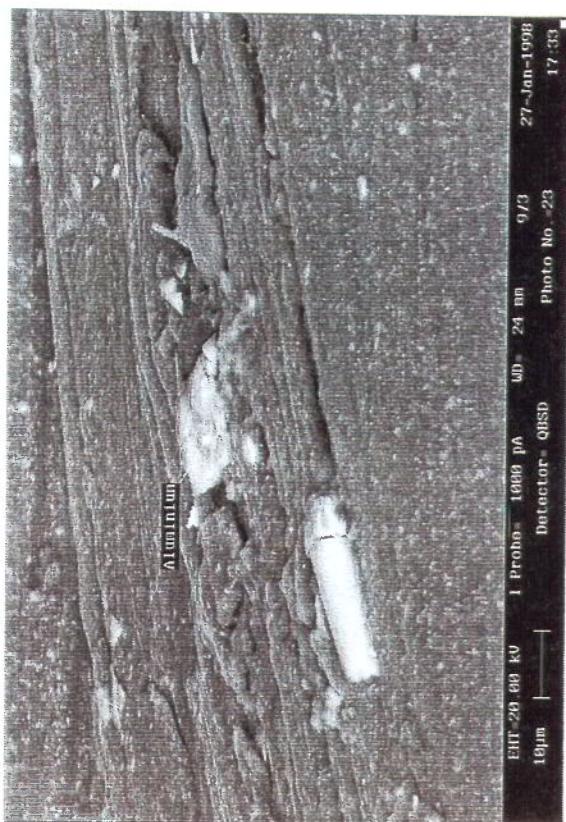
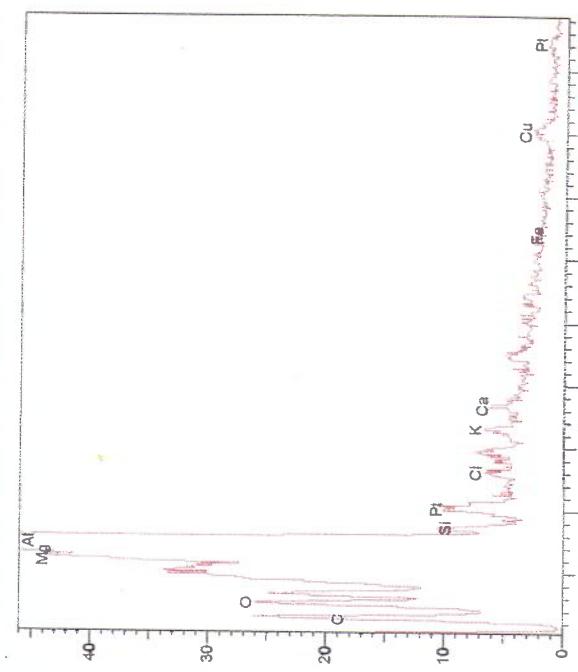
Wire from outboard harness - micrograph and EDX spectrum of embedded aluminium in insulation of wire, 9/3

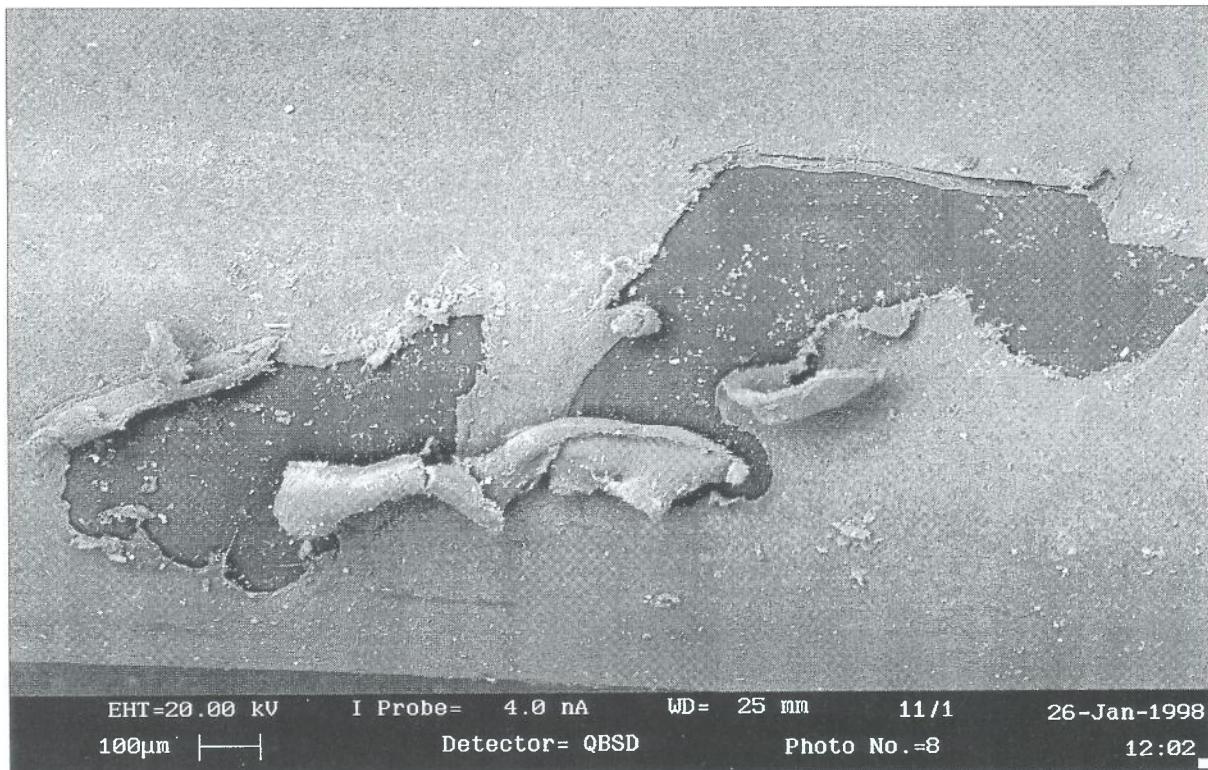
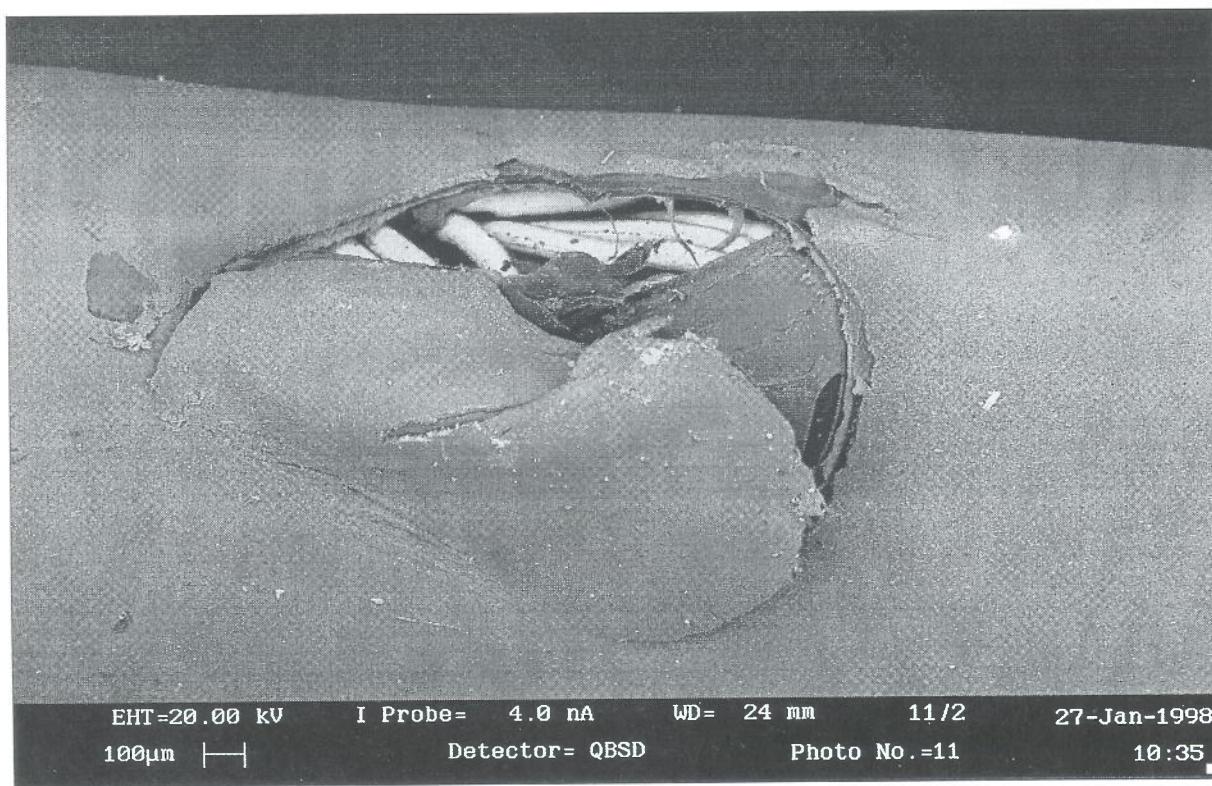
Wire from harness which suffered electrical failure
Mechanical damage at a distance of ~ 10 mm from blackened area

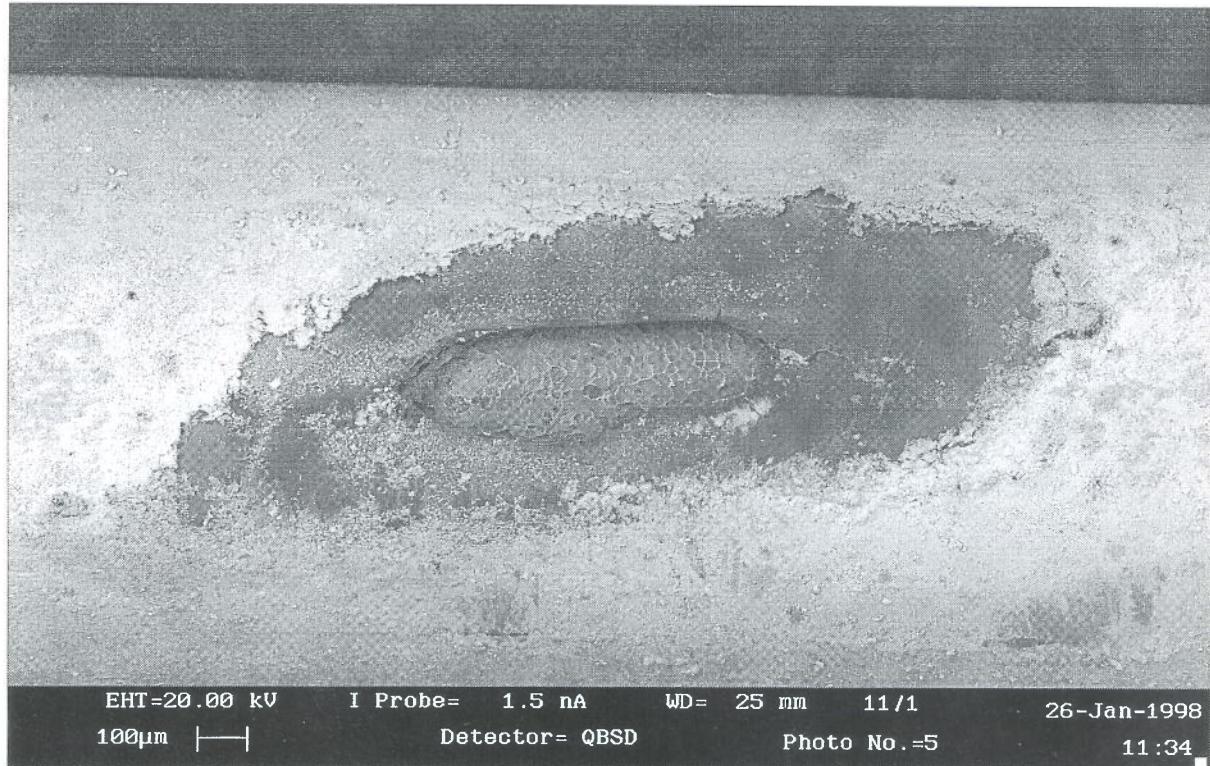
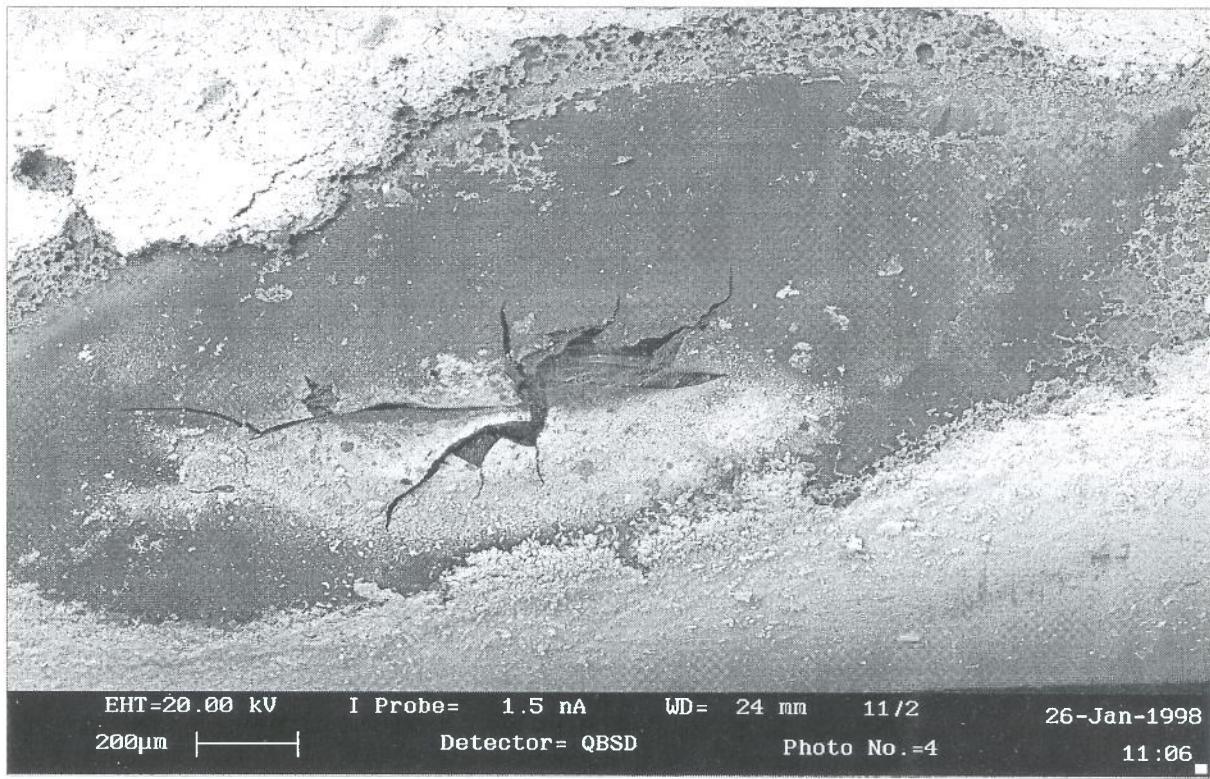
Wire from harness which suffered electrical failure
Heat damage at a distance of ~ 10 mm from blackened area

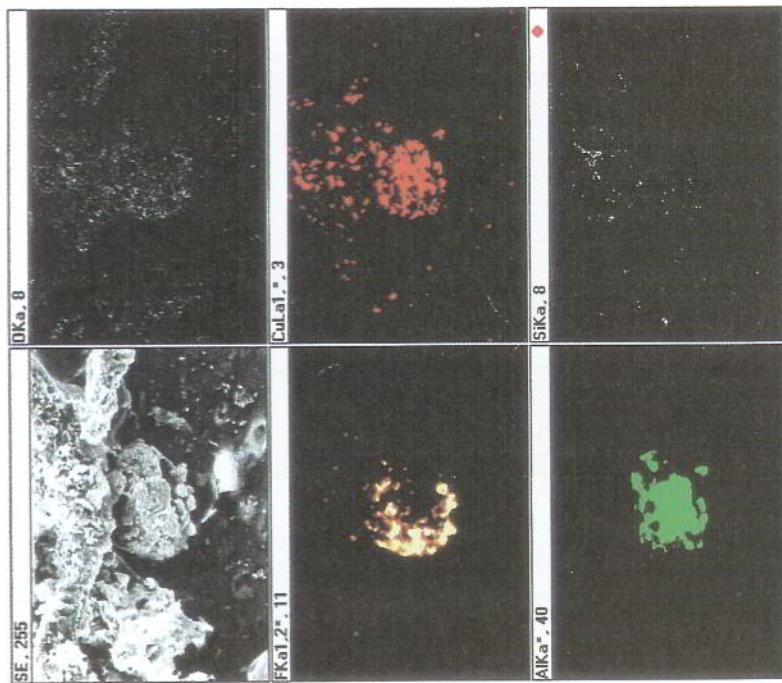
LHS: micrographs and EDX spectrum of aluminium sphere
on insulation of wire 11/5

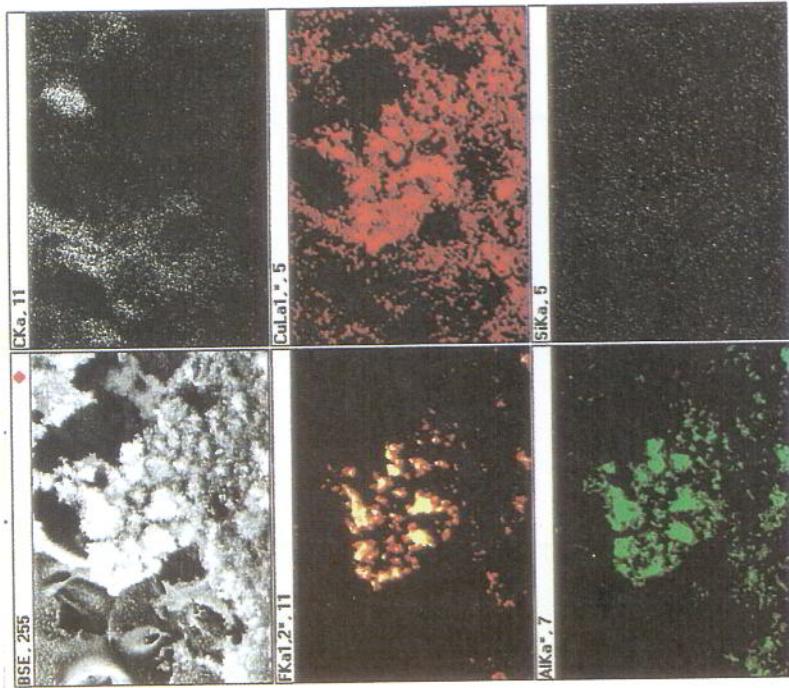
LHS: micrographs and EDX spectrum of aluminium and copper
'dust' on insulation of wire 11/7
Upper micrograph - location; Lower micrograph - detail

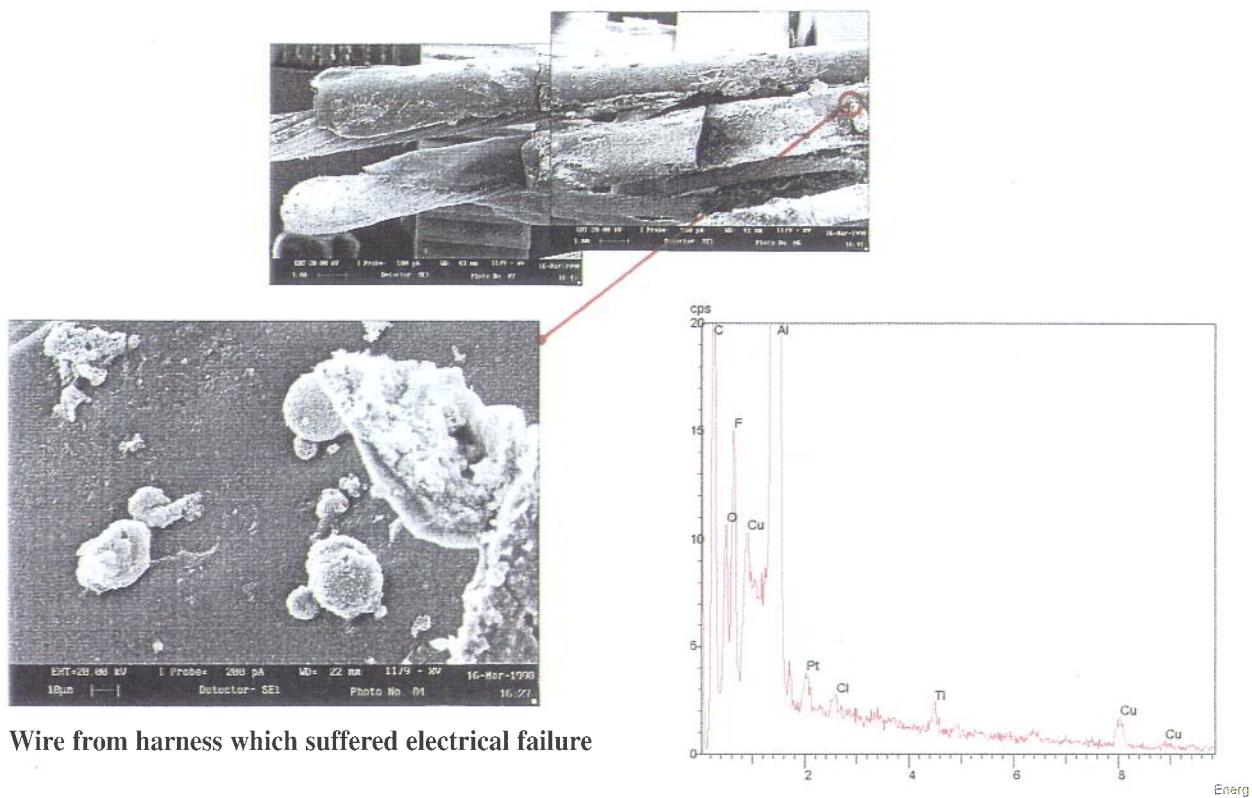
Micrographs and EDX spectrum of aluminium spheres on insulation of wire 11/9
Upper micrograph - location @ O; lower micrograph - detail

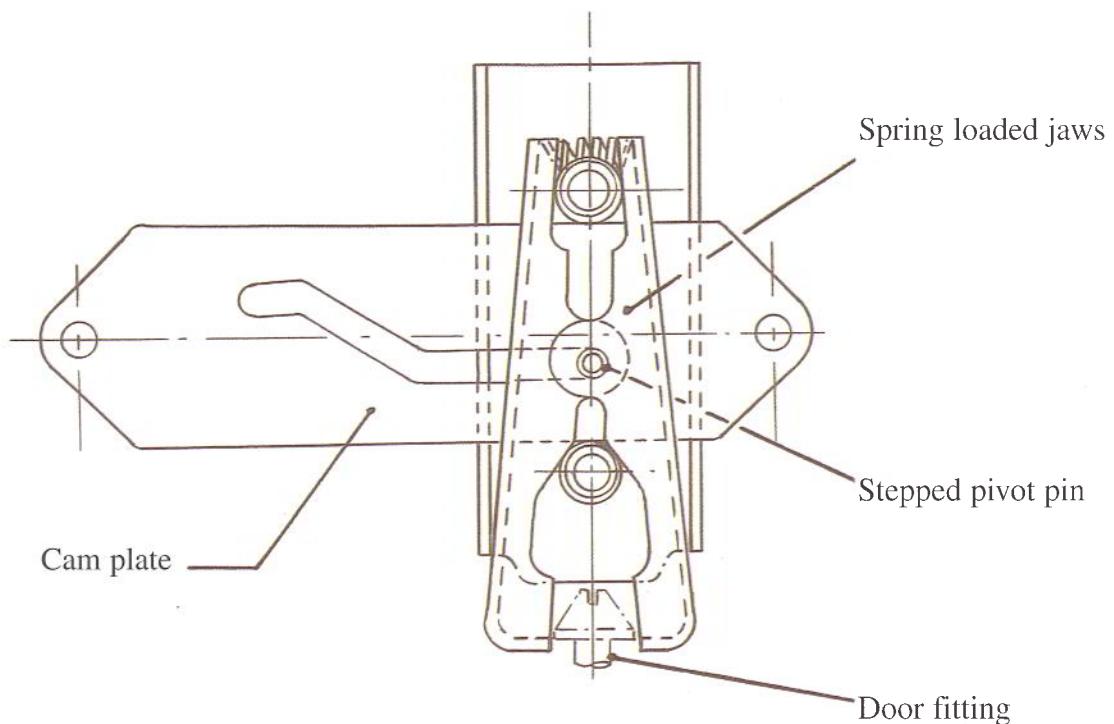
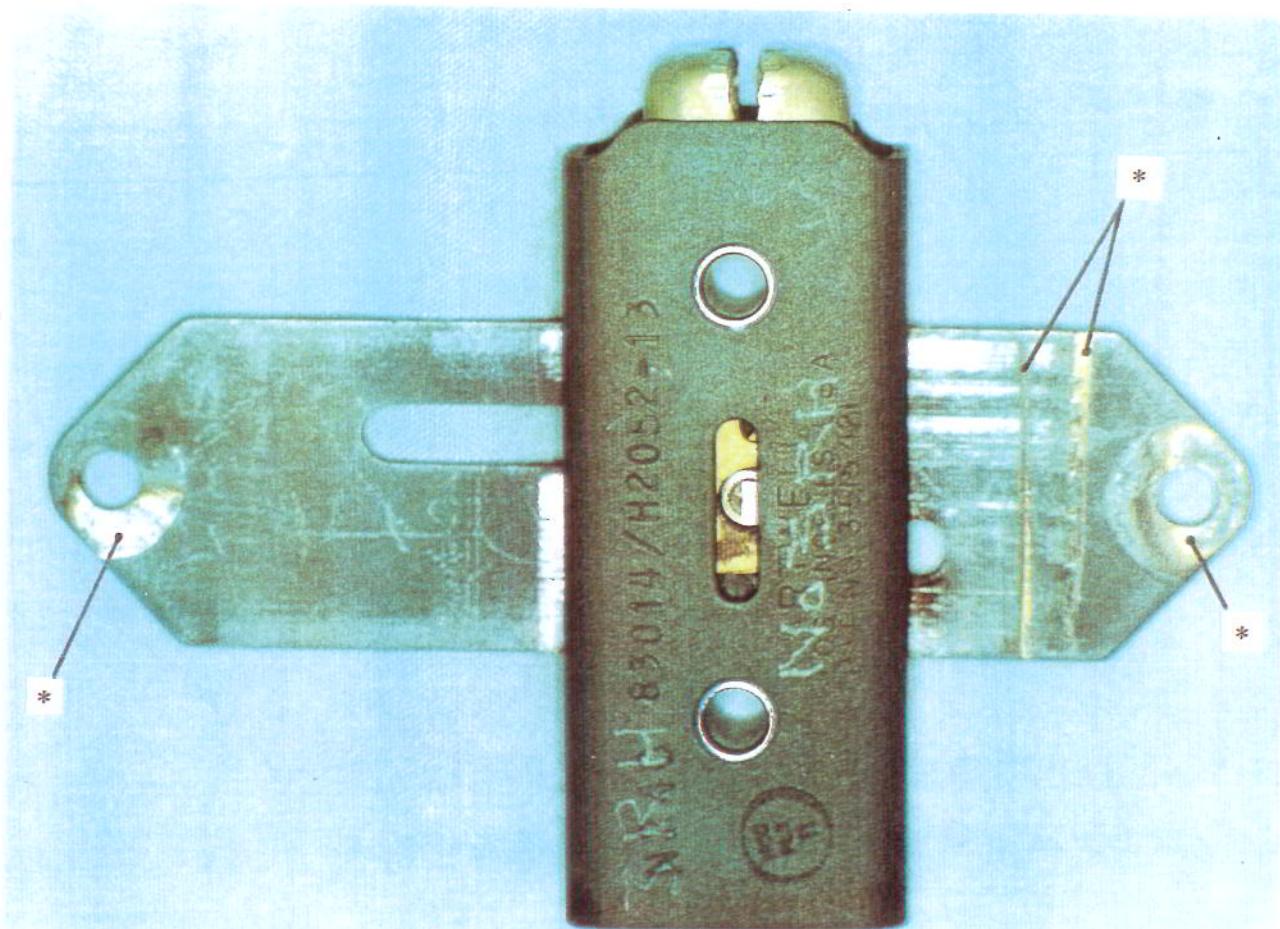
- 6 The jamming of a severely worn latch, associated with the right off-wing slide compartment, prevented that escape slide from operating during the evacuation; such latches exhibited vibration induced wear on other aircraft.

Latch No 3 from left side of aircraft, as found, and jammed mid-travel. Note evidence of fretting around operating rod attachment holes and on cam plate (*), and displaced pivot pin.

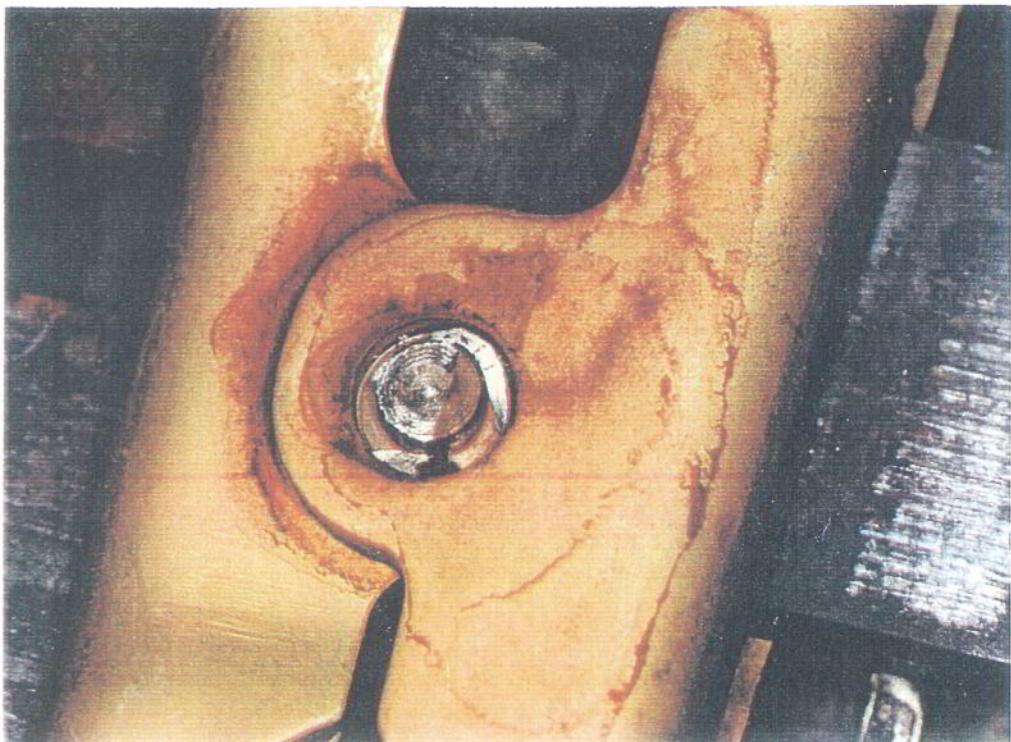
Detail of damage to top of stepped pivot pin, No 3 right side latch.

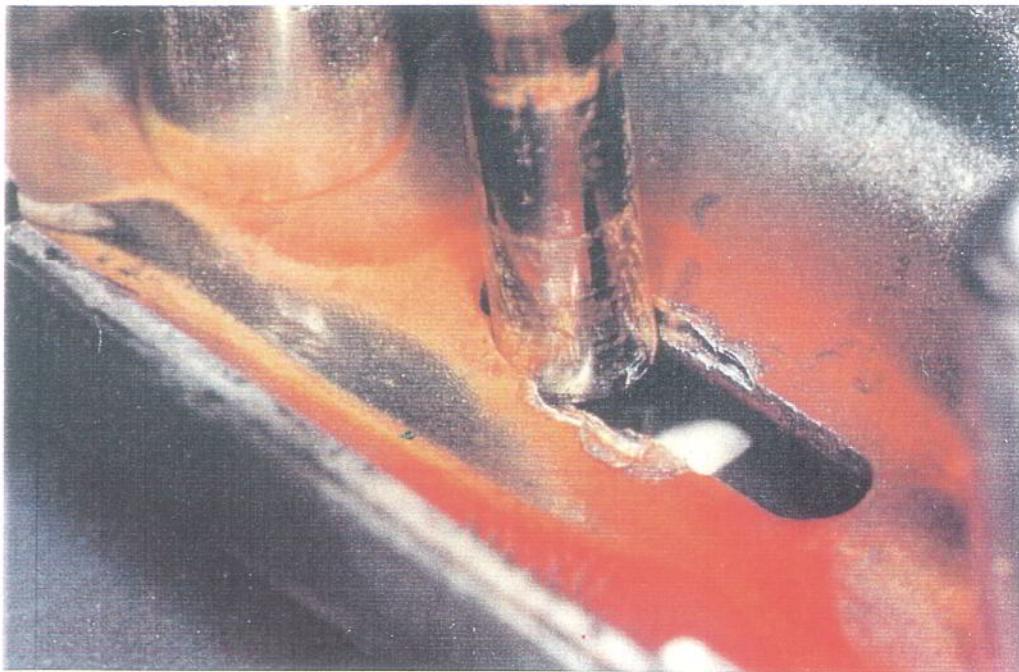
Detail of lower part of stepped pivot pin, located in area of frettage/wear on the inside face of the lower latch housing. The damage to the right of the pin along the slot edge was caused during the attempted operation and forced opening of the door. Orange deposits resulted from wear between jaws and housing.

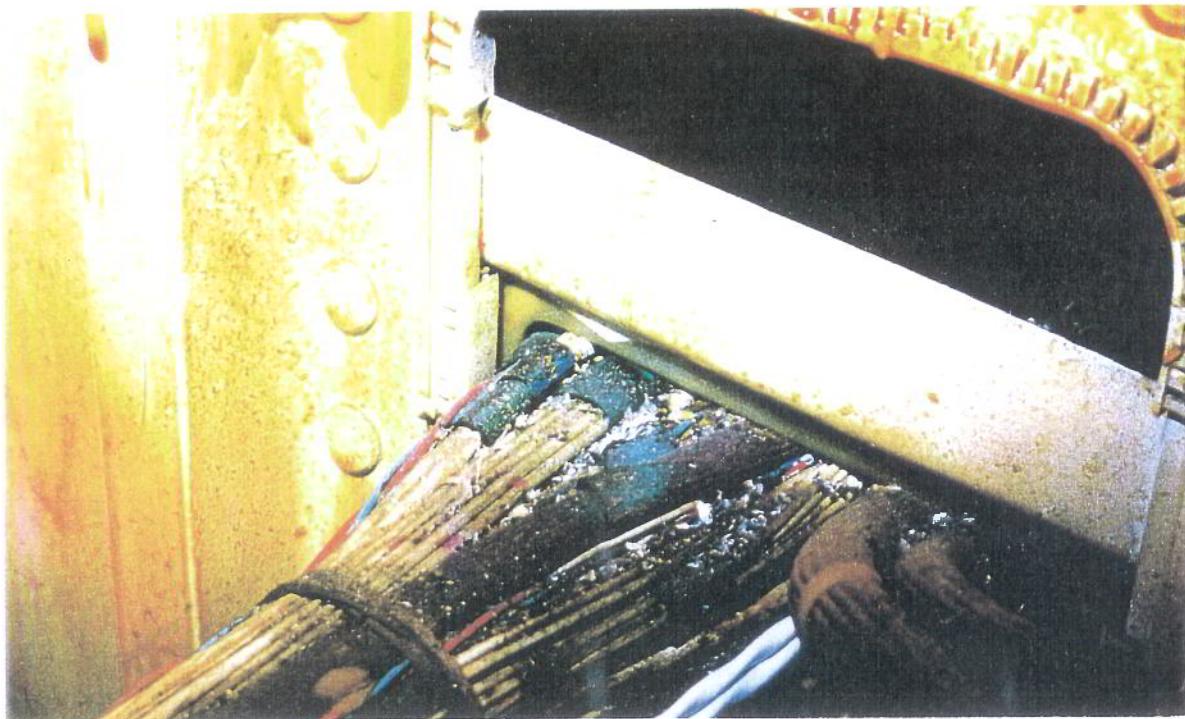
Contamination of wiring looms by drilling swarf, found in a retired B747, above, and an A300, below.
