Air Accidents Investigation Branch

**Report on the accident to
Airbus A340-311, G-VSKY
at London Heathrow Airport
on 5 November 1997**

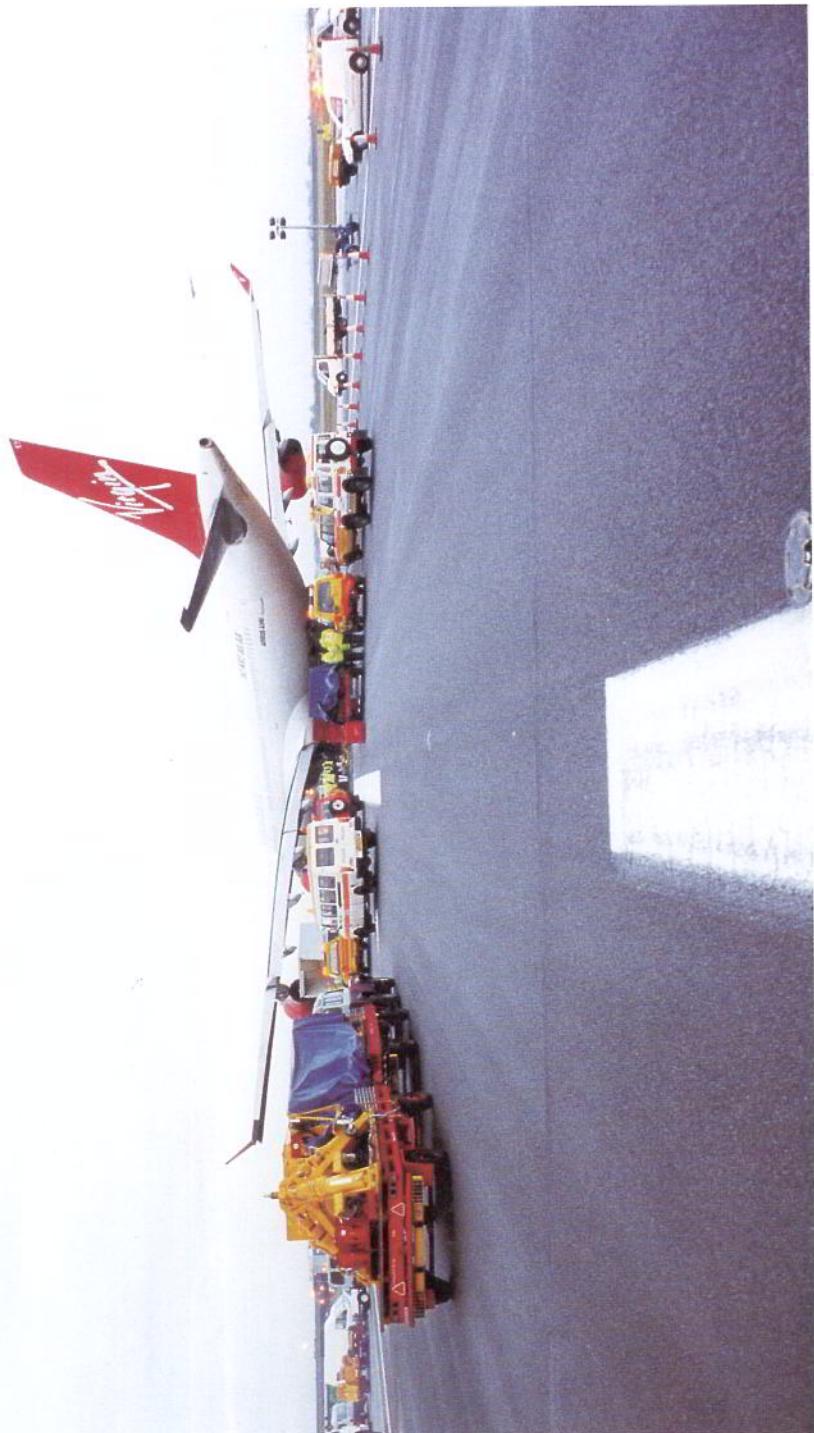
This photograph, taken the following morning, shows the aircraft after jacking and prior to moving. Note the runway centreline markings and aircraft heading. The runway had been repaired by the time this photograph was taken

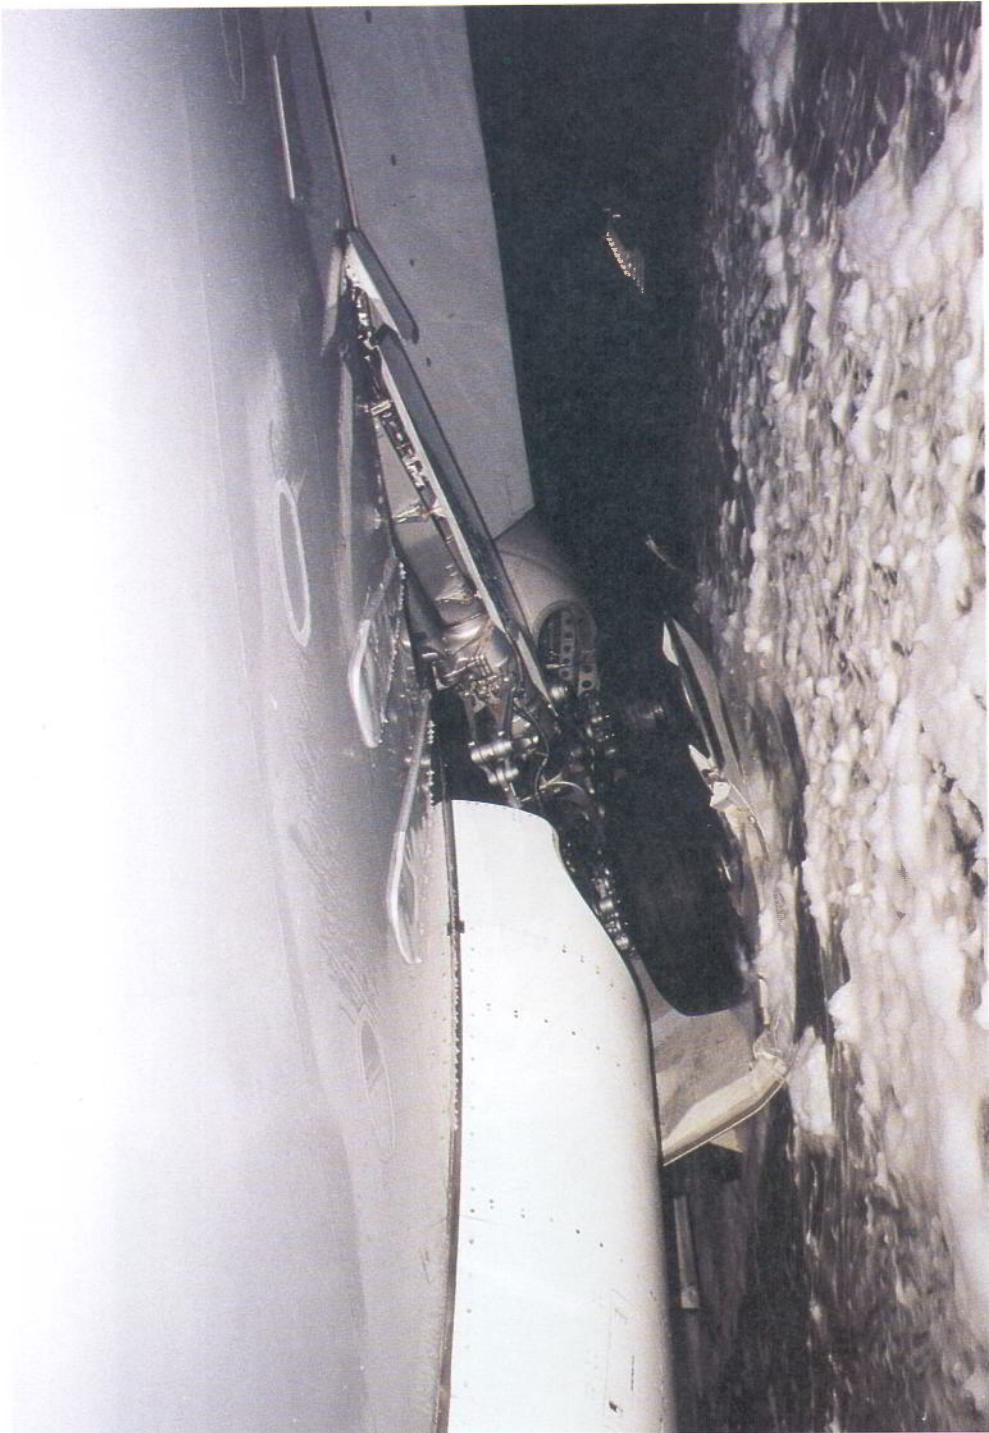
Subsequent examination of the left main landing gear found that it was jammed by the No 6 brake torque rod which had become trapped in the keel beam structure (Appendix 5) and that the torque pin retaining the rod at the brake end was not present, allowing the unrestrained rod to pivot about the retained end.

Left main gear jammed in partly extended position

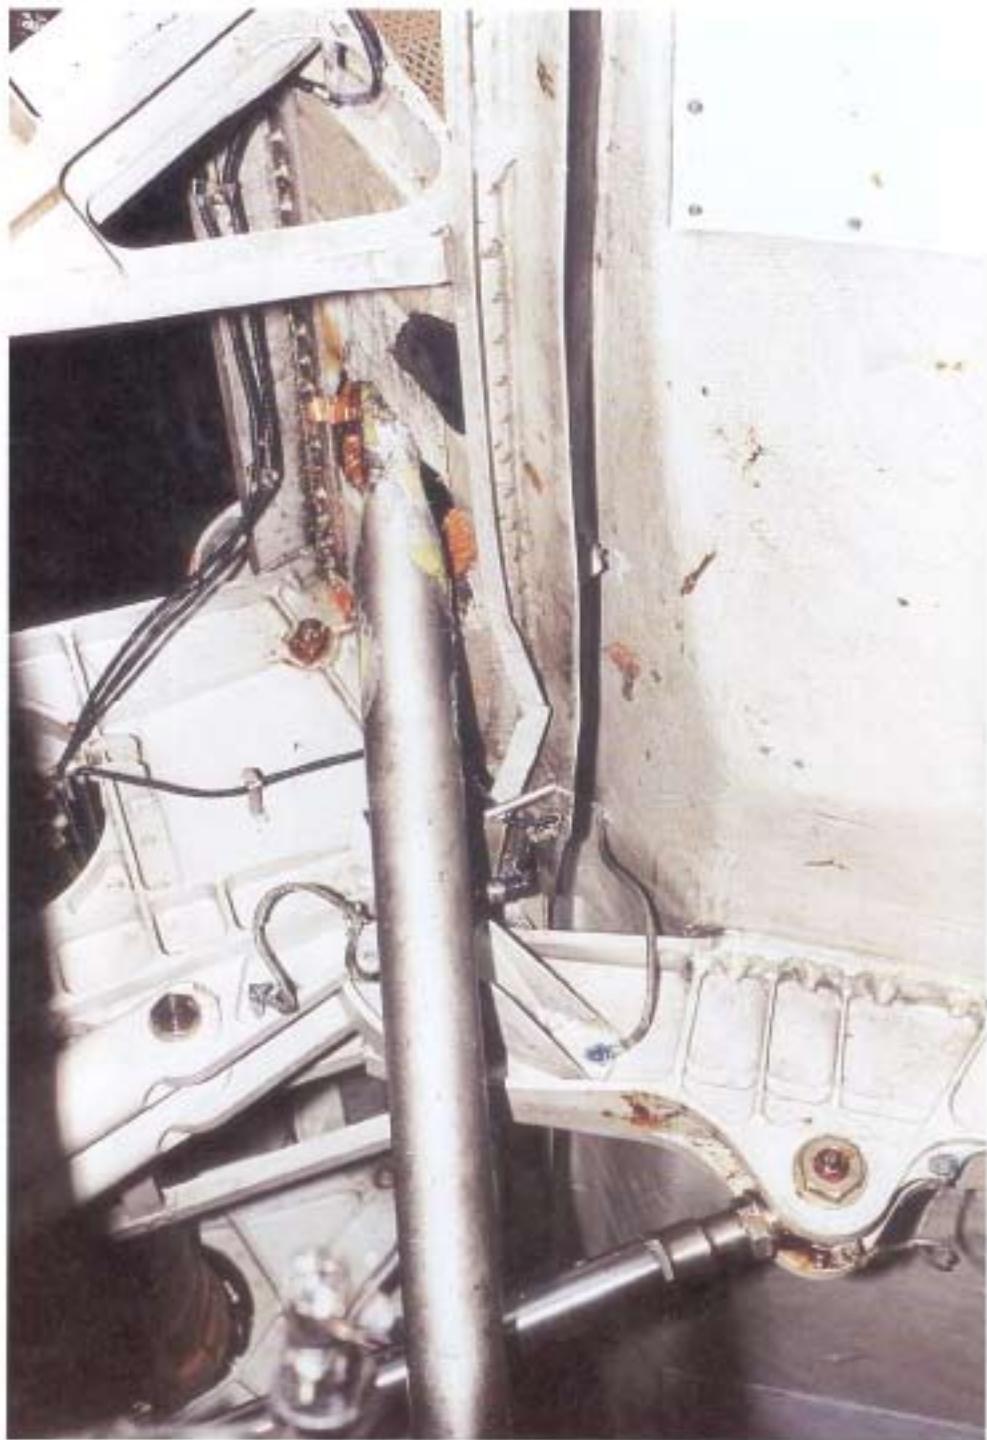
Examination of the left main landing gear found that the gear had been jammed by the No 6 wheel brake torque rod which had disconnected from its brake pack assembly and had become trapped in the keel beam structure. The associated torque rod pin was subsequently found beyond the end of Runway 24L at Los Angeles International Airport, the departure airport.

No. 6 brake torque rod jammed in keel beam structure

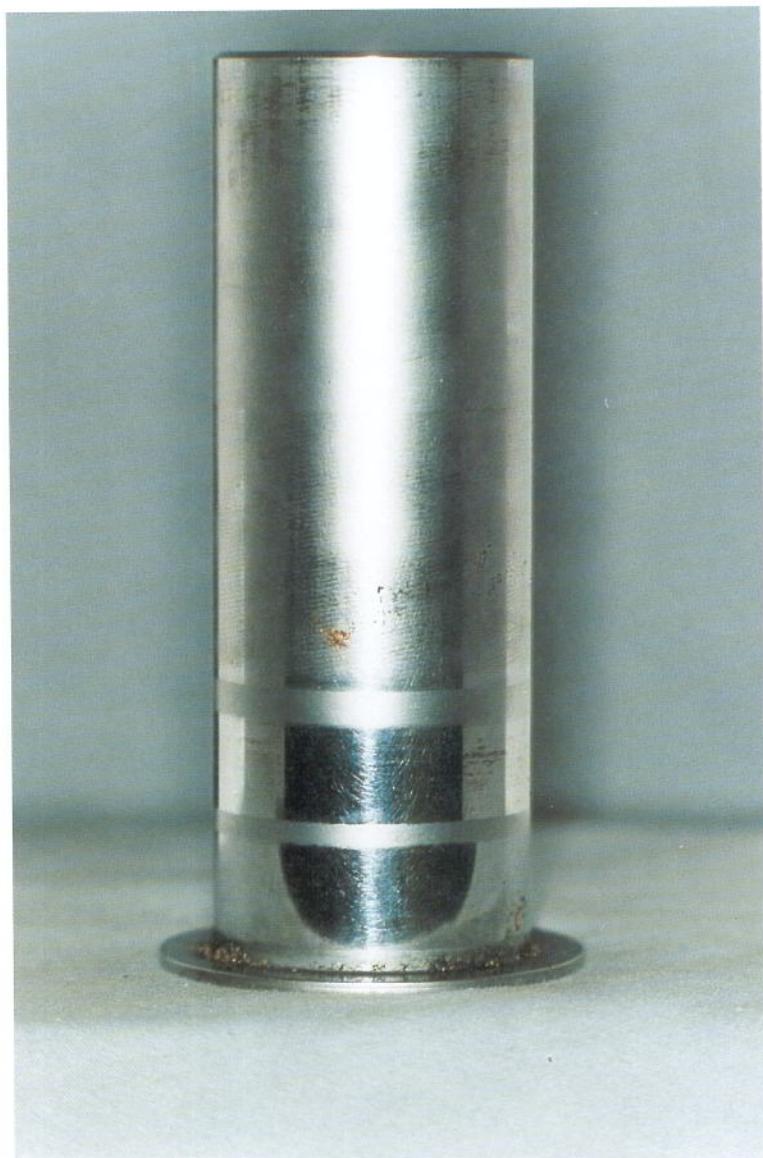
A later search conducted at Los Angeles International Airport was successful in finding the missing torque pin in the area between the end of the departure Runway 24L and the Pacific shoreline, close to the Airport (Appendices 6 and 7). However, the retaining hardware was not found.

The No. 6 torque pin recovered from the departure end of runway 24L at Los Angeles Airport

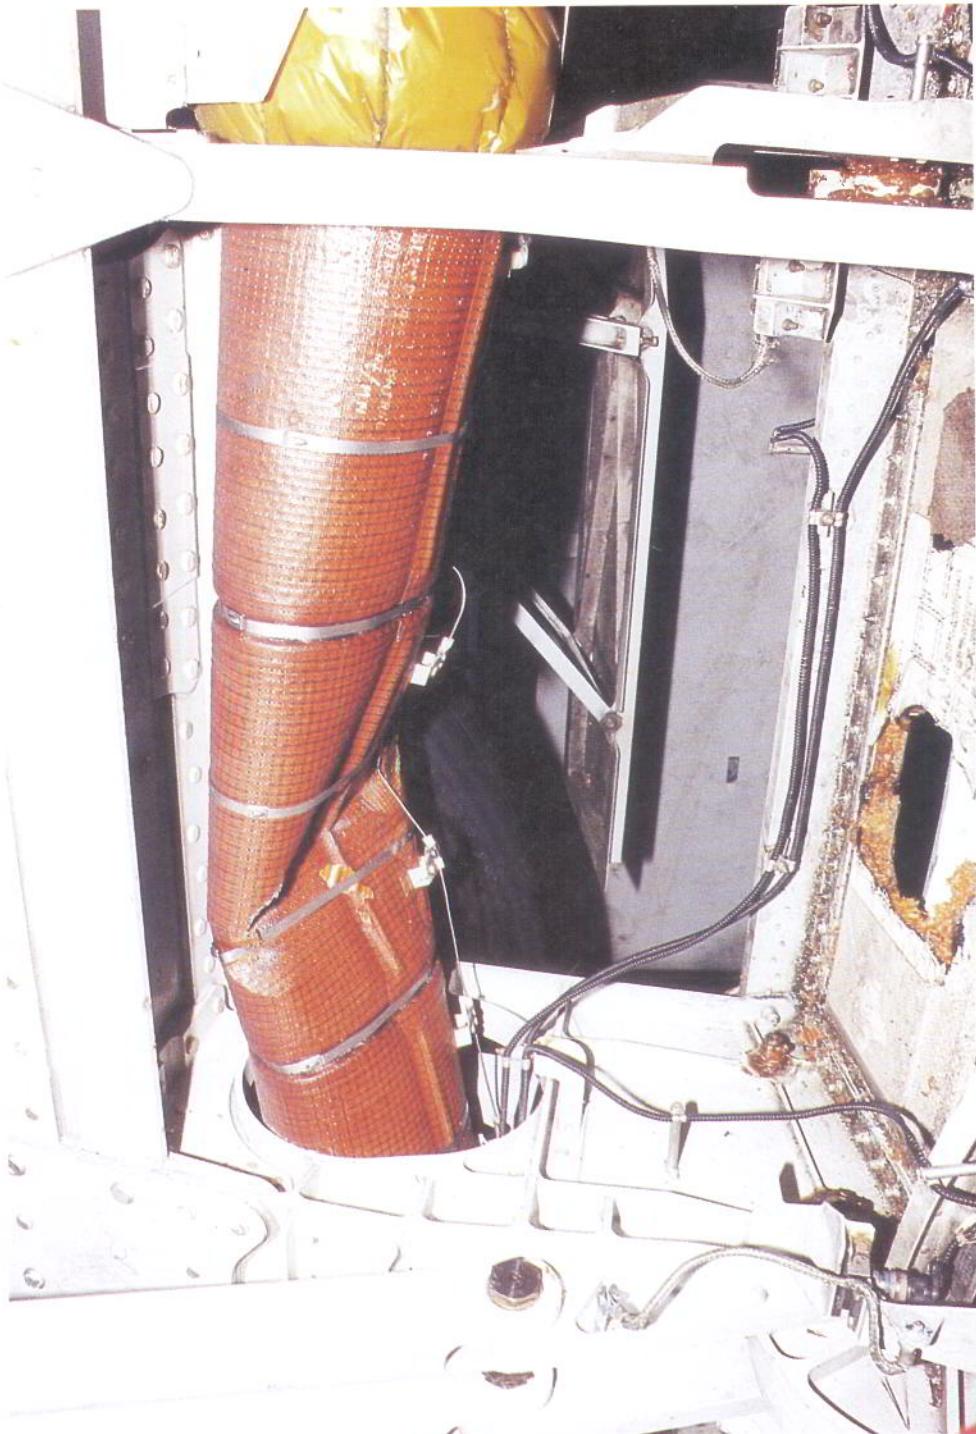
The aircraft sustained major damage to the right main landing gear, including the brakes, wheels and tyres. The undersides of the Nos 1, 2 and 4 engine pods contacted the runway surface during the landing and sustained abrasion damage. There was permanent deformation of the structure adjacent to the No 2 pylon, which had taken the majority of the vertical load as the aircraft came to rest. This had caused a minor fuel leak from the wing in the vicinity of the No 2 pylon, although due to the low fuel state this was not apparent until later when the aircraft was being repaired. In addition, all four engines were presumed to have been shock loaded and were removed for inspection and/or overhaul. The Nos 1 and 2 engines had suffered some damage to their gearboxes. The inboard main gear doors had been destroyed by contact with the runway surface while open. All the landing gears, except the centre gear which had been retracted, were removed for overhaul as a precautionary measure. Some damage to the keel beam and adjacent systems had been caused by the mechanical interference between the No 6 brake torque rod and the keel beam (see Appendix 8).

View of the damage to the keel beam area. Note the damage to the honeycomb panel and distortion of the nearer edge member at the bottom of the picture

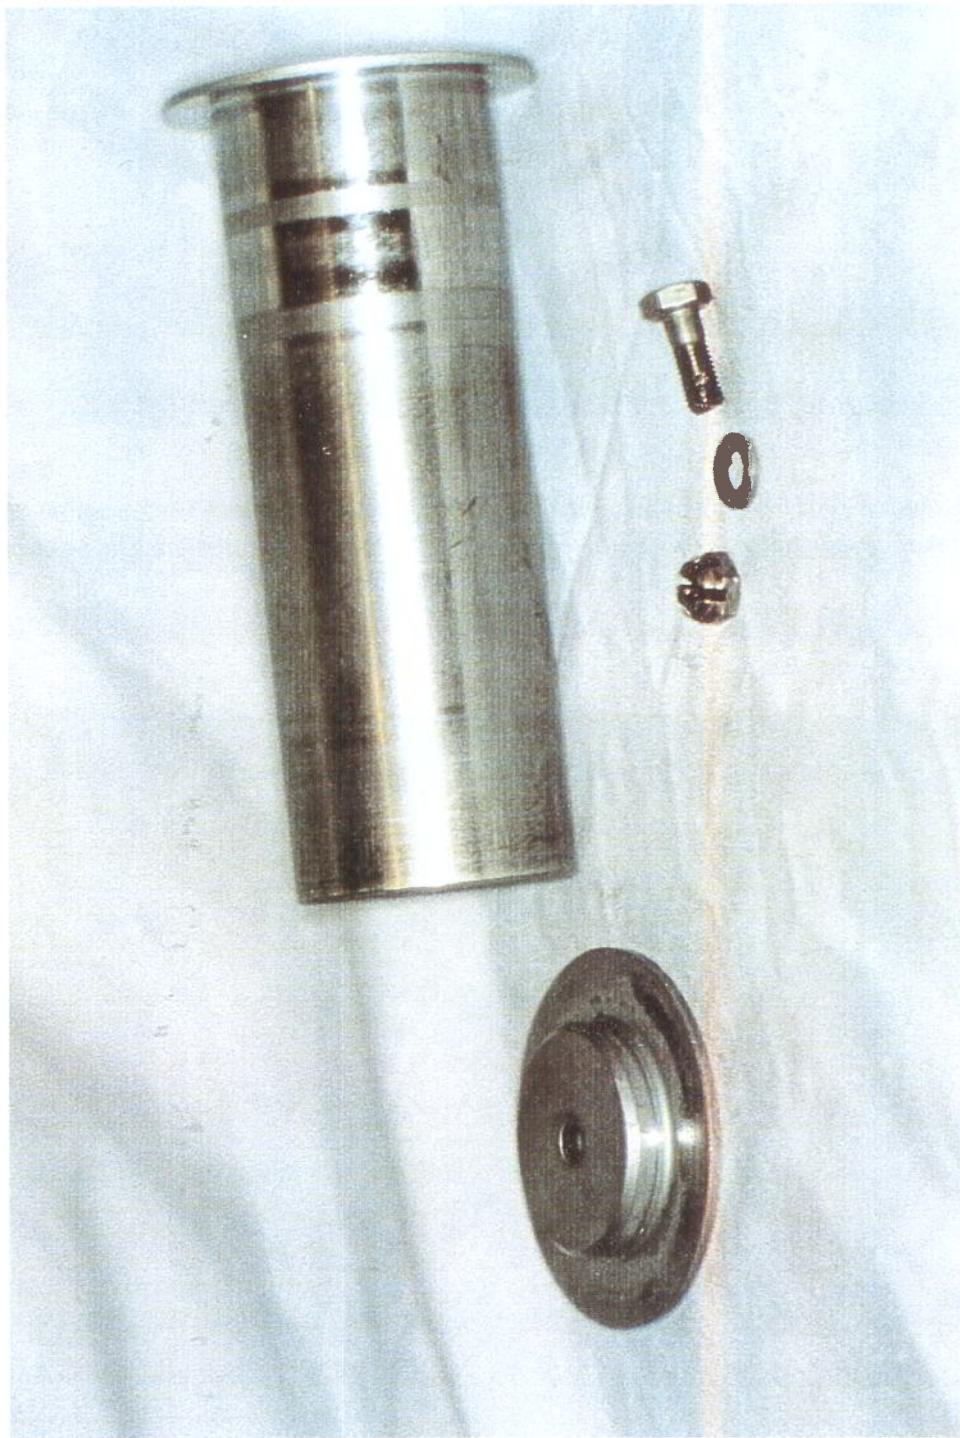
Pin, retainer and fasteners removed from No. 5 position,
adjacent to missing parts at No. 6 brake position

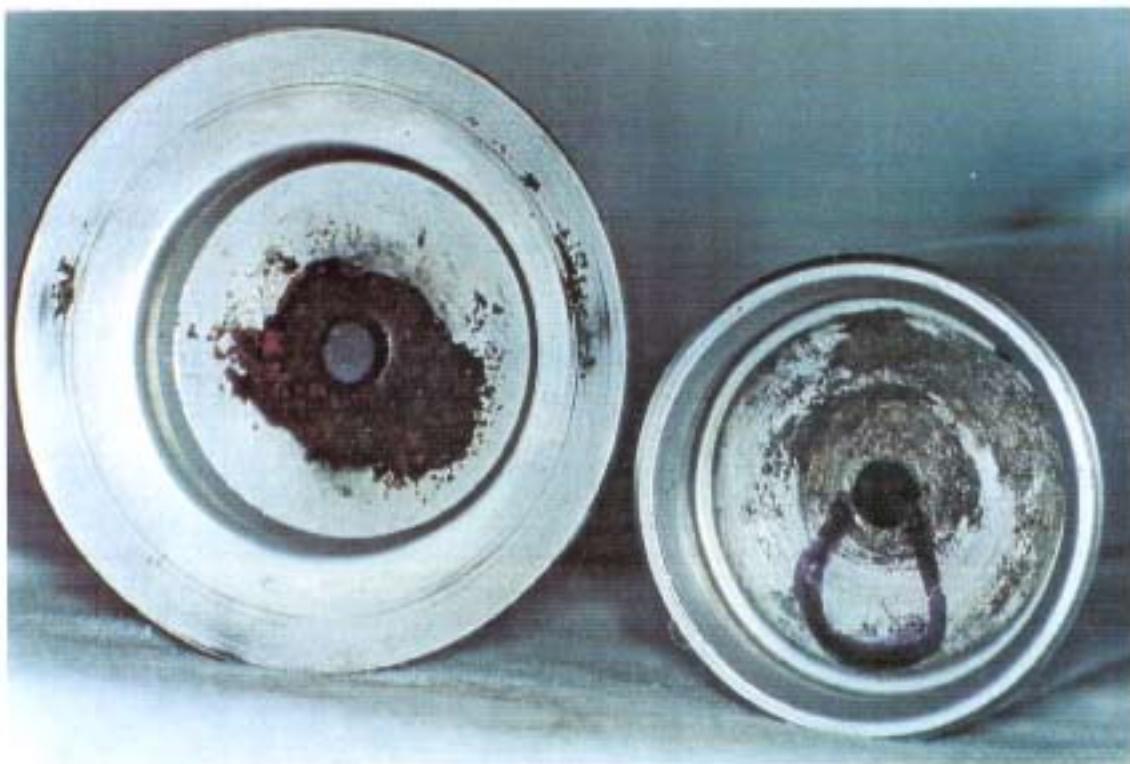
Plate A1

a torque pin from G-VAEL was found to have a large radial crack in its end diaphragm which was considered to have been propagated by a stress corrosion mechanism (Appendix 18, plates A1 and A2);

View on the outer end of the pin and the inner end of the end cap from the No. 5 position on Virgin A340 Airbus registration G-VAEL showing extensive interface corrosion. The position of the radial crack is marked in black ink

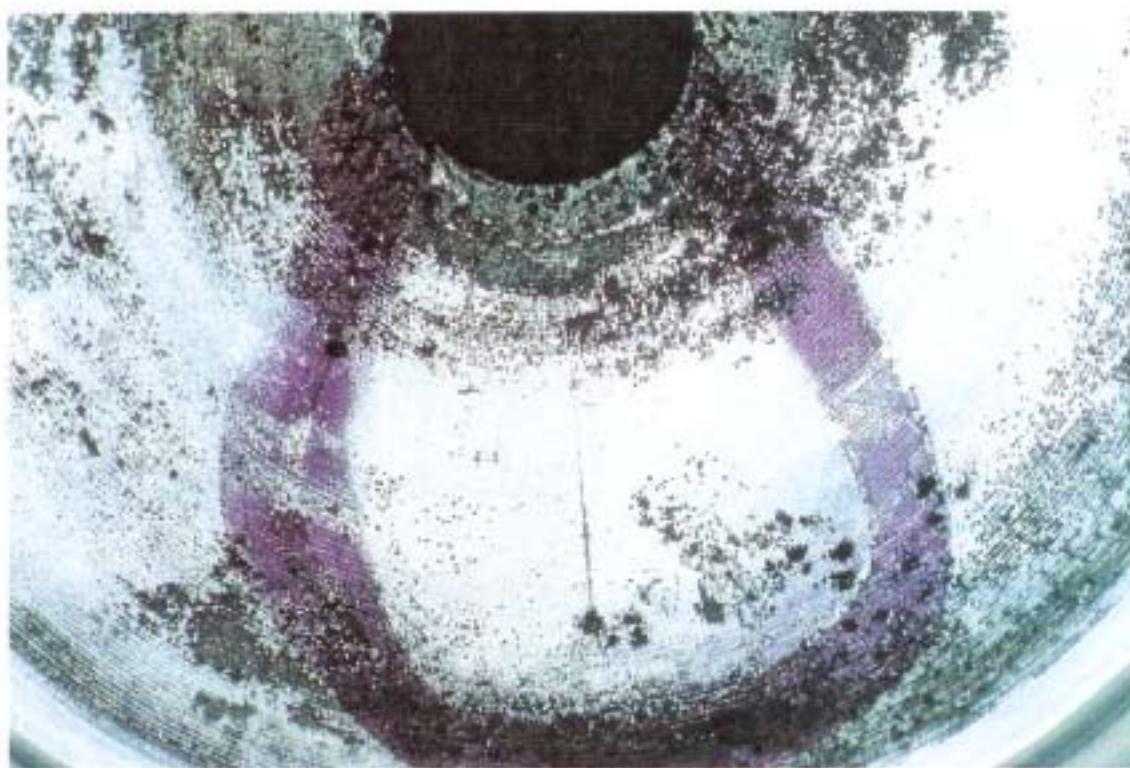
Plate A2

Close up of the radial crack marked on Plate 1

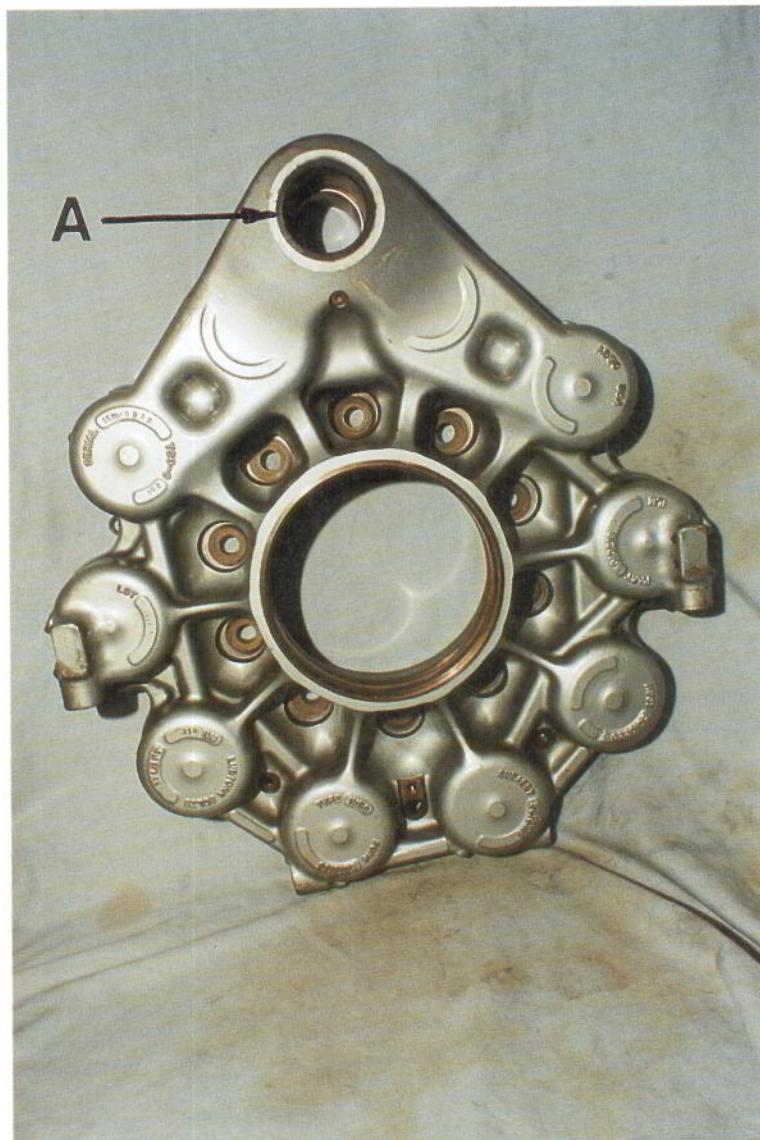
Plate 1

A specialist report was also prepared on the condition of the brake piston housings from the No 6 position on G-VSKY (S/N SEP91-0039) and on the No 2 position from G-VSUN (S/N APR94-0111), which had experienced a possibly related incident at Hong Kong. Examination of brake unit S/N SEP91-0039 at the manufacturer's facility showed no obvious damage. The brake unit was subsequently functionally checked satisfactorily without leaks. Strip examination found no defects within the brake mechanism. However, one of the two bushes (the one closest to the brake torque rod) which sleeve the torque pin was found to have migrated and had adopted a slightly angled setting. It had moved 0.023 inches (0.58 mm) on one side and 0.019 inches (0.48 mm) on the other. There were no obvious marks or damage from the torque pin within the bores. Examination of the No 6 brake torque rod showed no evidence of bush migration and the overall distance across the bush flanges was within drawing limits. When the bushes were removed, it was found that although the bushes themselves were undamaged, significant distortion of the bore of the piston housing had occurred in the plane of the rod. The bore was measured and was found to be oval by 0.009 inches (0.23 mm) at the top, with the distortion extending about one third of the way into the bore. The segment of the bore which was distorted was 180° opposite to that which would be loaded with the brake fitted at the No 6 position. There was evidence of machining marks throughout showing that compression, not wear, was responsible for the

Brake plate reported to be from the position on the left hand main undercarriage on Virgin Airbus G-VSKY from which the brake reaction rod became detached. The plate was identified Part 5010218-1 ILM, SUBASSY 5010219-1, Serial No. SEP91-0039, TSO-0 26C, AB80-USA, TYPE IVBQ FORG 5010169

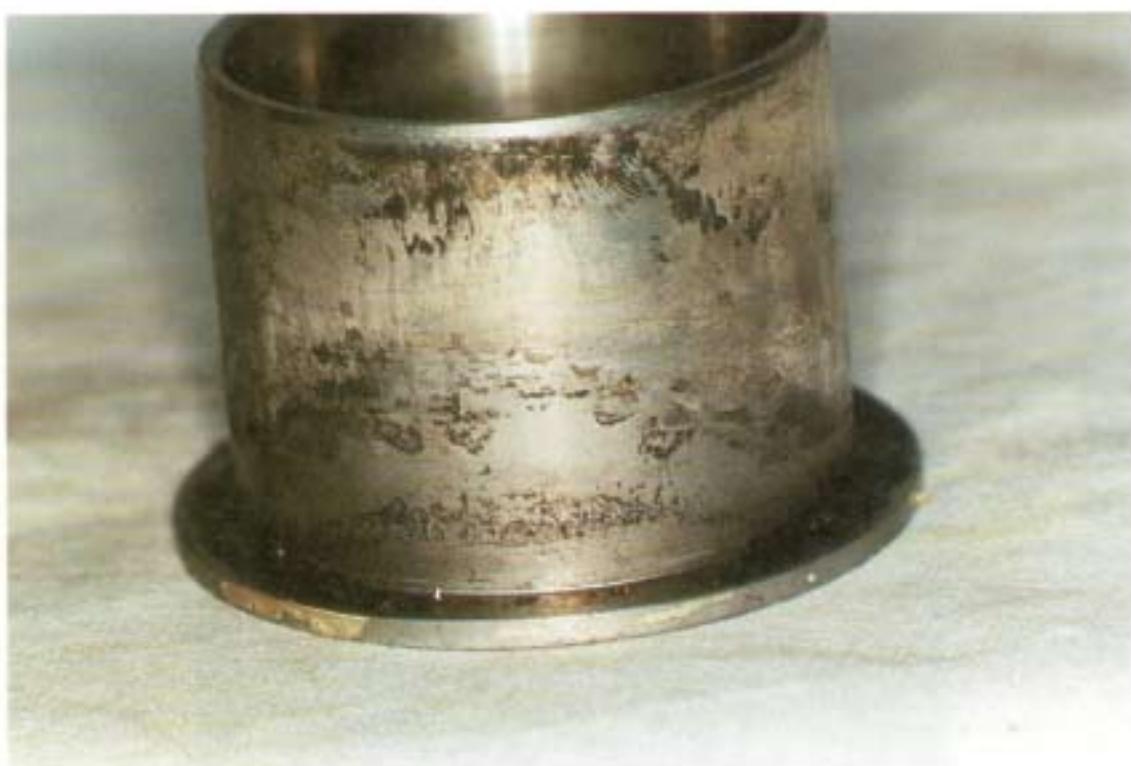
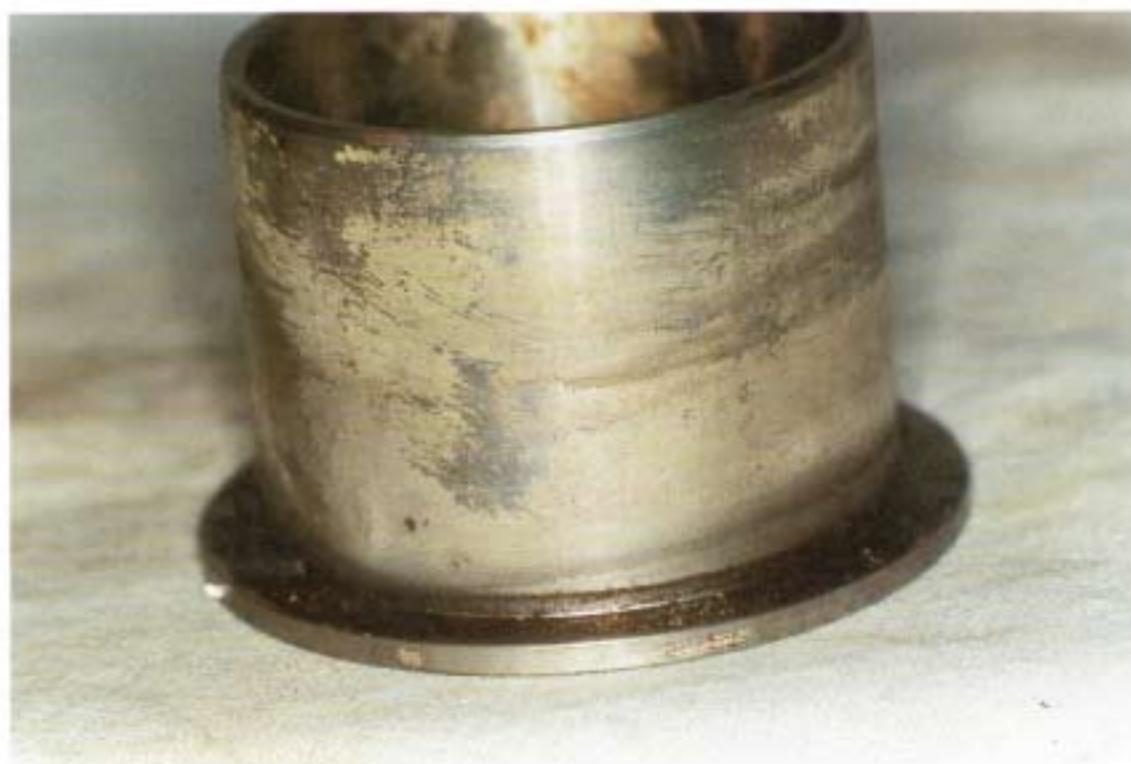
Plate 3

Two views on the bush from position A on Plate 1. The pattern of the debris and marking conforms to the general pattern of the marking within the hole shown on Plates 4 & 5.

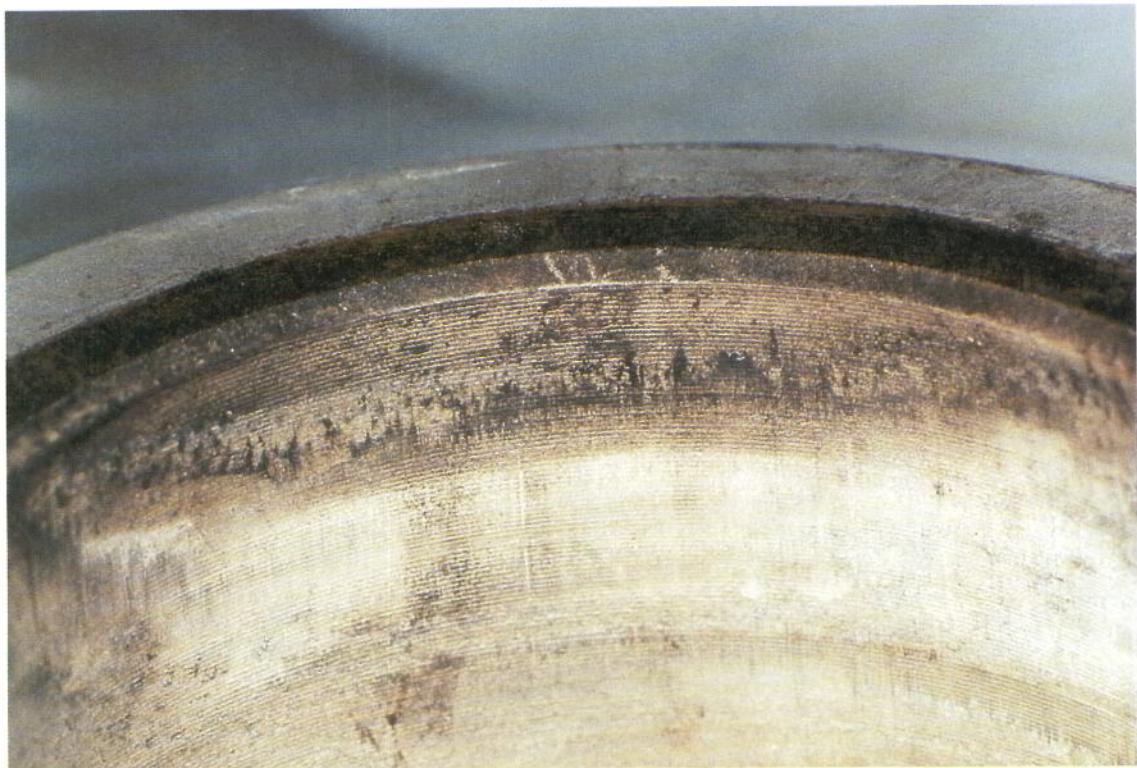
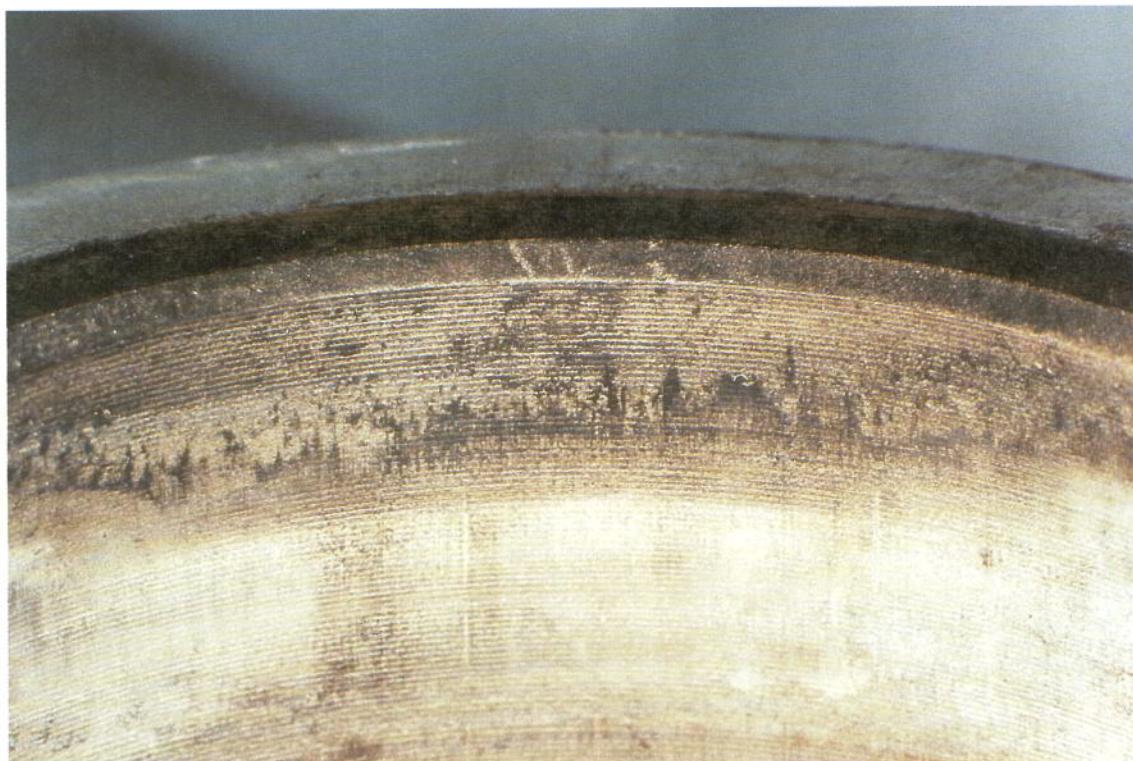
dimensional change. Furthermore, the void thus created between the bush and the bore had become contaminated with debris, which was visible as a 'tide mark' on the bush and was deep within the bore. This indicated that the damage was 'old' and had occurred long before the accident flight. Some photographic extracts from the report are shown at Appendix 19.

The marking within the hole where arrowed on Plate 1 shown at two different magnifications. It can be seen that the original machining marks have not been removed even though the hole was 0.009 ins oval. The maximum diameter was at this position

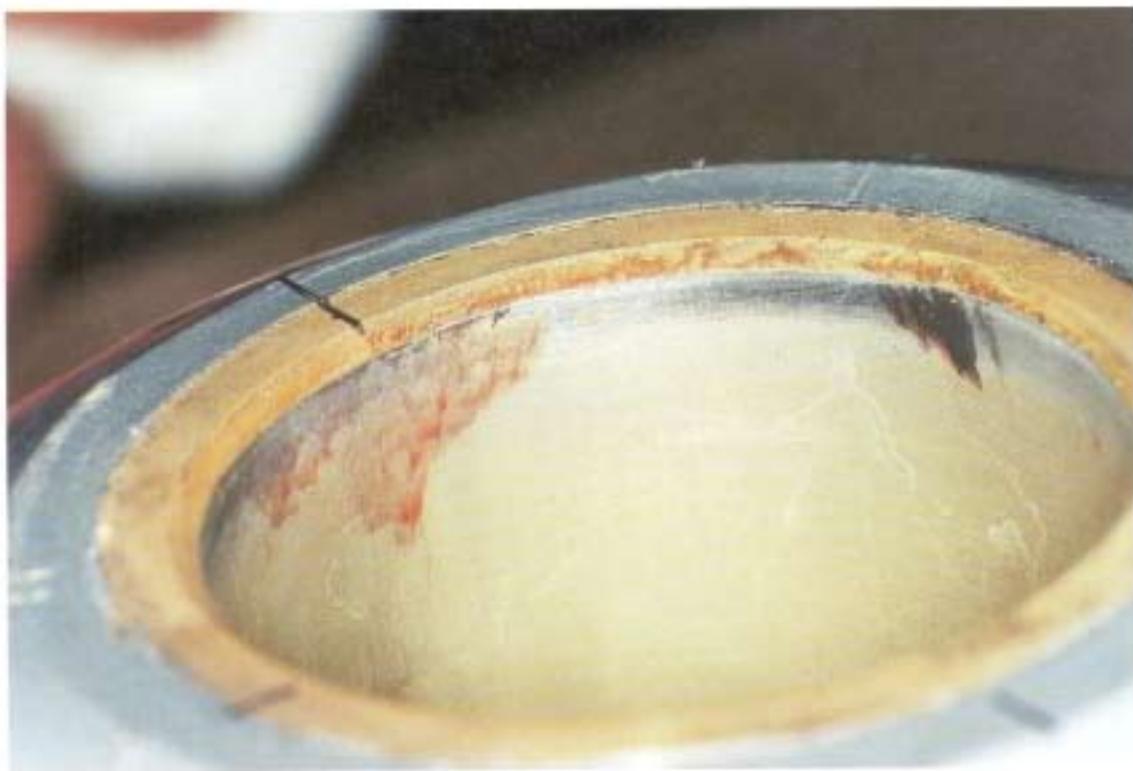
Plate 6

Brake Plate Serial No. 0111 – April '94 – Hong Kong incident – end of hole remote from
brake pack – start of 'compression' mark around rim.

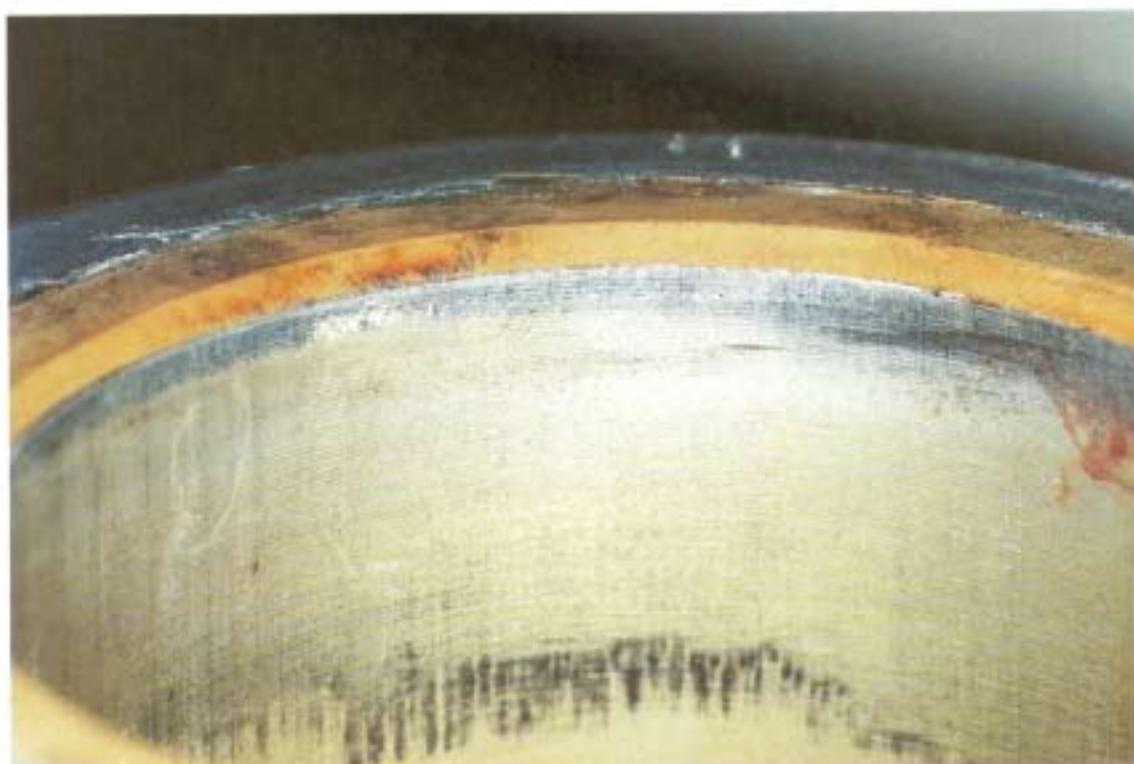
Plate 7

As Plate 6 but further round hole
