CONTENTS

SPECIAL BULLETINS

ACCIDENT

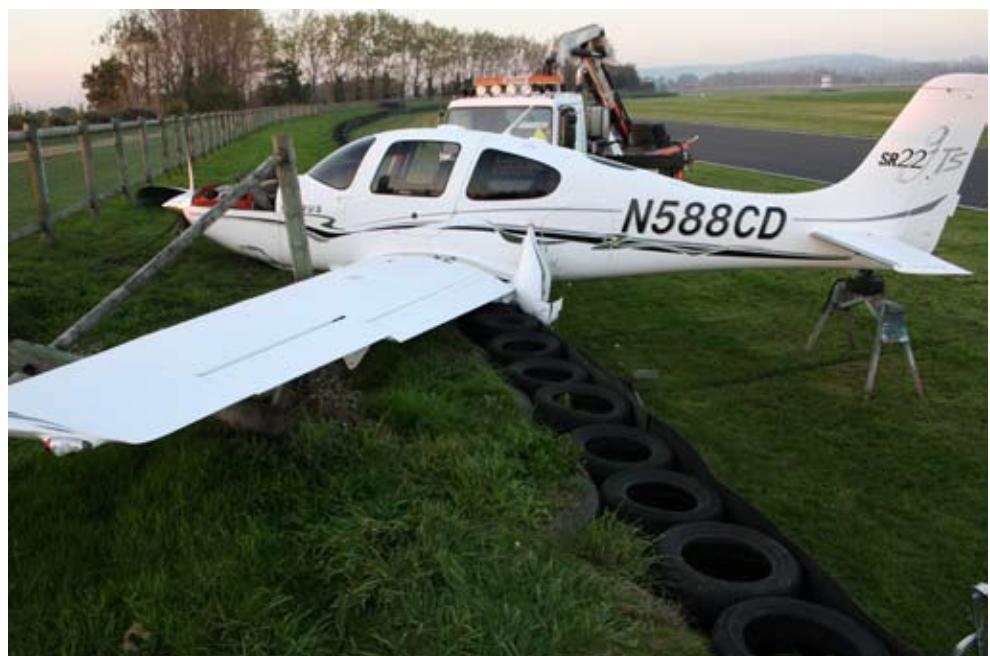
Figure 1
Aircraft in its final resting position against the tyre barrier

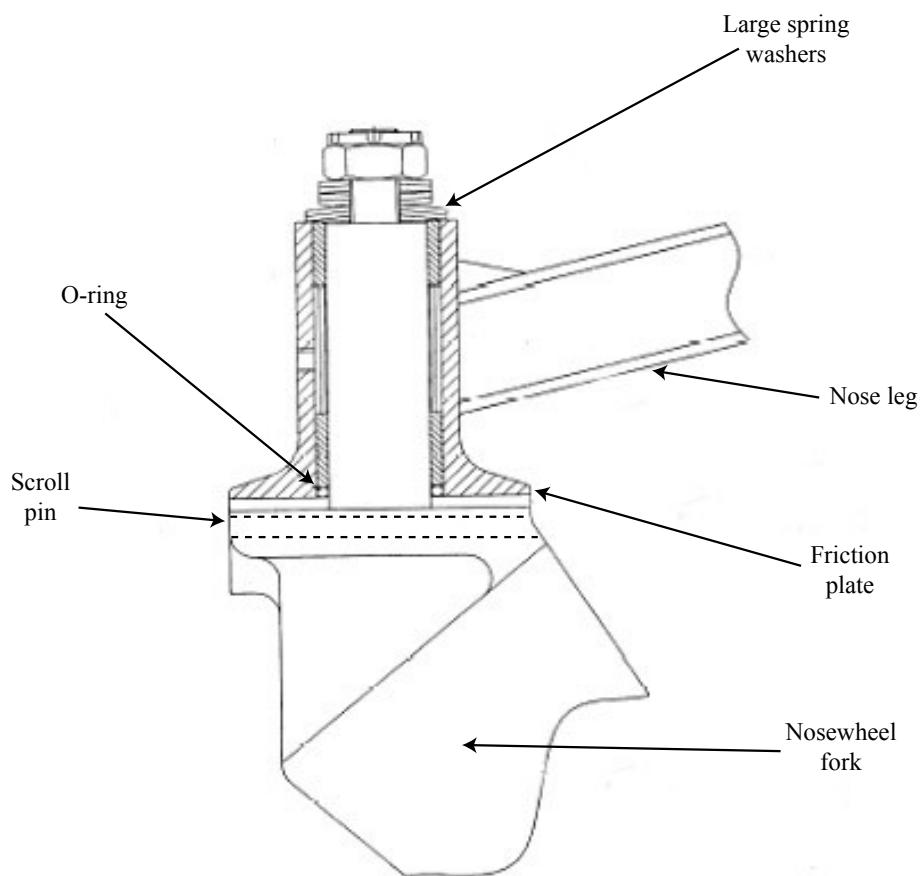
Figure 2
Details of attachment of nosewheel fork to leg

shaft fitted into a cylindrical housing welded to the lower end of the nose gear leg, see Figure 2.

The threaded upper end of the pivot shaft was inserted through a bushed hole within the cylindrical housing and was secured by means of a nut, which tightened down onto a stack of spring washers. These, in conjunction with a friction plate between the fork and the housing, allowed the nosewheel to castor. The spring washers provide shimmy damping, with the level of damping being adjusted by tightening or loosening the nut.

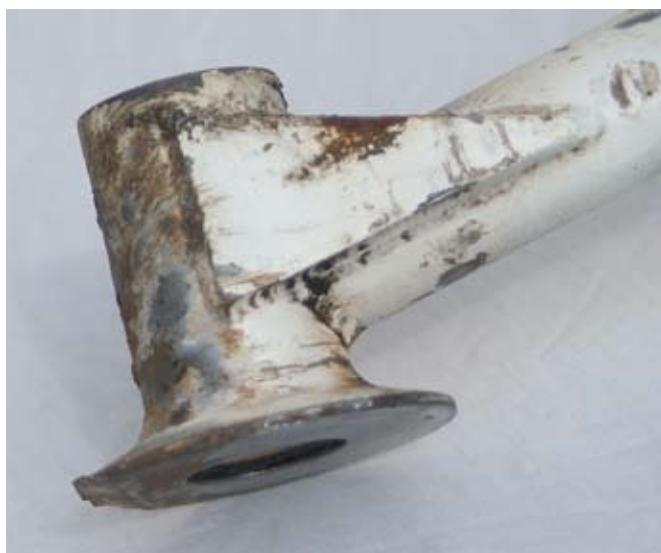
Figure 4
Pivot shaft housing and nose gear leg

The underside of both the pivot shaft and the front of the pivot shaft housing had worn to a 'chisel edge', see Figure 4. This was consistent with the aircraft having rolled along the runway without the nosewheel and nosewheel fork, but with the gear leg swept forward in its normal position.

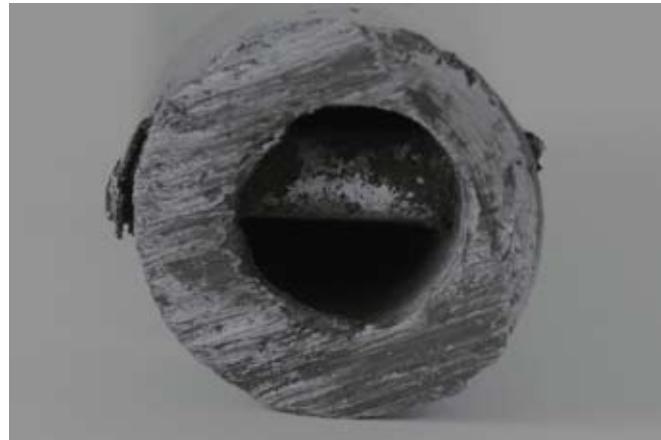
**Figure 6**

The scroll pin in the pivot shaft had failed in shear due to overload, see Figure 5. The hole in the pivot shaft for the scroll pin had not been drilled accurately across a diameter, see Figure 6. There were also burrs present on the internal surface of the pivot shaft next to the hole for the scroll pin. The hole was not perpendicular to the axis of the pivot shaft, hence the scroll pin was aligned slightly nose down. The off-centre and

Detail of failed scroll pin in pivot shaft

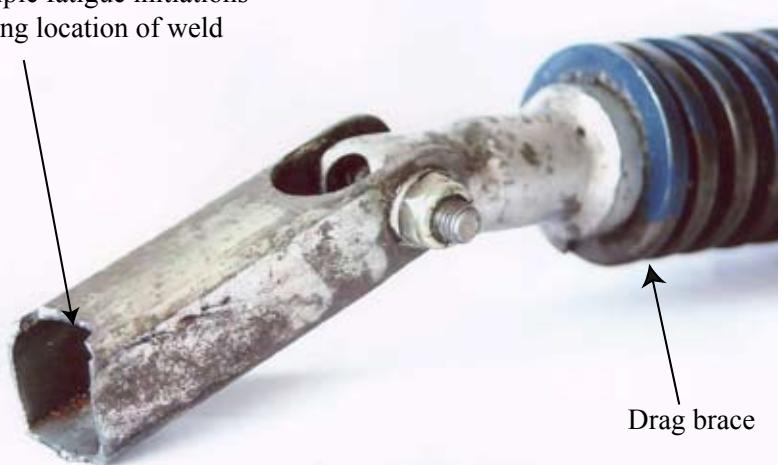
Figure 2

The longitudinal engine mount tube had failed at the location of the weld attaching it to the rear lateral

Multiple fatigue initiations along location of weld
