Aviation Occurrence Report – 200404589

**Aircraft Loss of Control
Lake George, NSW
21 November 2004**

VH-TAG

Fairchild Industries SA227-AC Metro III

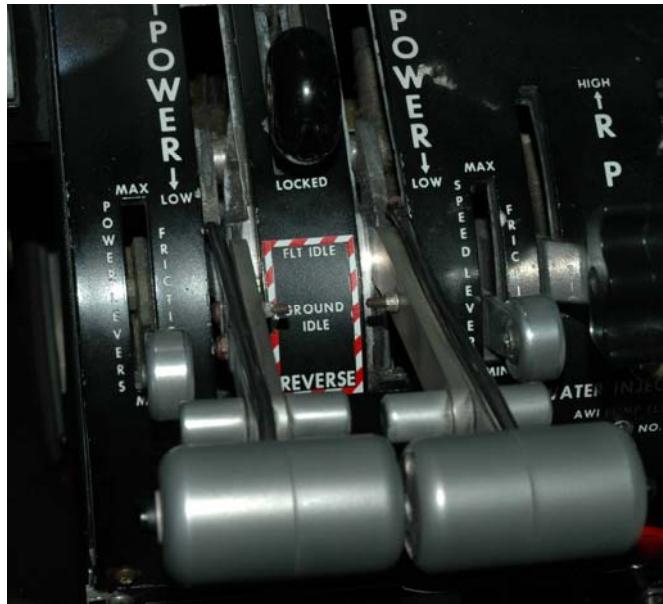
Figure 1: Power levers and markings

In order to prevent inadvertent selection of beta range in flight, the power levers were fitted with a supplemental latch mechanism that required the lifting of toggles (located below the power lever handle) to allow the lever to move through a detent from flight idle into the beta range.

Placing the power lever at the flight idle position with the landing gear retracted activated the 'landing gear warning' horn. No additional auditory warning was provided if the power lever was moved further rearward of the flight idle gate into the beta range. The 'Pre Planned Engine Airstart – SRL On' procedure called for the power lever to be brought back to the flight idle gate and then moved forward about $\frac{1}{4}$ inch until the landing gear warning horn was silenced. The CVR data indicated that the landing gear warning horn sounded four times during the occurrence sequence; the first time (lasting 14 seconds) was when the instructor initially brought the left engine power lever into the beta range.

Following the occurrence, the left propeller was found to be fixed in the 9 degree start-locks position. After release of the start-locks, the left engine and propeller operated normally during all ground testing and a subsequent in-flight engine shutdown and a start. No problems were identified with the detent on the power lever between the flight idle and beta range.

The Australian Transport Safety Bureau recommends that the United States Federal Aviation Administration consider revising Title 14 Code of the Federal Regulations, Part 23.1155, to require a positive means to prevent operation of the propeller in the beta mode while in flight (regardless of pilot action), unless the aircraft is certified for such use.
