A U S T R A L I A N   T R A N S P O R T   S A F E T Y   B U R E A U

AIR SAFETY INVESTIGATION

200100348

# **Cessna C310R, VH-HCP 3 km E Newman Aerodrome**

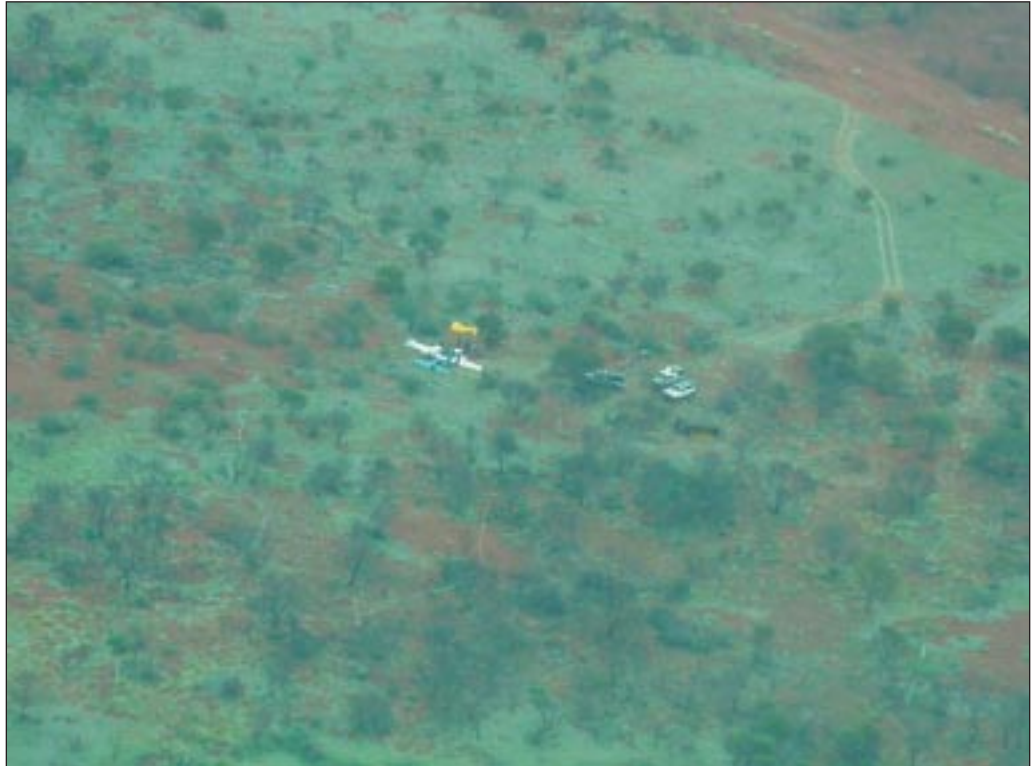
**FIGURE 8:**

**Aerial view of aircraft wreckage (note lack of wreckage trail, indicating steep flight path impact angle and low relative forward speed)**

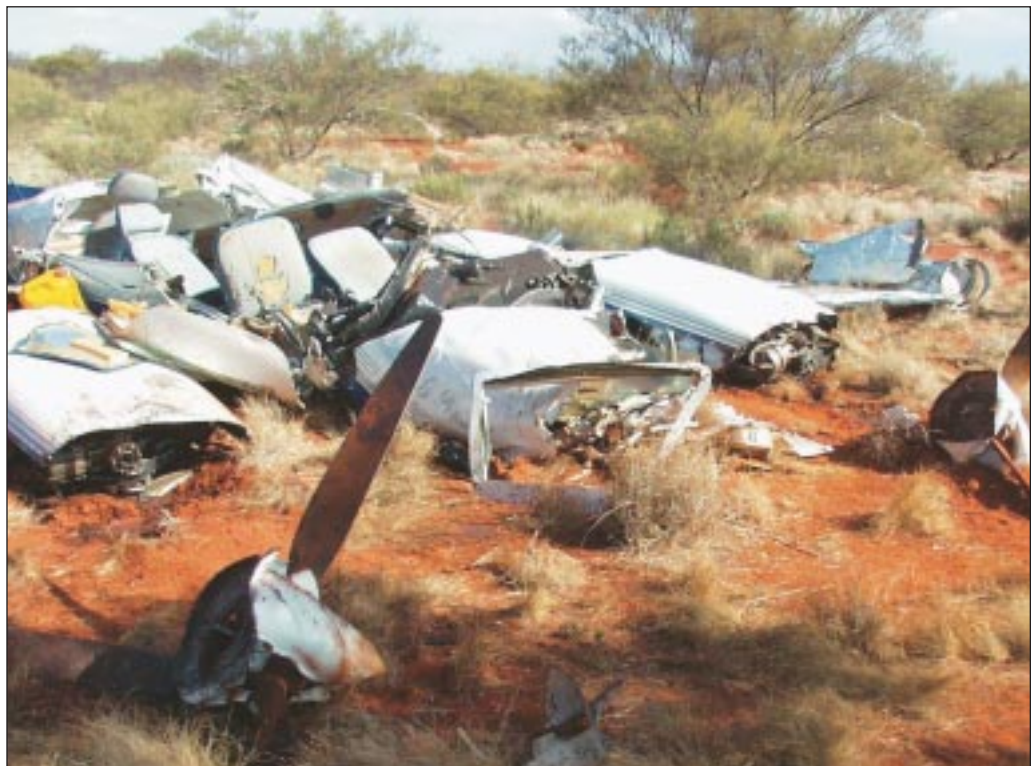
**FIGURE 9:**

**View of wreckage from front of aircraft (roof of aircraft cabin cut away by emergency services personnel, prior to arrival of ATSB investigators)**

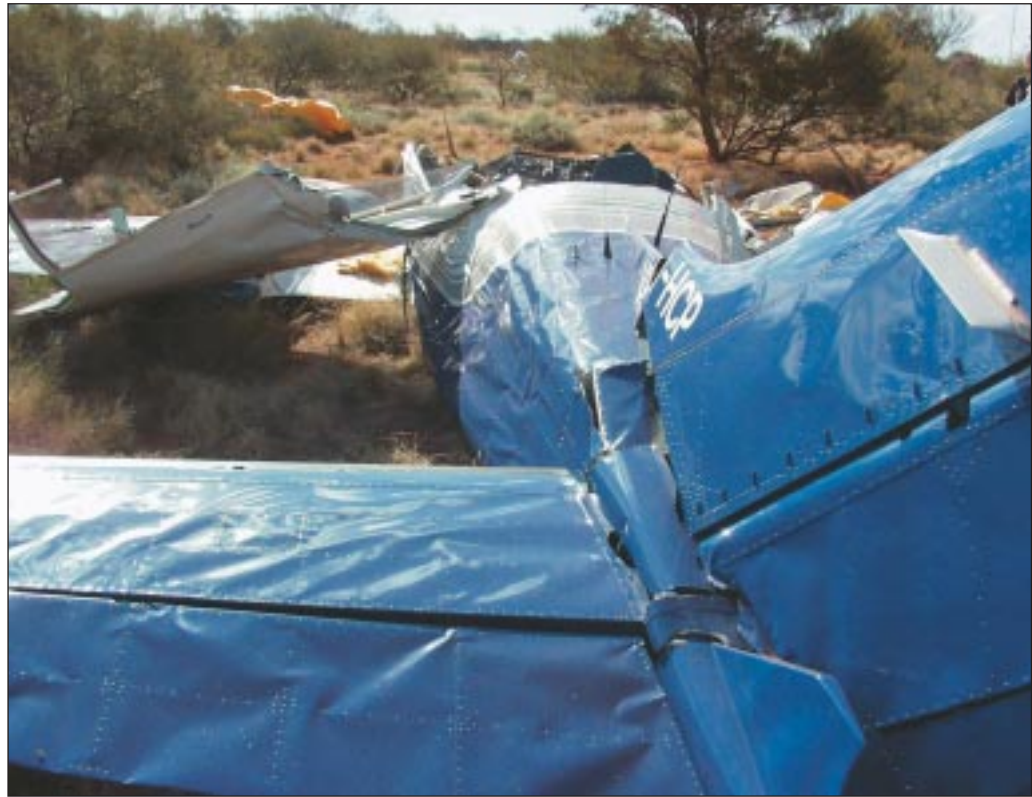
**FIGURE 10:**  
Rear view of aircraft fuselage

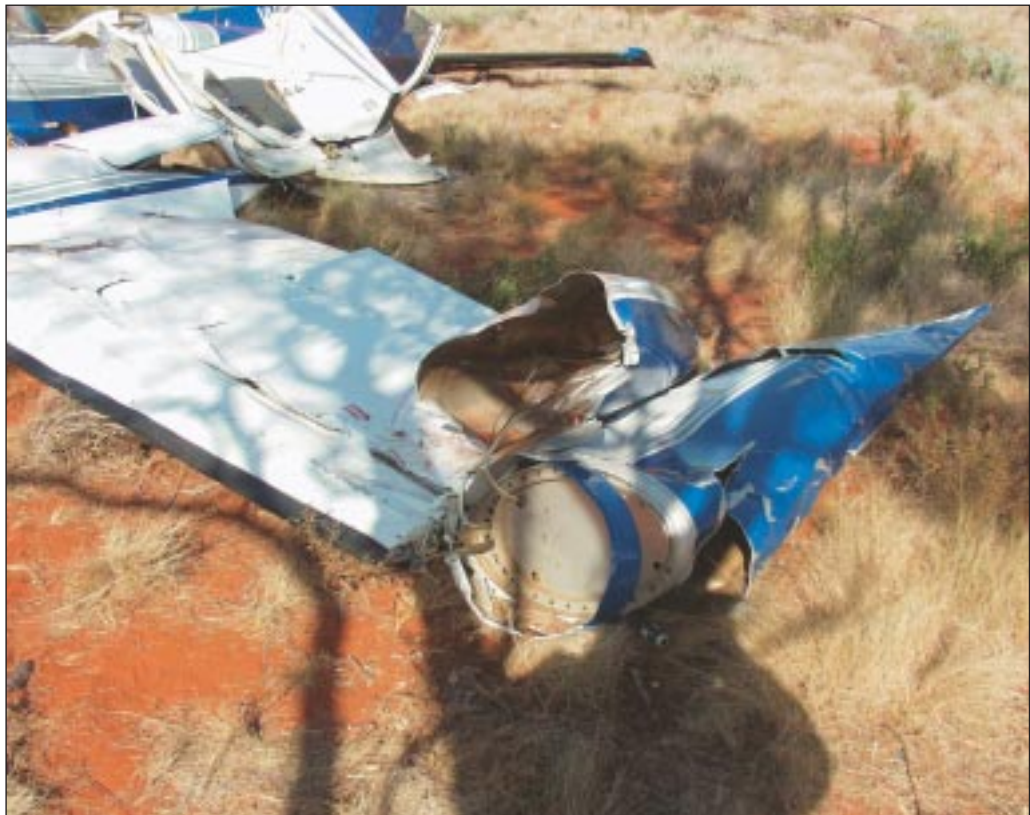
About 8 L of fuel was recovered from the left auxiliary fuel tank. The underside of the wing skin in the vicinity of the inboard auxiliary fuel cell exhibited damage that was consistent with fuel contained in the inboard cell acting on the skin during impact with the ground. The inboard cell was also holed in the vicinity of the fuel drain fitting, and when filled with water was observed to leak at that point. This damage was assessed as being impact related and a consequence of the initial ground contact.

**FIGURE 11:**  
Damage to left main fuel tank

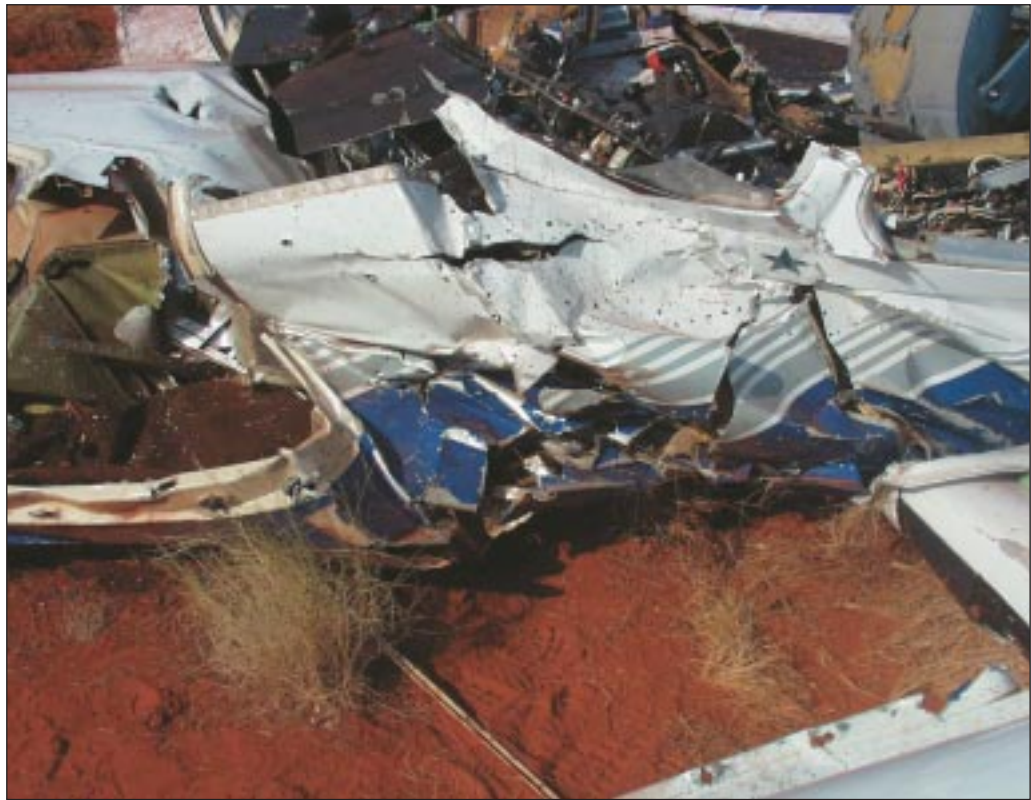
**FIGURE 12:**  
**Crush damage to forward fuselage section**

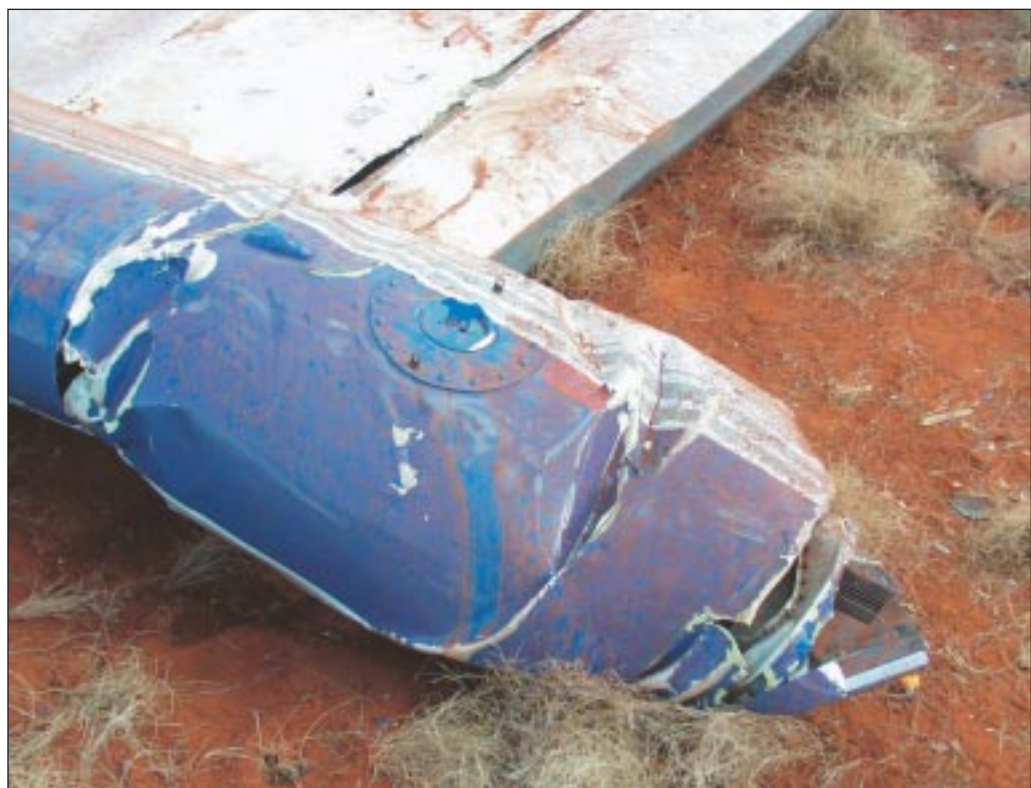
The right main fuel tank was significantly damaged on impact. There were some holes and compression damage to the forward part of the tank structure, although the rear part of the tank remained substantially intact.

**FIGURE 13:**  
**Impact damage to right main fuel tank (note fuel cap previously disturbed by emergency services personnel prior to arrival of ATSB investigators)**
