ATSB TRANSPORT SAFETY INVESTIGATION REPORT
Aviation Occurrence Investigation 200404590
Final

Bell 206B, VH-CSH Dunedoo, NSW

22 November 2004

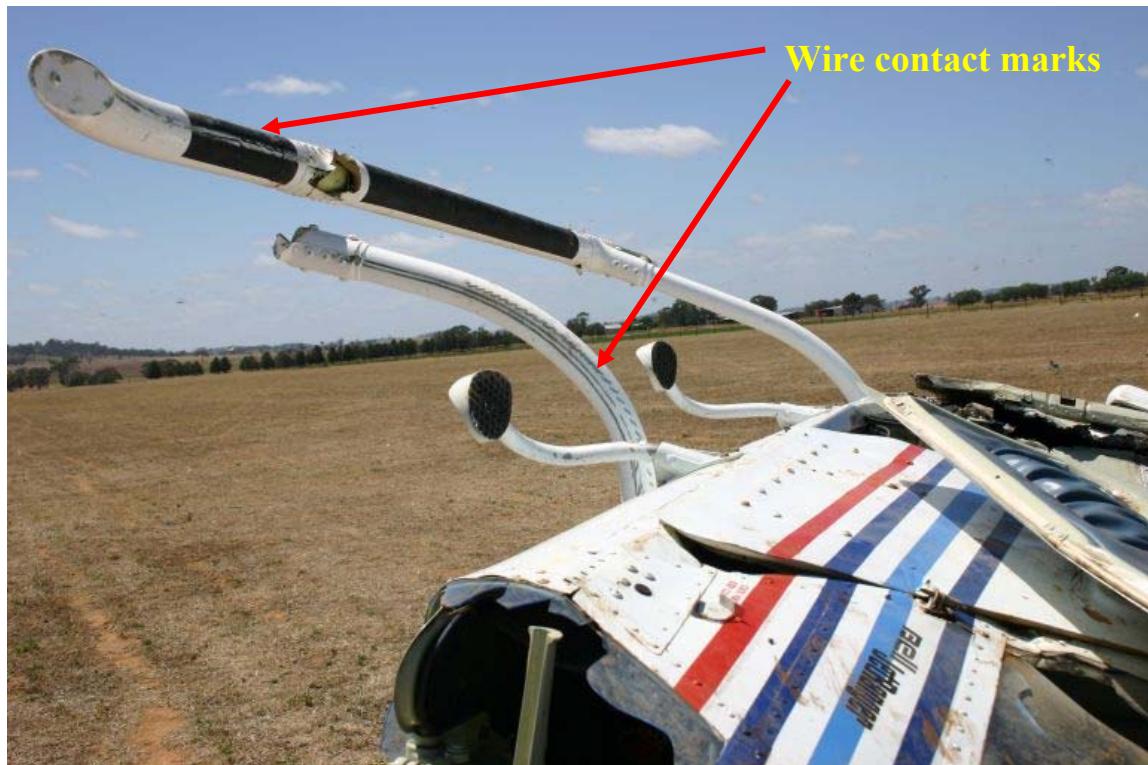
Figure 9: Powerline contact with the right skid landing gear

Examination of the powerlines and the helicopter skid landing gear revealed that the helicopter had struck both wires, while crossing at about 85-90 degrees relative to the powerline (see Figure 8), at a point between the skid landing gear and the fuselage floor. Impact markings on the helicopter's skid landing gear front crosstube and the forward, upper surface of both landing gear skids, indicated that the helicopter had contacted the powerlines more heavily on the right side than the left (see Figure 9). There was also evidence of electrical arcing on the surface of both wires and on the right side of the helicopter's skid landing gear.

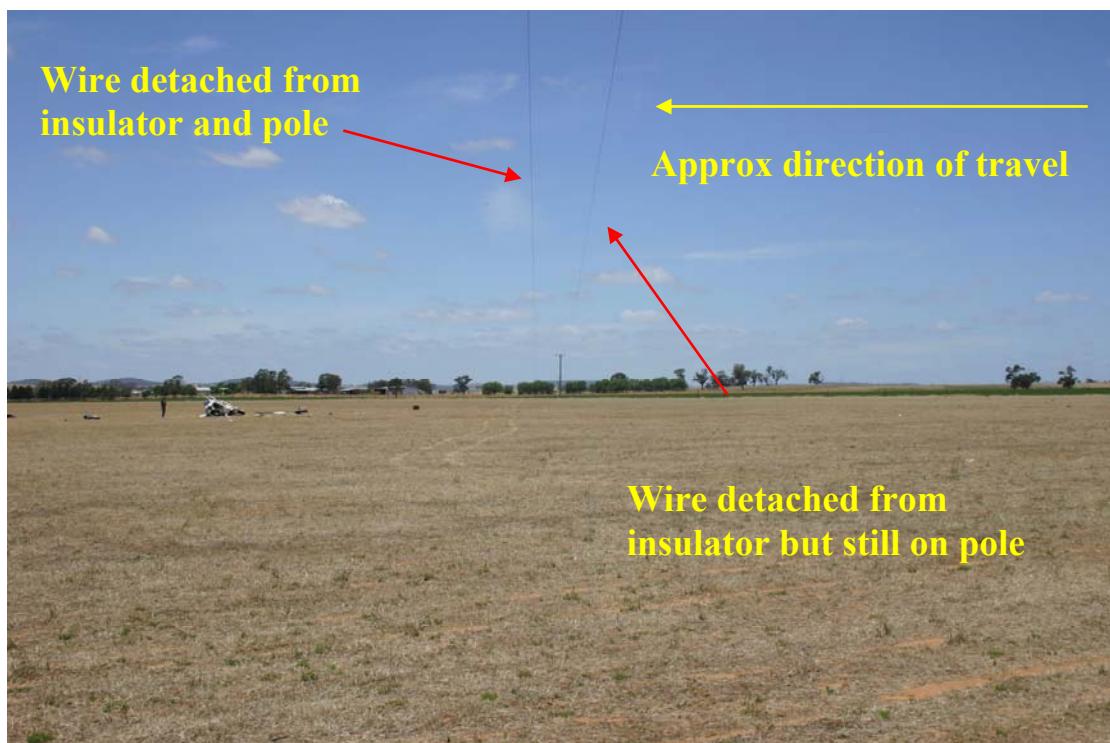
Figure 10: Powerline span showing final position of wires

The helicopter had pulled both powerlines from their attachment to the porcelain insulators on the power pole situated to the right of the helicopter's flight path. Both wires remained intact; one cable remained attached to the top of the power pole cross-member and the second cable was situated at a low height above the ground (see Figure 10).

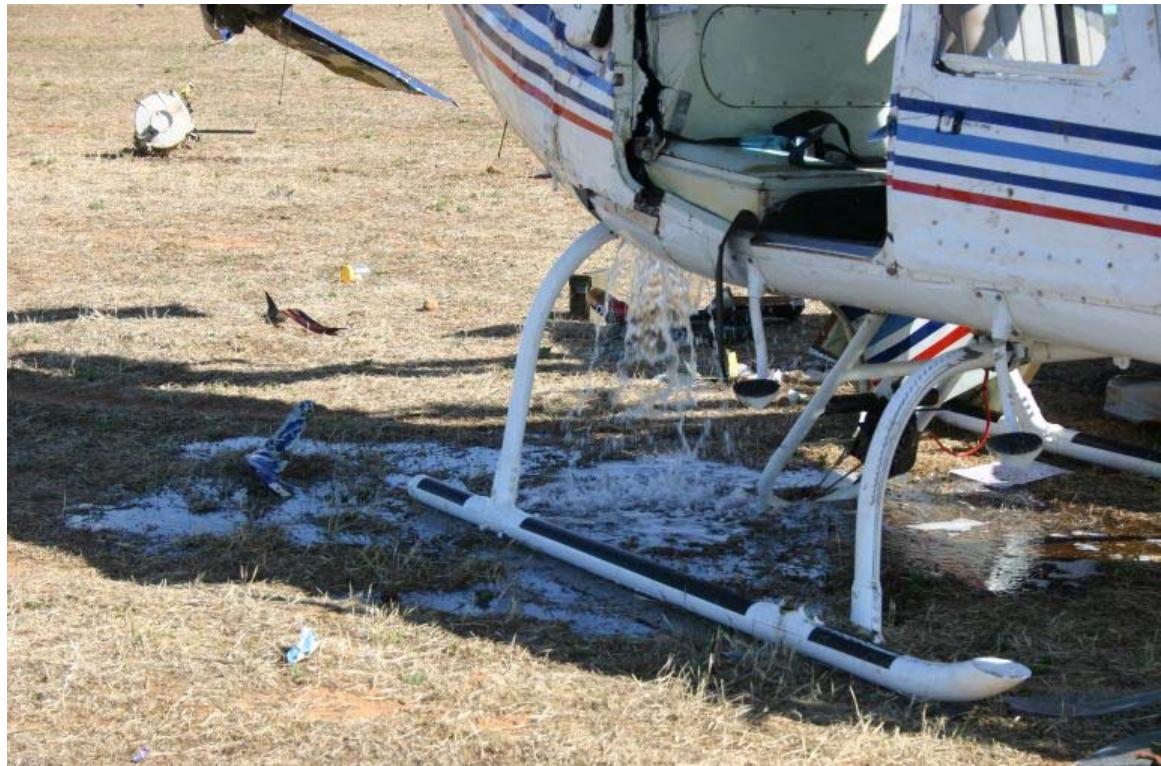
Figure 15: Disrupted fuel tank evident as helicopter is righted

During the process to return the helicopter to its skids, a large quantity of fuel drained onto the ground. The amount could not be measured, but was consistent with a quantity sufficient to ensure continued flight (see Figure 15).

Note: Aviation turbine fuel flowing from ruptured fuel tank onto ground.

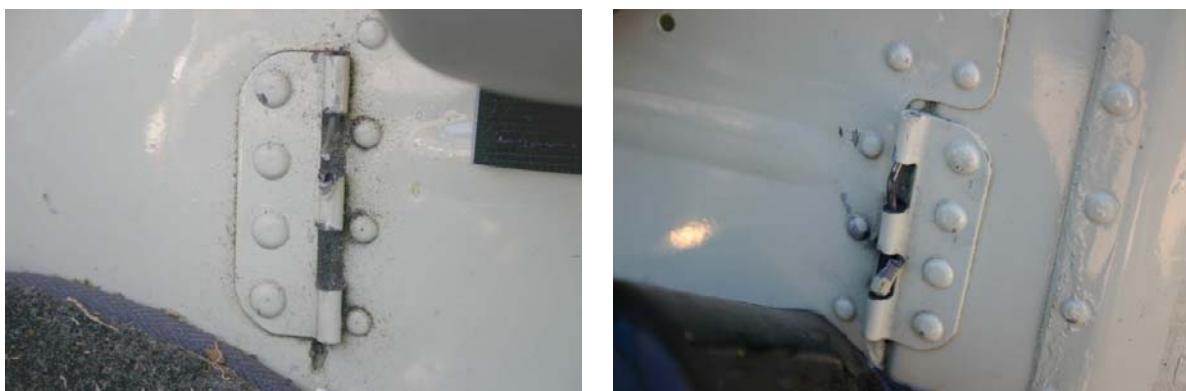
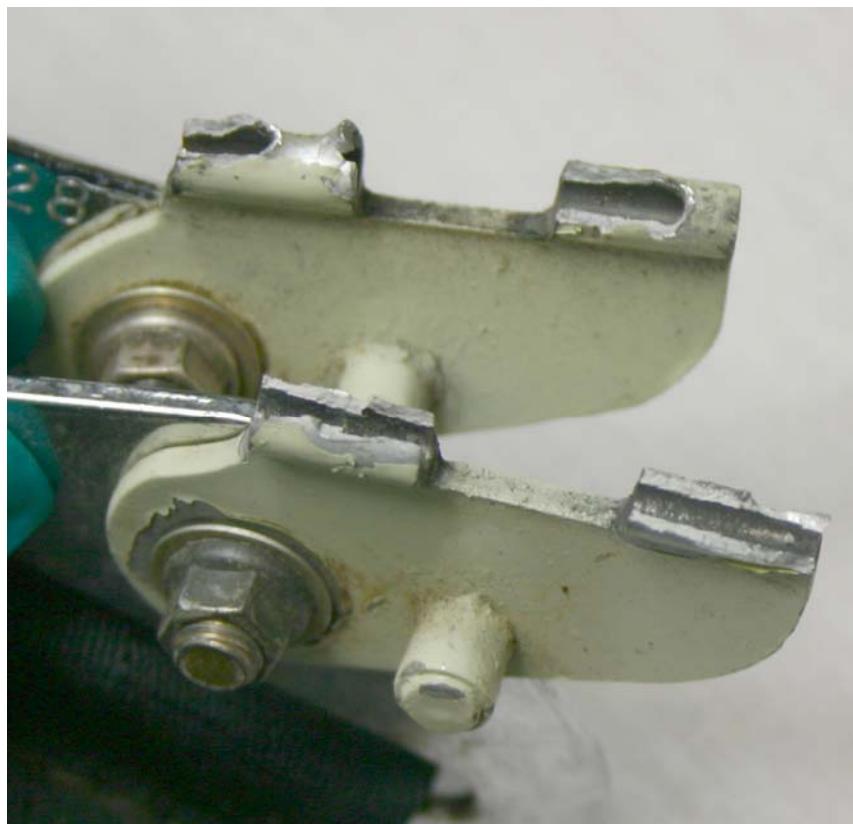
Examination of the pilot's seat harness revealed that it appeared to have been correctly fastened, and that the attachment points were intact. The front seat passenger's four-point harness seatbelt assembly was also found intact and correctly fastened for flight. However, both of the 'piano hinge' attachments that secured the end of each lap belt to the airframe had failed during the accident sequence. Examination of the fracture surfaces of those attachments indicated that they had failed in overload (see Figures 18 and 19).

Figure 18: Failed seat belt (airframe) attachments for left front crew seat

Figure 19: Failed seat belt attachments for left front crew seat

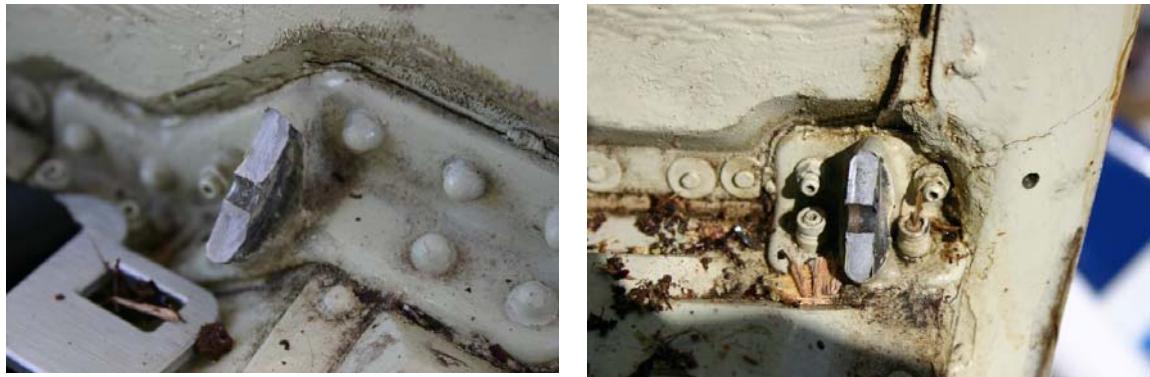
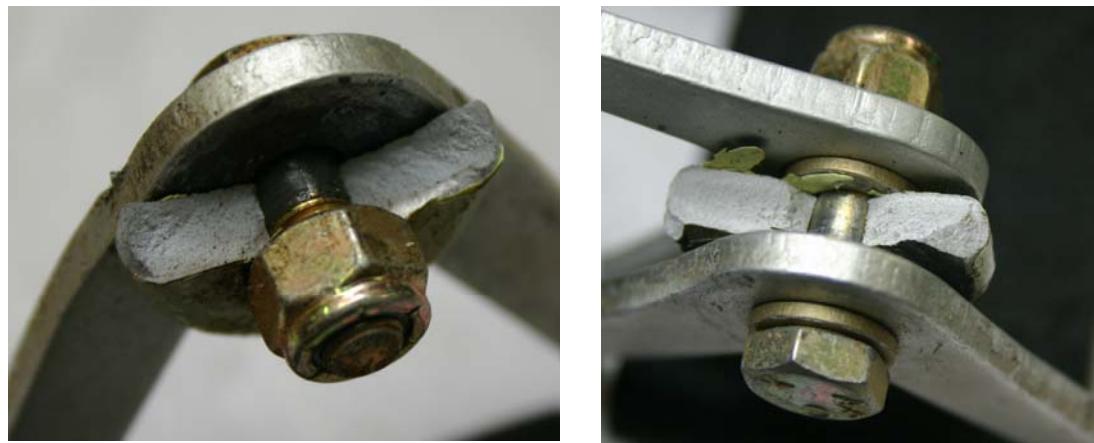
Both seat belt attachment points, for the passenger who was seated in the left rear cabin, had also failed as a result of the impact. Examination of the fracture surfaces of the rear bulkhead attachment points revealed that they had failed in overload (see Figures 20 and 21). The seat belt had been correctly fastened.

Figure 20: Failed seat belt (airframe) attachments for left rear cabin seat

Figure 21: Failed seat belt attachments for left rear cabin seat
