AVIATION SAFETY INVESTIGATION REPORT  
200204328

## Hamilton Island Aerodrome

Piper PA-32-300, VH-MAR  
26 September 2002

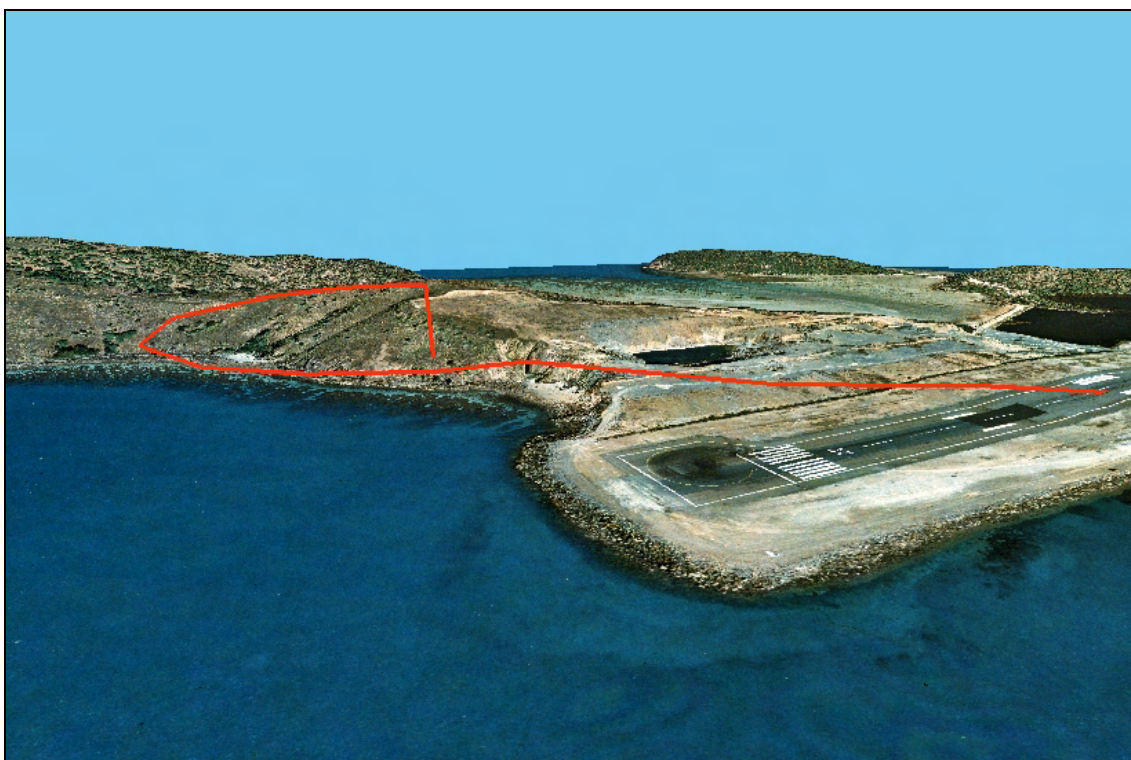
**Figure 2:** Probable aircraft flight path

A number of witnesses reported that, when part way around the turn, the engine again 'cut out', and the aircraft descended '...like a dart' before impacting the sloping ground of the hillside. There was no report of any object falling from the aircraft, or of any vapour or smoke emanating from the aircraft. The maximum height achieved by the

aircraft was reported as approximating the 98 m (322ft) elevated ground to the southwest of the runway end and in the background of the witnesses field of vision. An indication of the probable aircraft flight path is at Figure 2.

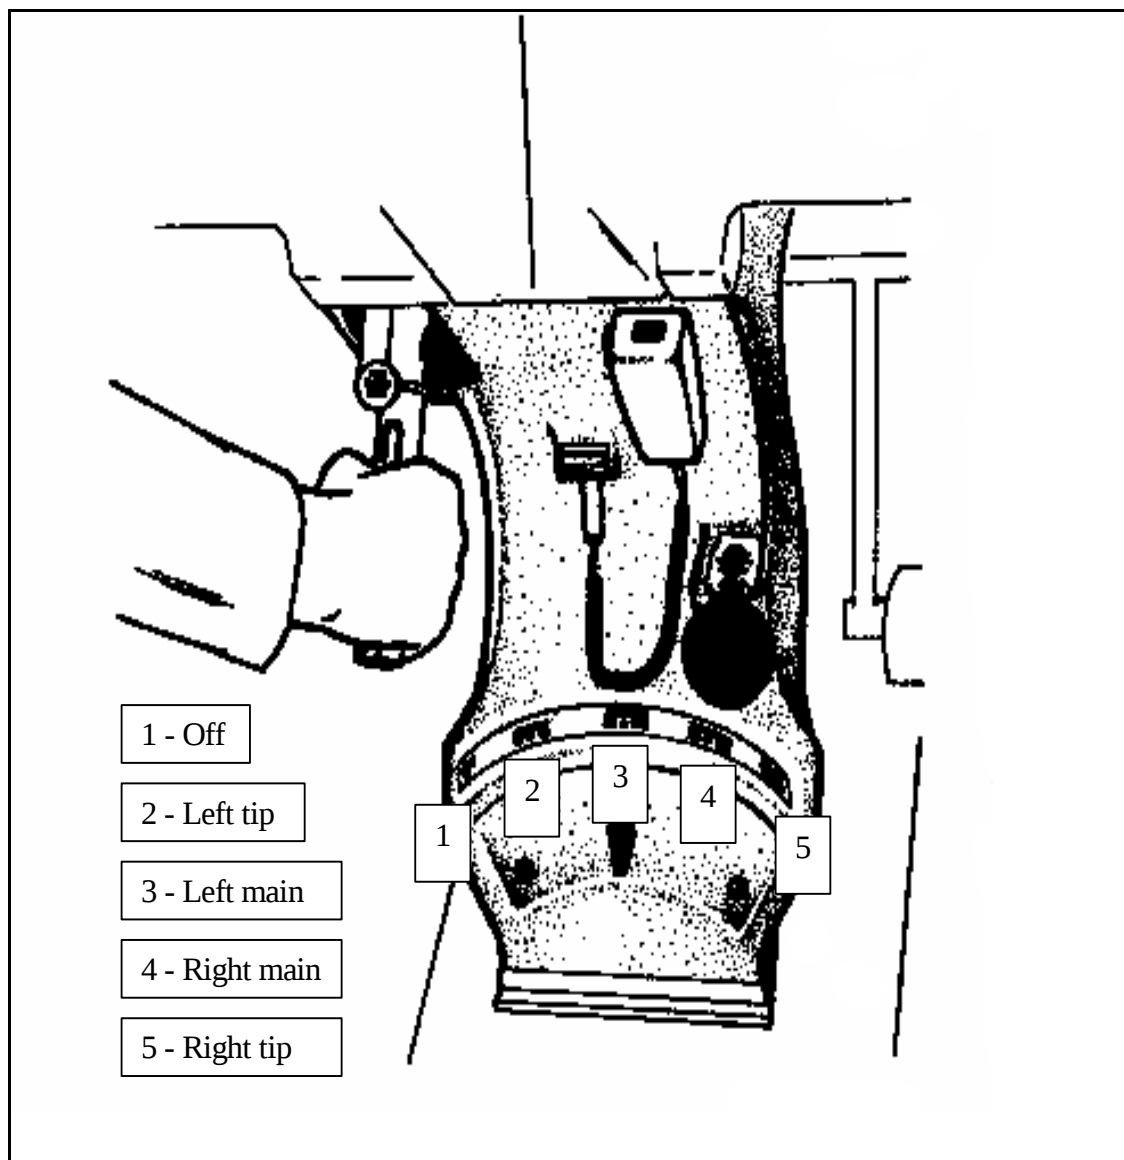
**Figure 3:** Fuel selector control positions

The fuel selector valve was in a beyond the OFF position consistent with being driven beyond the off detent by impact forces. The absence of witness marks on the fuel selector housing and plate prevented determination of the position of the fuel selector mechanism prior to impact. There was no evidence of any pre-existing defects. Although the fuel selector valve detent mechanism was intact and showed minimal wear, it was not possible to determine its pre-impact effectiveness.

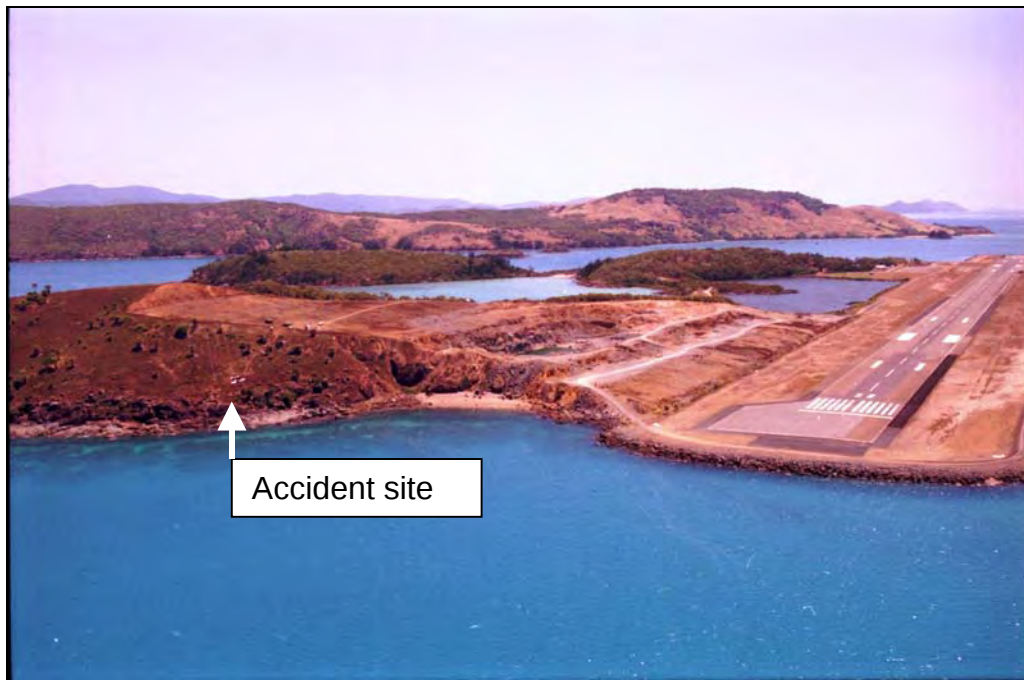
**Figure 6:** Accident site location

The accident site was located approximately 300 m to the west of the take-off runway centreline and approximately 100 m south of the departure end of that runway. The terrain at the accident site was inclined at an average of 19 degrees down to the horizon, with light scrub and numerous small groups of palm trees. Numerous large rocks were found in the vicinity of the impact point. A photograph of the location of the accident site is at Figure 6.

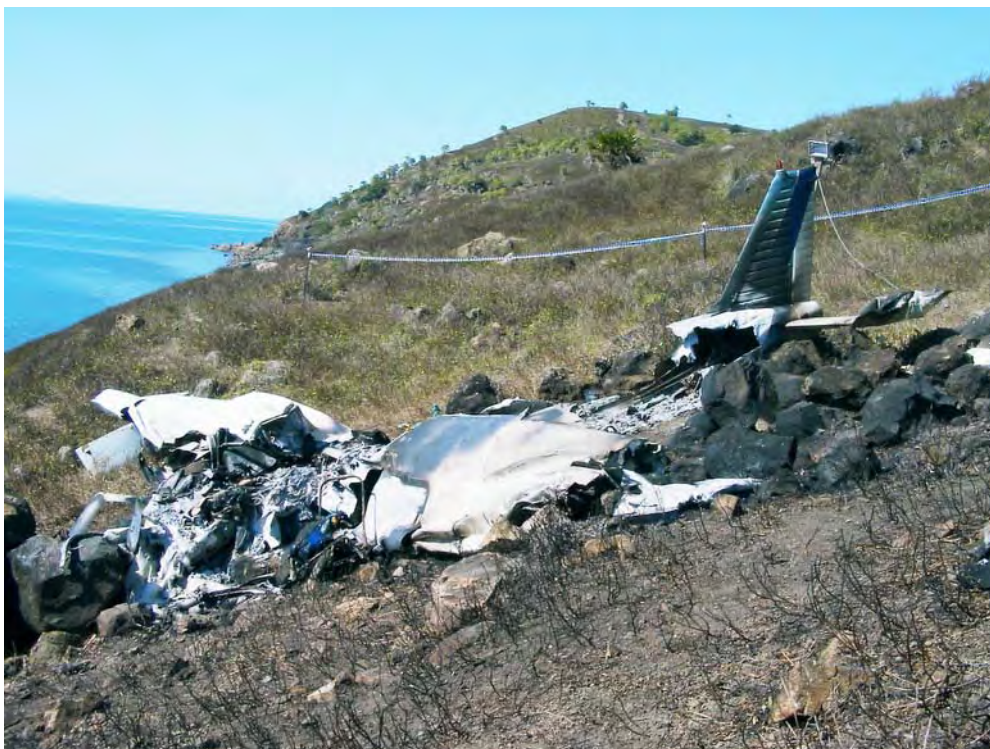
**Figure 7:** Accident site aircraft photograph

The aircraft wreckage was substantially intact, upright and in the immediate proximity of the impact point. The nose of the aircraft was oriented in an east-north-easterly direction. All structural components and flight control surfaces were located in the immediate vicinity of the wreckage. That was consistent with the aircraft being intact upon impact with the ground. A severe post-impact fire consumed the majority of the aircraft's fuselage. A photograph of the aircraft at the accident site is at Figure 7.

The aircraft struck the ground with minimal forward speed over the ground. Indications were that the right wing of the aircraft contacted the ground first, while slightly banked to the right and in a nose low attitude. That was estimated to have been about 70 degrees nose down to the horizon. There was evidence of aircraft rotation to the right at ground impact.

The right wing exhibited impact damage to the lower leading edge and the main fuel tank was ruptured and protruded forward of the wing leading edge. The wing tip tank was dislodged from the wing, but remained largely intact. Damage to the wing was consistent with impact with the ground and adjacent rocks.

Impact forces distorted the left wing leading edge and breached the main fuel tank. The leading edge wing tip exhibited crush damage. The post-impact fire consumed the underside of the left wing and tip tank.

The propeller spinner was wedged against a large rock and the propeller was found loosely attached to the engine crankshaft. The crankshaft was bent to the right and down from its normal position. The engine was largely intact, but the post-impact fire had consumed the sump. There was extensive damage to the induction and exhaust system piping.

Most of the cabin fittings and the aircraft fuselage were consumed down to the level of the floor pan by the post-impact fire. That fire damage continued aft to the stabilator assembly. The stabilator assembly was complete and the vertical stabiliser was intact. There was impact damage to the outboard under surface of the left stabilator, consistent with its having struck surrounding rocks. Fire had consumed all three aircraft tyres.
