ATSB TRANSPORT SAFETY INVESTIGATION REPORT

Aviation Occurrence Report – 200502137

**Evacuation
Hobart Airport
17 May 2005**

**VH-VQI
Boeing 717-200**

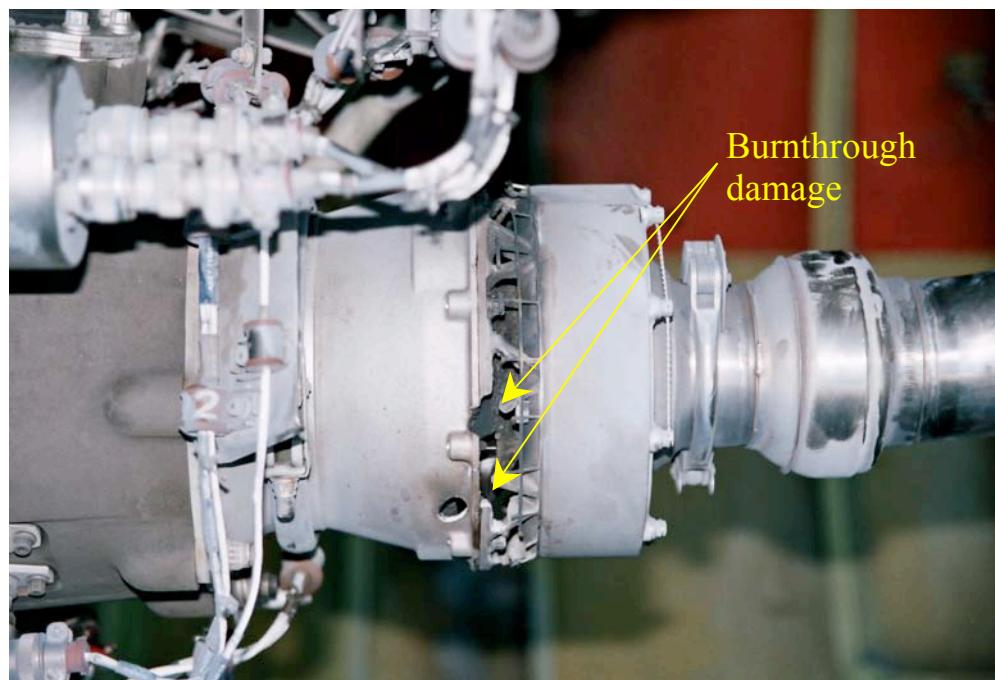
Figure 2: Failed air-turbine starter on right engine

The right engine air-turbine starter assembly P/No ATS100-510 3505934-8, S/No. 0101-0850, failed during the engine start sequence (Figure 2). The starter was removed and sent to the United States (US) manufacturer for detailed examination under the supervision of the US National Transportation Safety Board (NTSB). The examination revealed that the starter failed as a result of a loss of lubricating oil from the starter while in-service. The oil loss was a result of an incorrectly installed starter output shaft seal retaining ring.

The right engine air-turbine starter had a total time in service (TTIS) of 8,522.3 hours and total cycles since new (CSN) of 6,996 cycles. The air-turbine starter had been removed in-service and installed on the right engine of VH-VQI 415.7 hours prior to the failure. The component maintenance manual for the starter output shaft retaining ring installation provided a schematic diagram of the correct ring installation orientation but did not highlight this requirement in the accompanying instructions.

The right engine air-turbine starter failed during the engine start sequence leading to the streaming of sparks and a significant amount of smoke from the vicinity of the right engine. The starter failed due to the loss of lubricating oil, which was the result of an incorrectly installed starter output shaft seal retaining ring. The oil seal retaining ring can be installed in one of two directions and, if installed in the incorrect direction, can lead to loss of oil from the starter. The starter had been initially assembled at the component manufacturer and had been the subject of in-service removal and installation by maintenance personnel prior to the failure.

Without clear instructions provided in the component maintenance manual on the correct orientation of the starter output shaft oil seal retaining ring, it is likely that the retaining ring was installed incorrectly during the last installation procedure, some 417.5 hours prior to the starter failing.

- The right engine air-turbine starter failed during the engine start sequence as a result of the loss of oil from the starter.
- The loss of oil from the air-turbine starter was a result of the output shaft oil seal retaining ring being installed incorrectly during installation.
- The output shaft oil seal retaining ring installation design permitted the ring to be installed in either of two directions.
- The output shaft oil seal retaining ring installation instructions did not adequately highlight the correct retaining ring orientation.

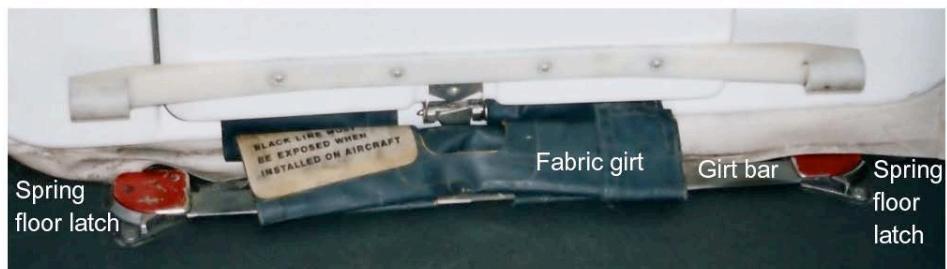
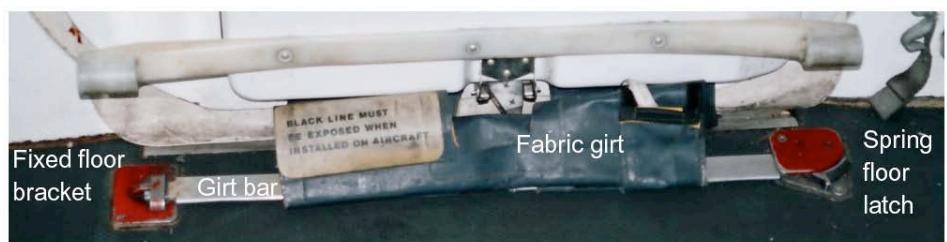
Figure 4: Door L1 (top) and R1 (bottom) girt bar with door in armed mode

On the two forward doors (L1 and R1), the slide was located inside each door. To be in the armed mode, the slide had to be attached to the aircraft via a fabric girt to a girt bar which was attached to two floor latches (see Figure 4). If the door is opened in the armed mode, the girt bar remains attached to the floor and the slide is pulled out of the door by the fabric girt. Automatic inflation of the slide then follows.

The Door Right 1 (R1) slide fell from the aircraft intact in its casing and there were no defects found with the slide, floor latches, fabric girt or girt bar. If the girt bar was attached to both floor latches (armed mode), the slide would have remained connected to the aircraft after the door was opened. If the girt bar was not attached to either floor latch (disarmed mode), then the slide would not have been pulled out of the door. The only way the slide could have been pulled out the door but not remained attached to the aircraft was if the girt bar was attached to one of the floor latches but not the other. The same result would have occurred no matter which end of the girt bar was attached to the floor latch.

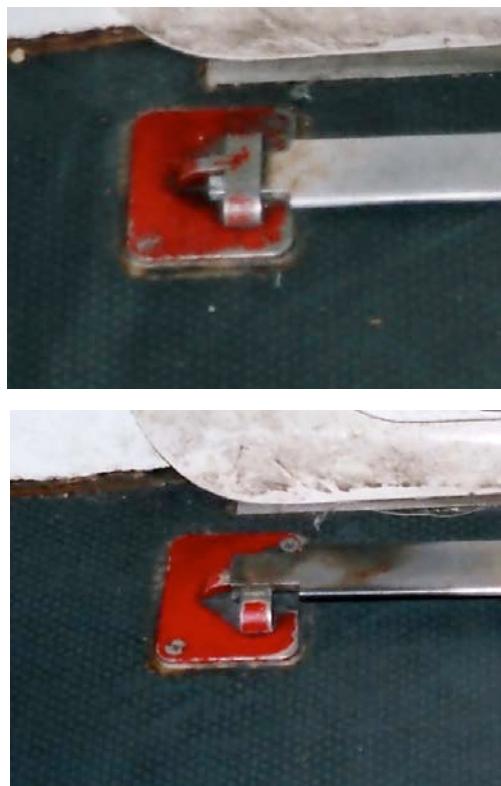
Figure 5: Girt bar floor bracket from R1 with girt bar in armed mode (top) and girt bar on top of floor bracket (bottom)

The forward R1 fixed floor bracket on the incident aircraft was painted red, as were the spring loaded latches. However, the paint on top of the bracket had worn away. The girt bar was an un-painted, aluminium bar. It can be seen in Figure 5 that if the girt bar was placed incorrectly on top of the fixed bracket, it looked similar to when the girt bar was placed inside it as designed.

The second possibility is that R1 was not properly armed during the earlier door arming procedure. It can be seen in Figure 5 that when the left end of the girt bar was placed on top of the fixed bracket, careful visual inspection was needed to confirm whether it was inside the bracket. This was partially a result of the worn paint on top of the floor bracket, revealing metal the same colour as the girt bar. Given that the door arming cross-check by the Door Left 1 (L1) flight attendant occurred from the other side of the aircraft, that the lighting at floor level was not very bright, and that the red paint was not a high enough contrast with the surroundings, an end of the girt bar could have been quite easily perceived as being inside the bracket when in fact it was on top. If the cross-check system involved flight attendants crossing the cabin and physically touching the girt bar where it was connected with the floor brackets, there would be a much greater chance of a partially armed door being discovered before flight.

- The red paint on the forward fixed girt bar bracket for the Door Right 1 slide girt bar had been worn away and the resulting metal surface was very similar in appearance to the girt bar.
- Most of the passenger injuries occurred on the Door Left 1 slide, which was short and steep. The slide design met the requirements of the US Federal Aviation Administration regulations that control slide design.

- The operator’s Engineering and Maintenance section have raised a special inspection card requiring a visual inspection of the door L1 and R1 girt bar latches during maintenance C Checks, with any missing or faded red paint on these latches to be repaired.

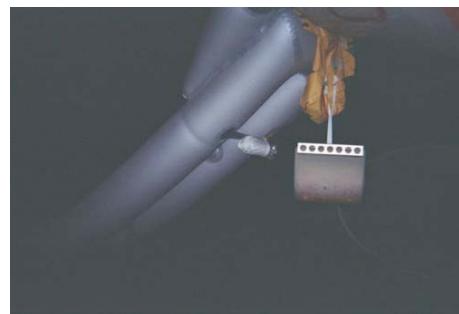
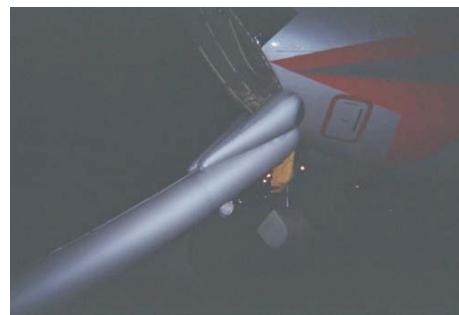
Figure 6: Slide from L1 (top) and tail cone D2 (bottom)⁷

Many of the passengers, as well as the flight attendants and ground personnel, reported that the L1 slide was very steep and short. They had expected a cushioning section at the end of the slide. Ground staff reported that passengers were jumping onto the slide and only actually contacting the slide about a half or three quarters the way down. The escape slide at D2 was longer (as the exit was higher) and less steep at the end (Figure 6).

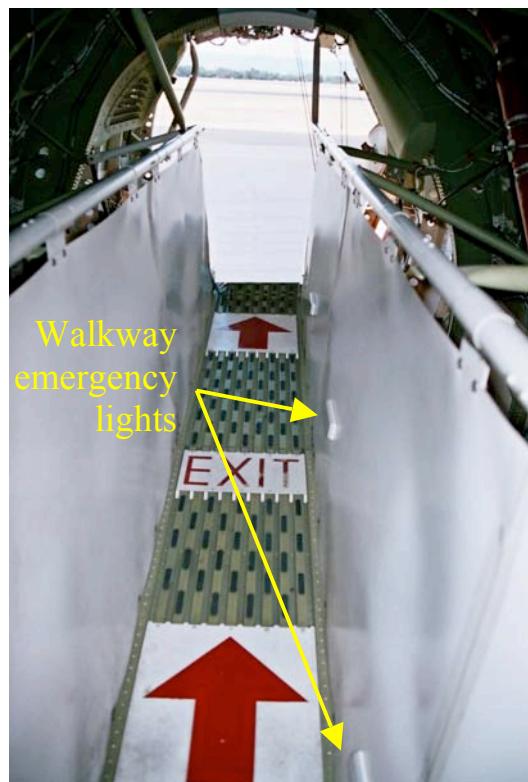
Figure 7: Evacuation walkway in the tail section from D2 to the slide

The D2 flight attendant reported that the tail area was dark and was only illuminated by the cabin lighting coming through the opened D2. The flight attendant reported that the painted arrows on the walkway (Figure 7) were difficult to see and she was concerned that passengers could fall down the side of the walkway due to the darkness. When the D2 door was opened, the flight attendant was also unsure, due to the darkness, if the tail cone had been ejected and if the slide had inflated. As such, she slowly walked to the end of the tail section walkway to confirm this before allowing any of the passengers waiting at D2 to enter the tail section.
