RAPID DESCENT

A series of unfortunate events leads a 737 captain to dive to the wrong conclusion.

ANALYSIS MURPHY'S LAW

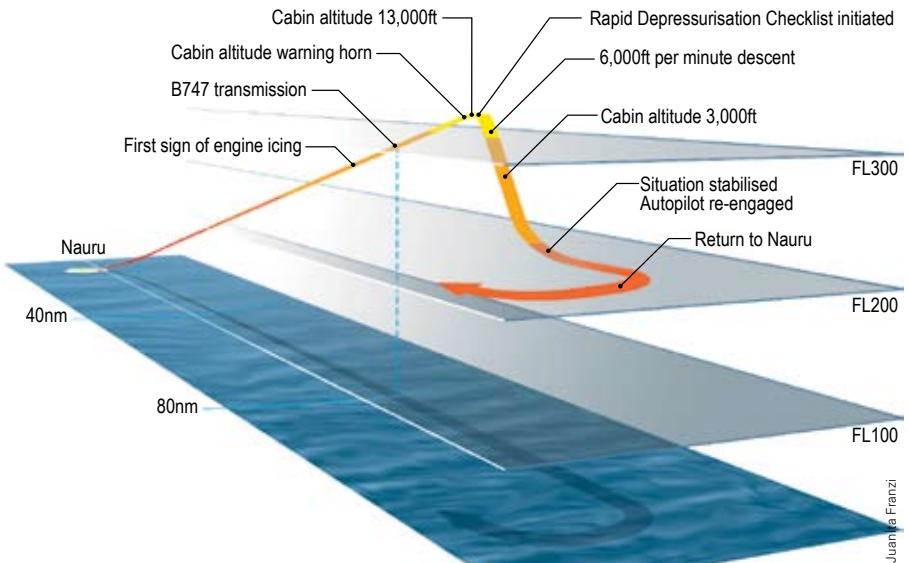
Situation stabilised: After the warning horn sounded, the B737 flight crew initiated a rapid descent, dropping 10,000ft in a minute. Once the situation had stabilised, the flight crew returned to Nauru, rather than continue to Samoa with a pressurisation problem.
