AVIATION SAFETY INVESTIGATION REPORT

BO/200105769

## Raytheon Beech 200C, VH-FMN

Mount Gambier, SA  
10 December 2001

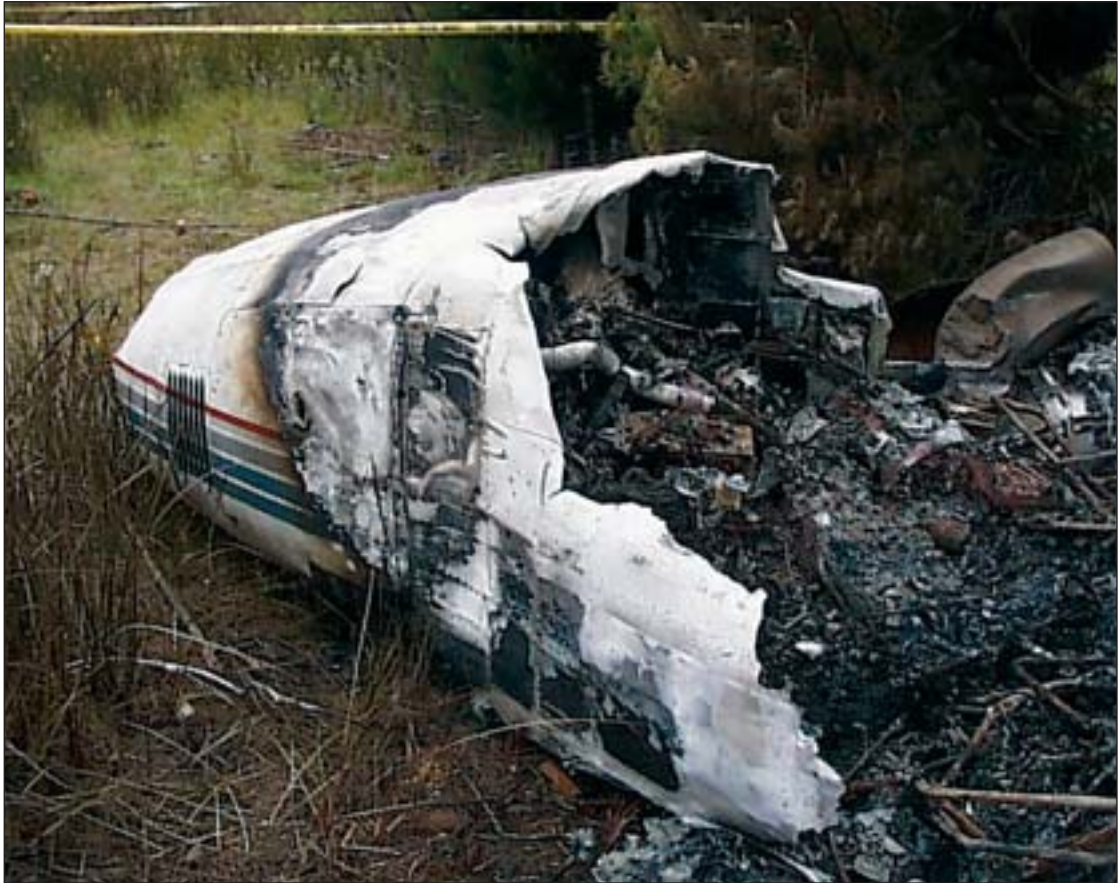
**FIGURE 4:**  
Extent of fire damage to cockpit area

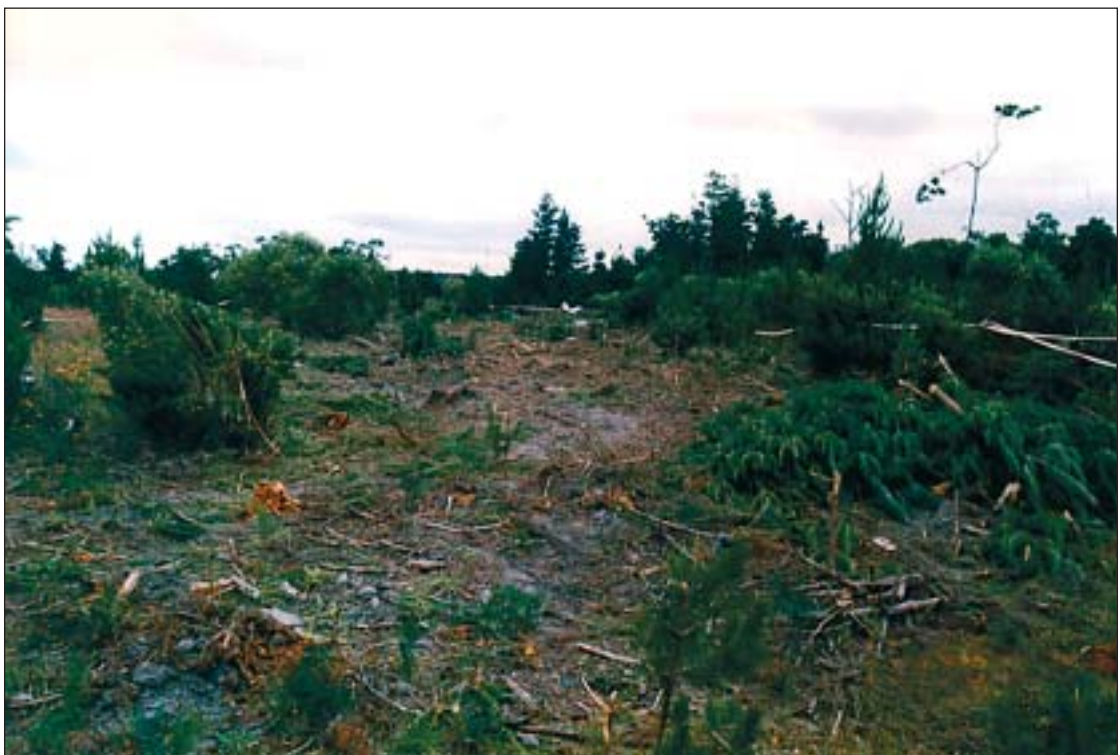
Ground vegetation consisted of a cleared pine plantation, with some secondary growth to a height of about 5 metres. Damage to trees in the approach path indicated an aircraft approach angle of about 10 to 13 degrees. The operator estimated that such an approach angle would

**FIGURE 5:**  
Impact swathe viewed from point of initial impact to final position

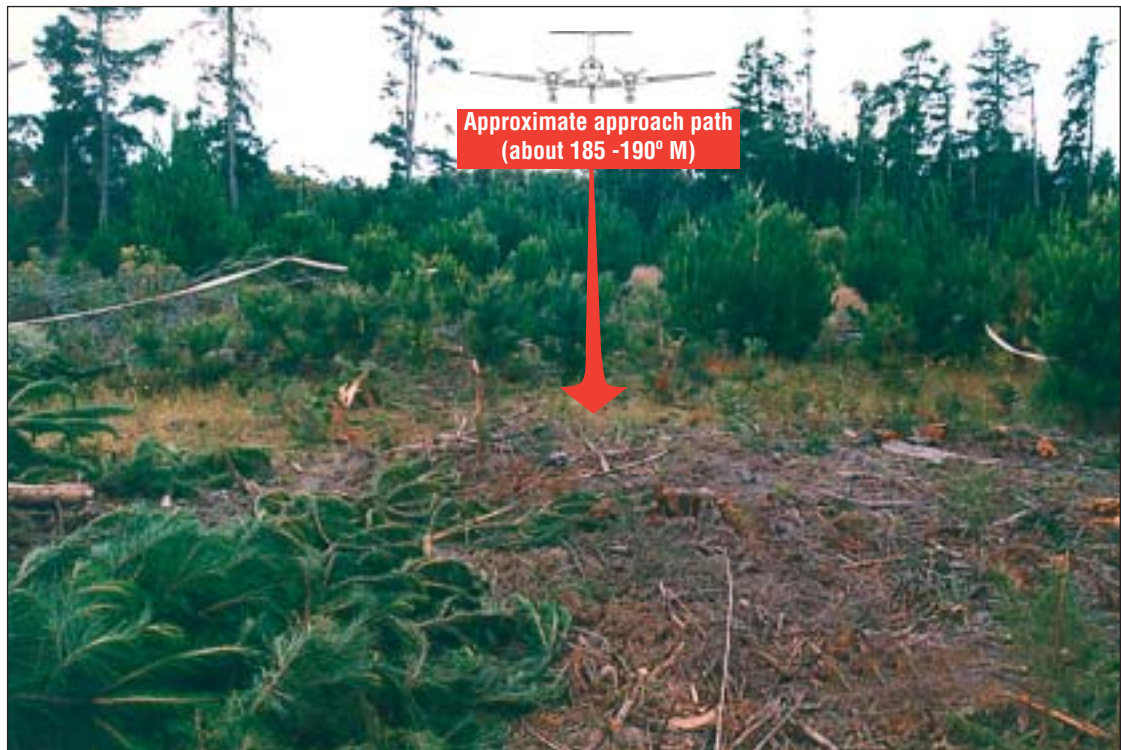
**FIGURE 6:**  
**Approximate aircraft approach path, looking back along flight path**

- The aircraft rate of descent at the point of impact was in excess of the 3 degree AT-VASIS glideslope. Damage to trees in the approach path indicated an aircraft approach angle of about 10 to 13 degrees. The operator estimated that such an approach angle would have required an aircraft attitude of about 5 degrees nose-down on the aircraft attitude indicator and a rate of descent of about 1,500 to 2,800 ft per minute, dependant upon indicated airspeed, wind effect and other factors. It is possible that the pilot remained at 1,200 ft or above until 5 NM from the VOR.

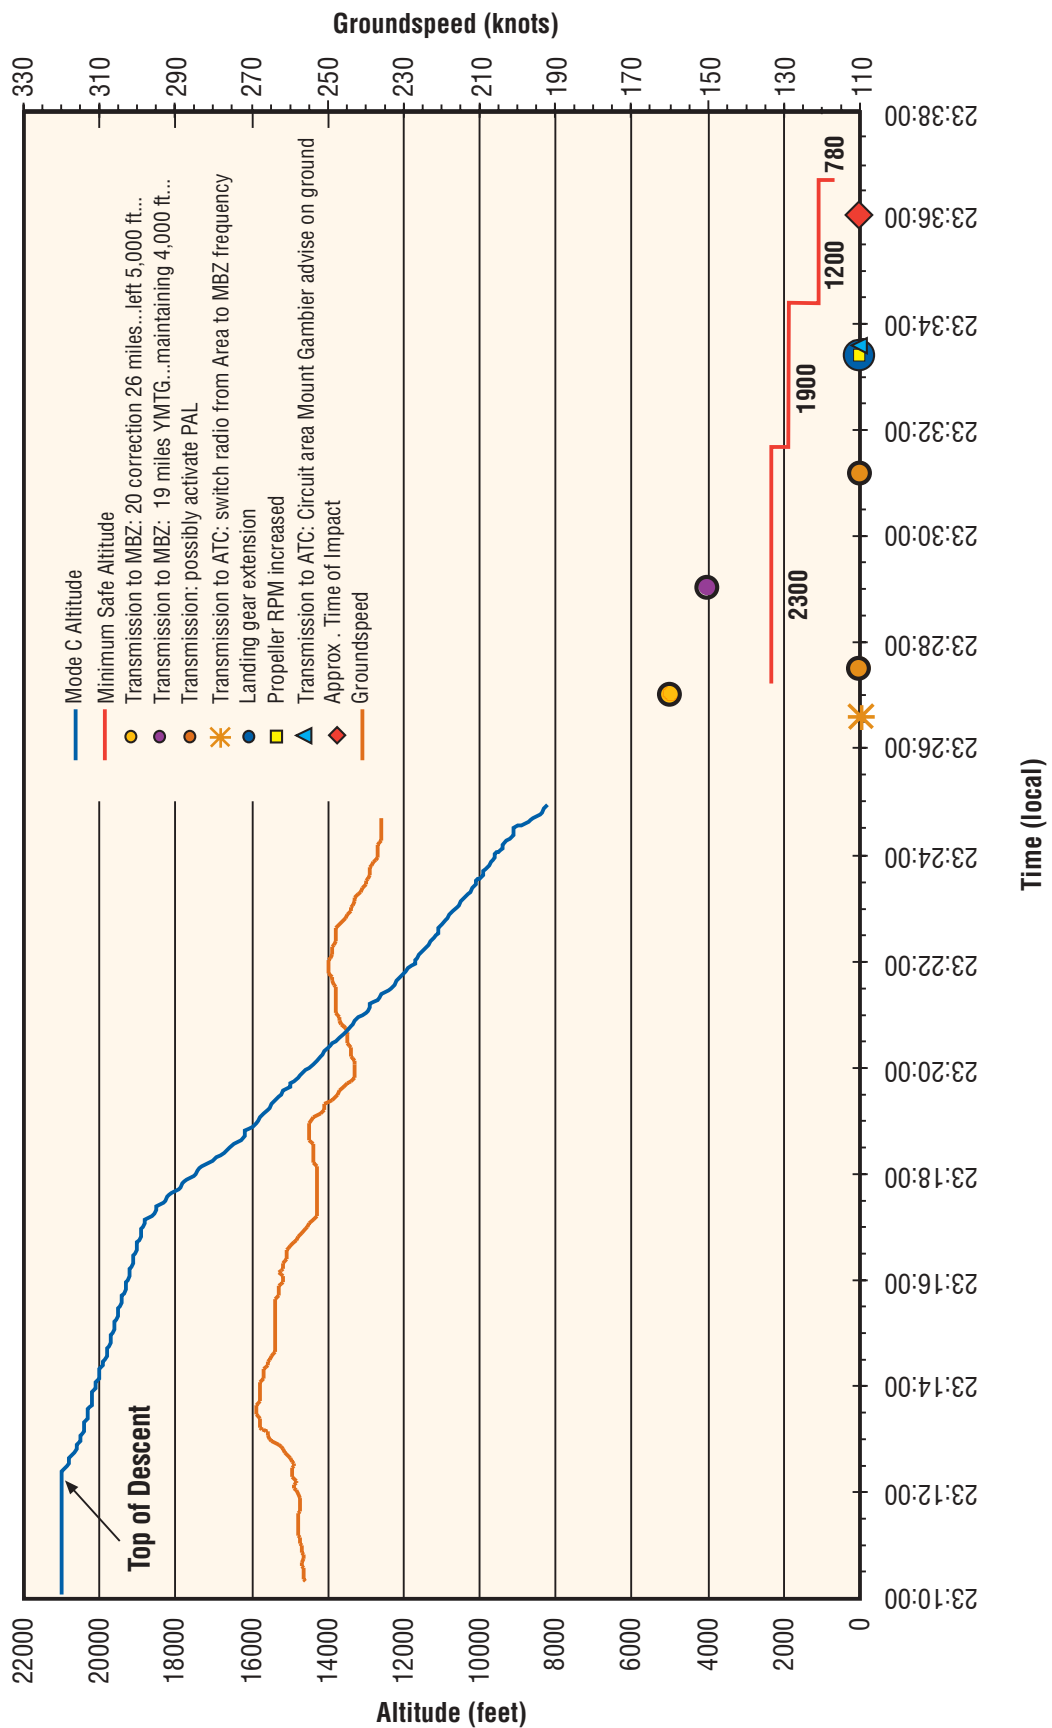
**FIGURE 9:**  
Aircraft descent profile<sup>10</sup>

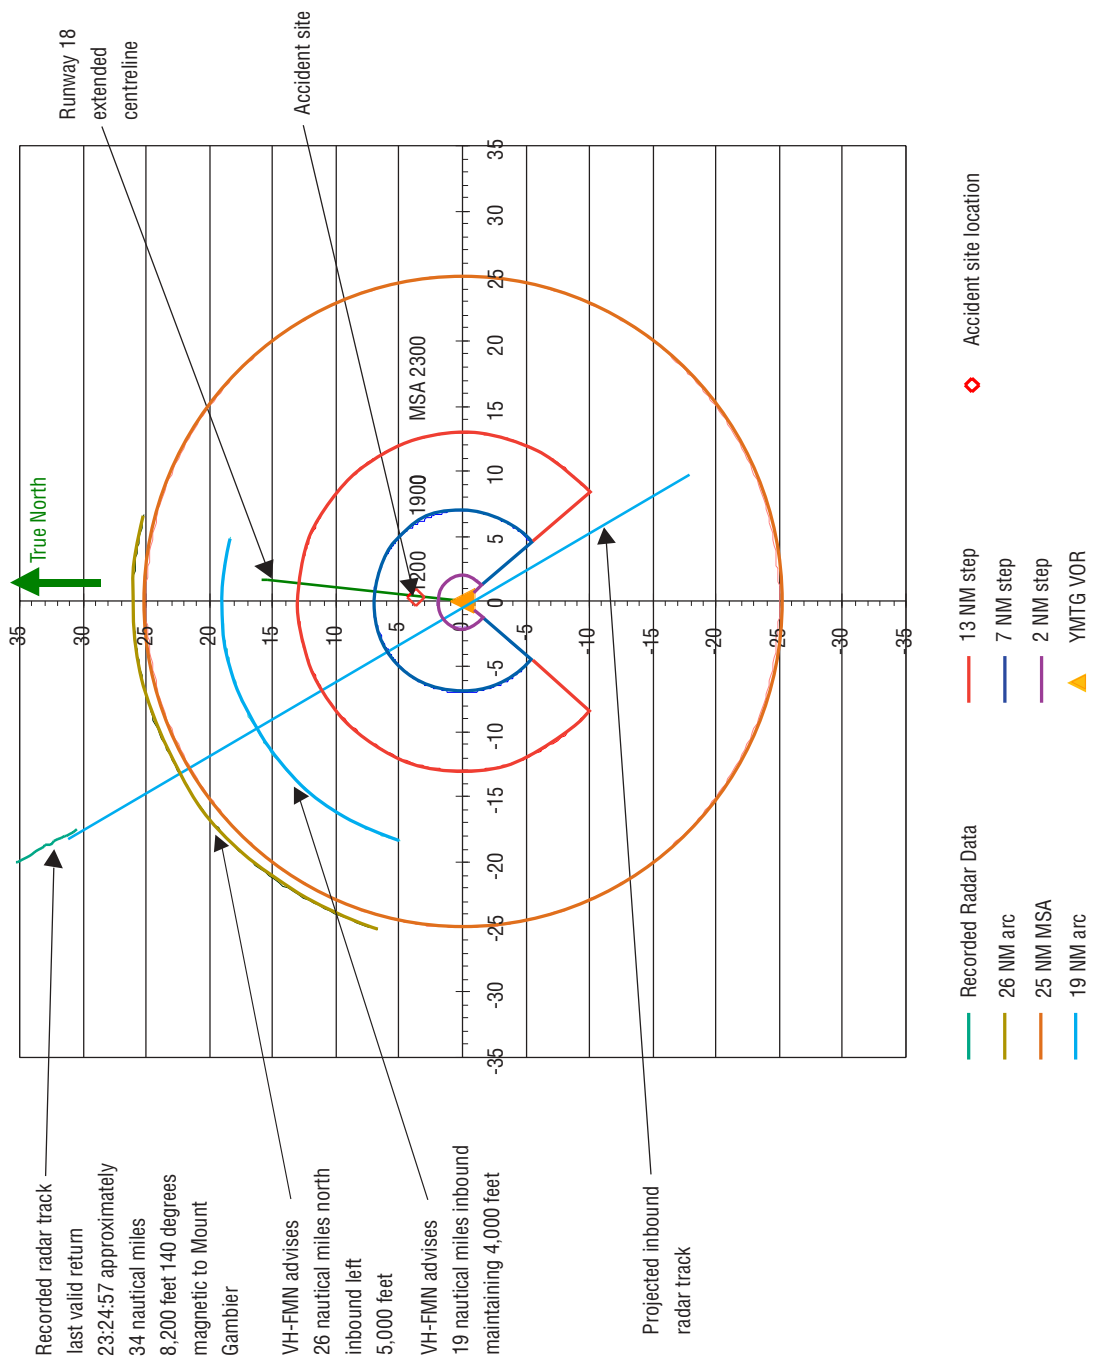
**FIGURE 10:**  
Plan view depicting pilot position reports and radar data<sup>11</sup>
