ATSB TRANSPORT SAFETY REPORT
Aviation Occurrence Investigation – AO-2010-089
Preliminary

**In-flight uncontained engine failure
overhead Batam Island, Indonesia
4 November 2010
VH-OQA
Airbus A380-842**

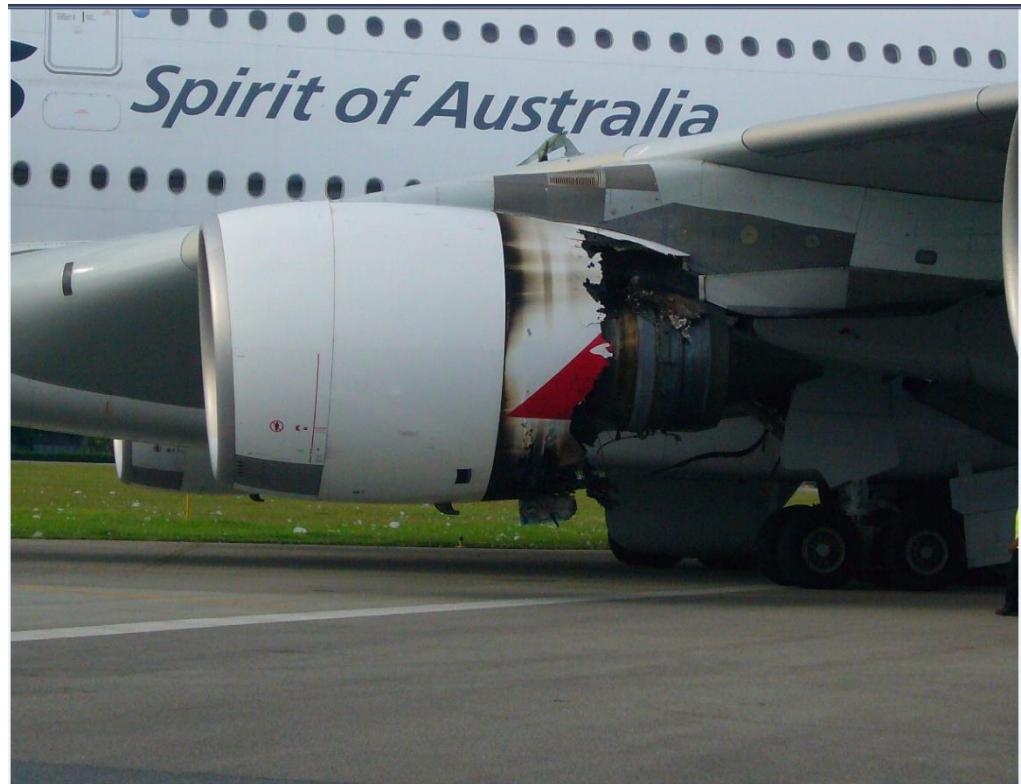
Figure 1: VH-OQA showing the damaged No 2 engine

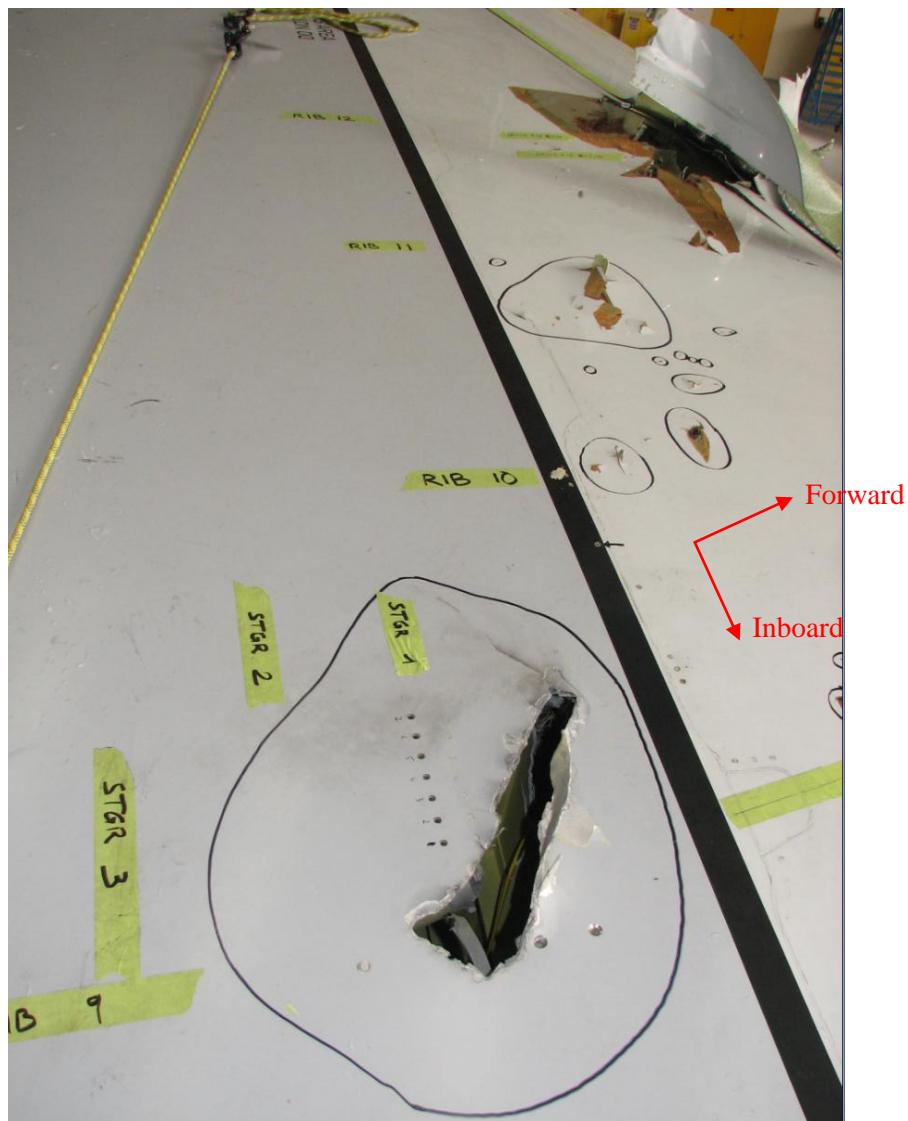
The failure of the No 2 engine ejected a number of engine components that struck the aircraft or were liberated overboard. Sections of the intermediate pressure (IP) turbine disc penetrated the leading edge of the left wing inboard of the No 2 engine, resulting in damage to the leading edge structure, the front wing spar and the upper surface of the wing (Figure 3). A small section of liberated turbine disc penetrated the left wing-to-fuselage fairing, resulting in damage to numerous system components, the fuselage structure and elements of the aircraft's electrical wiring. Released debris also impacted the left wing's lower surface, resulting in a fuel leak from the Number 2 engine fuel feed tank and left wing inner fuel tank.

Figure 3: Damage to left wing upper surface

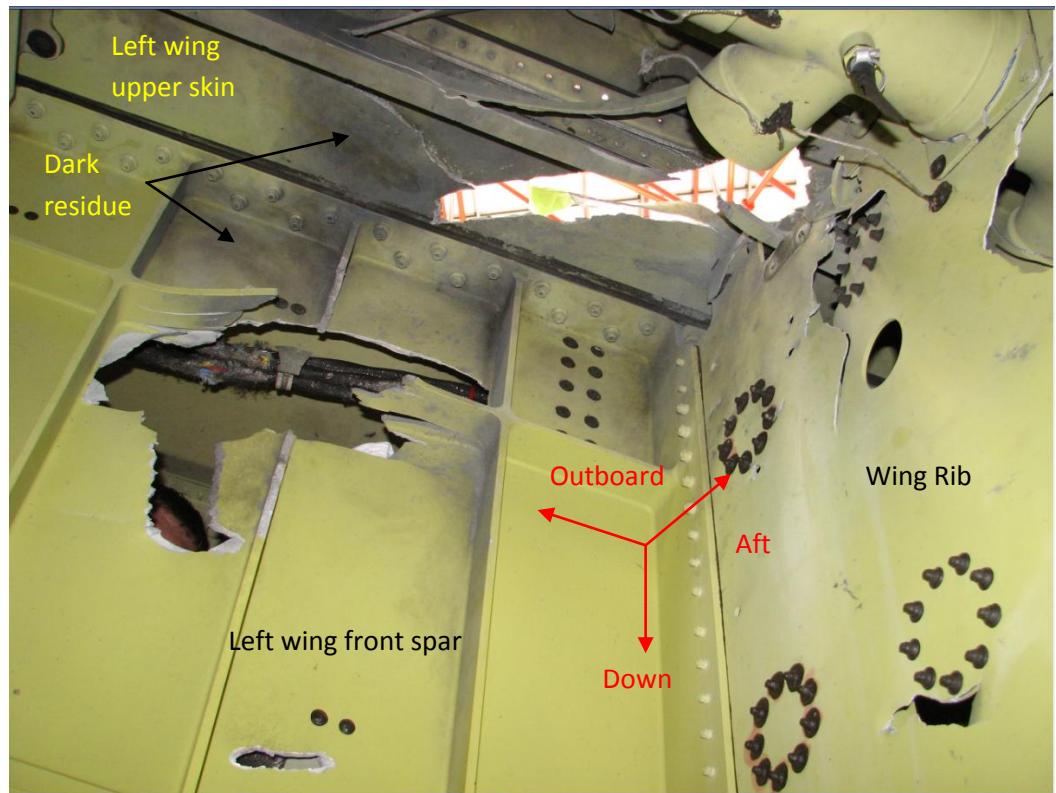
A dark residue was observed inside the left wing inner fuel tank between ribs 8 to 10 (Figure 4). The residue will be subject to further technical examination.

Figure 4: Dark residue observed in the left wing inner fuel tank

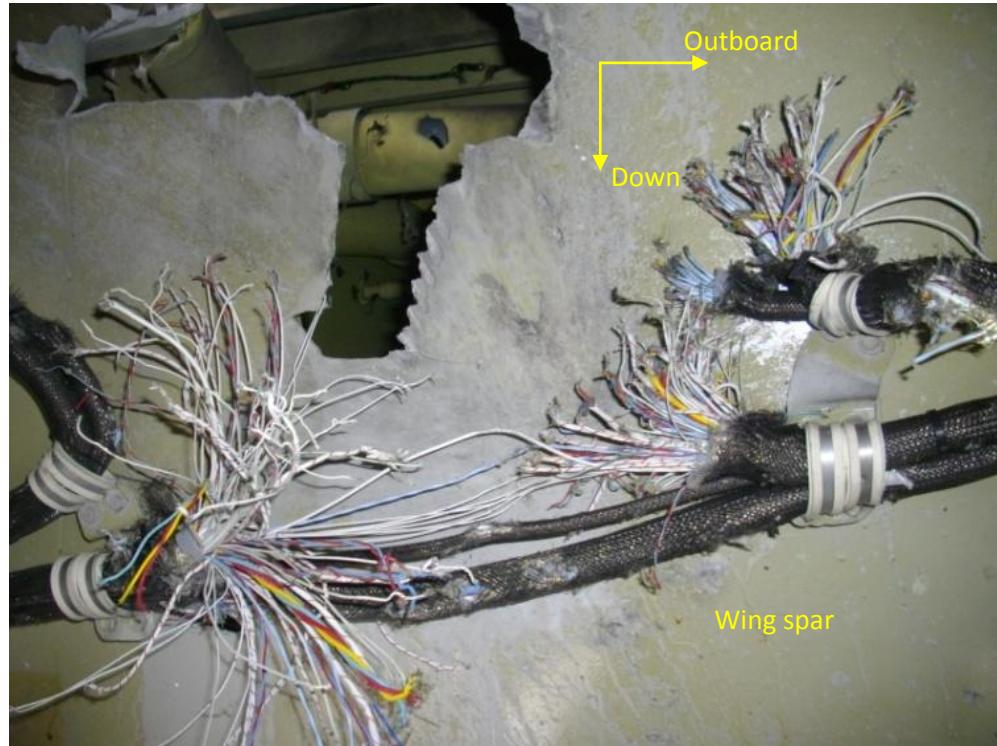
Impact damage from the liberated engine debris affected a number of aircraft systems. Damage was observed to: elements of the aircraft's electrical wiring that affected the operation of the hydraulic system, landing gear and flight controls; a number of fuel system components; and the leading edge slat system (Figure 5).

Figure 5: Damage to electrical wiring located in the leading edge of the left wing

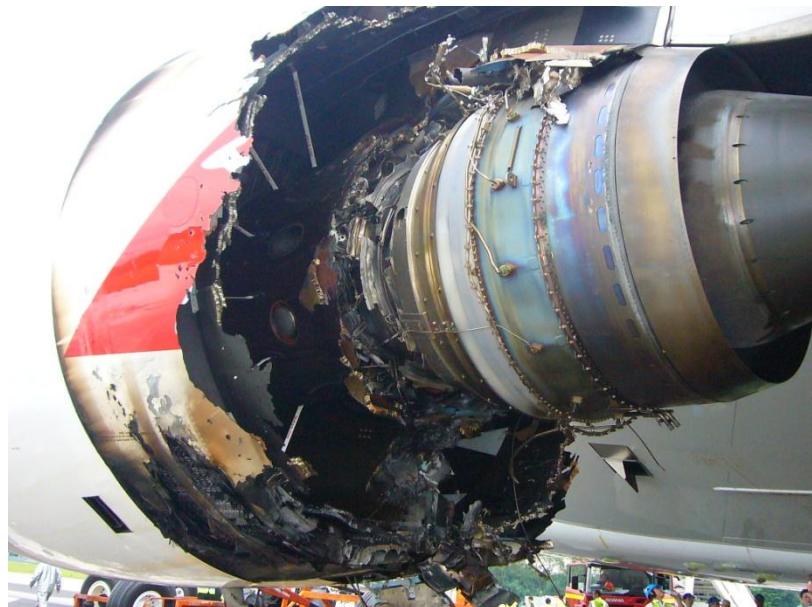
Examination of the failed No 2 engine indicated that it had sustained an uncontained failure of the IP turbine (Figure 7). The turbine disc, blade and nozzle

Damage was also evident to the engine cold stream duct and outer cowl panels. The No 2 engine thrust links were severed and extensive damage was evident to the LP turbine nozzle guide vanes and stage-1 LP turbine blades.

Figure 7: Damage to the No 2 engine

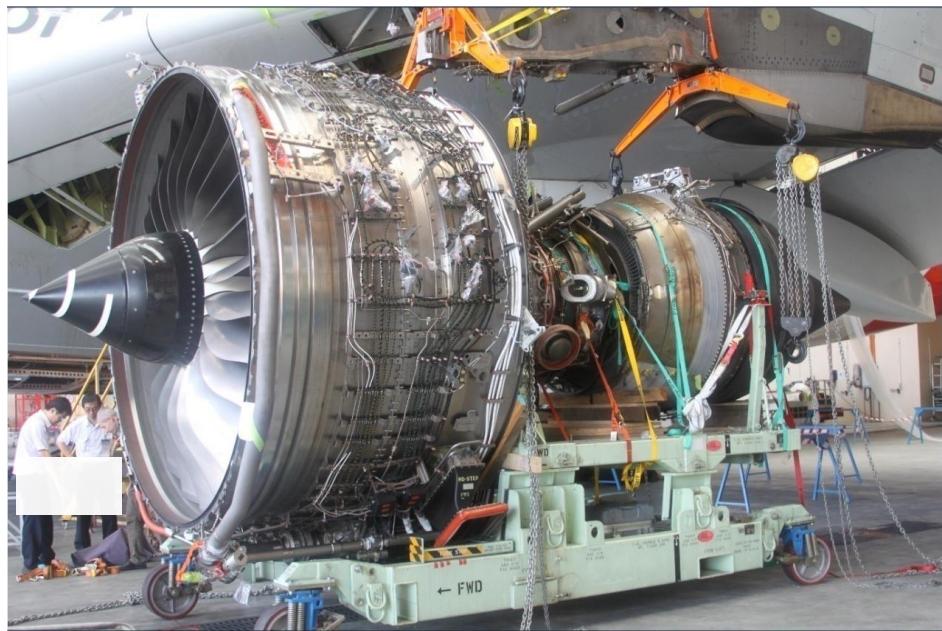
The No 2 engine was removed from the aircraft and taken to a certified Trent 900 engine maintenance, repair and overhaul facility in Singapore. The engine has been examined and disassembled, under the supervision of the ATSB, and relevant components have been forwarded to the Rolls-Royce plc facility in Derby, in the UK for technical examination (Figure 8).

Figure 8: No 2 engine after removal from the aircraft

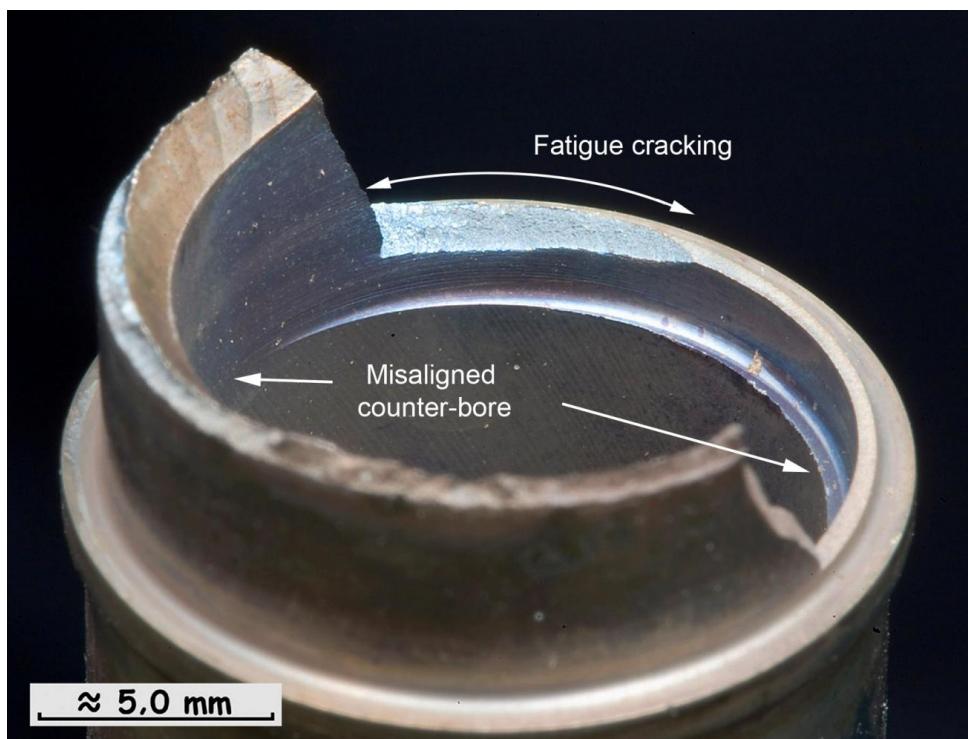
A recent key finding from those examinations was the presence of an area of fatigue cracking within a stub pipe that feeds oil to the HP/IP bearing structure. That cracking was associated with a misaligned region of counter-boring within the stub pipe outlet. The misaligned counter-boring had produced a localised thinning of one side of the pipe wall (Figure 9).

Figure 9: Detail of stub pipe showing misaligned counter-bore

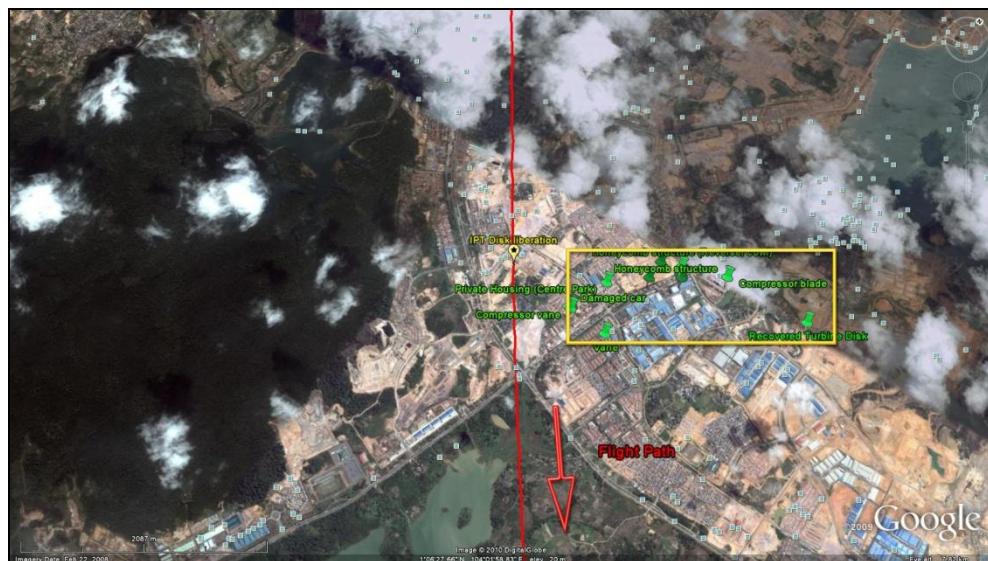
The components that were located on Batam Island were all to the left of the aircraft's flight path. A large segment of IP turbine disc was located about 2.5 km from the aircraft's location at the time of the failure (Figure 10).

Figure 10: Area of recovered components

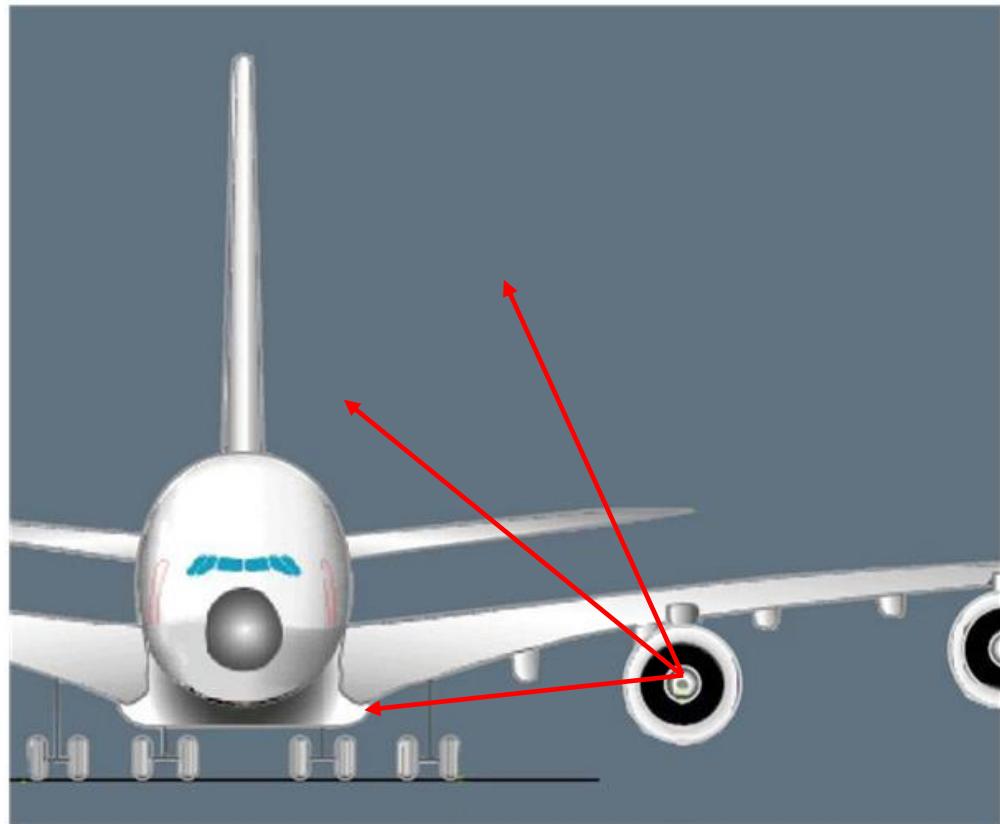
Damage to the aircraft's left wing and the wing-to-fuselage fairing indicated that several IP turbine disc segments were liberated inboard (Figure 11).

Figure 11: Known direction of travel of some of the liberated engine segments

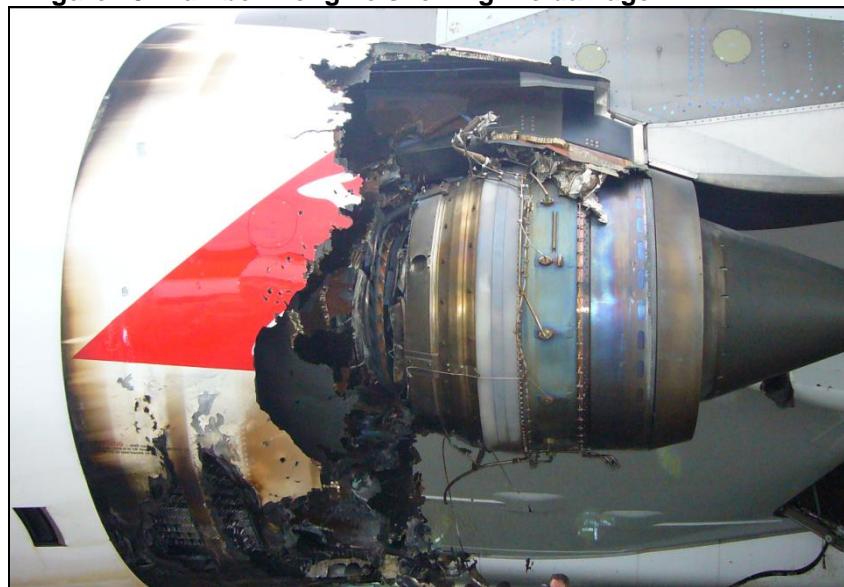
The rear section of the No 2 engine and cowl was damaged by fire (Figure 13). Some components forward of the engine firewall were heat affected.

Figure 13: Number 2 engine showing fire damage

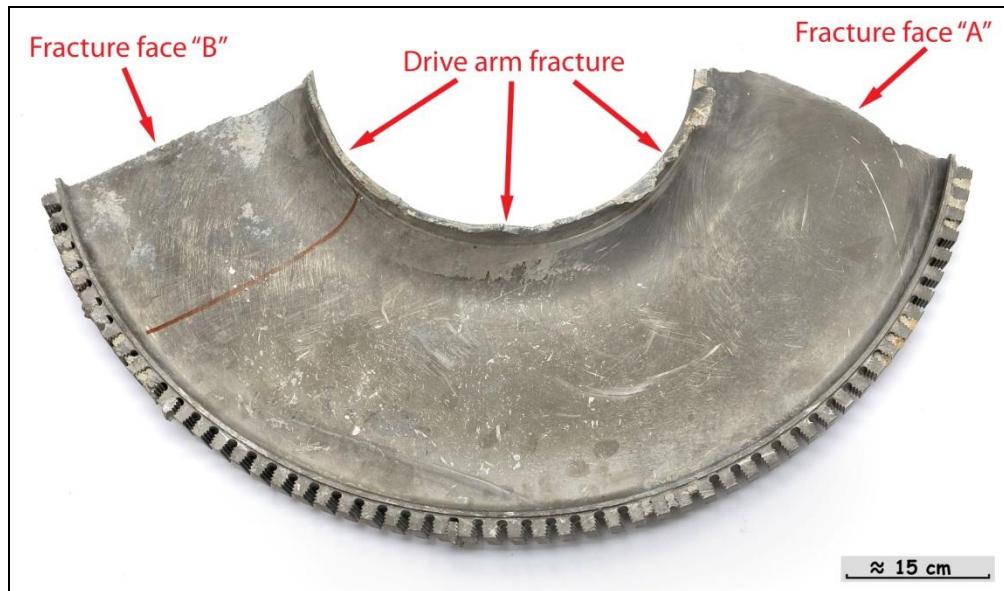
The recovered section of IP turbine disc approximated one-third of the total disc (Figure 14).

Figure 14: Recovered section of IP turbine disc (as viewed from the rear of the engine)

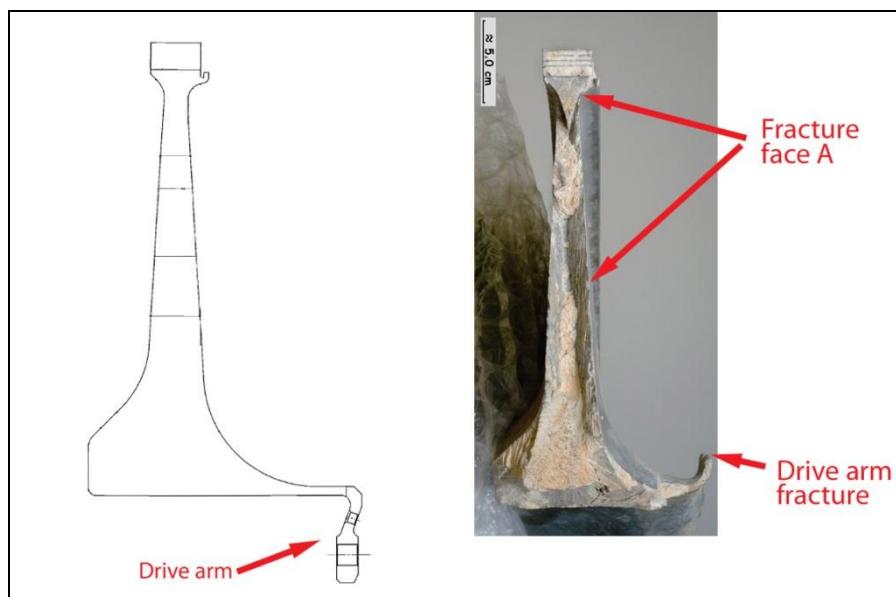
The mass of the recovered IP turbine disc section was almost 70 kg. The section exhibited three distinct fracture faces; two radial fractures from the bore to the external diameter (labelled 'A' and 'B' in Figure 14), and a circumferential fracture face in the region adjacent to the drive arm (the central cylindrical connection to the intermediate pressure spool shaft). The remaining section of the drive arm presented considerable plastic deformation, having bent outward by about 90° (Figure 15). The arm failed at the R850 holes and a section of the drive arm is still missing.

Figure 15: Cross section of the recovered portion of the IP turbine disc

Visually, the IP turbine disc fractures all appeared to be consistent with a ductile overstress failure mechanism. There was no visible evidence of any pre-existing defects identified during the preliminary examinations.

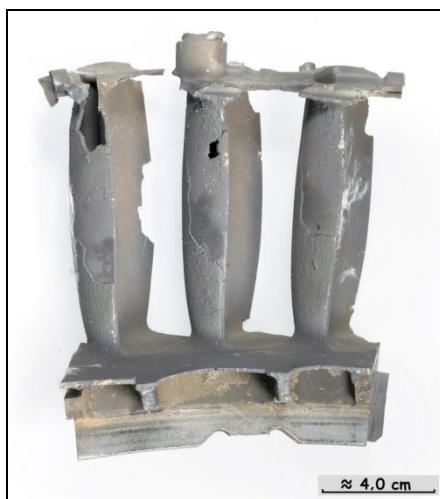
Three triple segments of the LP1 NGV were received. One of the segments was almost complete, with all three vanes present along with the inner platform and some areas of the outer platform (Figure 16). The remaining two NGV segments retrieved contained the remains of the inner platform only, and the vanes exhibited significant damage.

Figure 16: Portion of LP turbine first stage nozzle guide vanes that was recovered from Batam Island, Indonesia

Evidence of a deposit was observed on the leading (inlet) vane surfaces (as shown in Figure 15). A flaked sample of the deposit was extracted from the vane and the cross section prepared for further examination.
