National Transportation Safety Board

Investigative Update of Battery Fire Japan Airlines B-787 - Jan 7, 2013

Deborah A.P. Hersman
Chairman
January 24, 2013

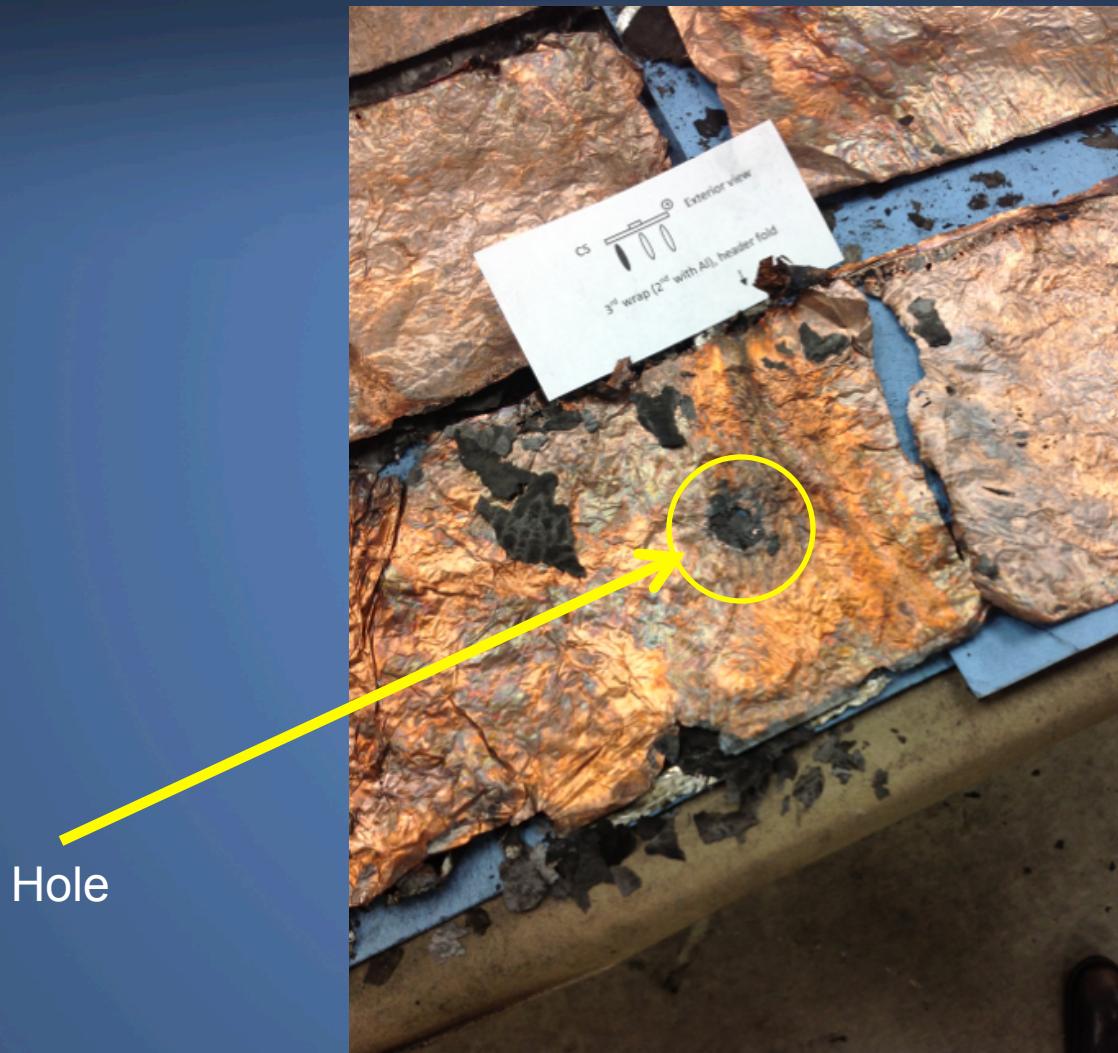
Damaged Electrode - Internal Short Circuit

Hole

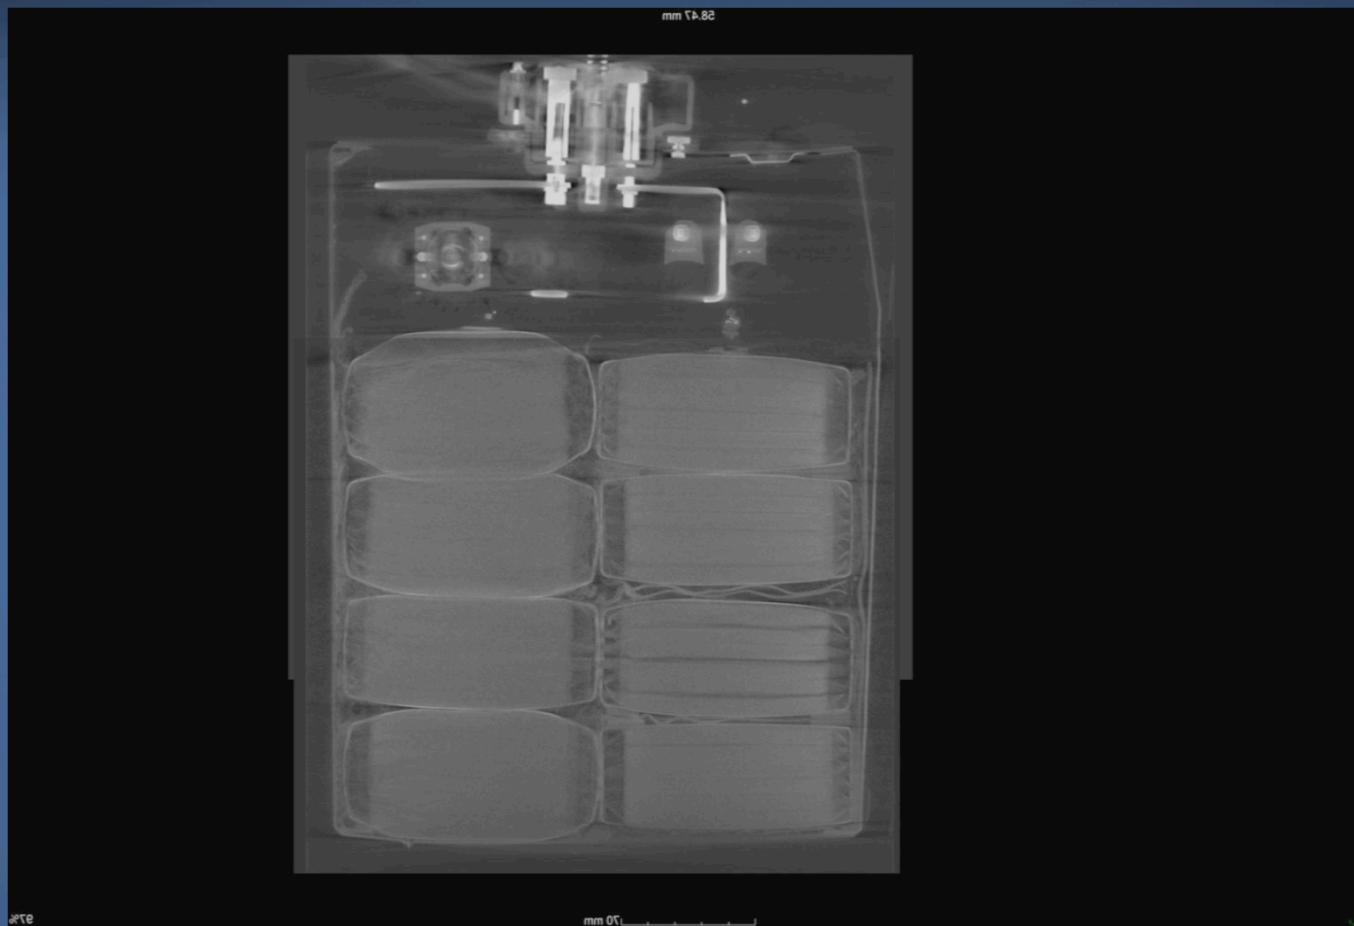
CT Scan of Battery

- Fire was present
- Signs of thermal runaway
- Signs of electrical short circuiting
